# SHORE POINT ARCHITECTURE, PA

9 Main Avenue  
HPC Demolition Application Text  
5/4/21

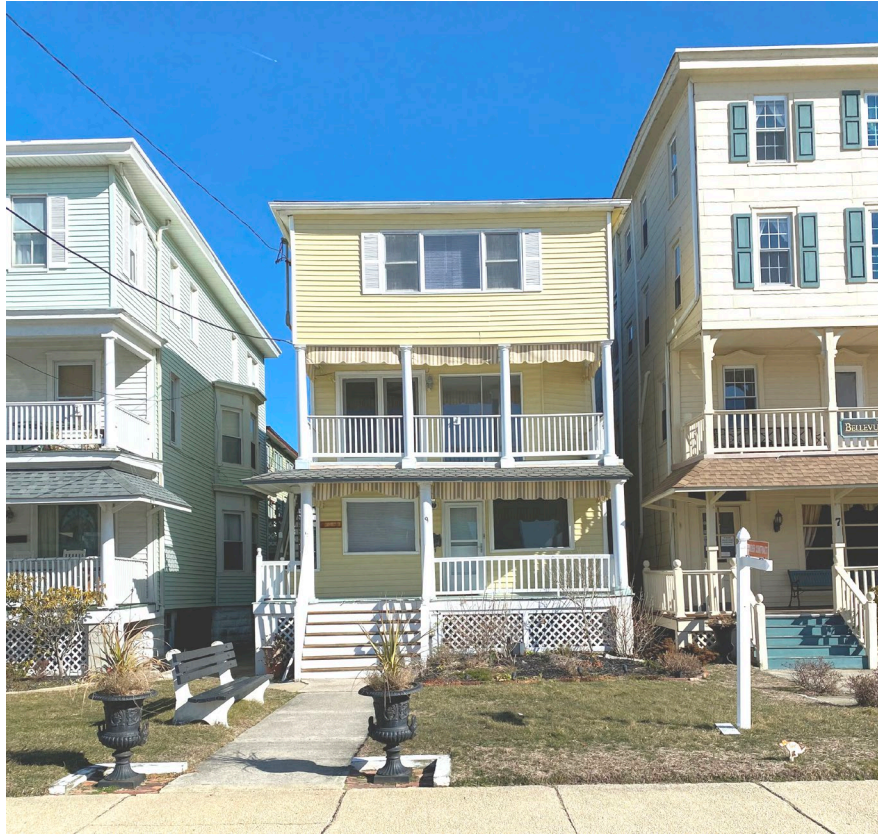
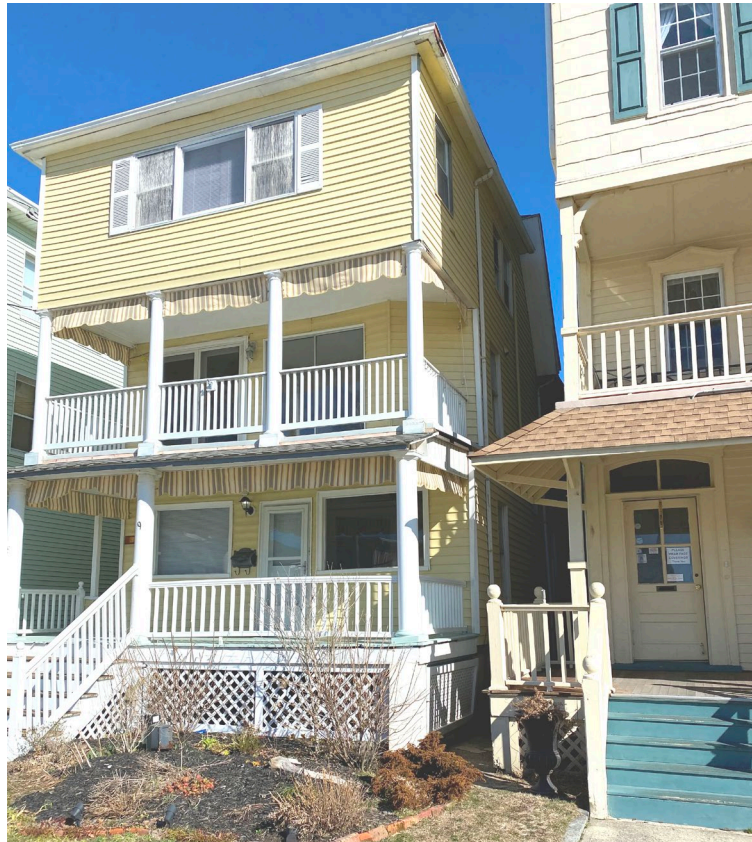
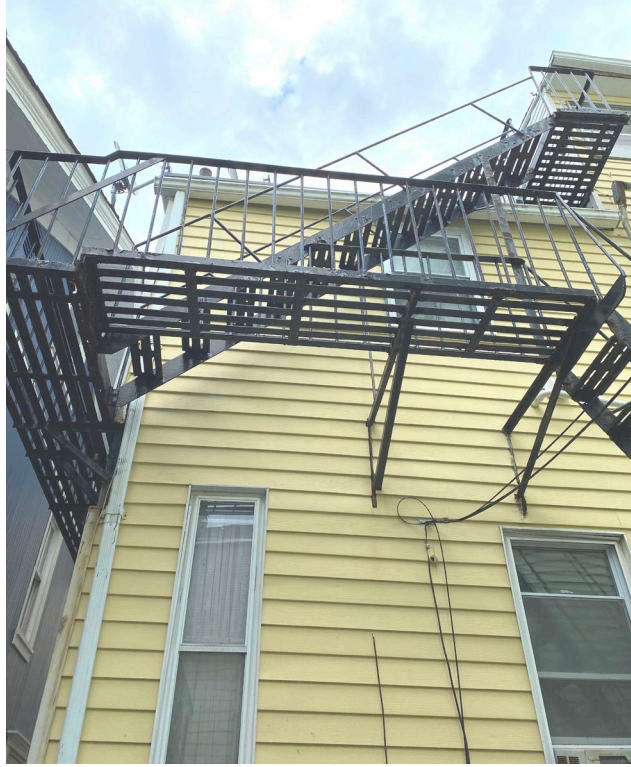
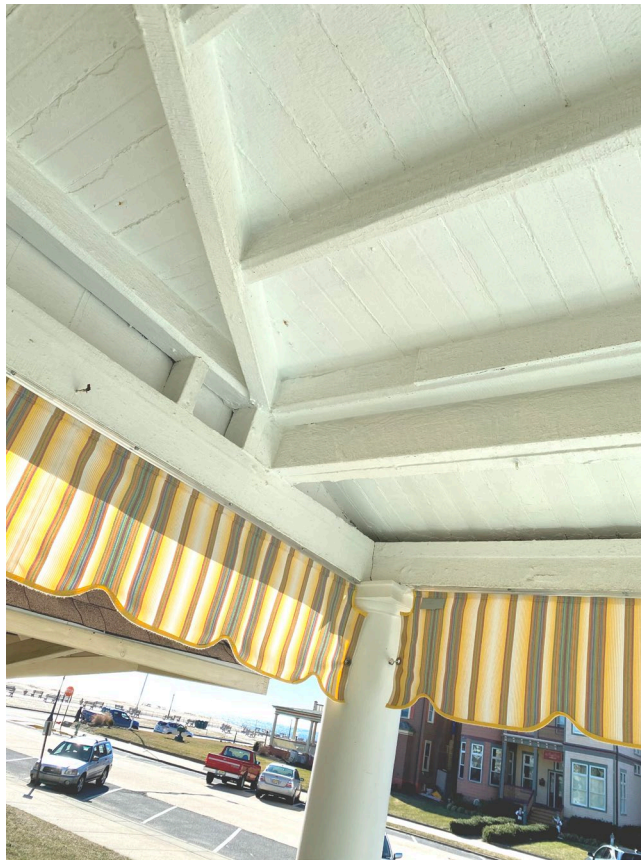
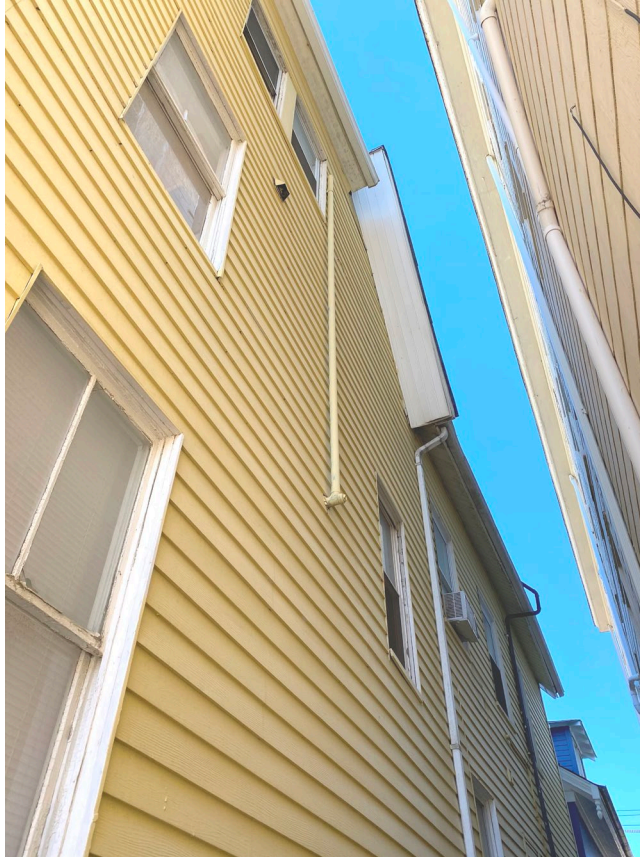
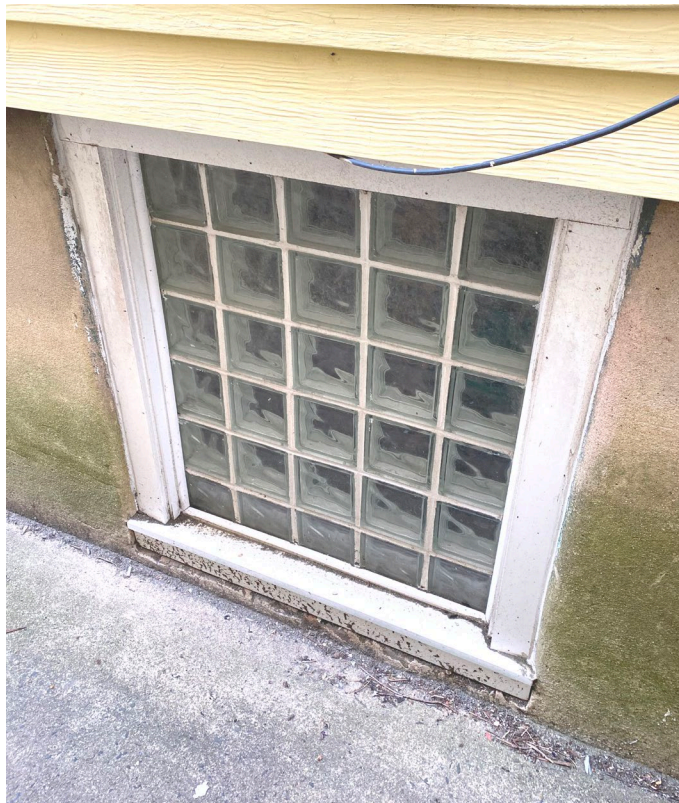
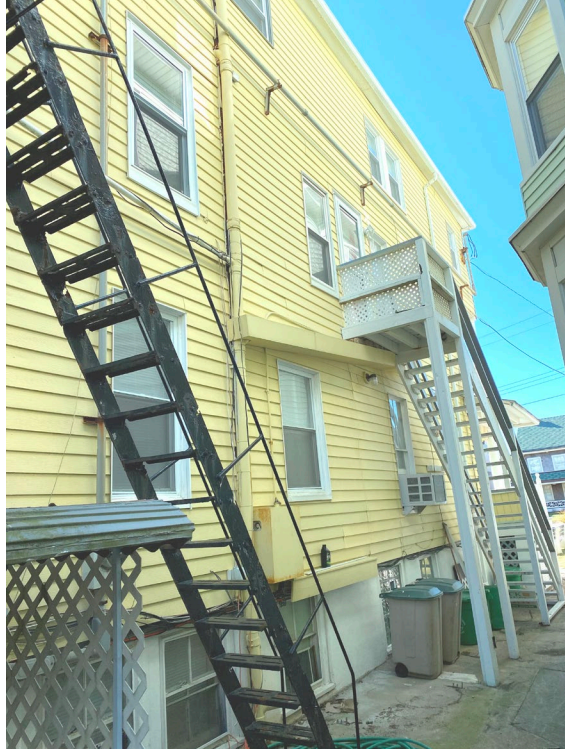
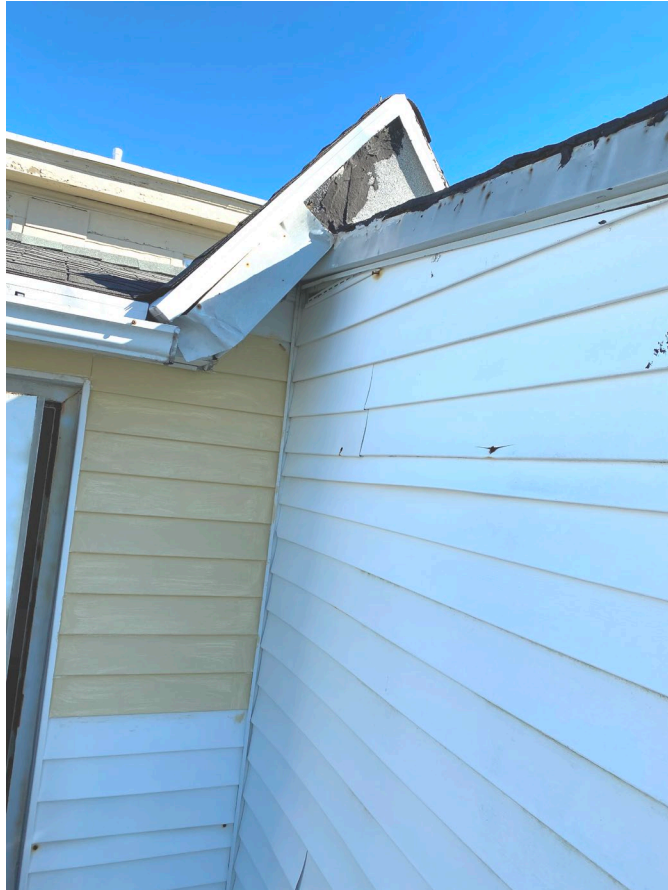
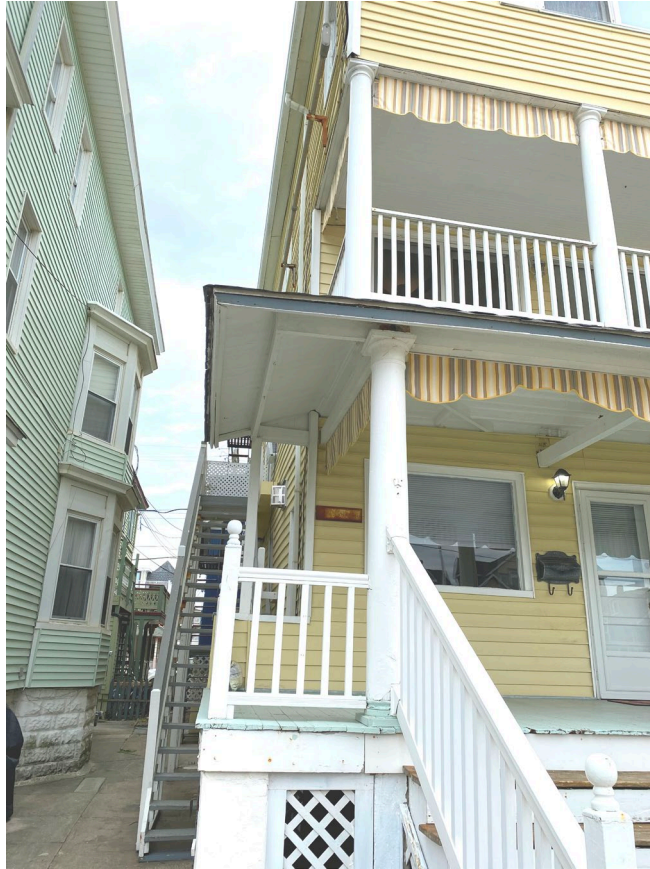
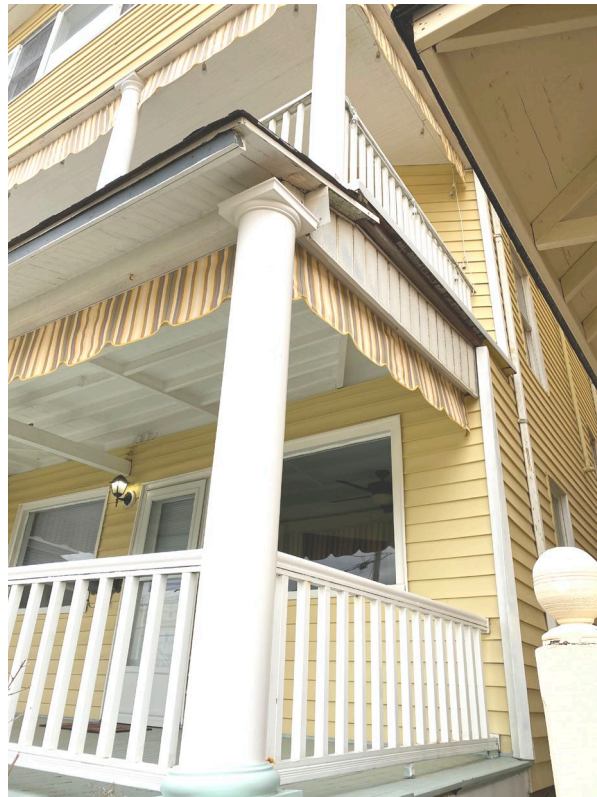
Between the 1930's and today, the house was transformed from a hotel (as indicated on the 1930's Sanborn map), into a multi-family dwelling (see "Existing Conditions Drawings", sheet A-2), and the roof form was (likely) expanded and modified several times. The current roof form consists of a low-slope, 2:12, hip roof at the front portion of the house, a very steep sloped half-gable (18:12) that intersects with the low slope hip roof at the east side of the house, an asymmetrical gable at the rear of the house (consisting of a 13:12 pitch on the east side and a 2:12 pitch on the west side, which was likely modified to allow for access to a metal fire-escape), and a small portion of a gable roof that projects above the main roof line on the west side of the house. Additionally, there are several level changes that exist within the structure, which suggests the building has been expanded numerous times. There are varying window/door sizes, window/door types, window/door head heights, and window/door arrangements, which suggests that much of the original fenestration has been modified over time. Metal fire escapes and wood framed exterior stairs have been added to provide egress from the individual dwelling units. Vinyl siding has been installed throughout and all original siding, trim, and windows / door casings have been removed or concealed. The existing porch (which was likely not designed to handle a third-floor building load and roof load), is failing structurally, particularly at the south-east corner, where over 9" of settlement was observed. The low-slope hip roof, which is structurally unsupported and cannot support itself in its current configuration, is deflecting significantly at the interior of the third floor. See photos of the existing conditions below.

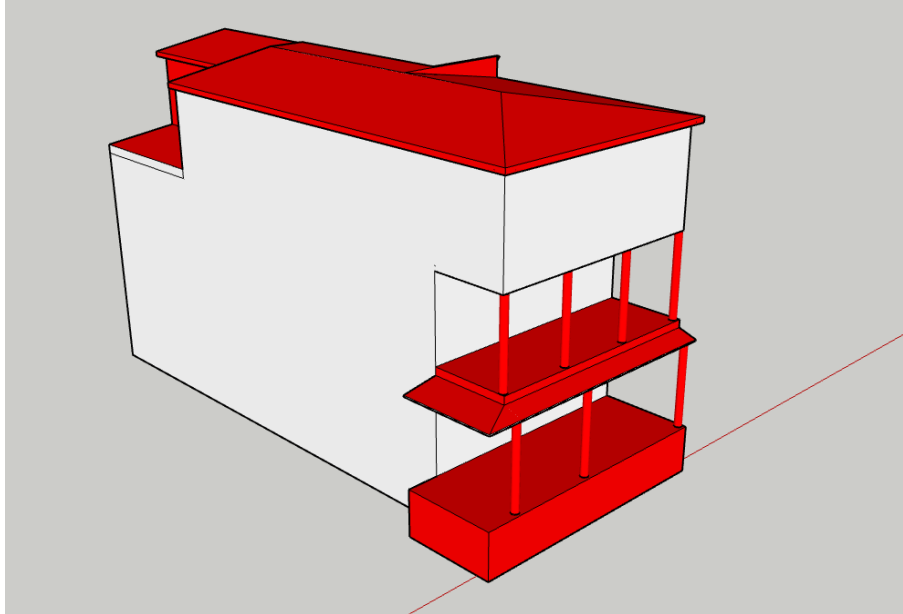
View from south-west

As part of this application, we are requesting demolition of the following areas for partial demolition, 33.7%: The entire roof area; the entire first and second floor porches; and portions of the third floor, side / rear wall areas. The areas are indicated for demolition are indicated on Architectural Drawing, A-3. Additionally, to assist in clarifying the areas to be demolished, a 3D “massing model” was created and the areas scheduled for demolition are highlighted in red (see below).
