06. Window and Door Condition Report

The house currently contains 89 doors and windows that fall under the purview of the Commission. We have sorted these into five categories: Basement Windows, Historic Windows, Secondary Windows, Vinyl Windows, and Modern Windows. To assist in understanding and reviewing so many fenestrations, we have color-coded them by type and illustrated their location on the enclosed floor plans and elevations. Also included are photographs of each individual window and door showing its characteristics and condition.

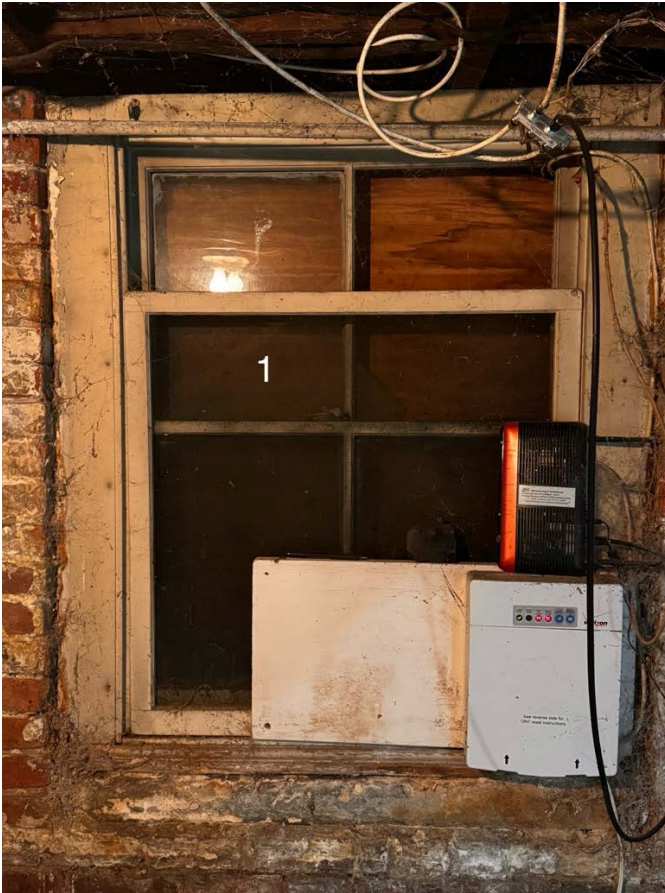
#1 — Basement, west elevation. This basement window is larger than all the other basement windows and may have been modified at an earlier time. A portion of the window sits below grade. We propose modifying the opening to match the dimensions of the other, more typically shaped basement windows that sit above grade.

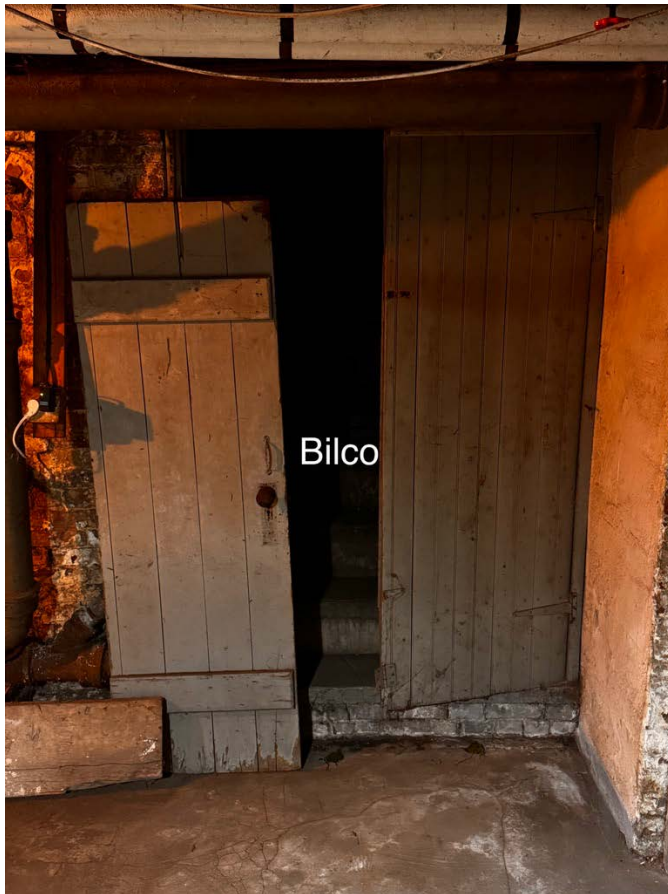
Bilco — Basement, west elevation. Existing concrete steps to exit to grade. There are a pair of interior wooden doors and a pair of exterior wooden doors; all are in poor condition. We propose replacing the entire Bilco enclosure with a new metal unit painted to match the body of the house.

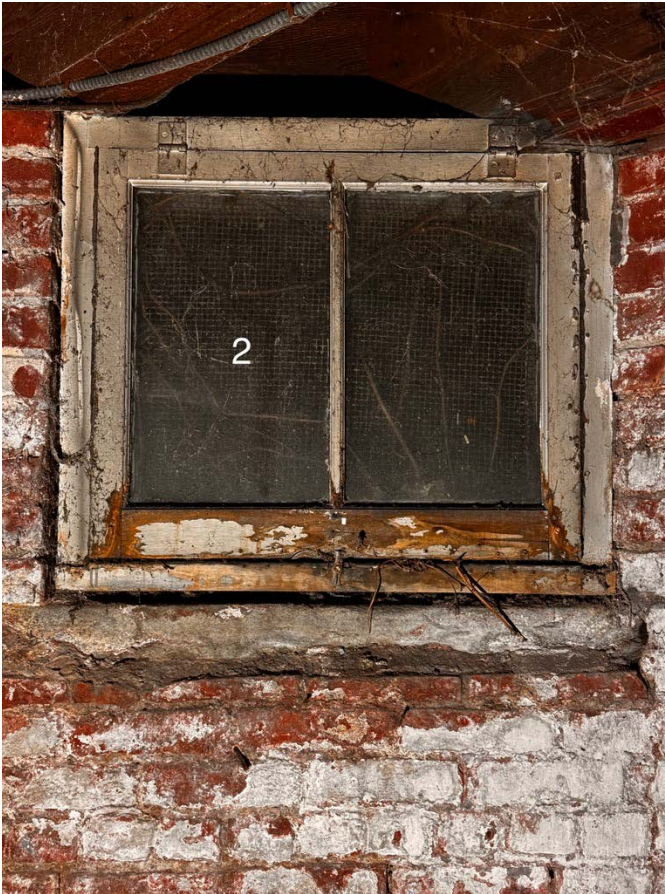
#2 — Basement, west elevation. This window is typical of the single-muntin, two-pane window found throughout the basement. All basement windows are wood and in poor condition. Many of these windows (including this one) have wet rot due to their proximity to grade. The wood is moist and spongy. We proposed replacing all basement windows with a conforming, wood-core window with the same muntin pattern.

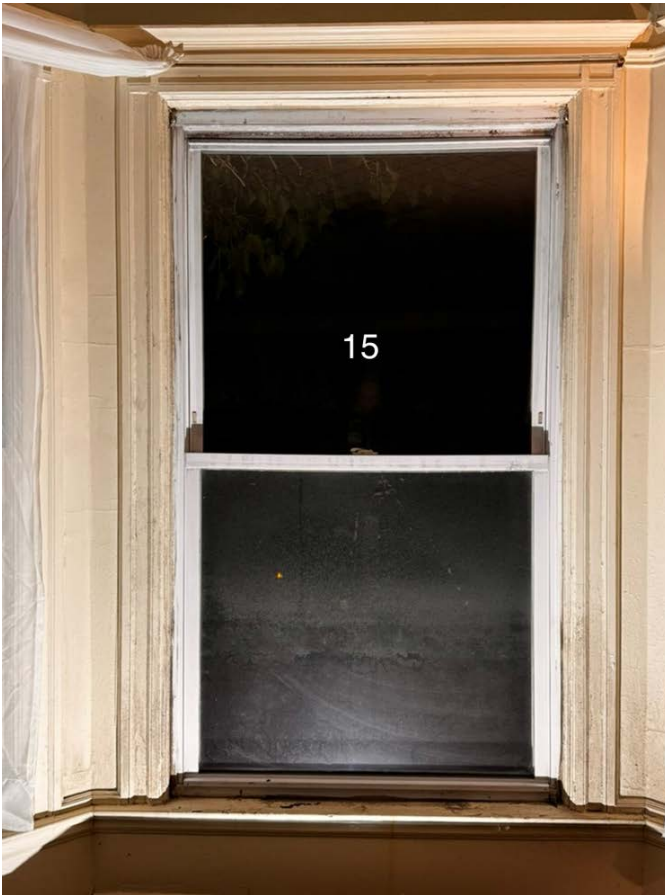
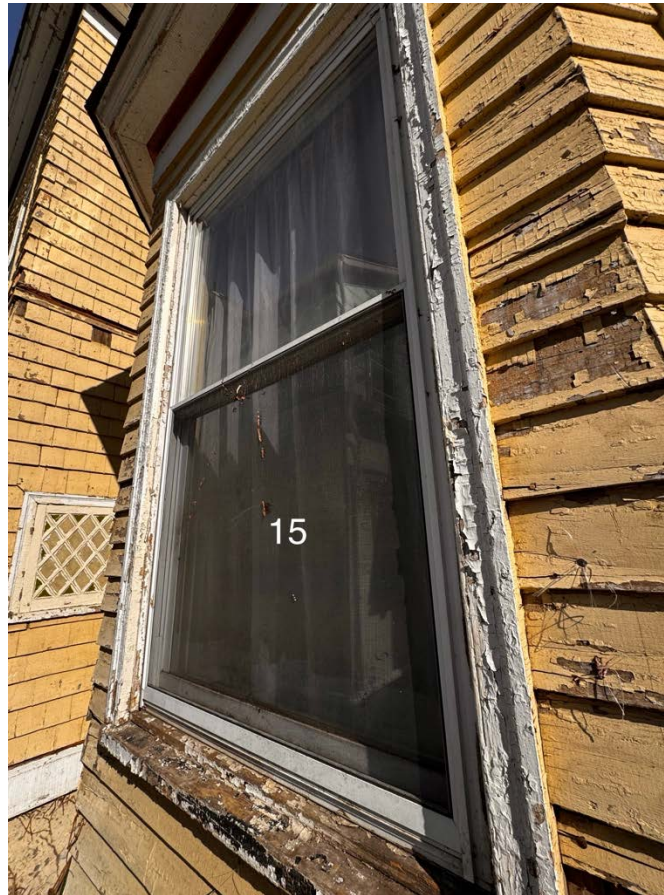
#15 — Level 1, west elevation. This vinyl window is in the center of the Level 1 west bay.

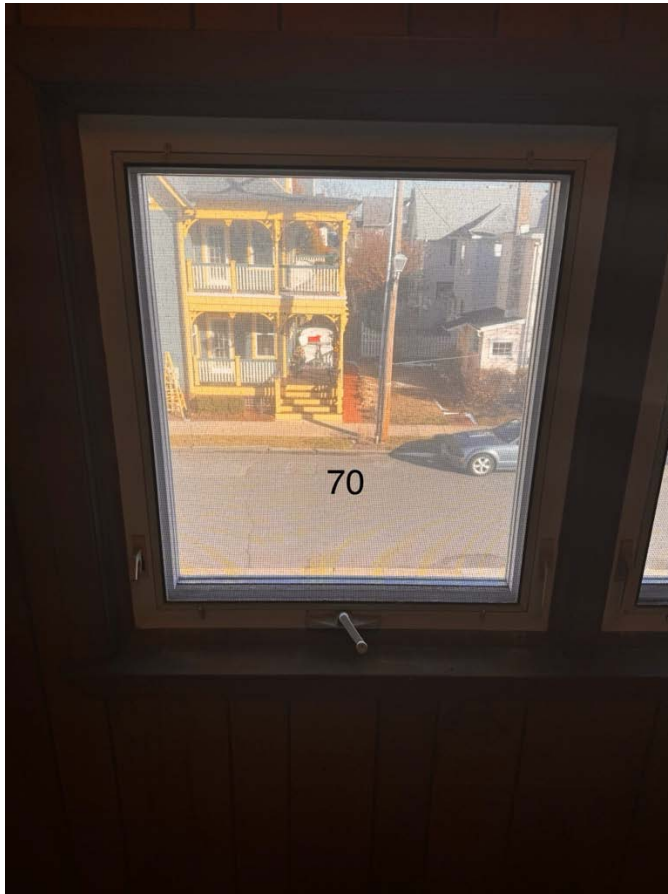
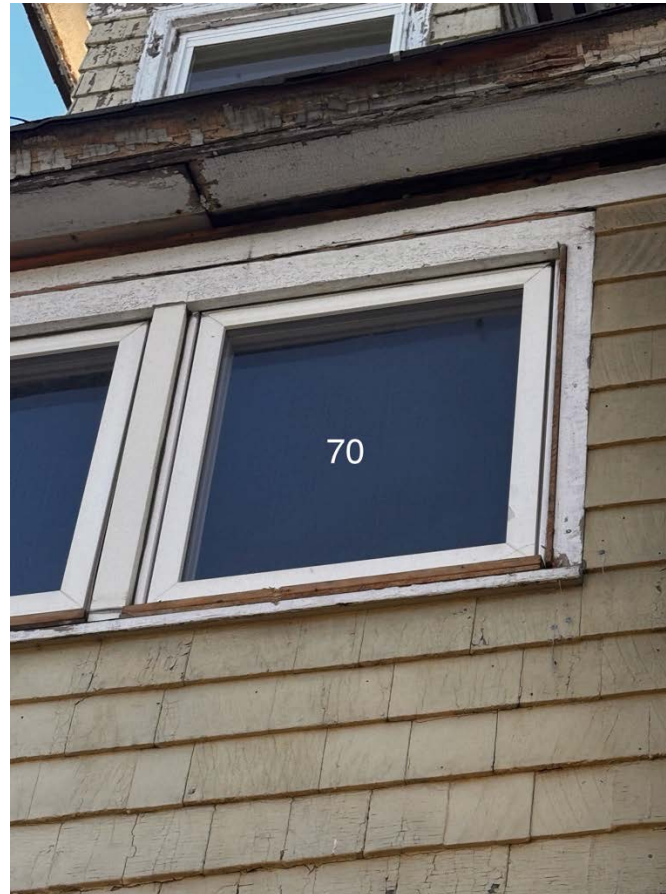
#70, #71, #72, #73 — Level 2, east elevation. These four vinyl awning windows occupy an area that used to be a balcony of covered porch. This area is proposed to be restored to a porch area and these four non-historic windows are to be eliminated from the elevation.

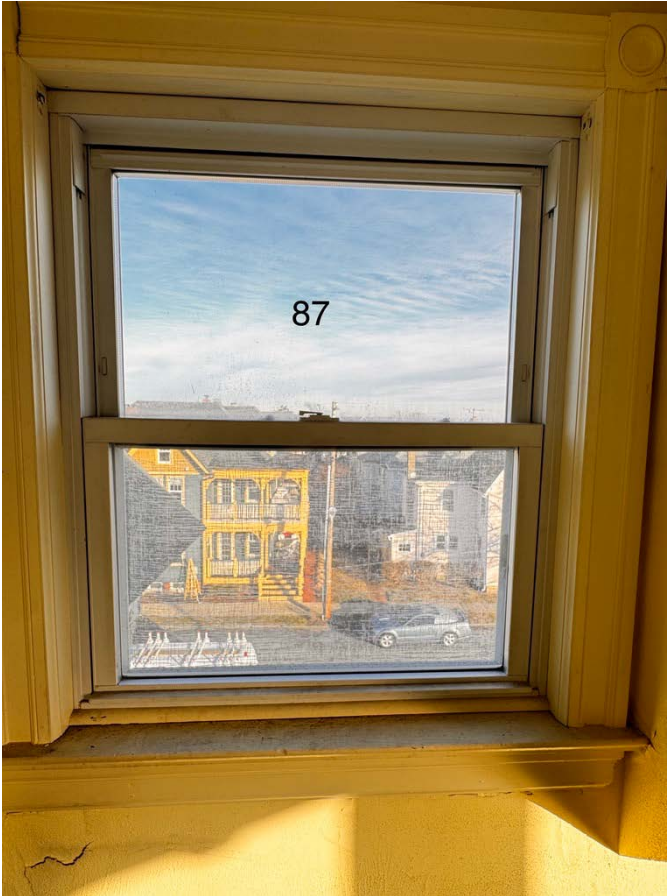
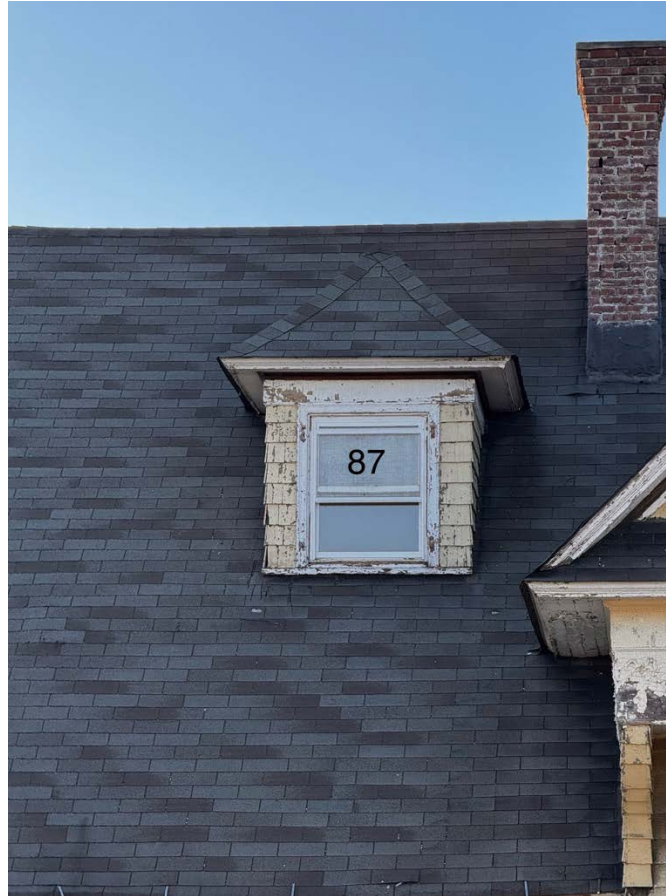
#87 — Level 3, east elevation. This vinyl window is in an east-facing dormer near the rear of the house.

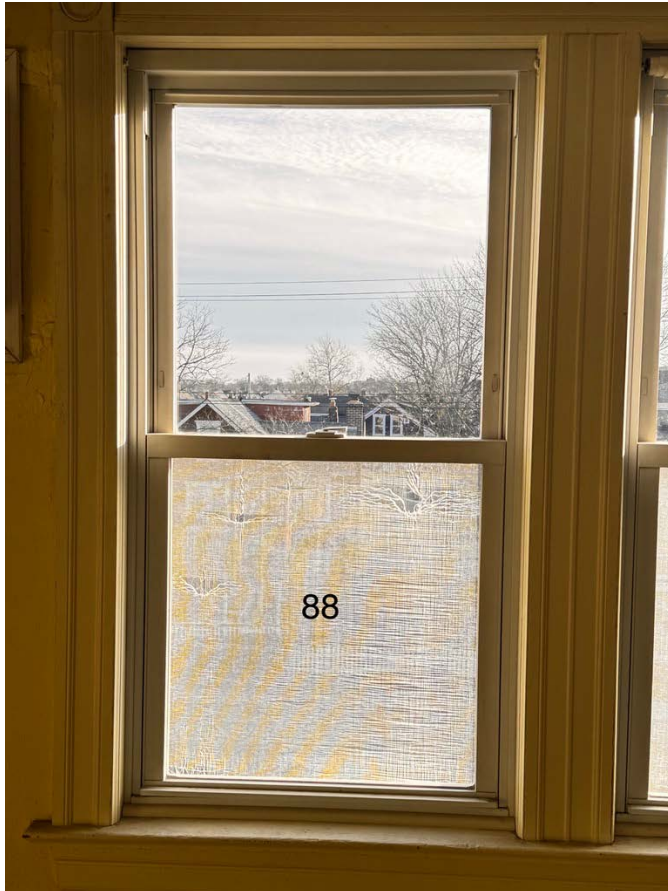
#88 — Level 3, south elevation. This vinyl window is one of a pair in the south facing gable. (This window is not part of the current application but is outlined here for clarity purposes only.)

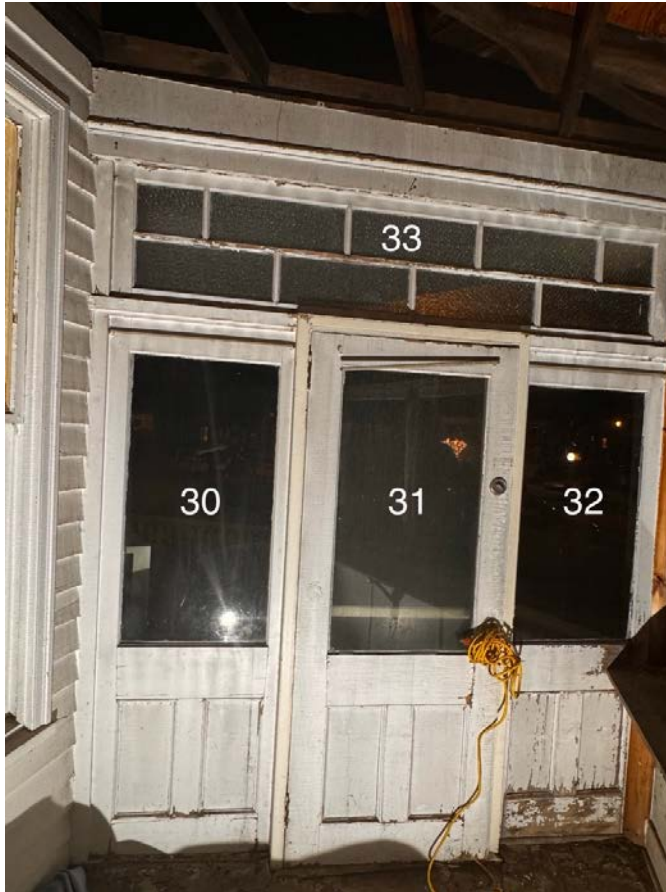
#30d, #31d, #32d, #33 — Level 1, north elevation. These three non-operable ½ light, interior doors were rigged up as a makeshift wall of a non-conforming porch enclosure. They are surmounted by a multi-pane clerestory panel of textured (Florentine) glass. There is no indication any of these elements were part of the original building. These windows to be removed and the historic porch re-opened.

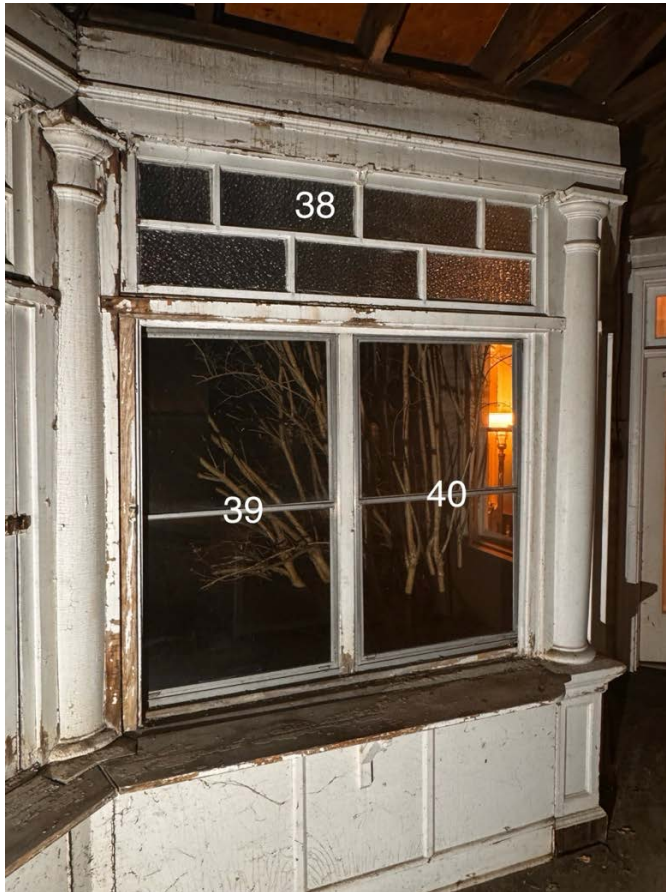
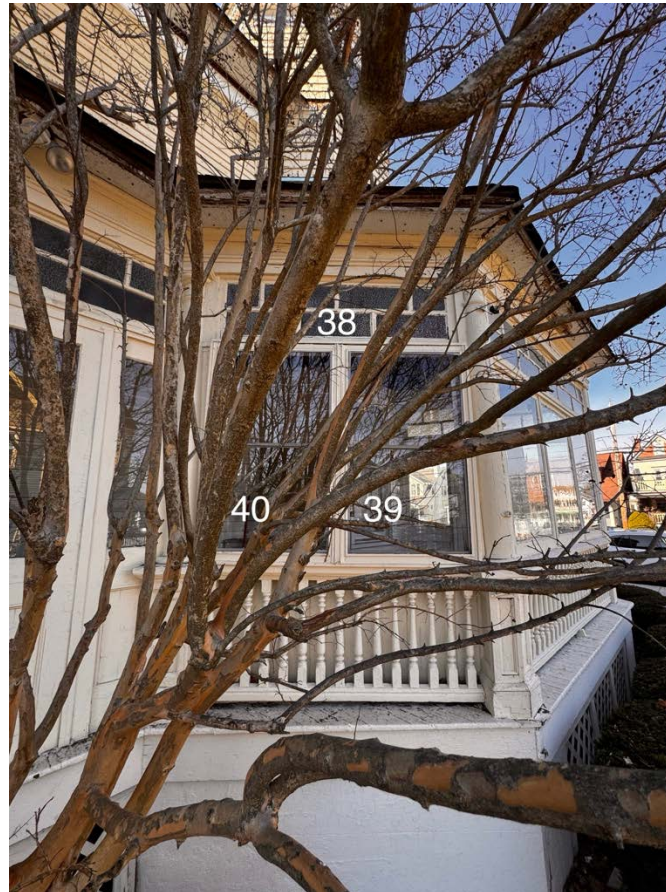
#38, #39, #40 — Level 1, east elevation. These two aluminum windows are surmounted by a multi-pane clerestory panel of textured (Florentine) glass. They are non-original, interior windows that will be removed completely and the historic porch re-opened.

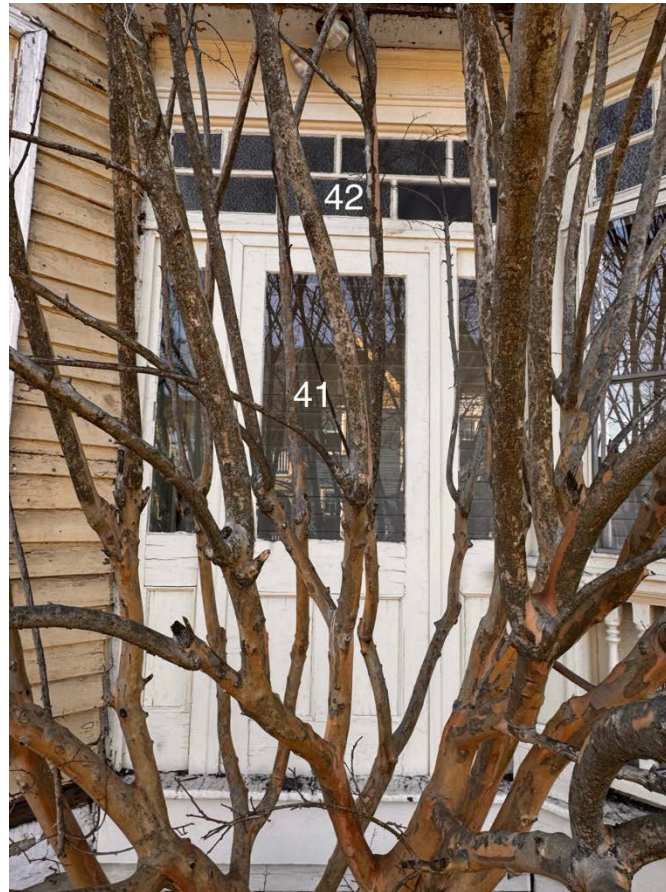
#41d, #42 — Level 1, east elevation. This interior door set with sidelights is not original nor historic. It does not resemble any of the doors or windows found elsewhere in the house. These elements to be removed completely and the historic porch re-opened.

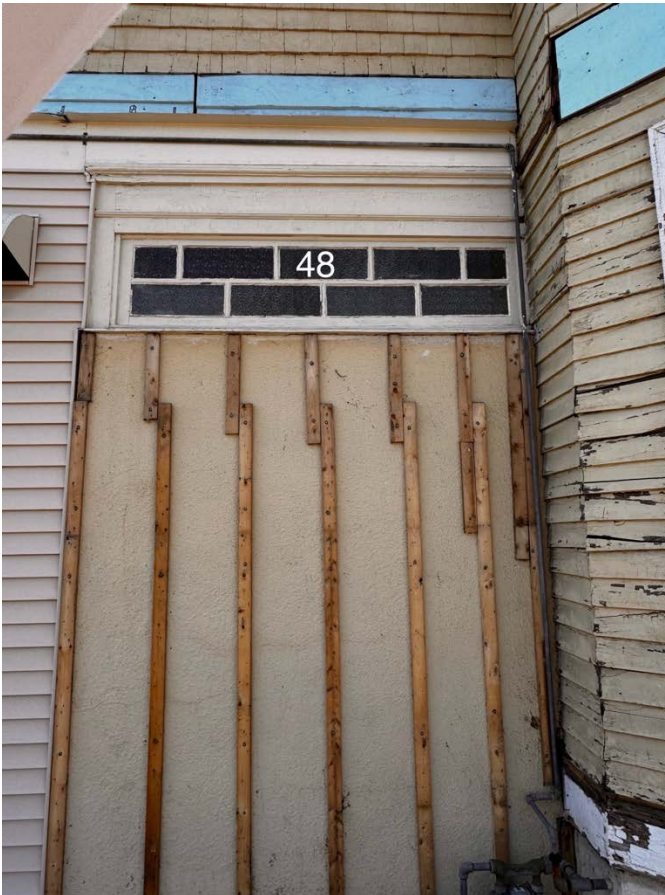
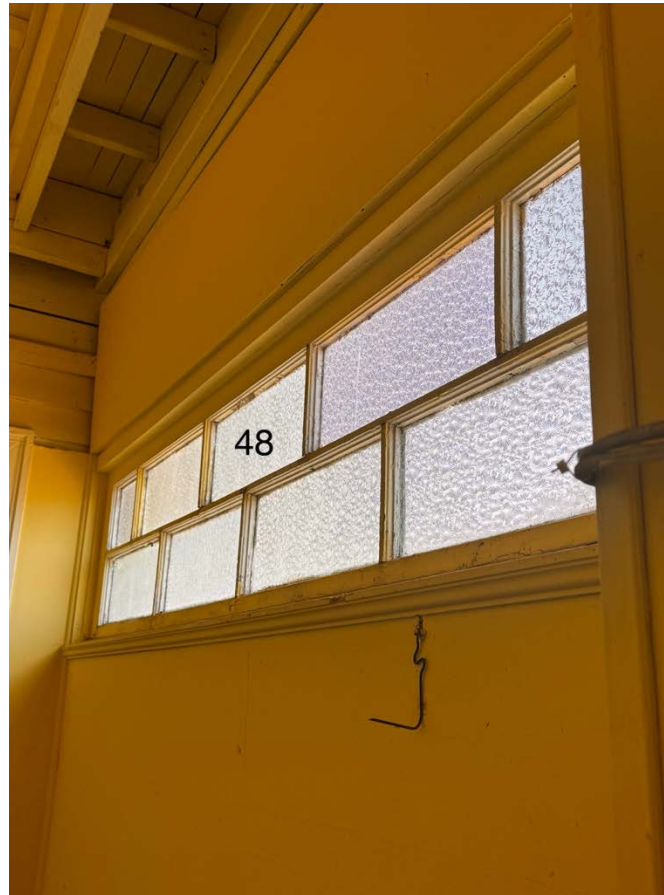
#48 — Level 1, east elevation. This is a multi-pane clerestory panel of textured (Florentine) glass. There is no indication it is original to the building (interior or exterior) and is proposed to be replaced by a historically appropriate windows.

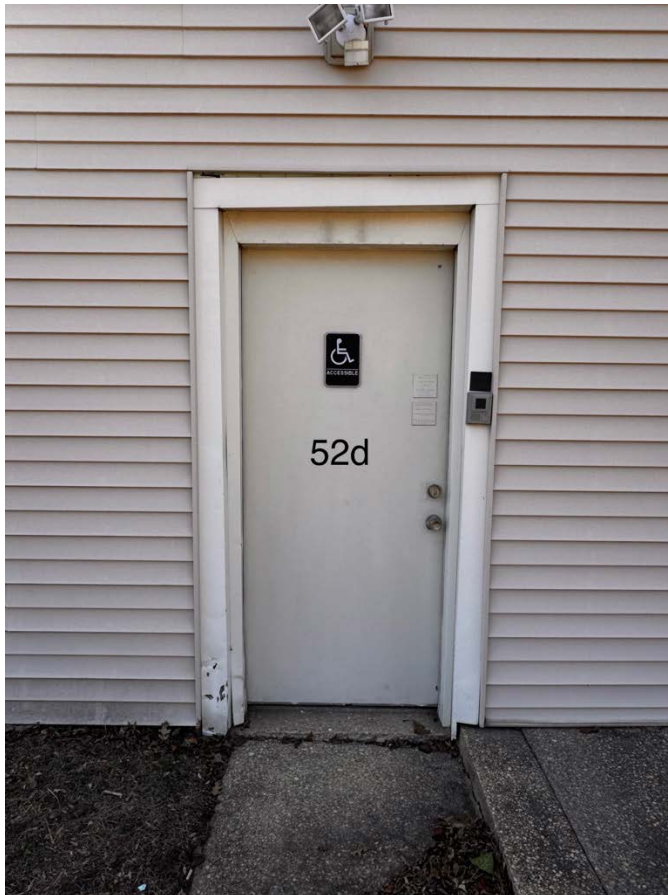
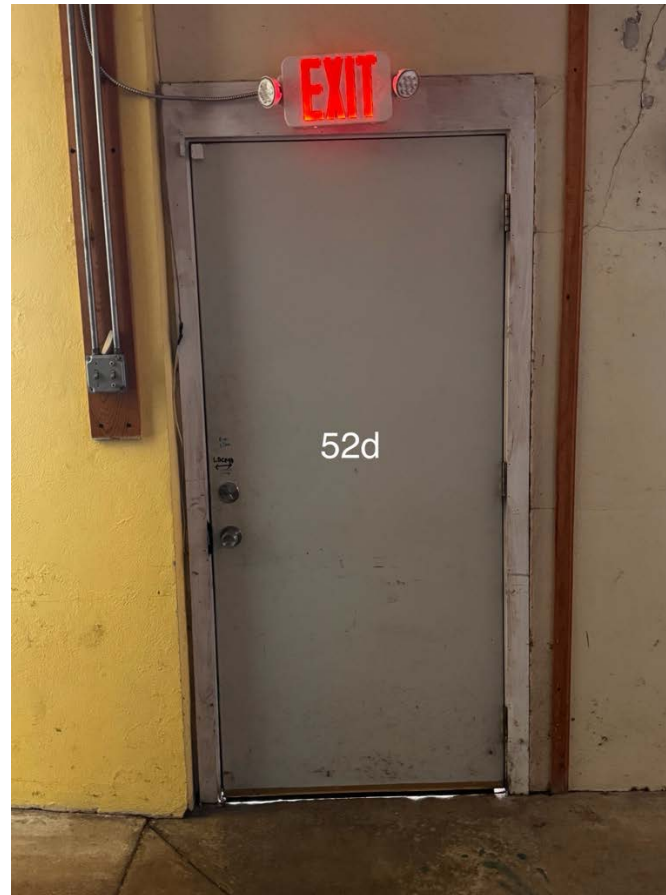
#52d — Level 1, east elevation. This is a metal/fiberglass door at grade in the garage. This door to be removed completely. (This door is not part of the current application but is outlined here for clarity purposes only.)

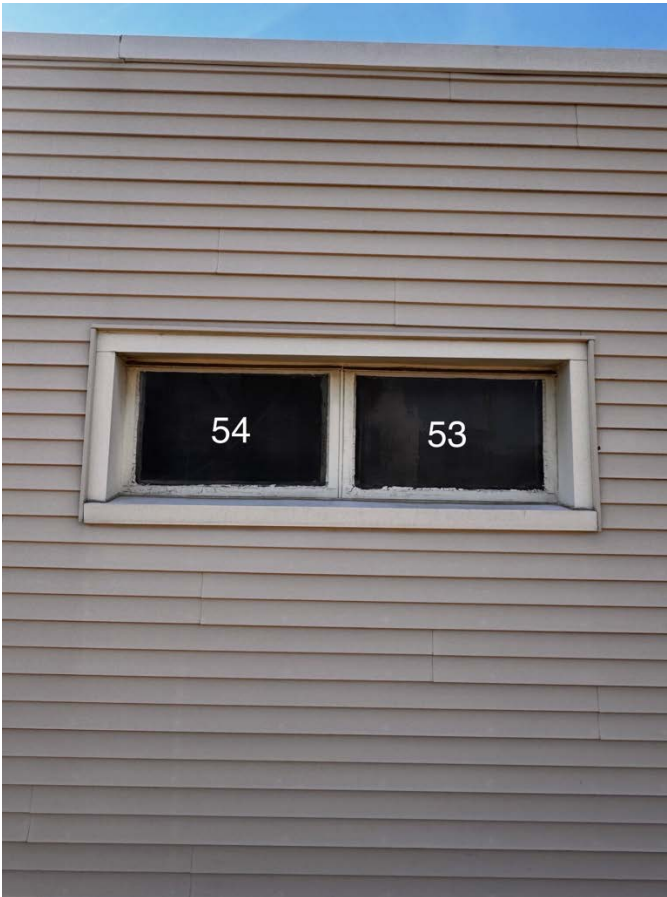
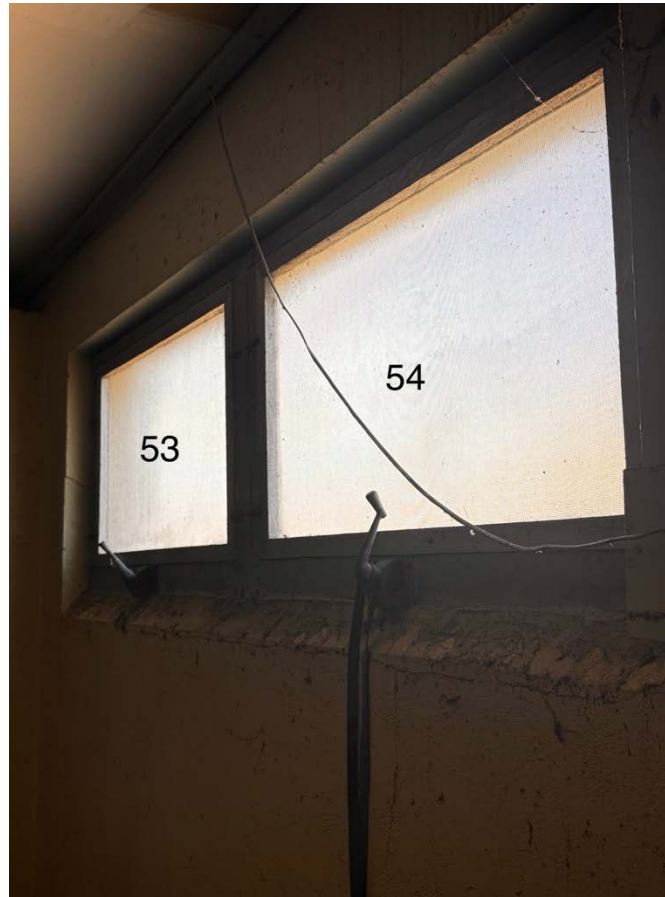
#53, #54 — Level 1, east elevation. This is a set of 2 aluminum awning windows set into the concrete block wall of the garage. (This window is not part of the current application but is outlined here for clarity purposes only.)

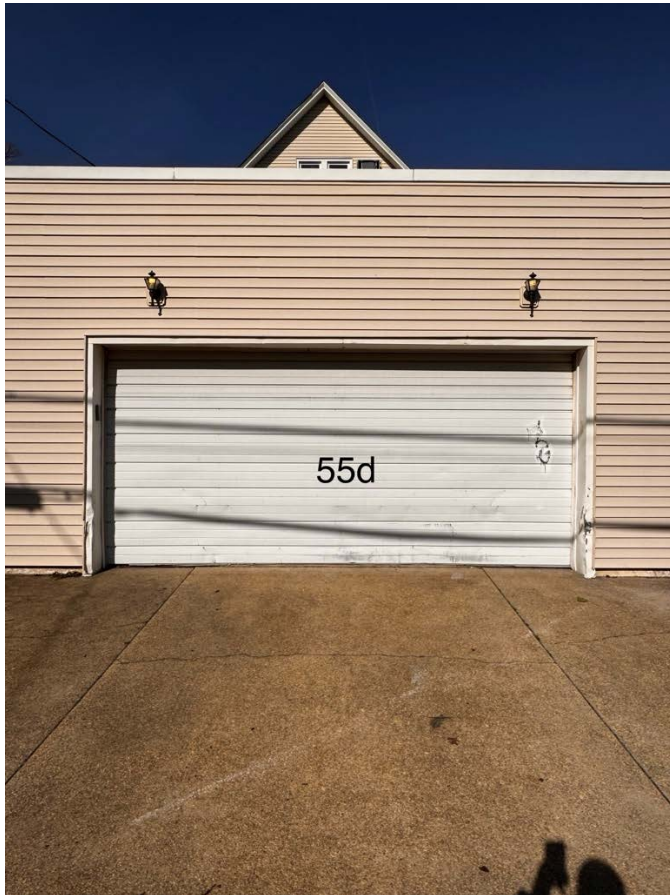
#55d — Level 1, south elevation. This is a fiberglass/plastic/metal 1 ½ width, non-conforming, top-rolling garage door. New, conforming carriage style doors will be proposed under a later application. (This door is not part of the current application but is outlined here for clarity purposes only.)

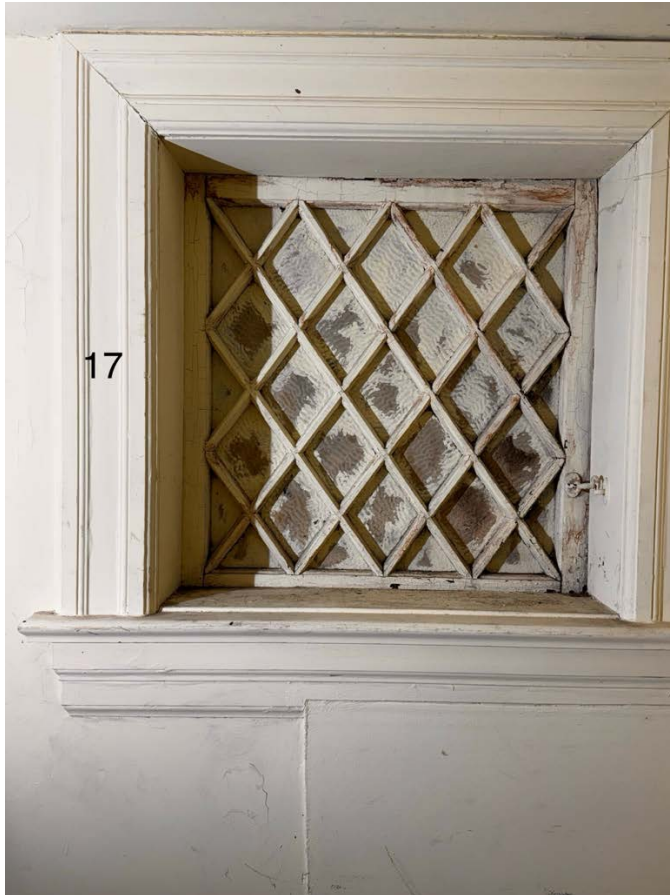
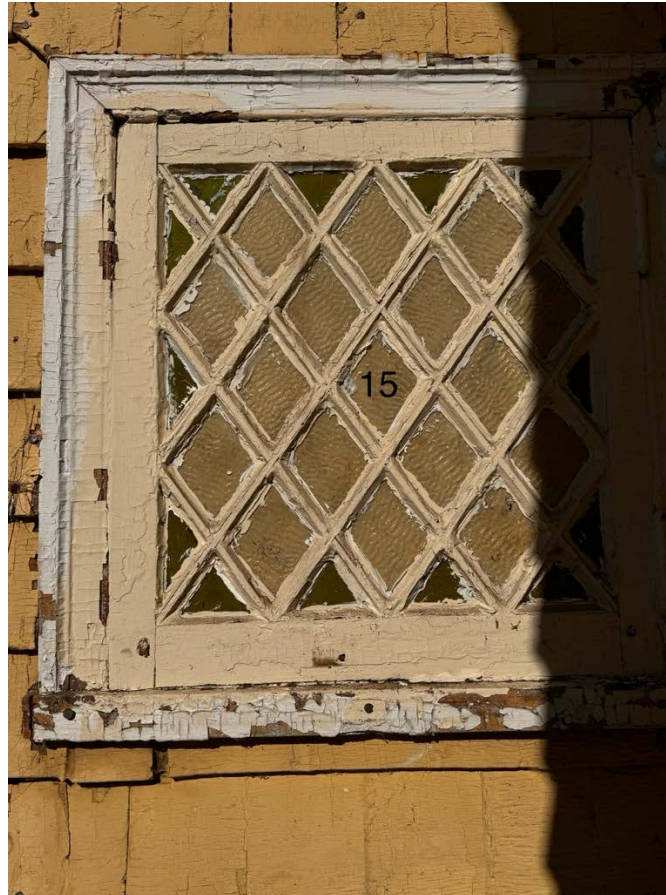
#17 — Level 1, west elevation. This window is located beneath the main stair, in a narrow closet (once a stair leading to the basement). While visible from inside the house, the window had been painted over and buried behind vinyl siding. Removal of the vinyl revealed a window with clear and green, Florentine glass (in a ripple pattern), with diamond muntins. The design and color of this window matches two similar windows on Level 3 (#77 and #70). The presences of these three windows suggests windows #18, #19, and #20 once shared this design. The window is beyond repair but will be replicated by a custom builder using the existing glass.

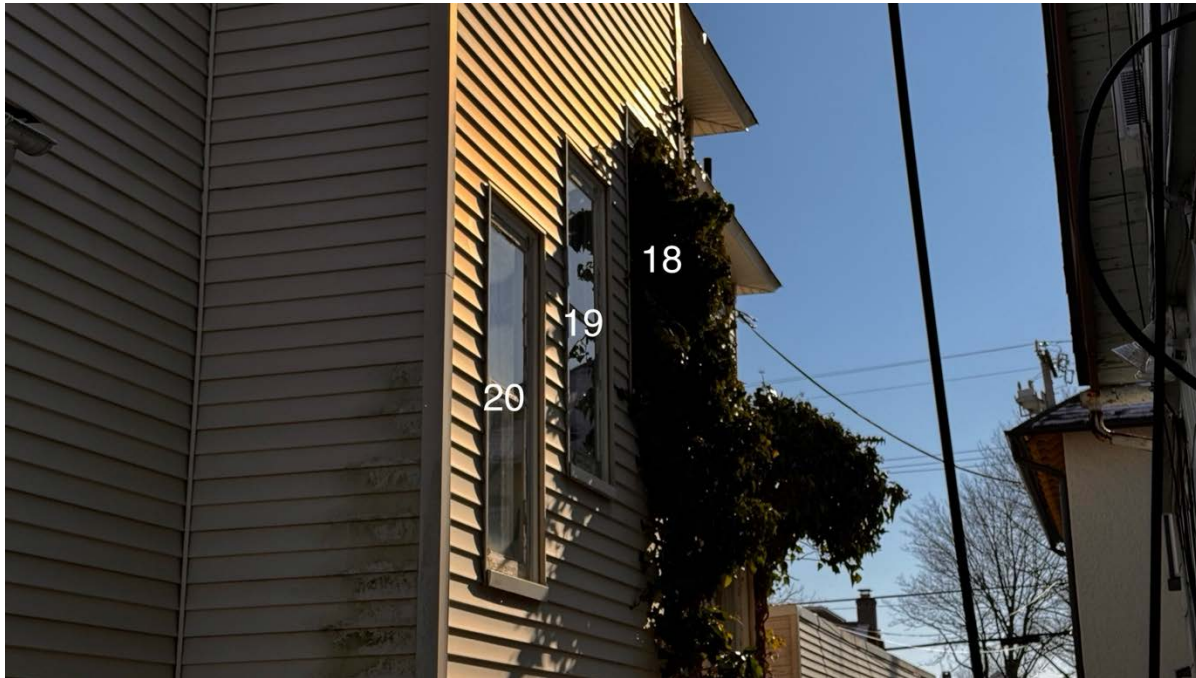
#18, #19, #20 — Level 1, west elevation. Three narrow windows occupy the staircase projection at the west elevation. The fenestration openings are very old but the existing stained-glass dates from the 1950s when the building was converted to a funeral home. The stained-glass panels are **not** of the same design, color, or pattern of the older stained glass found in the sidelights flanking the front door (#21 and #24). The condition of the sashes does **not** show the same degree of deterioration as is evident in other windows in this same projection. Also, the interior Victorian trims have been updated and include square (art deco) corner blocks; other, older trims in the house have traditional, Victorian circular (or target) corner blocks.

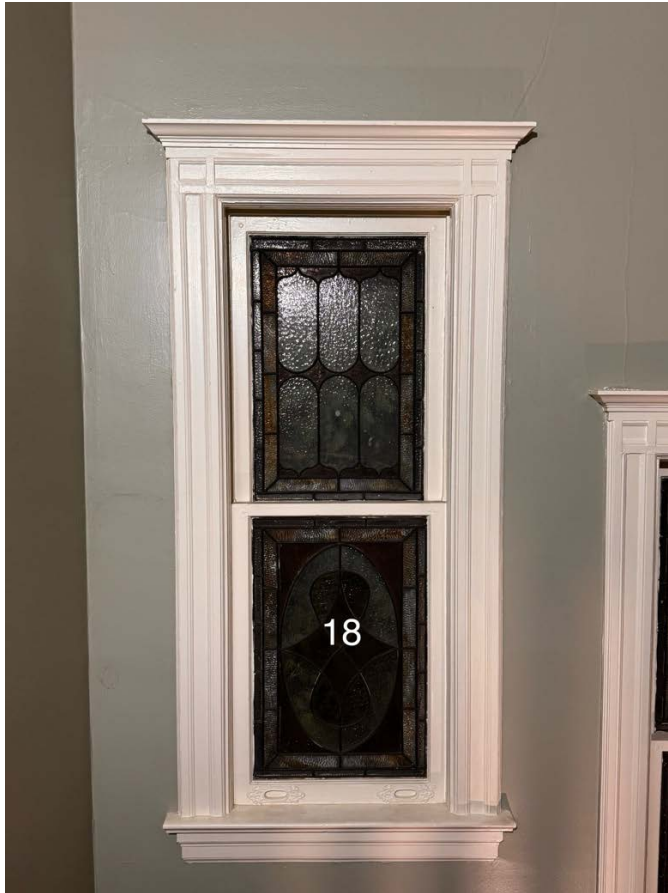
#18 — Level 1, west elevation. We proposed returning these to diamond muntin windows that replicate the patterning, texture and color of windows #17, #77, and #79.

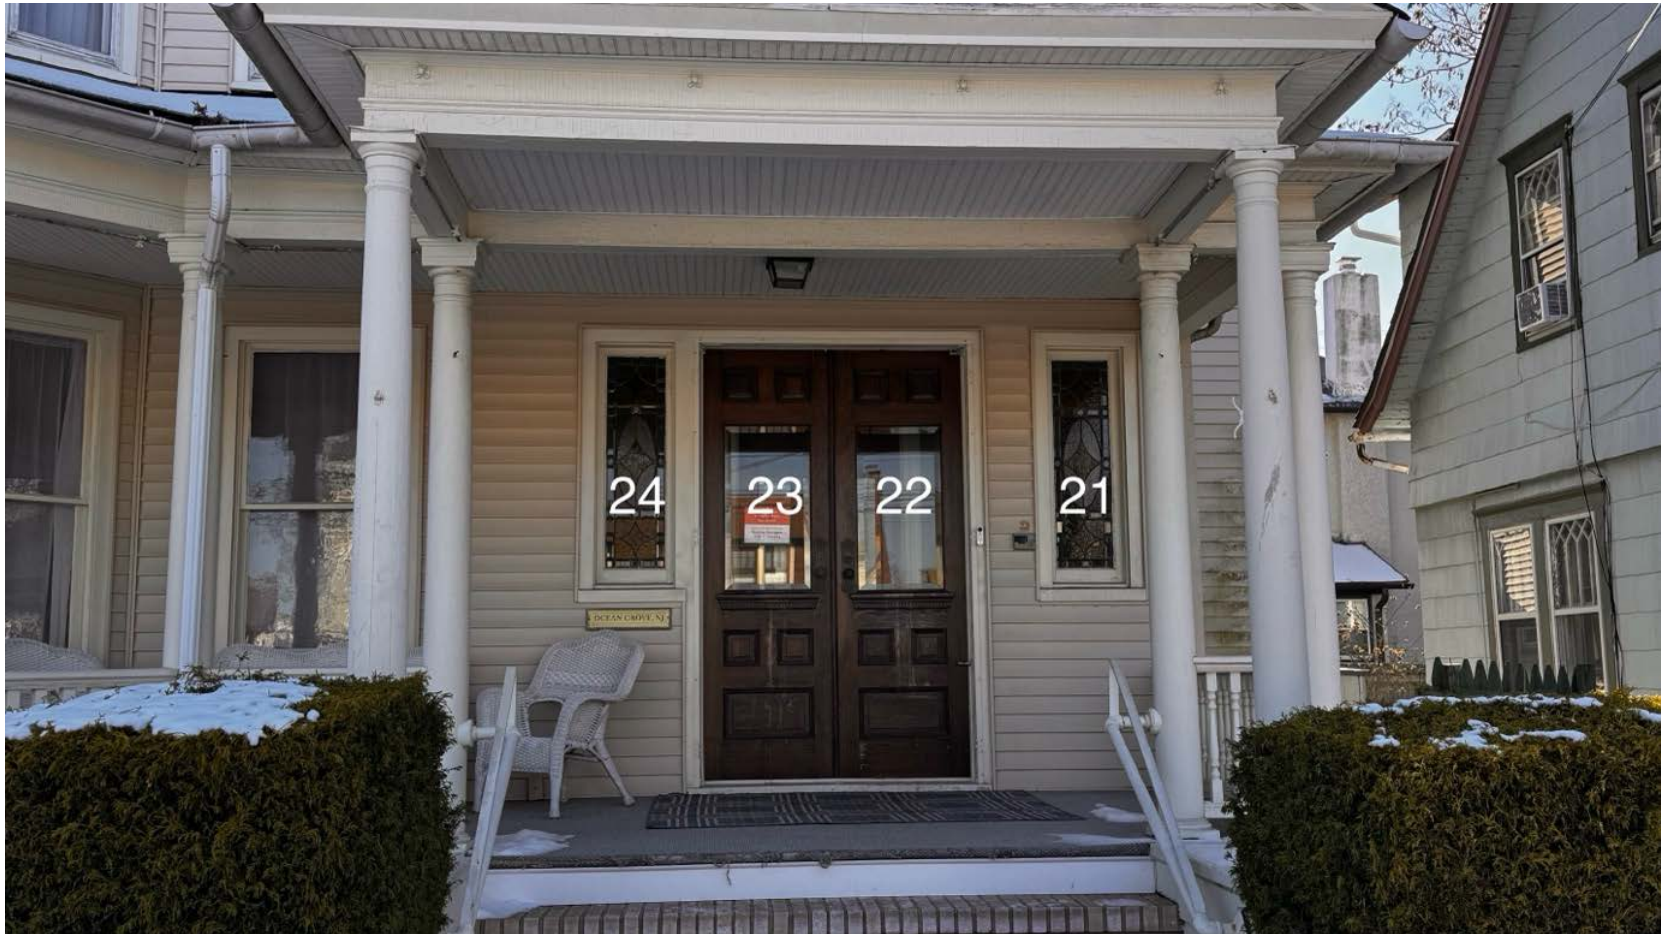
#21, #22, #23, #24 — Level 1, north elevation. Two stained-glass sidelights flank the double-front doors. One window (#21) is offset from the door trim in an atypical placement. We believe this is an artifact of the entry doors and pediment being shifted to the left during an earlier renovation. The upper right corner of window (#21) is unusually close to areas where the porch roof returns to the body of the house.

It is impossible to know why this one sidelight is offset. We proposed nudging the window left so that it flanks the door set (and falls within the door-frame trim) in a more historically appropriate manner.

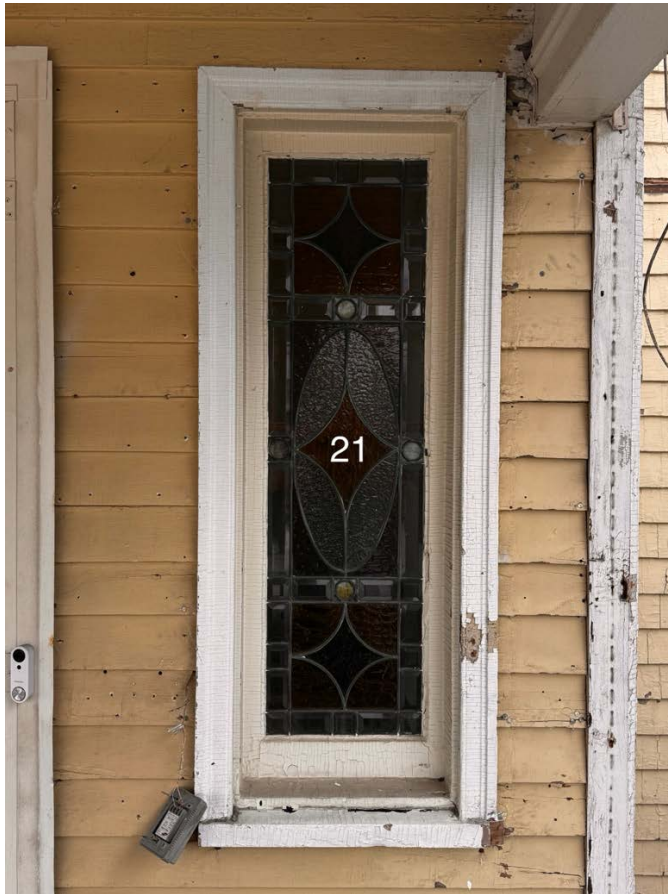
#21 — Level 1, north elevation. The how the sidelight at the right of the entry doors does not abut, and is not enclosed in the entry trims, as is typical with sidelights. Also, note how the upper right corner of the window crowds the area where the porch roof returns to the body of the house.

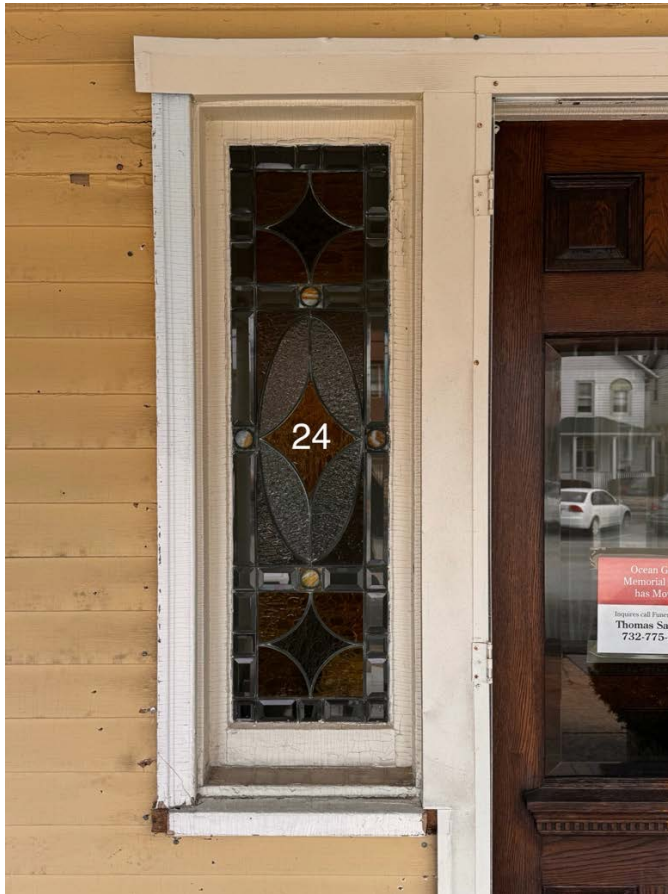
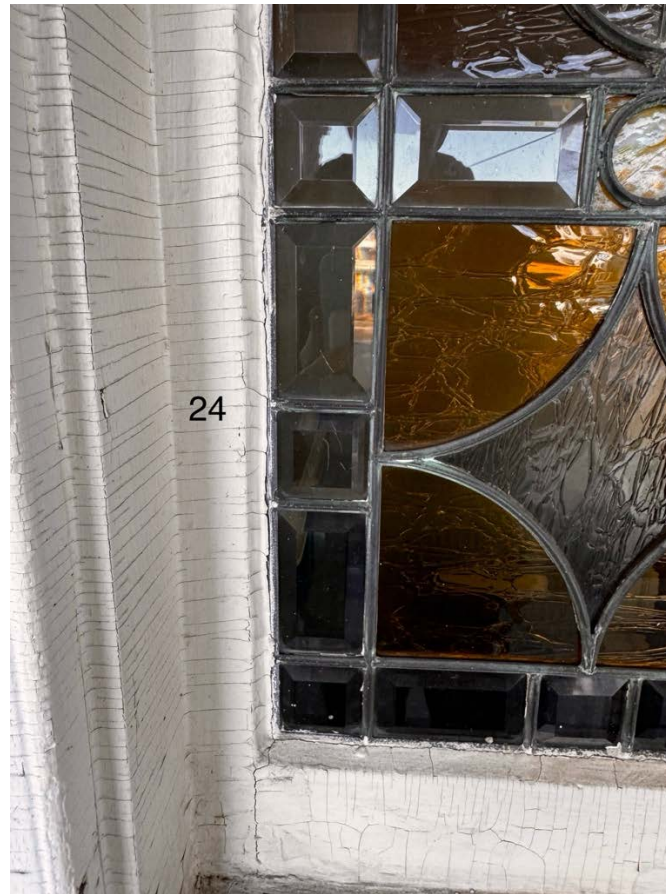
#24 — Level 1, north elevation. Note how this sidelight aligns with, and is included in the entry trim, making it part of the door set, unlike the modified window (#21) above. Retain and restore.

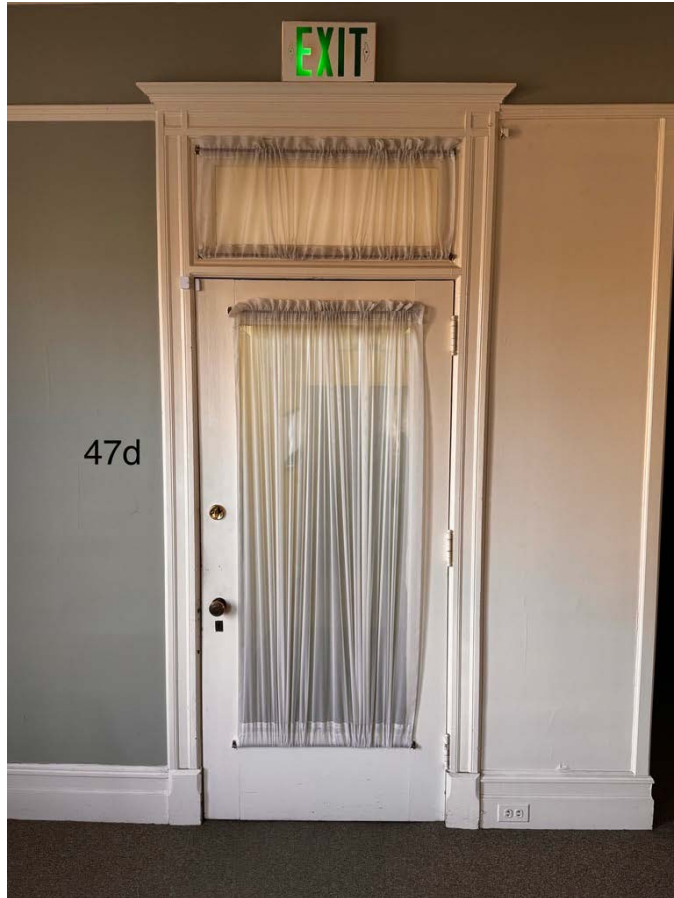
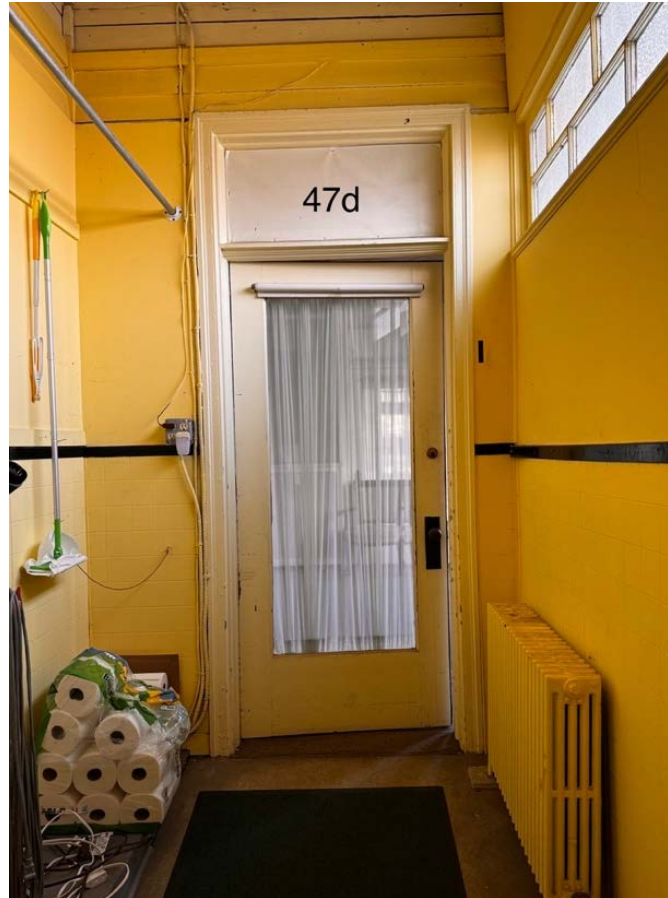
#47d — Level 1, east elevation. This door mirrors 43d (above) and currently opens into a hallway/ramp leading to the garage. This door and transom, while once exterior, are and will remain interior.

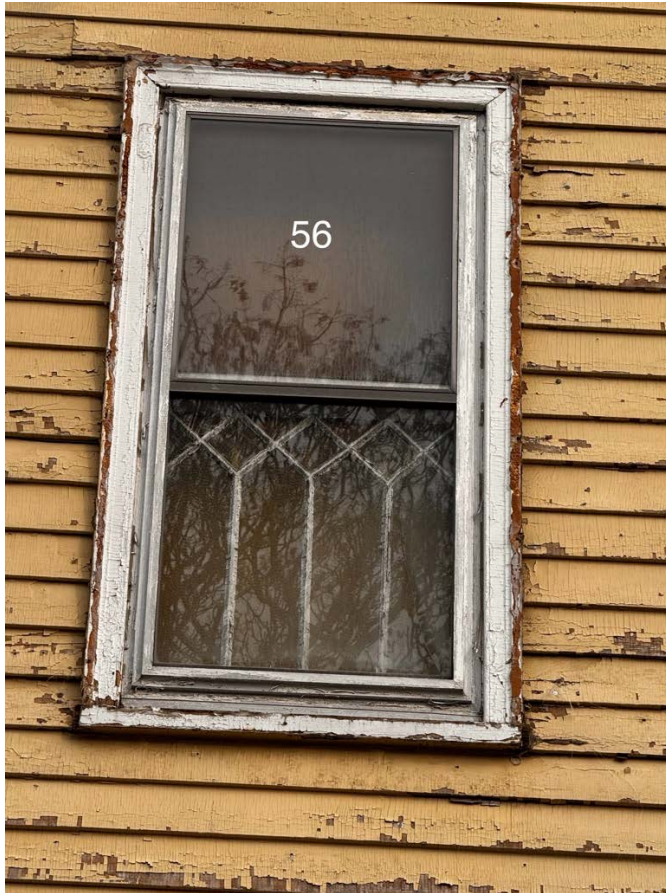
#56 — Level 2, west elevation. Window 56 is buried in the wall behind a tiled shower wall. However, the window is still visible from the exterior. This window matches window 75, which is located on the south elevation of the building but within the same room. The upper sash has fallen (the lower sash appears to be missing completely). An aluminum storm window is apparently holding everything in place.
