06. Window and Door Condition Report

The house currently contains 89 doors and windows that fall under the purview of the Commission. We have sorted these into five categories: Basement Windows, Historic Windows, Secondary Windows, Vinyl Windows, and Modern Windows. To assist in understanding and reviewing so many fenestrations, we have color-coded them by type and illustrated their location on the enclosed floor plans and elevations. Also included are photographs of each individual window and door showing its characteristics and condition.

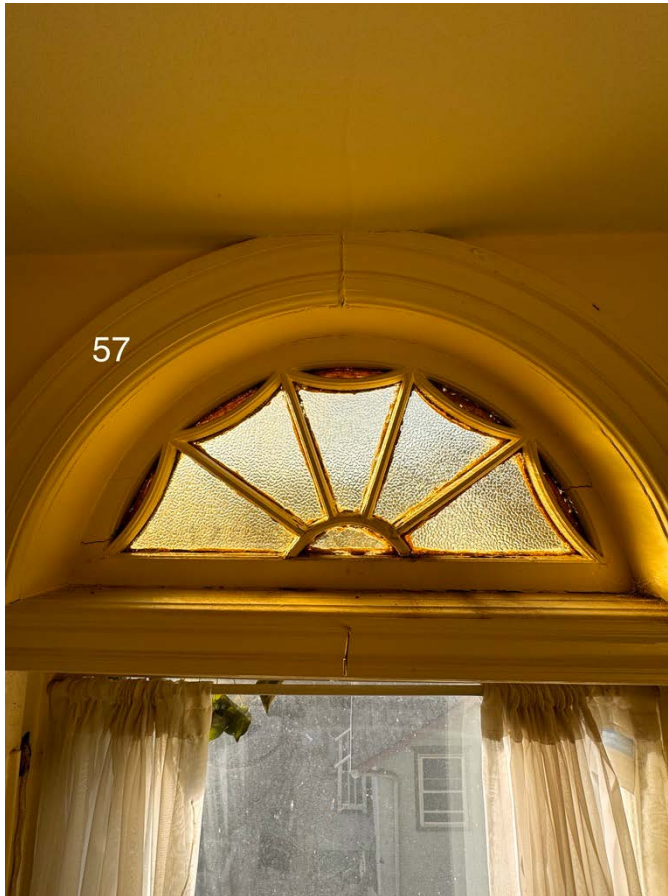
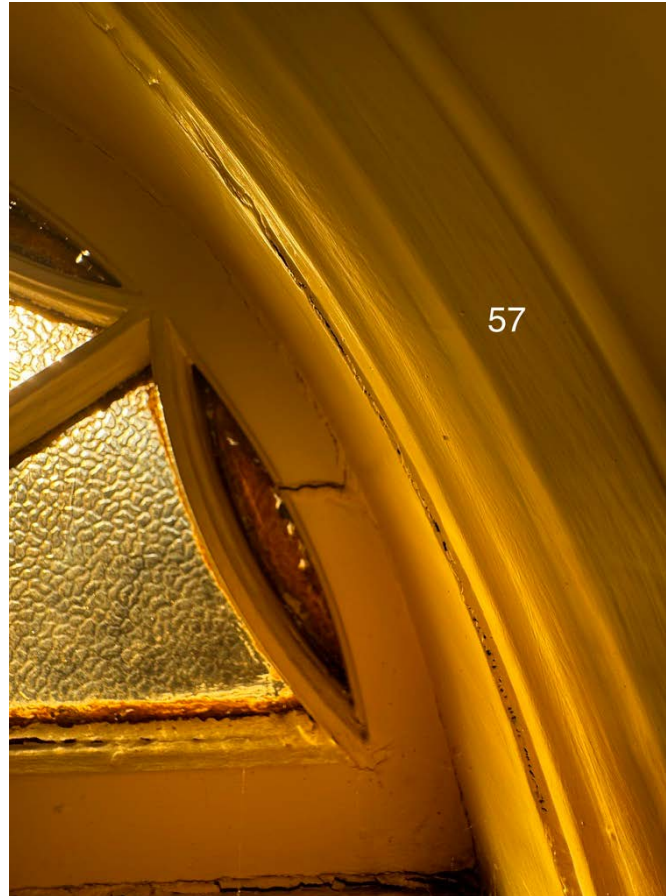
#57 – Level 2, west elevation. This is the only fan window in the building. Mr. Eastin’s report states, “The mulls have deteriorated to the point that only the pressure of the window being in place is keeping them together.” The window to be replicated by a custom building using existing glass.

#57, #58, #59, #60 — These sashes are beyond reasonable repair in my opinion.”

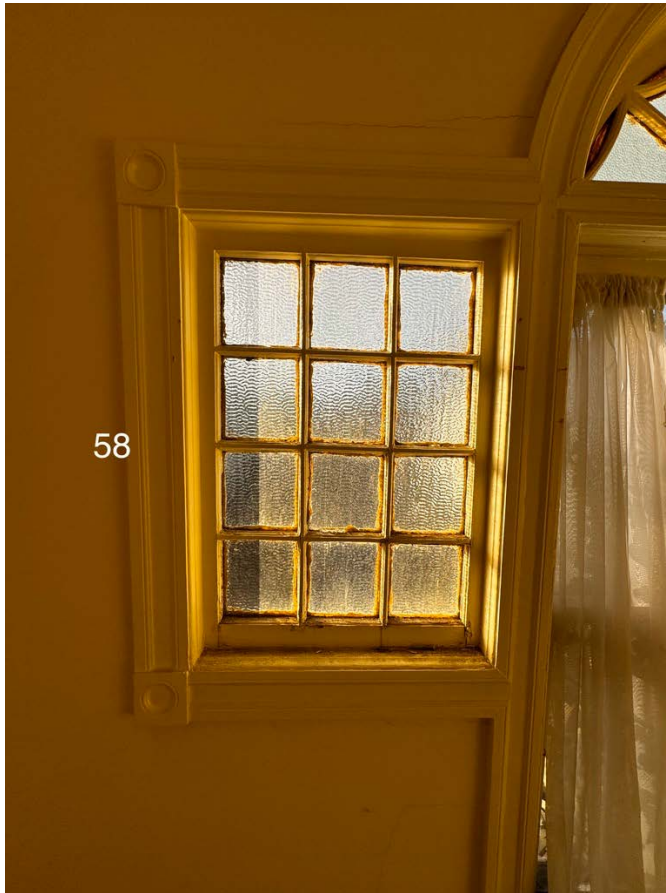
#58 — Level 2, west elevation. This appears to be a stationary window, though it may be a hopper windows (as is be found in #84 and #86). The window will have to be removed before its operability can be determined. The wood of the window is not restorable. Window to be replaced with a conforming window of the same dimensions and muntin configuration.

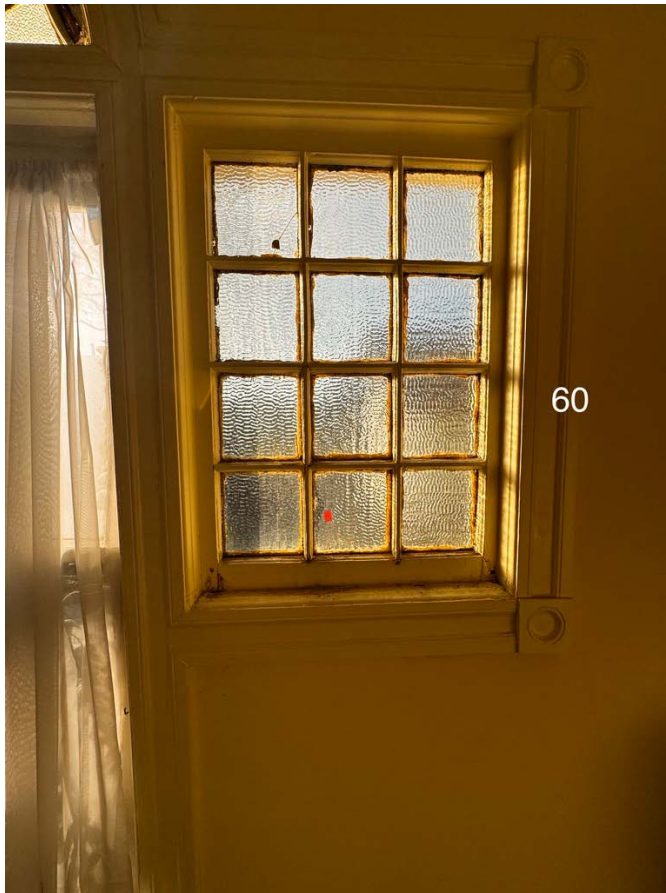
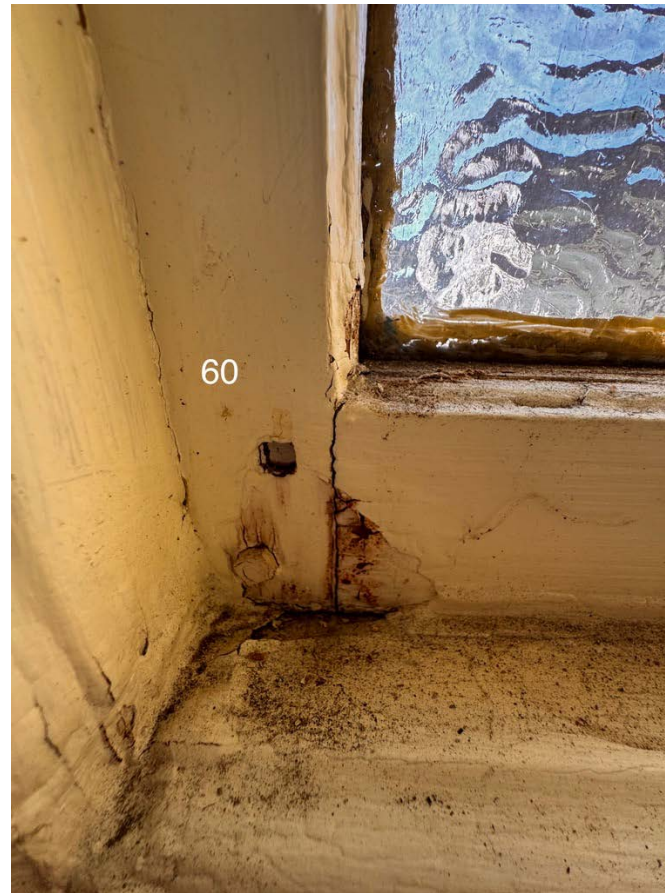
#60 — Level 2, west elevation. This window is the pair to window #58. Pegs holding the sashes together have dried and shrunk to the point where they have come unmoored or fallen out completely. Exterior conditions are very poor. Window to be replaced with a conforming window of the same dimensions and muntin configuration.

#60 — Level 2, west elevation. Detail of muntins showing them deteriorated to the point they’ve become soft and fibrous.

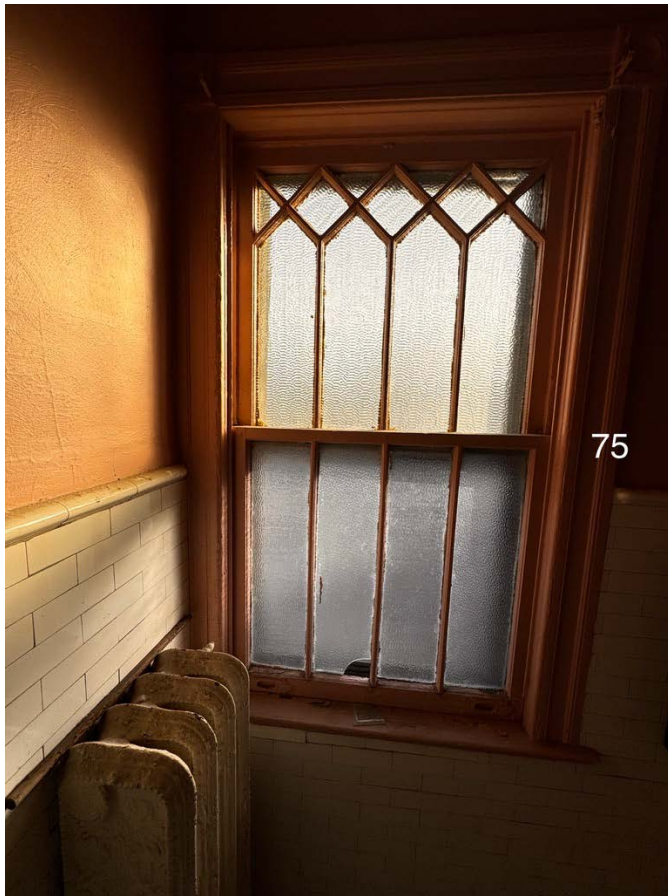
#75 — “The sashes are beyond reasonable repair in my opinion.”

#75 — Level 2, south elevation. This appears to be the type of window that was used throughout the house prior to later renovations. While one of the oldest windows, it is also the most severely damaged. Mr. Eastin’s report states, “Muntins are worn down or rotted down to near nothing leaving no area to be glazed.” Exterior conditions (the window is accessible from the garage roof) are very poor and are representative of exterior conditions on all original windows. Window to be replaced with a conforming Andersen “A” Series window with diamond and bars upper sash.

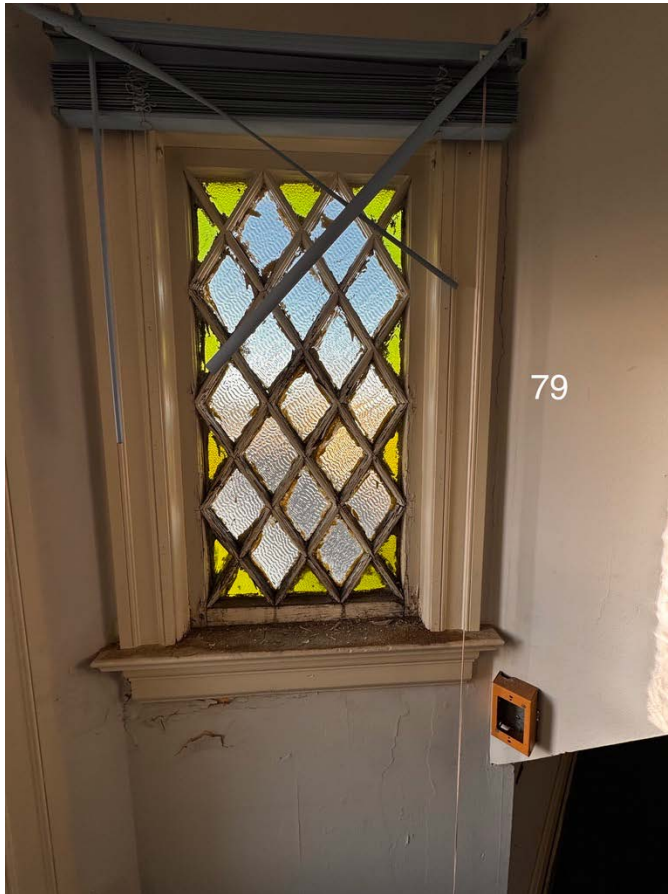
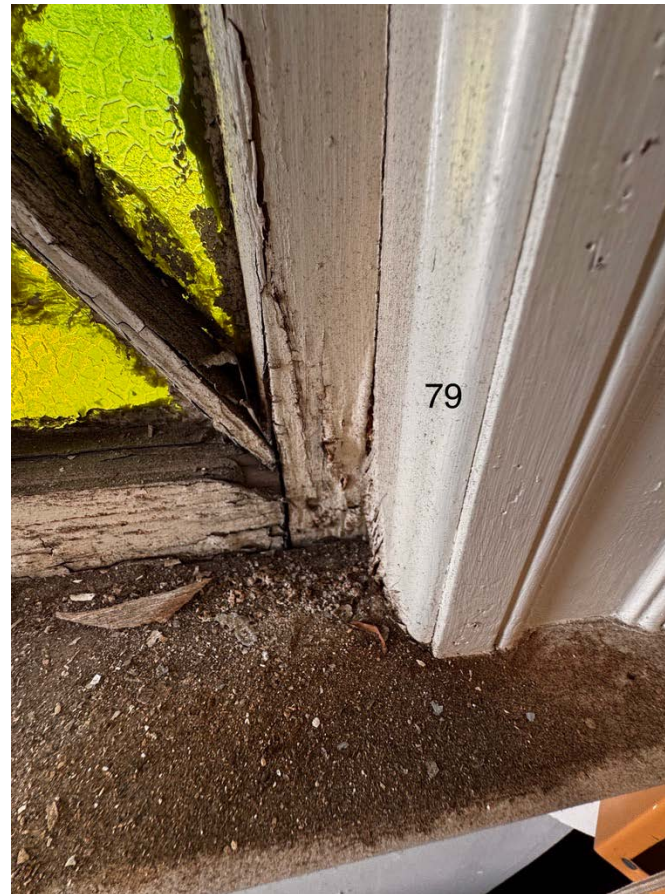
#79 —Level 3, west elevation. This is the pair of window #77. Window to be replicated by custom builder reusing existing glass.

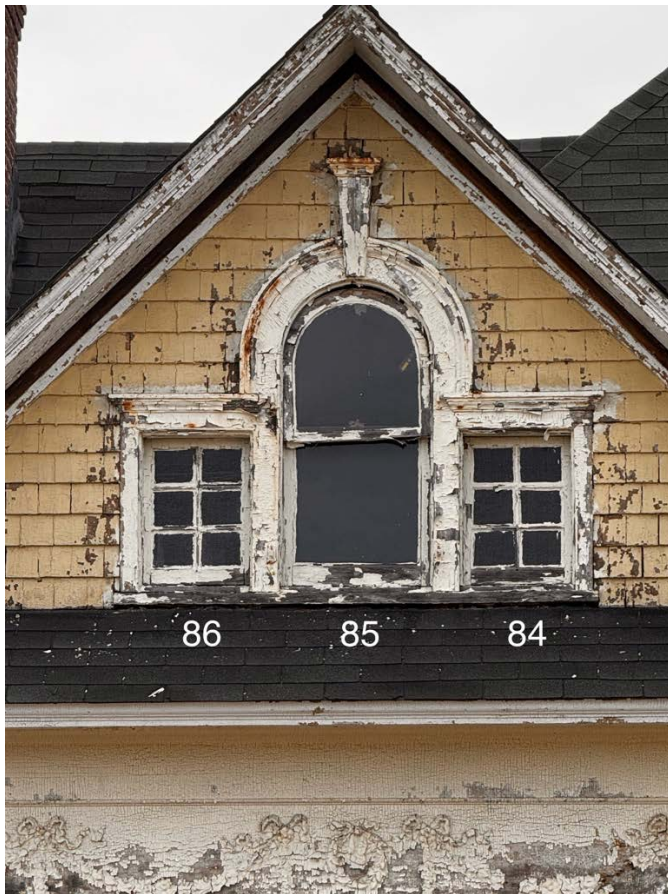
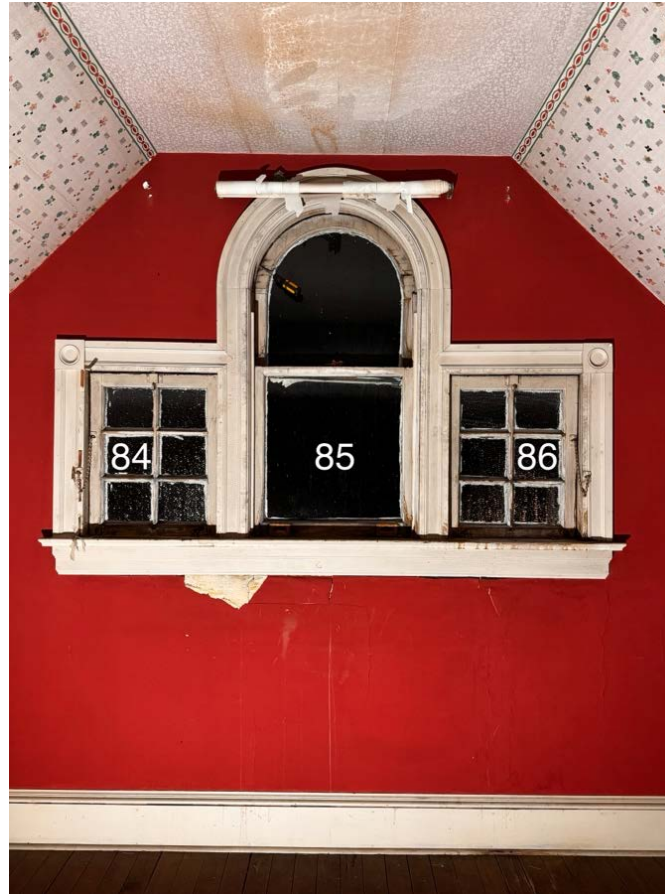
#84, #85, #86 — “These sashes are beyond reasonable repair in my opinion.”

#84, #85, #86 — Level 3, east elevation. These three windows form a group: a Palladian window flanked by two, six-pane hopper windows (i.e., bottom-hinged). The rounded window has wide molding with ornamental “keystone” ornament (common to certain Queen Anne and Italianate styles) Similarly hefty molding surrounds the two hopper windows. The trims on this window group mirror those of a similar group on Level 2 on the west elevation (see: #57, #58, #59, and #60). Mr. Eastin’s report states, “These sashes are beyond reasonable repair in my opinion.”

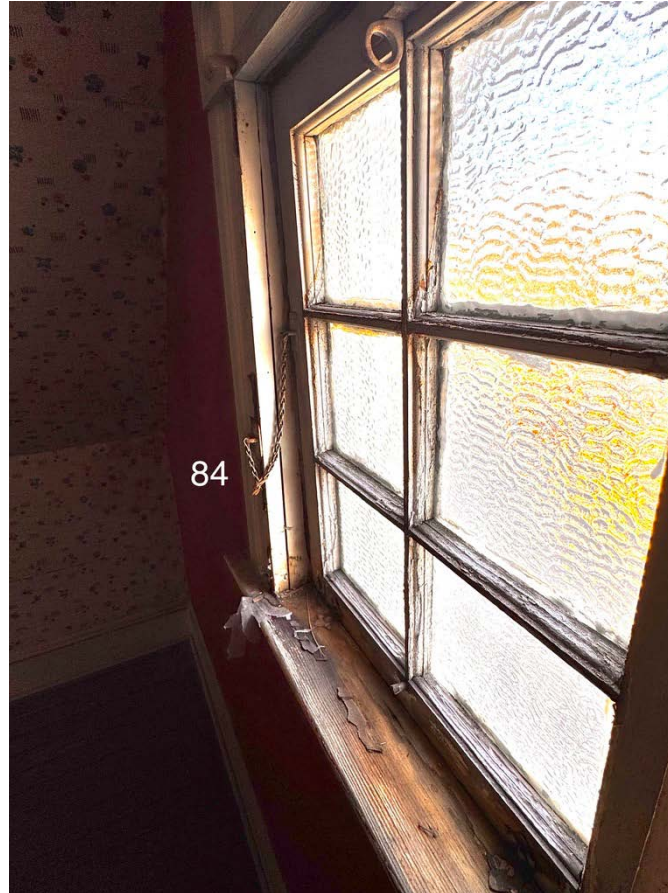
#84 — Level 3, east elevation. Replace with an Andersen “A” Series hopper window with the same muntin pattern.

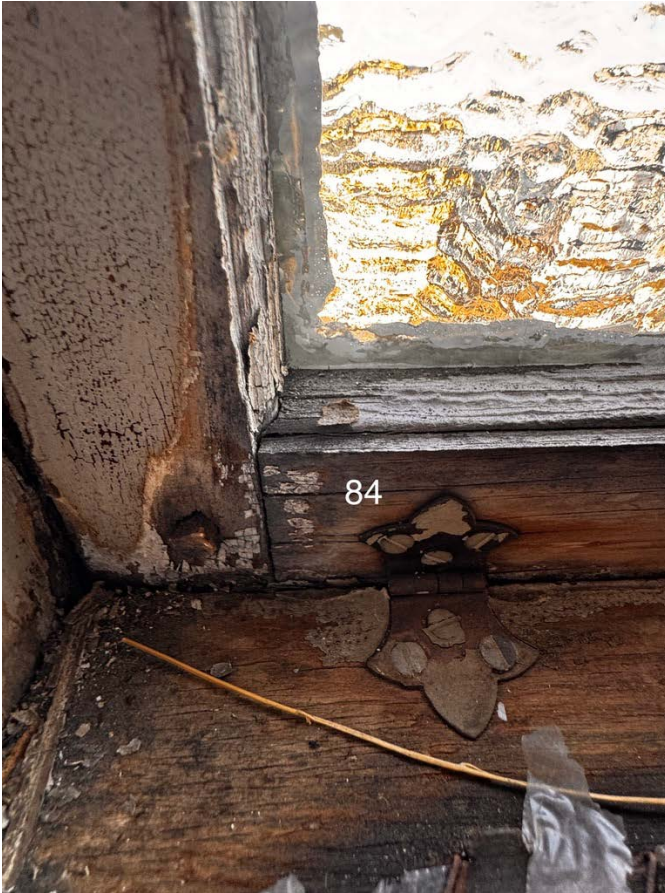
#84 — Level 3, east elevation. Exterior images show the extent of the dry rot in both the sashes and the frame. The wood is powdery with a lightweight “Styrofoam” texture.

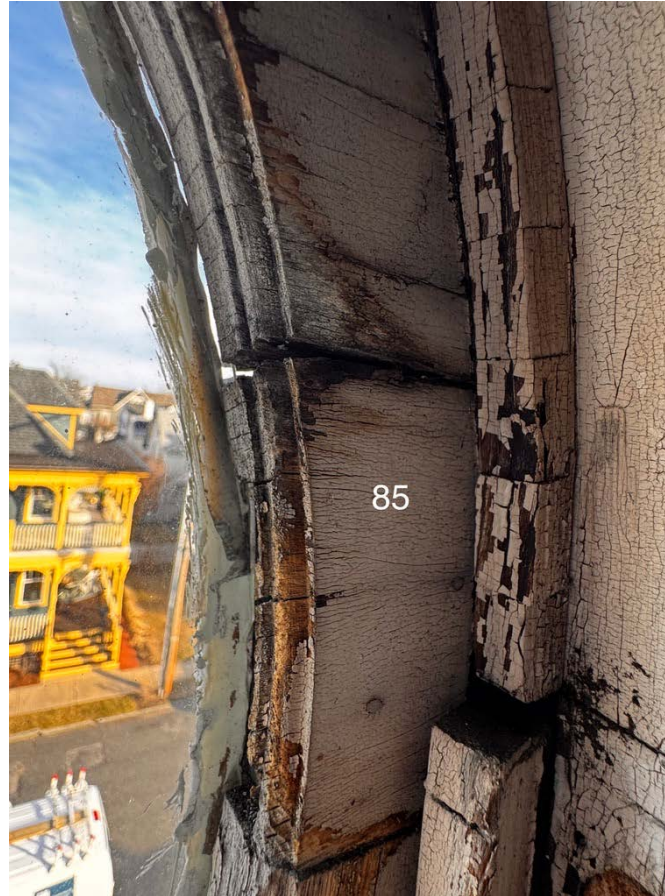
#85 — Level 3, east elevation. Replace with custom built window.

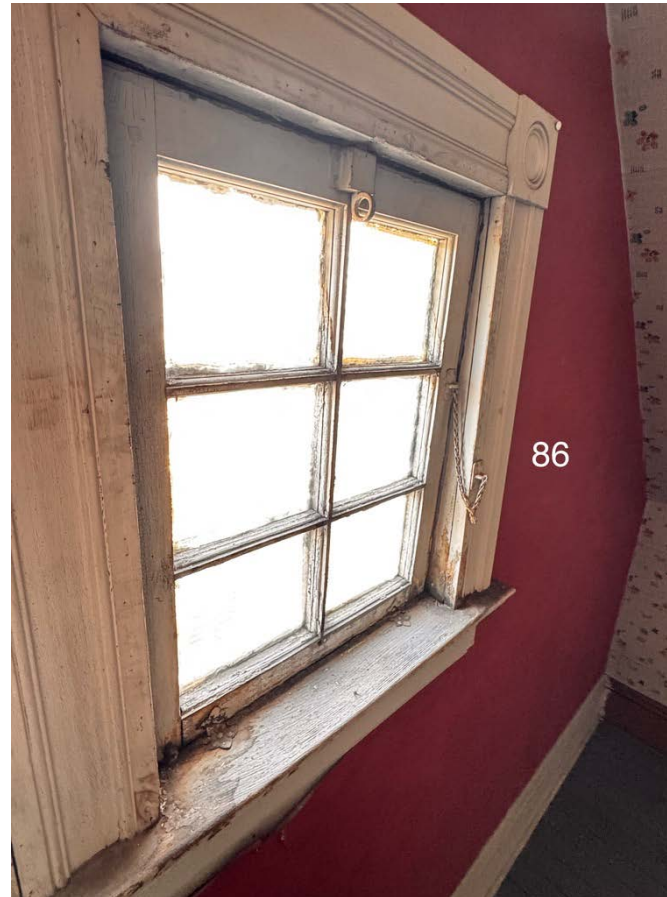
#86 — Level 3, east elevation. Replace with an Andersen “A” Series hopper window with the same muntin pattern.

#86 — Level 3, east elevation. The exterior of this window is equally deteriorated, with missing pegs connecting sash components, cracking, and dry rot.

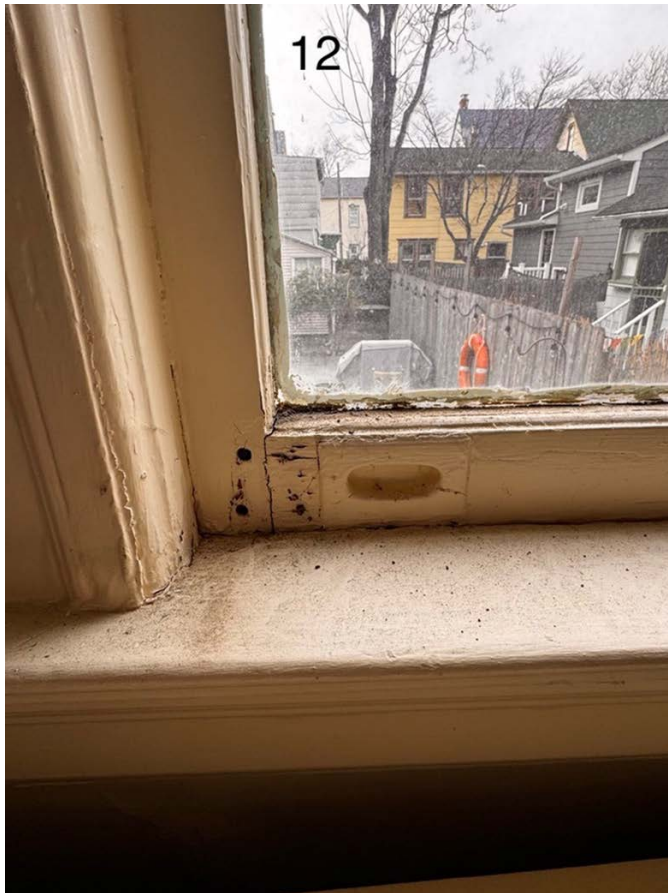
#12 — Level 1, west elevation. Cycles of moisture and heat have dried the windows and caused the pegs of the joints to wiggle free and deteriorate completely. These sashes are being held together by the window frames that surround them, as you can see in this photo showing missing pegs at the corner joint,

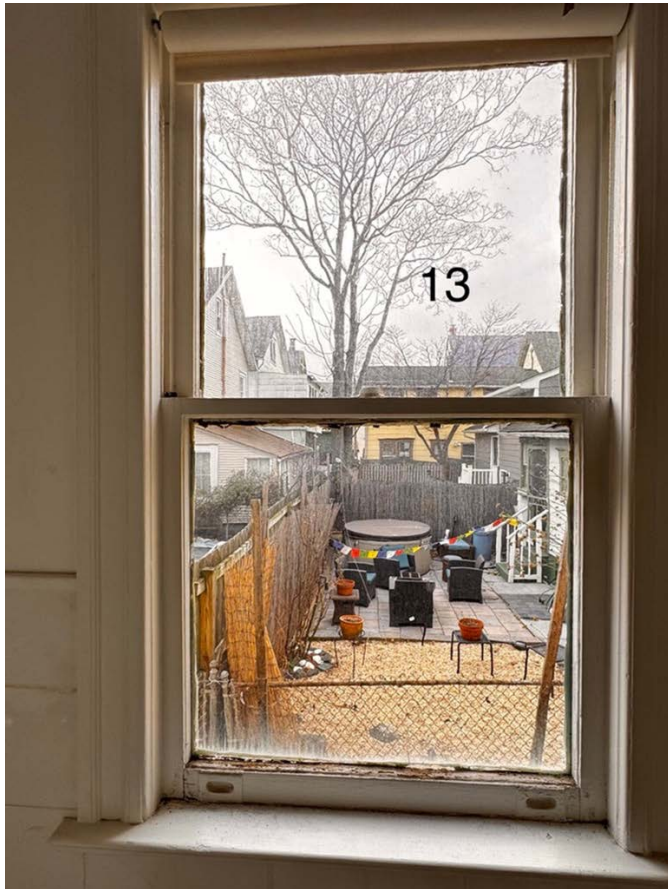
#13 — Level 1, west elevation. This window is on at the west elevation in what was once an open porch but was later enclosed. It does not match the historic window dimensions found elsewhere in the house and the sill height appears to have been raised (though there is no interior counter to rationalize such a shortening of the windows).

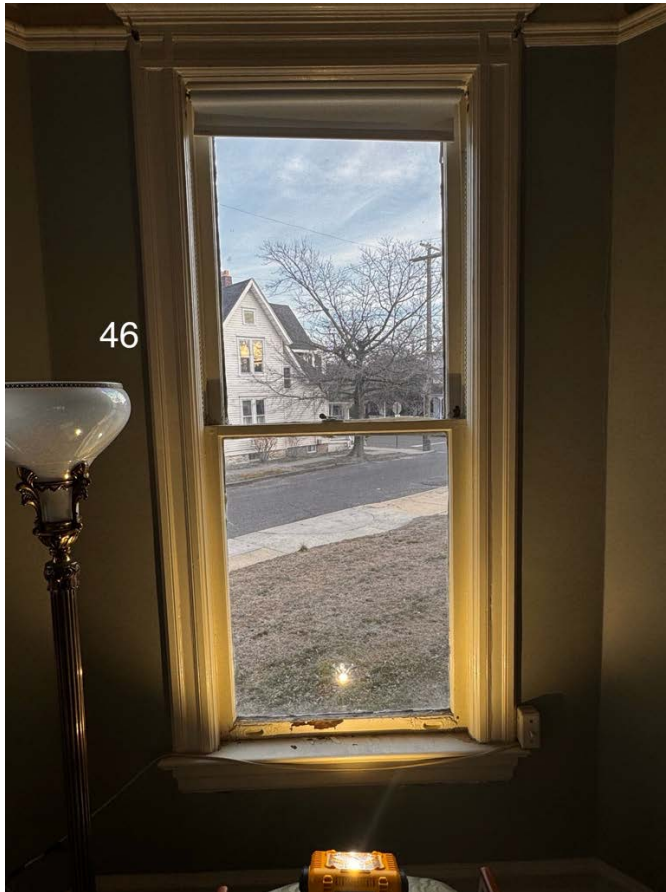
#46 — Level 1, east elevation. Even 1/1 window that are not original have suffered from decades of exposure to weather. The lack of proper storm windows has allowed water to pool in the frames, deteriorate the wood, and penetrate interior walls.

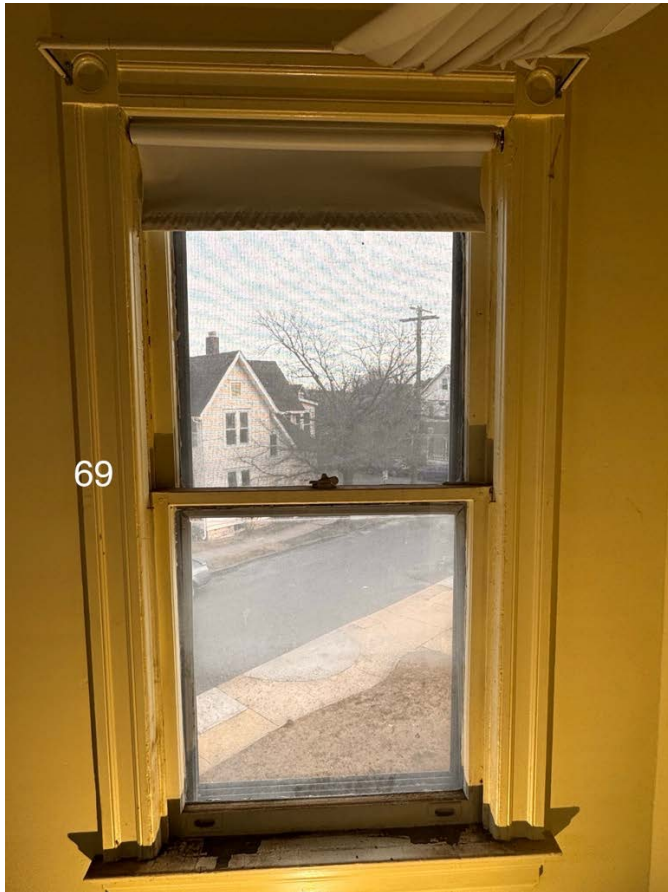
#69 — Level 2, east elevation. Another representative example of interior sashes that look restorable.

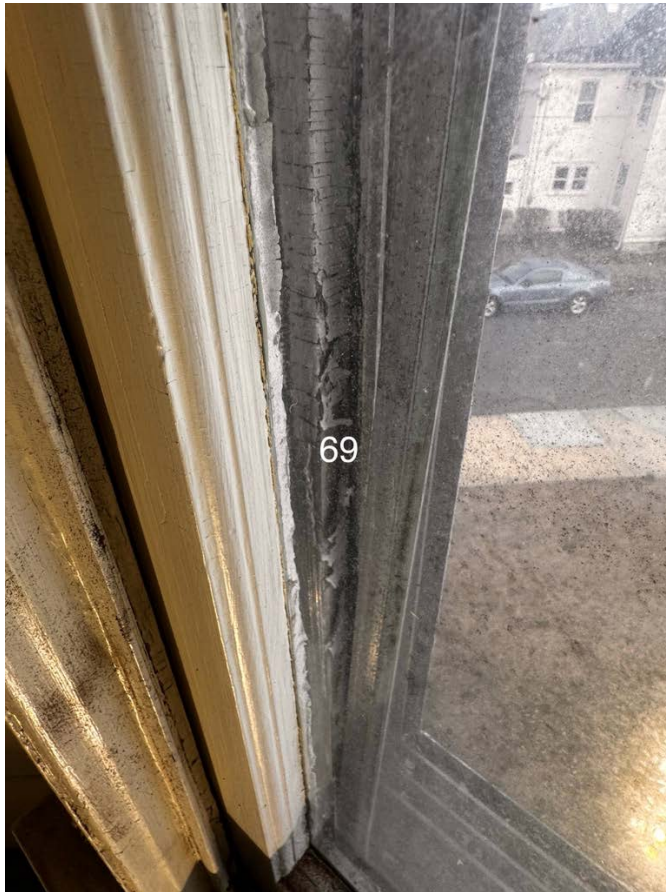
#69 — Level 2, east elevation. However, lifting the sash reveals window frames destroyed by rot and weather.

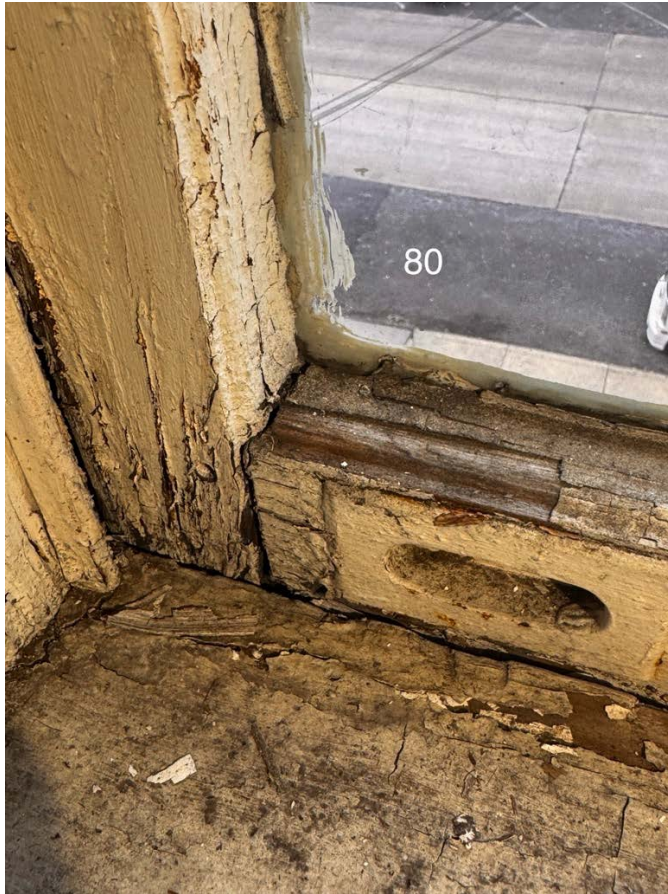
#80 — Level 3, north elevation. This Level 3 dormer window appears to be one of the original one-over-one fenestrations installed in 1894. The deterioration is extreme in both the sash and the window frame. Note: Windows #80, #81, #82, and #83 all date to the 1894 renovation and are beyond repair.

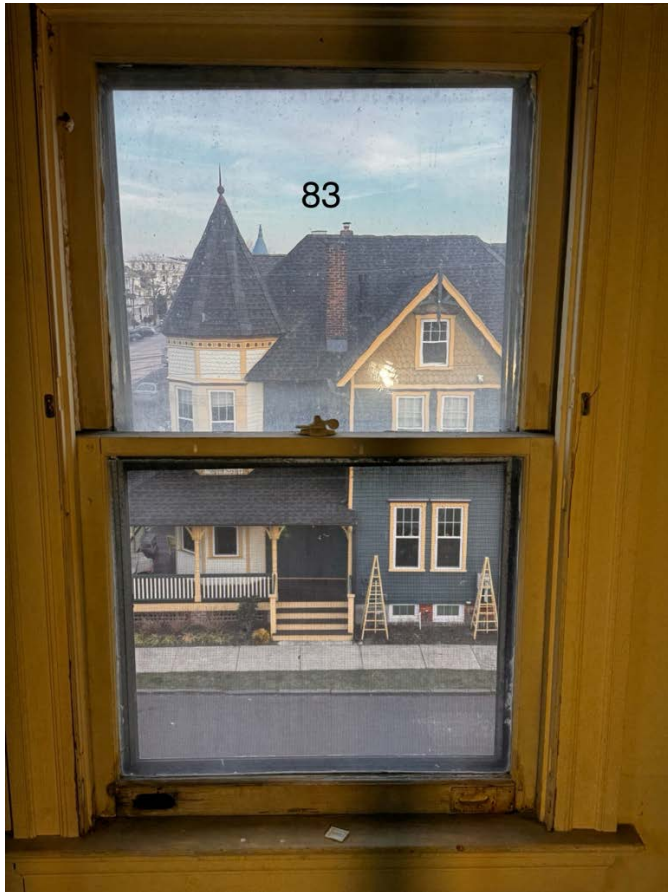
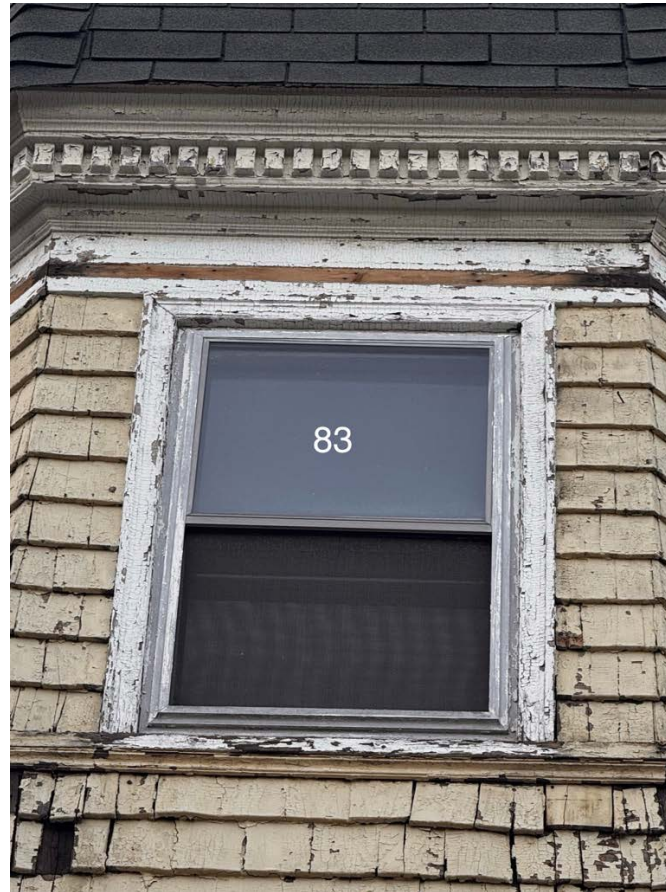
#83 — Level 3, east elevation.

However, further investigations revealed ONLY four of the existing 1/1 windows likely date from the 1894 renovation. They are the Level 3 dormer window (#80) and the Level 3 turret windows (#81, #82, and #83,) Unfortunately, these four windows are some of the most deteriorated in the entire house; decades beyond any hope of repair or restoration.
