## EXISTING WINDOW , SIDING & STRUCTURAL OBSERVATIONS -90 CLARK AVE.

Gannon Building & Remodeling has worked on hundreds of homes and other structures in and around Ocean Grove since 1985 . We have rebuilt countless Victorian era windows and doors over the last 35 years. We also have extensive experience in overall renovation of historic structures including but not limited to salvaging, repairing, weaving in of existing wooden clapboard siding. Mr. Heil , owner of 90 Clark Ave, at the request of the Neptune Township HPC, instructed us to prepare this report based on several site visits in 2019 and 2020. The architect, Brian Berzinskis, has numbered the windows, delineated areas of original siding on the attached elevations and provided photographs of same. We will refer to those items in this report.

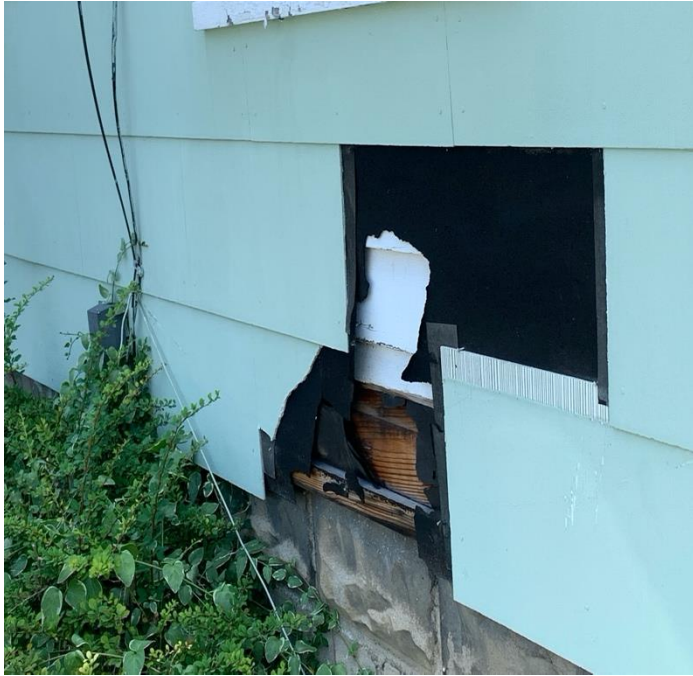
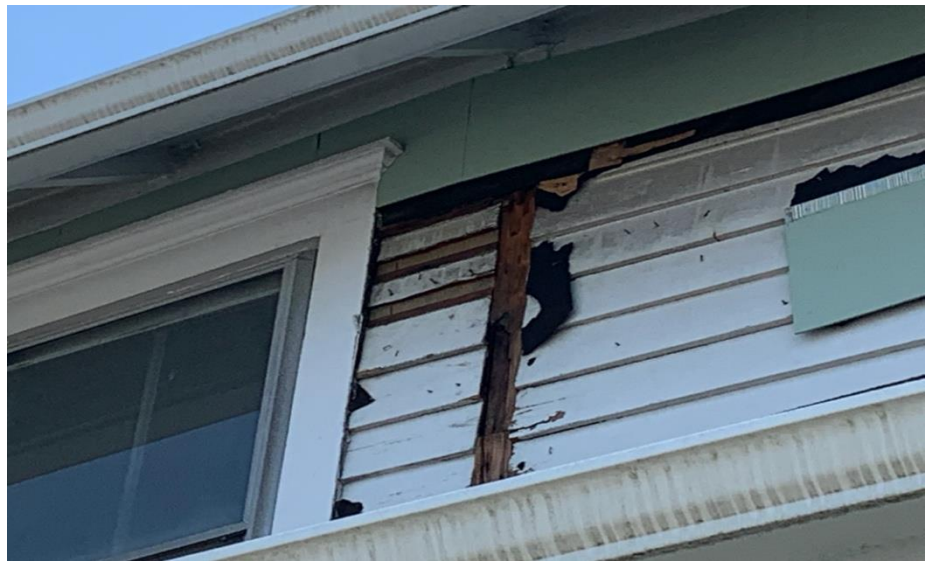
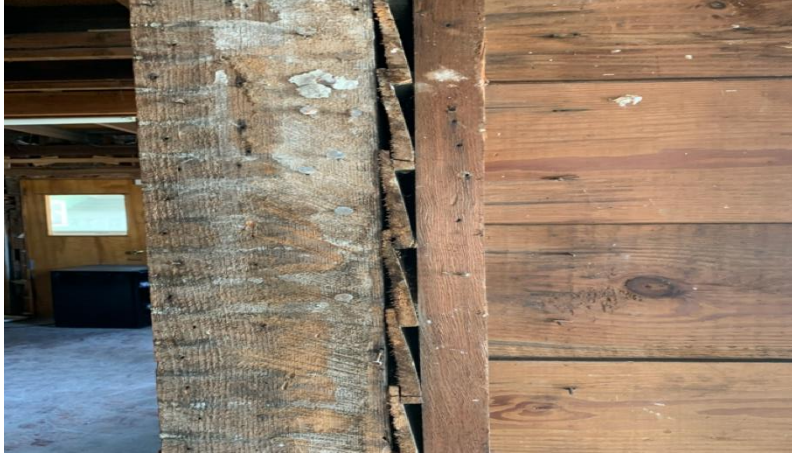
## Siding reveal

**Siding Overview:** Clapboard siding was found under some sections of the exterior layer of asbestos siding. Other areas of the house were sided with horizontal 1 by 6 and 1 by 8 pine . Some of it was tongue and groove, some was flat stock. The amount of original siding remaining on the building is fractional and denoted on the Elevations attached marked as area #1. The majority of the remaining original clapboard siding has been compromised by the removal of corner boards, rim trim boards as well as a multitude of cut out areas , furring strip damage , nail damage and years of neglect.(See photos attached) In addition, the original house was built as a balloon frame structure with the clapboard siding nailed directly to the structural vertical studs.(See Photos attached). In order to properly obtain structural code compliance, the existing clapboard should be removed and exterior plywood sheathing attached to the existing (some sistered/all firestopped ) vertical framing. Then the finished siding should be applied.

Exterior trim on all windows would need to be removed to install windows and/or new sheathing. Exterior trim is a hodgepodge of many styles , not only on the many additions but also on the original structure. Owner proposes to replicate the exterior trim of the original house with matching azek and crown molding. The owner proposes all new 2 over 2 windows, new hardi plank siding with same reveal as original and azek trim replicating the existing trim and homogenizing the entire house into a single style , again, replicating the original as closely as possible while bringing this house up to current structural and fire codes.

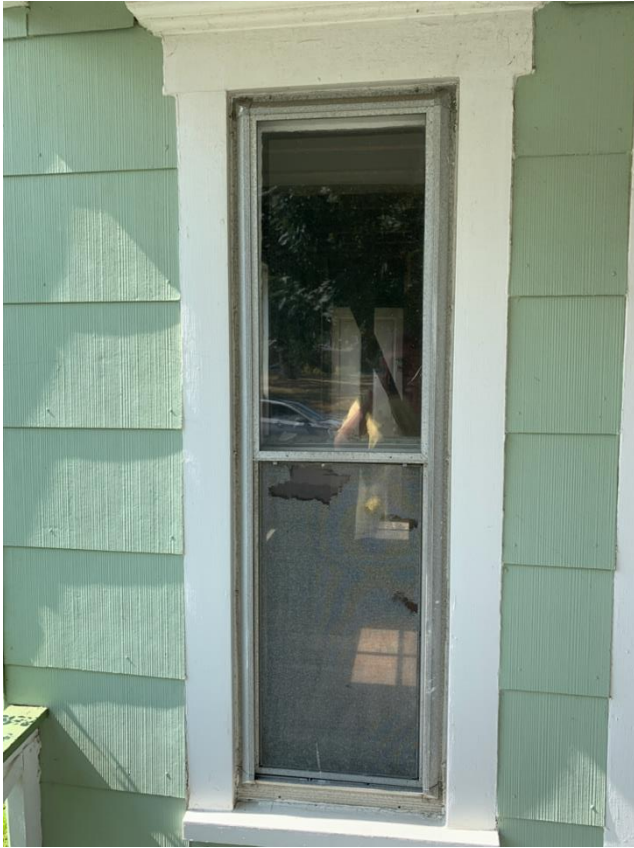
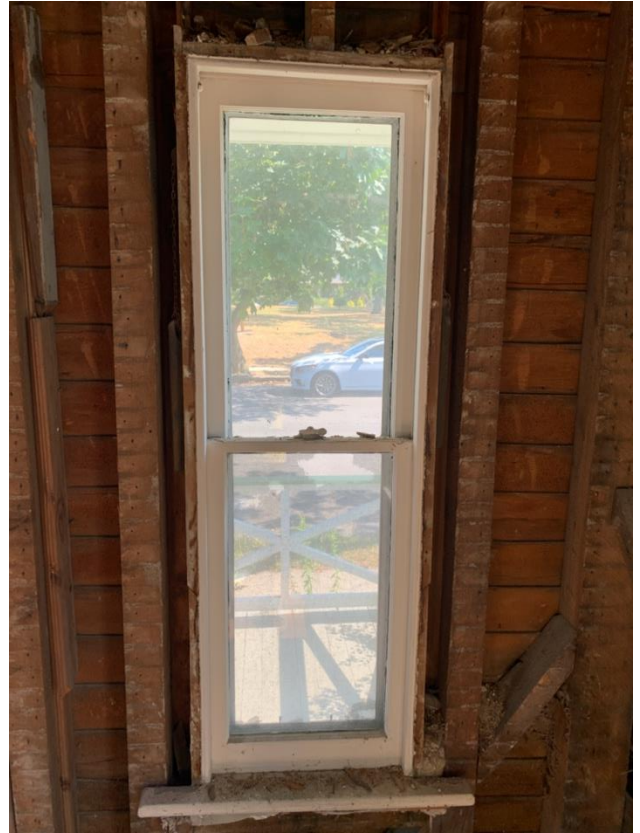
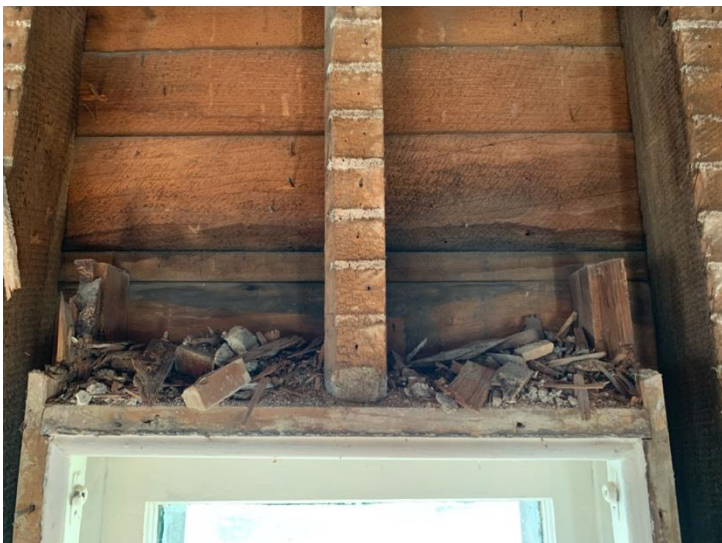
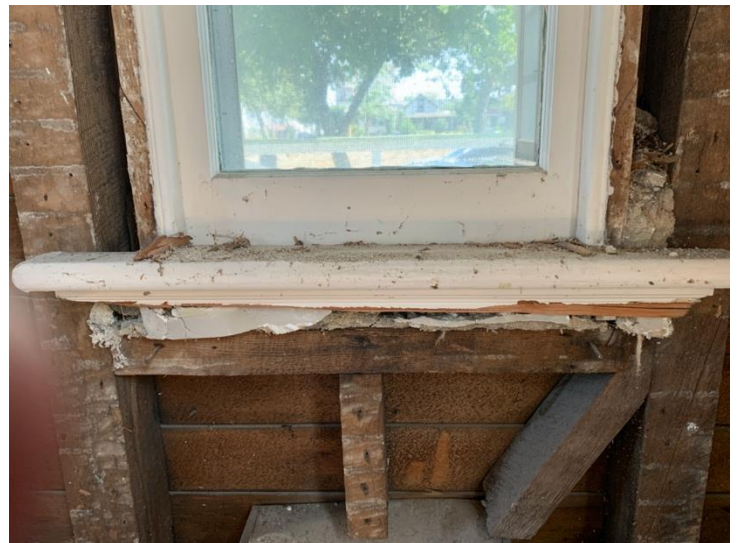
## Window 101

ORIGINAL Double Hung 2 over 2 single pane 5/4" frame wood window. Settlement and lack of headers caused both the window frame and sash to be out of square. Window is non- operational and appears to have been that way for many many years. Needs complete glass removal and dismantling requiring plane of old wood and wood replacement.

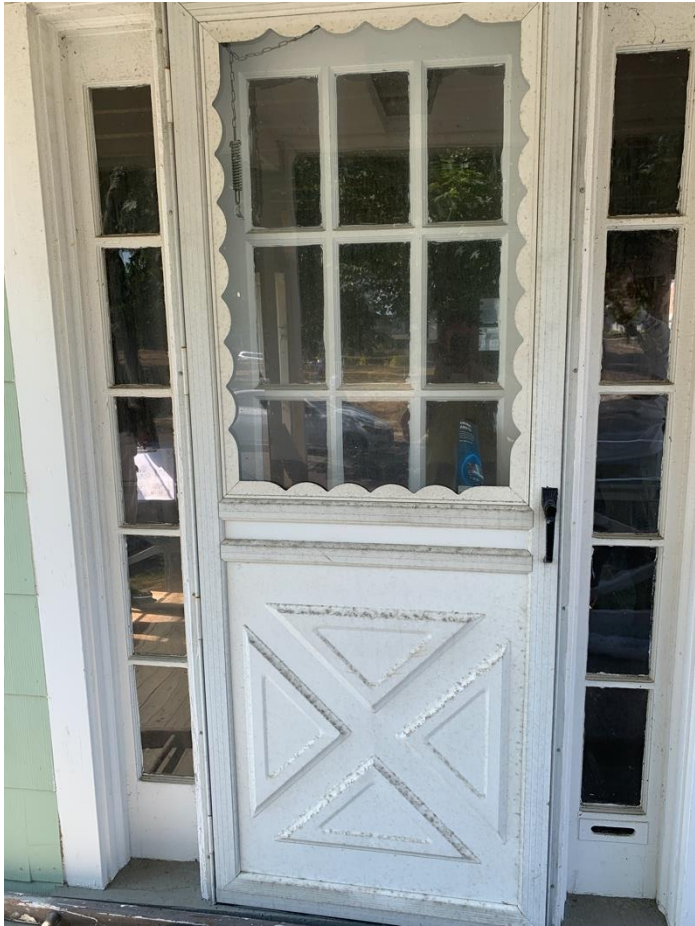
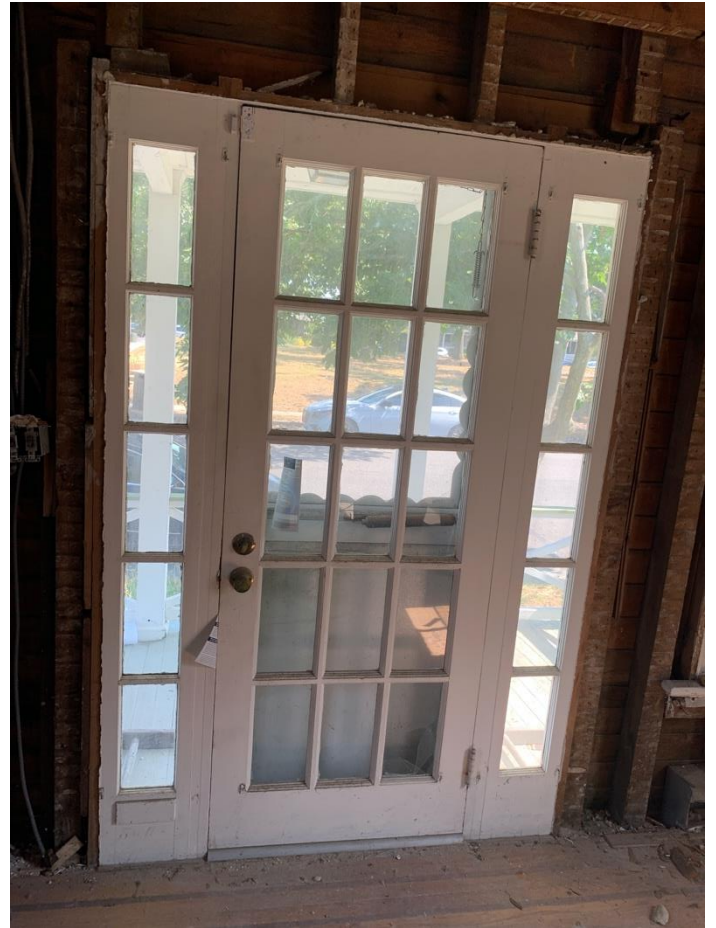
## **Front Door 102**

Front Door ... Replacement approved prior application....

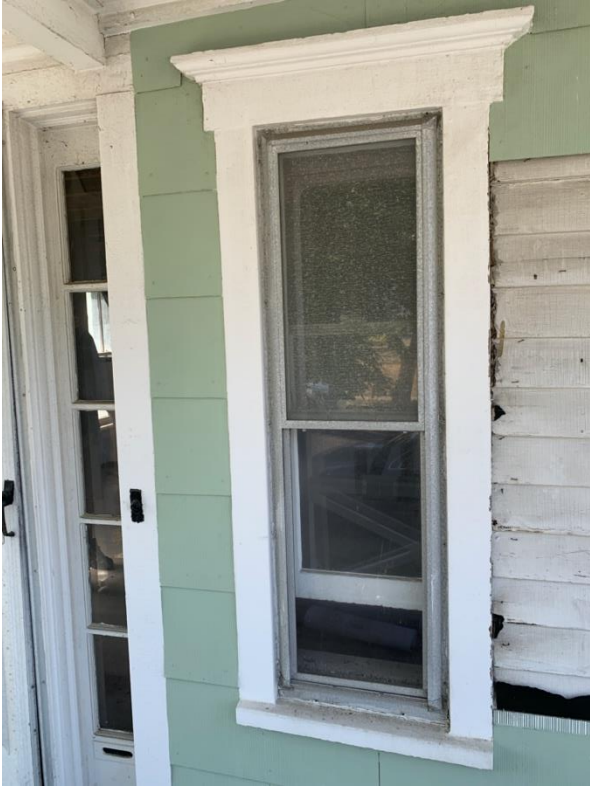
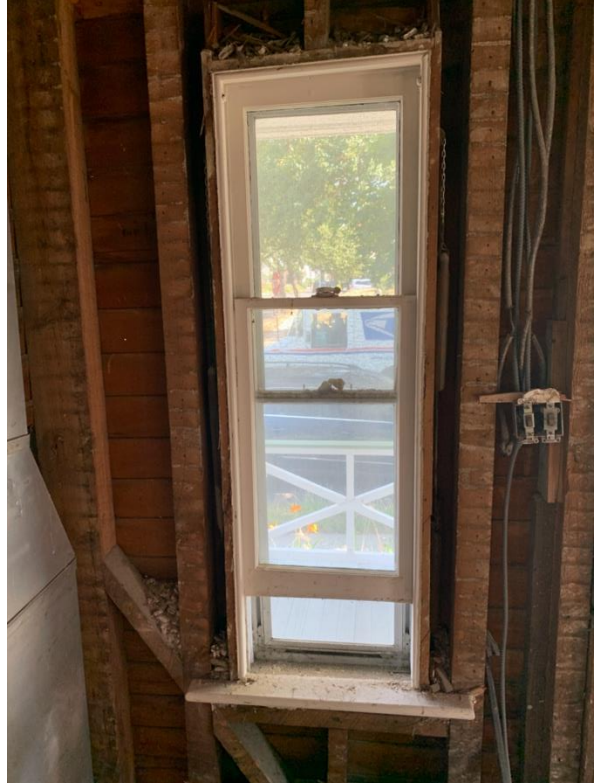
## Window 103

ORIGINAL – Same as window 101 and severely out of square

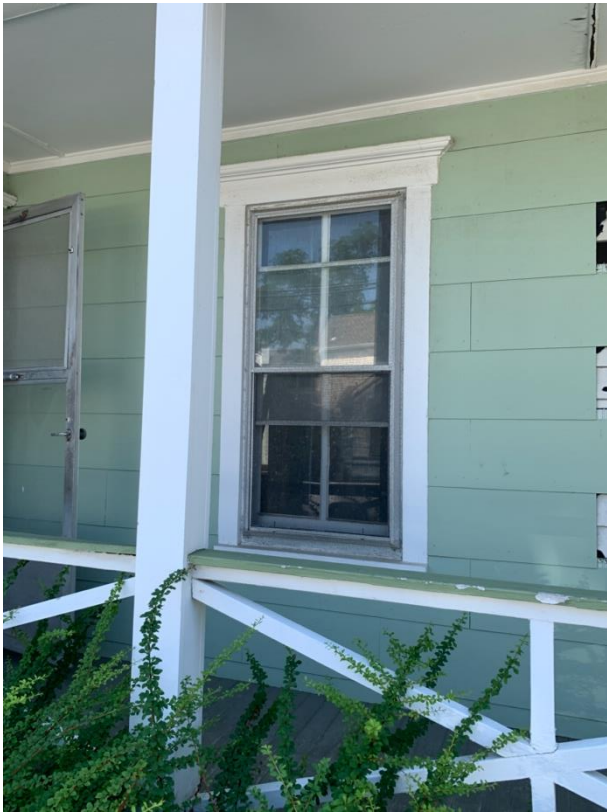
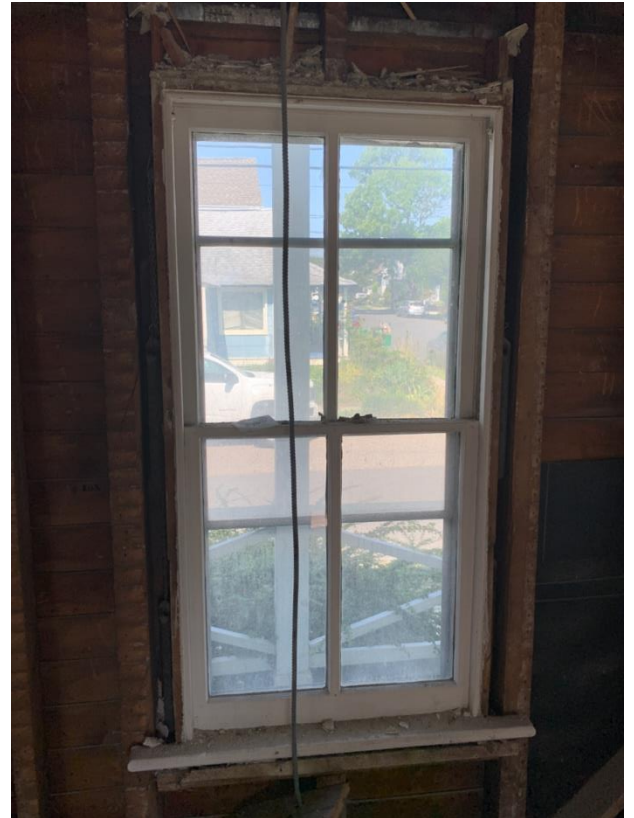
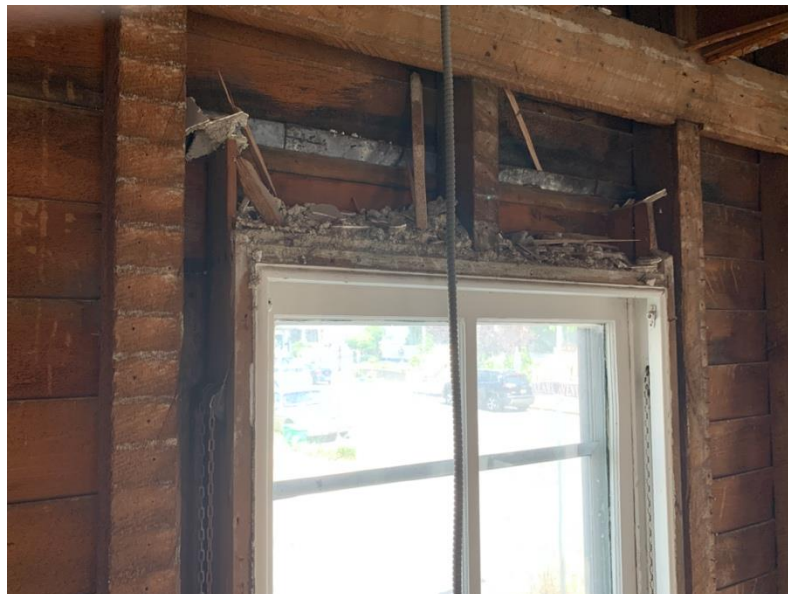
## Window 104

ORIGINAL – Same as 101

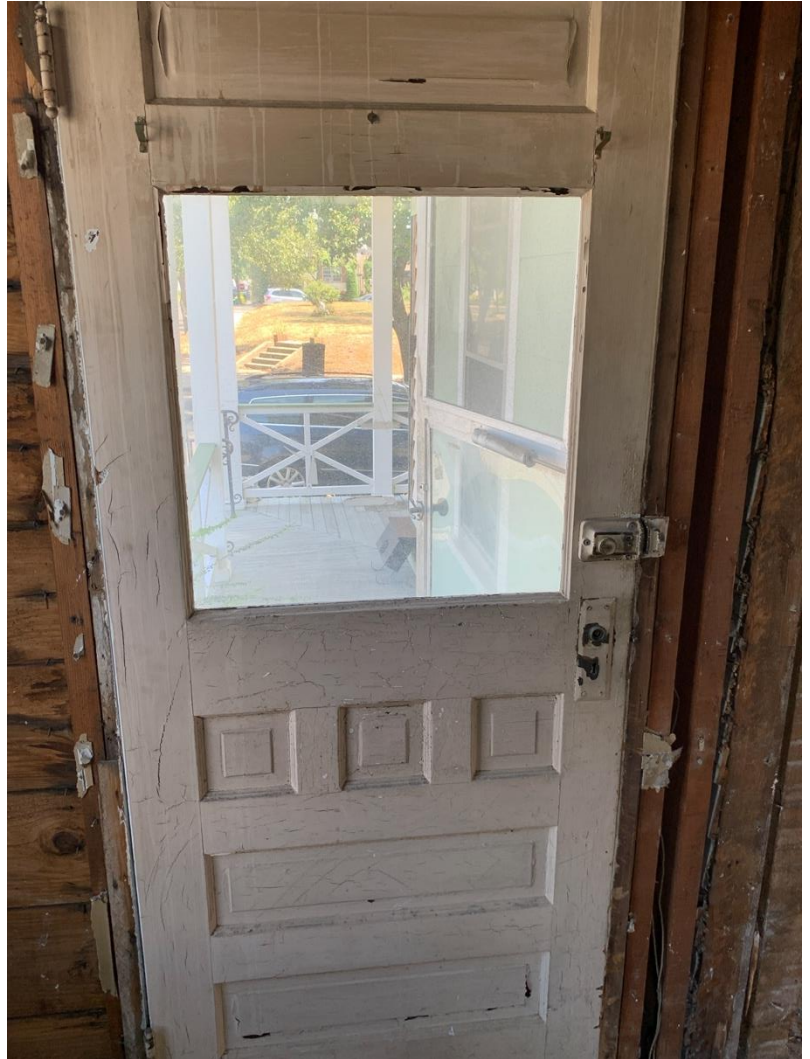
## Side Door 105

Side Door – 1 $\frac{3}{8}$ " thick . Not an exterior door – Plexiglass window in opening

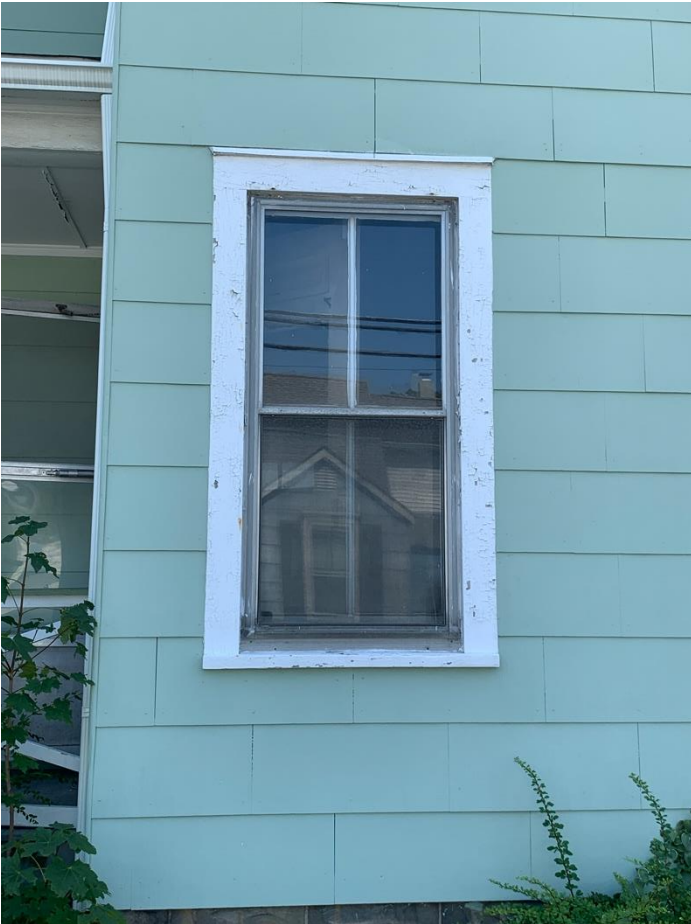
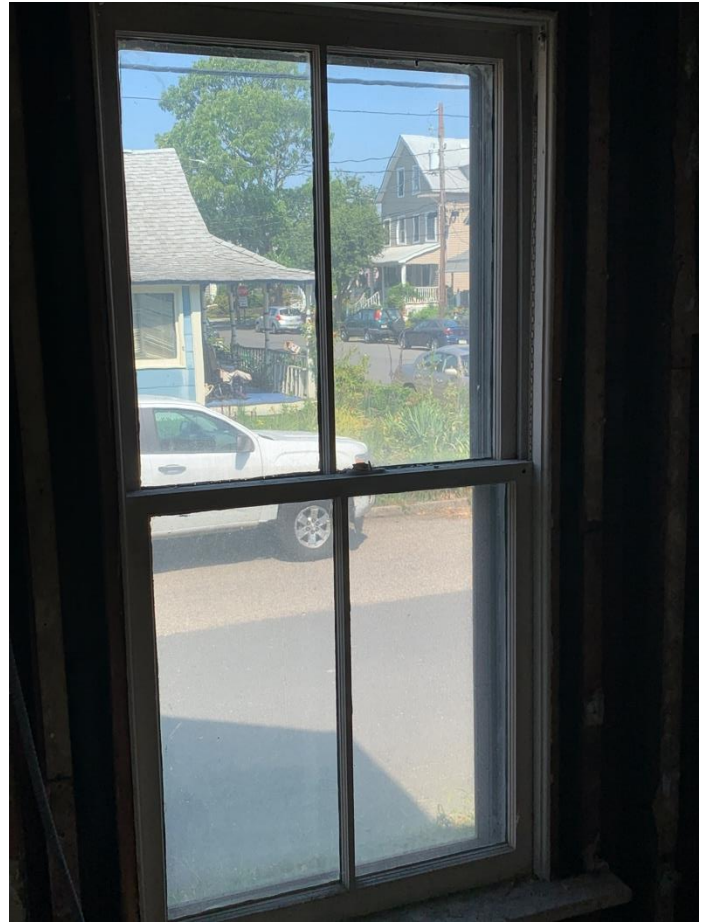
## Window 106

WEST ADDITION : Not original window – partially operational ... out of square

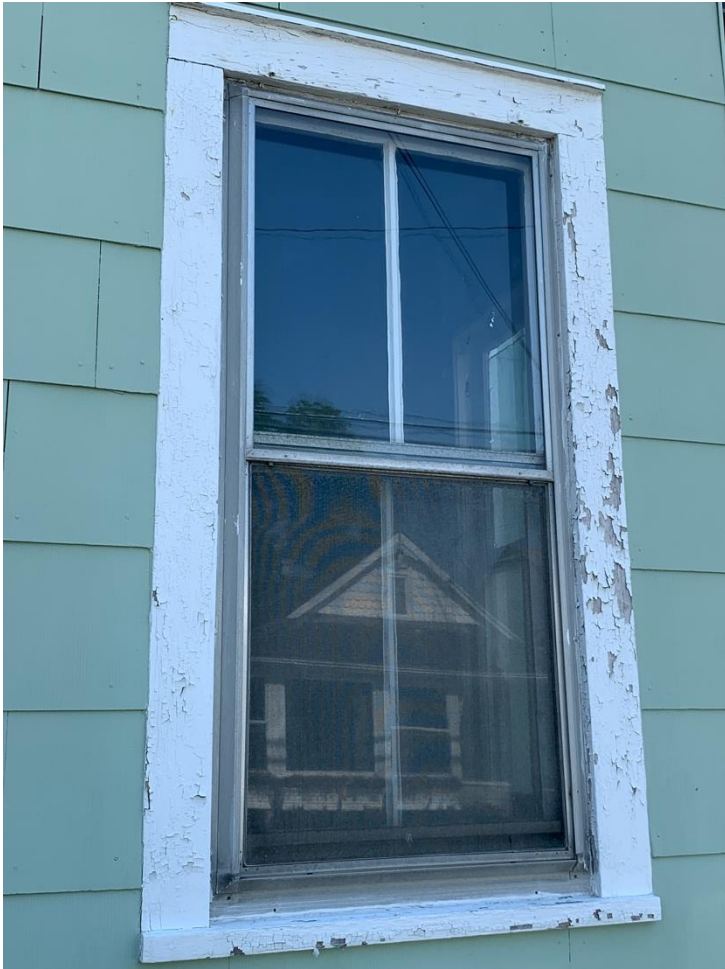
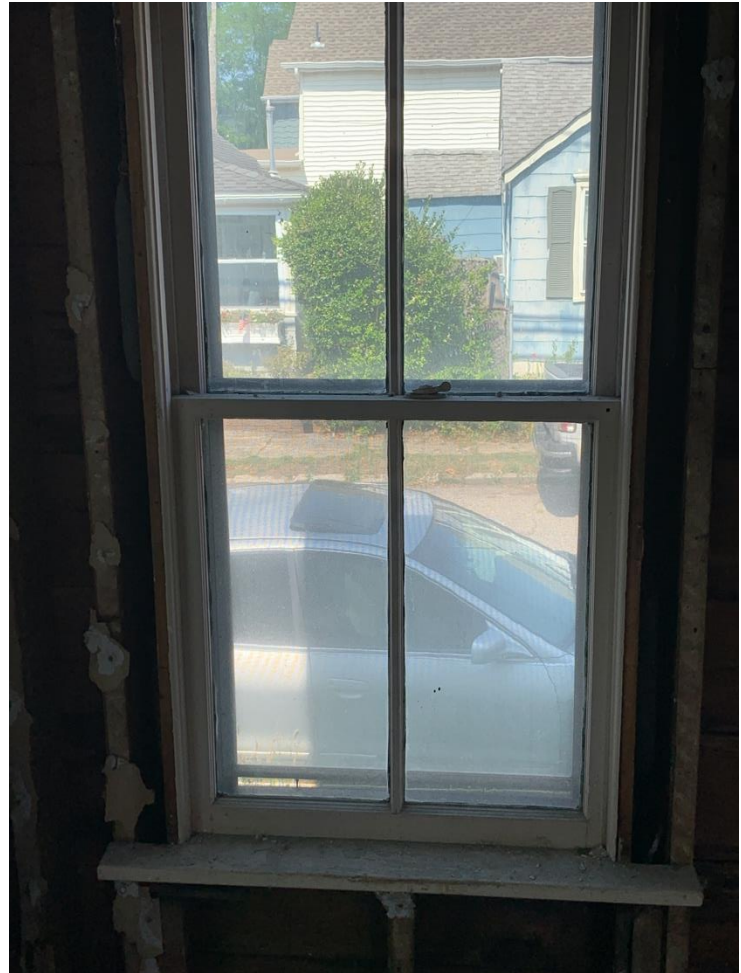
## Window 107

Not Original non operational ... out of square

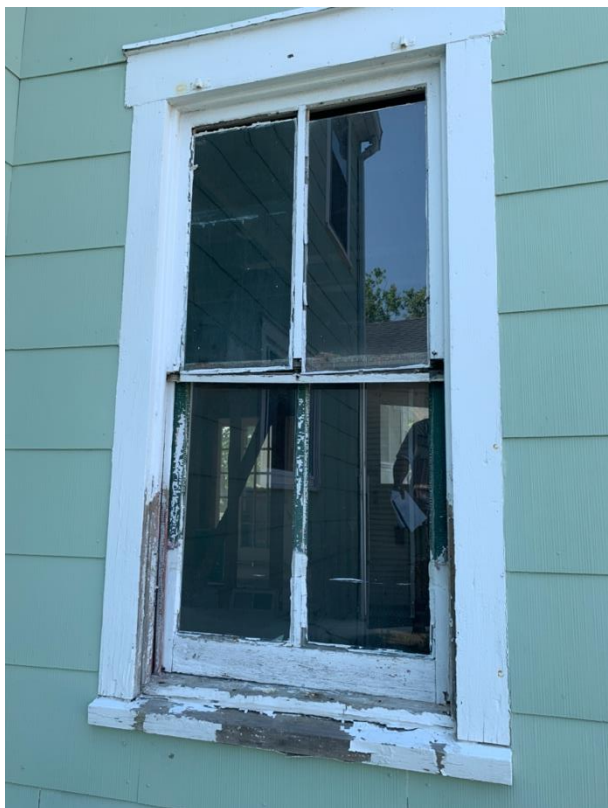
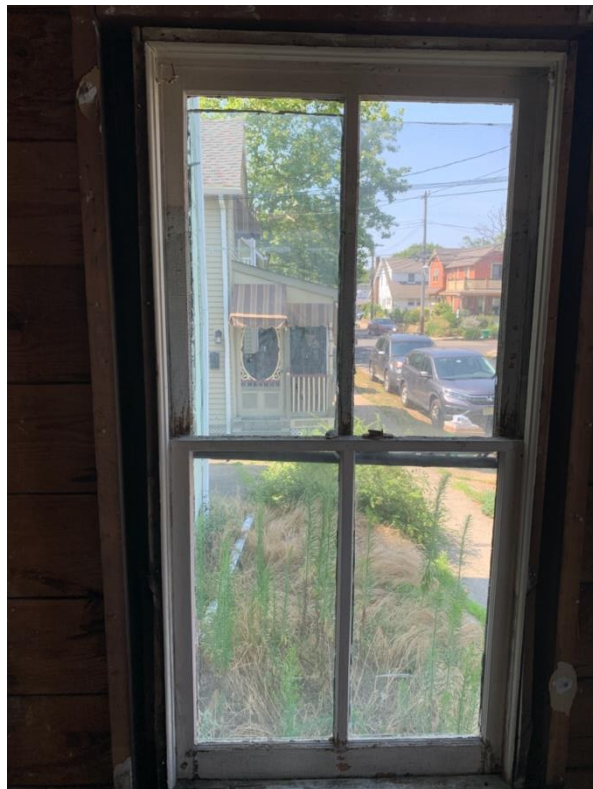
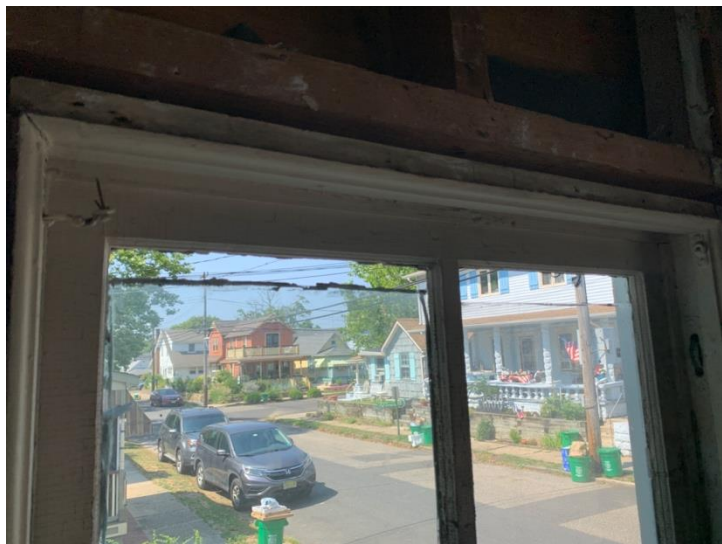
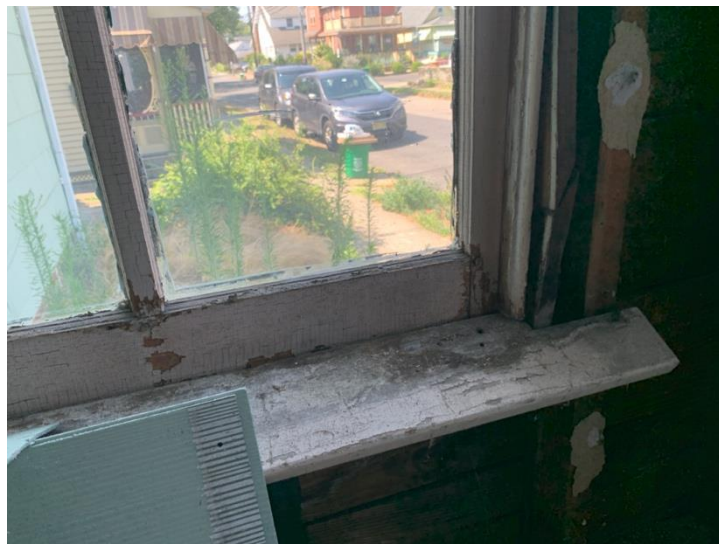
## Window 108

Not Original – non operational – total deterioration

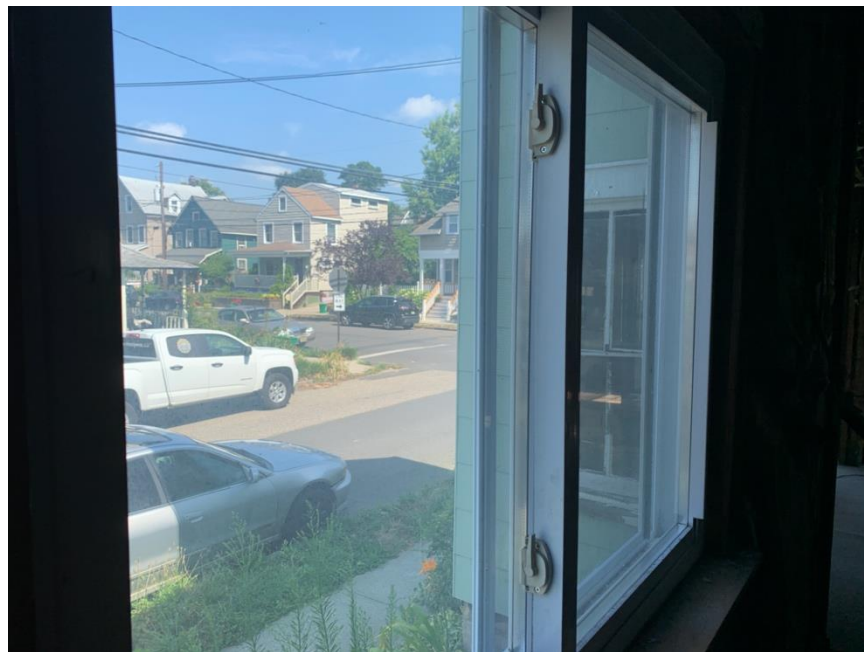
## Window 109

Vinyl Slider

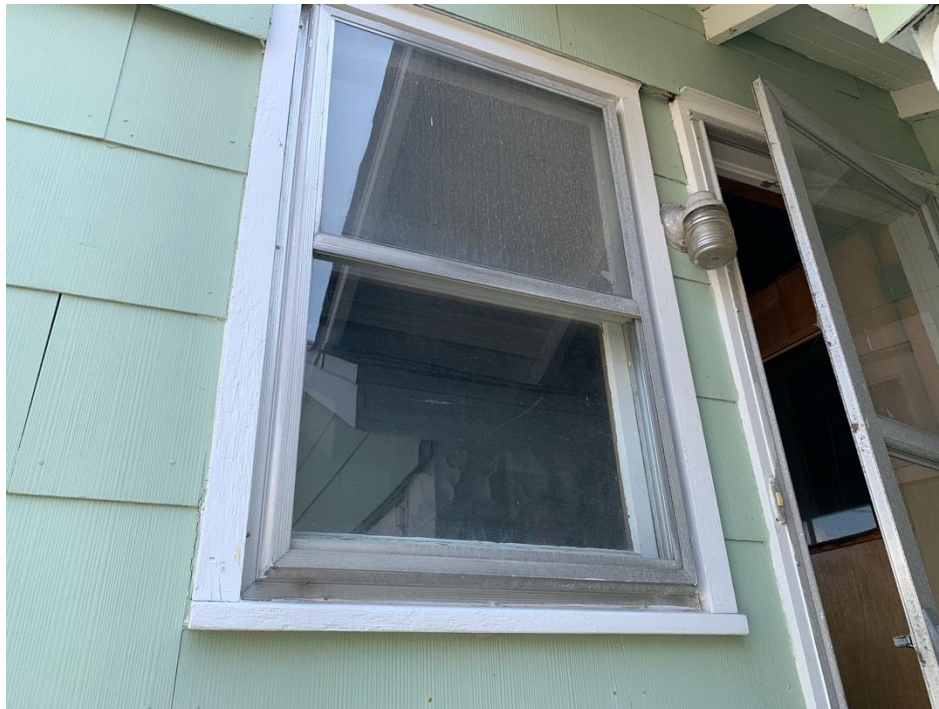
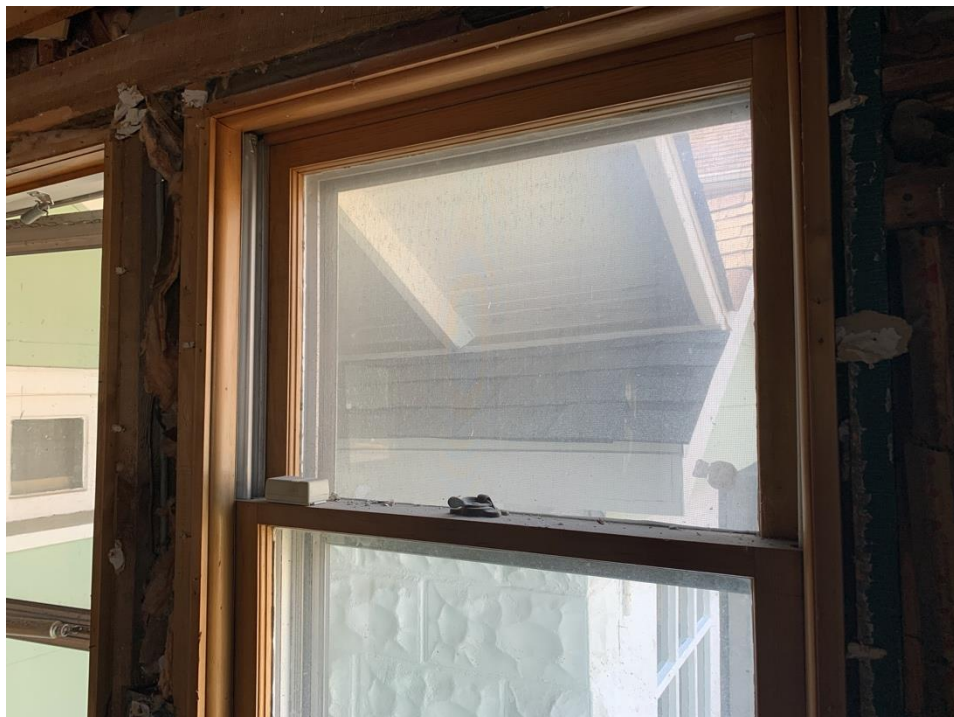
## Window 110

Double hung

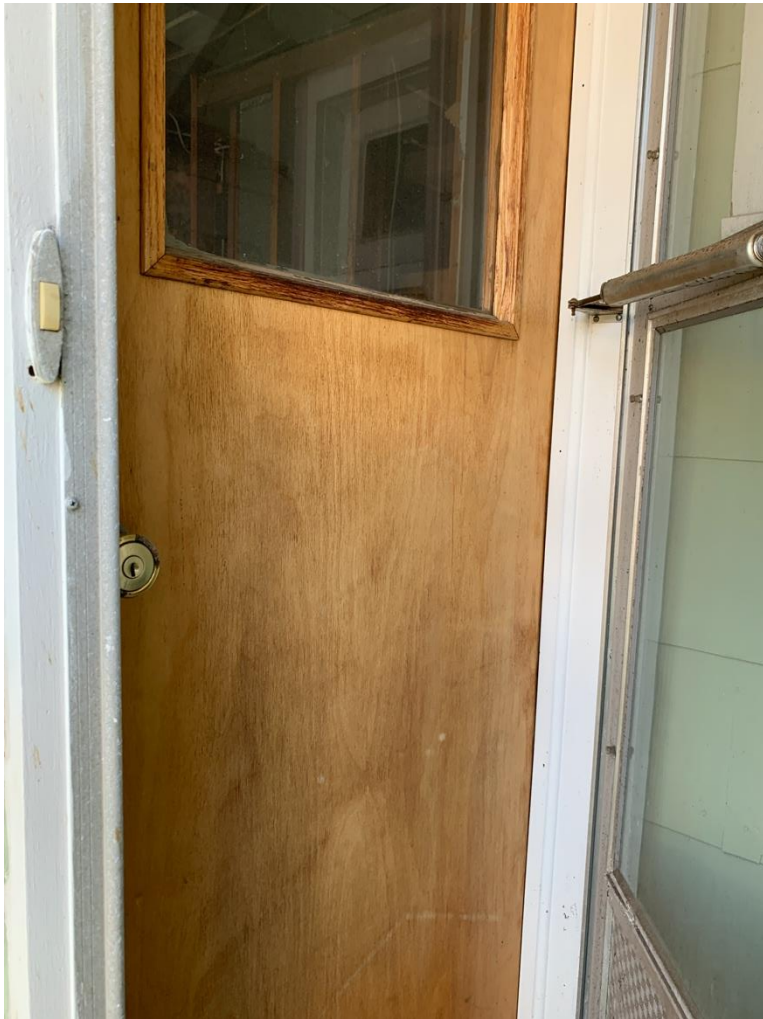
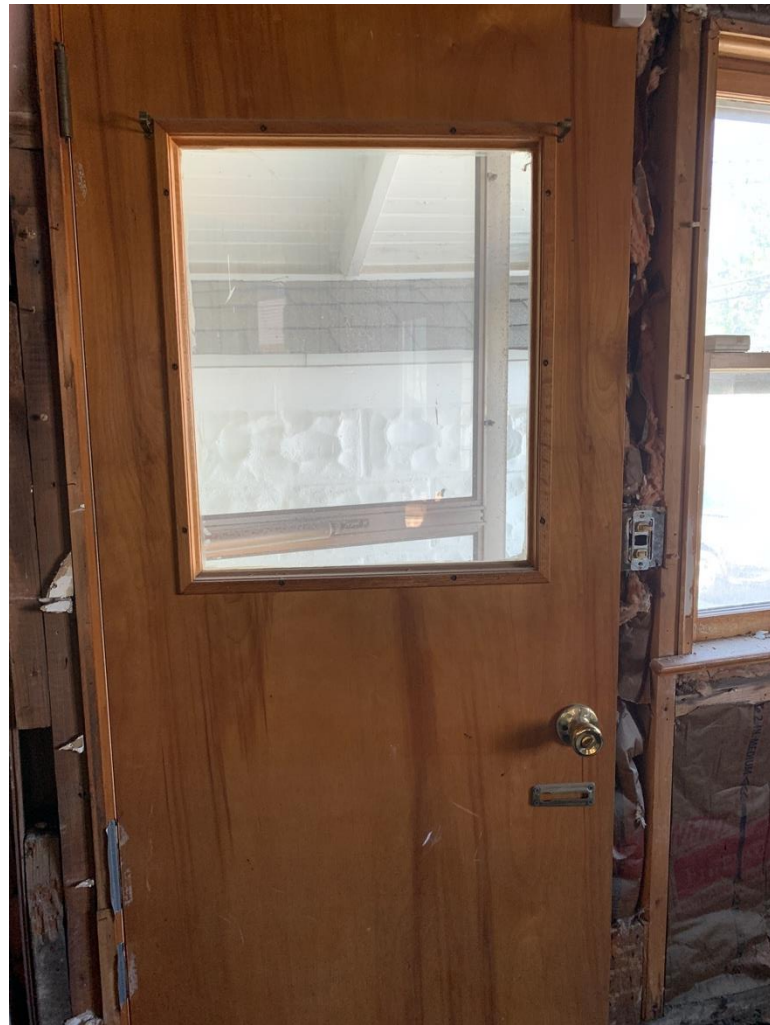
## Door 111

Wood door – not an exterior door ½ glass

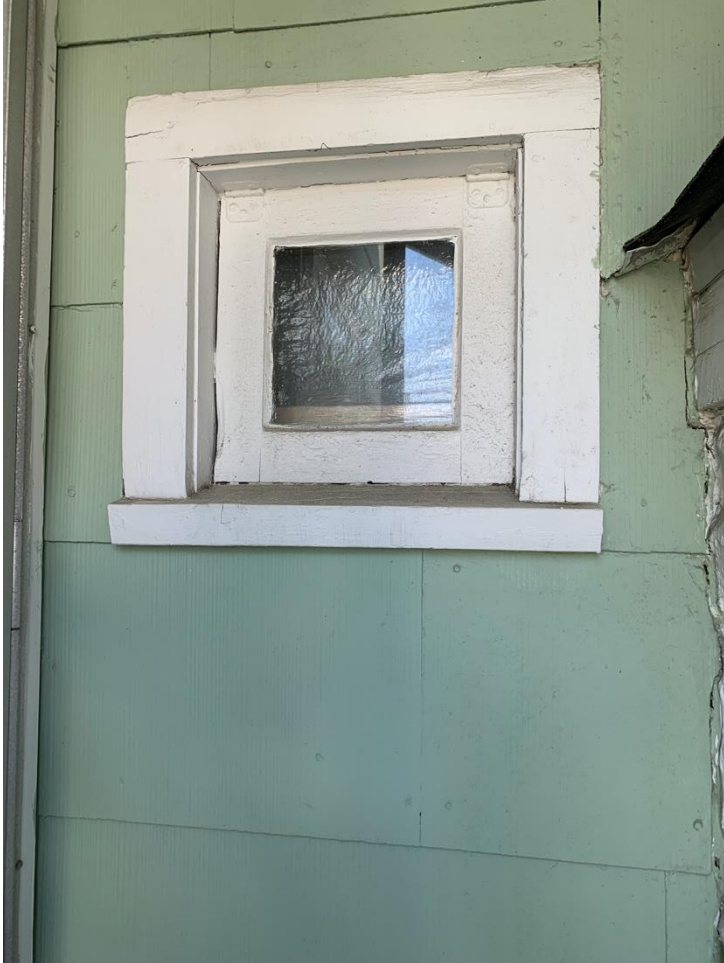
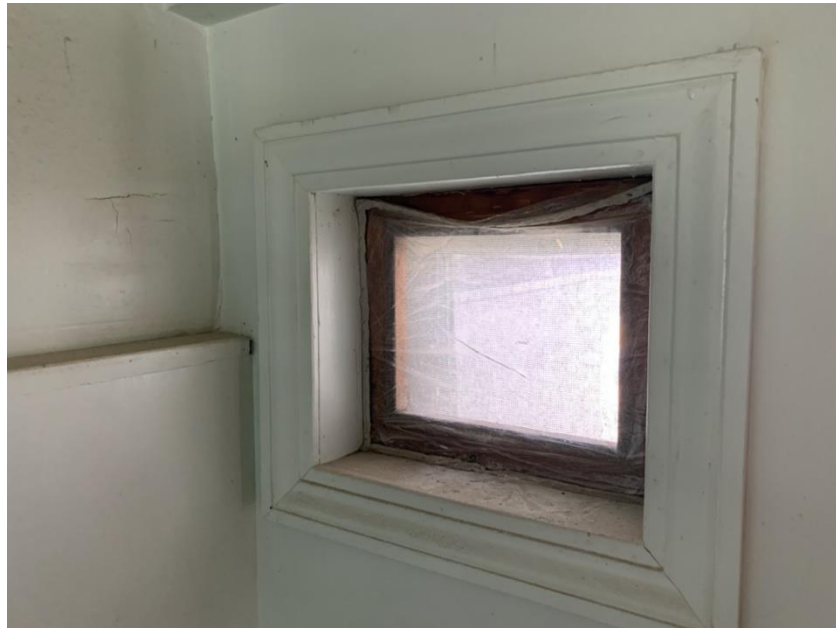
## Window 112

Miniture bath window - ??????

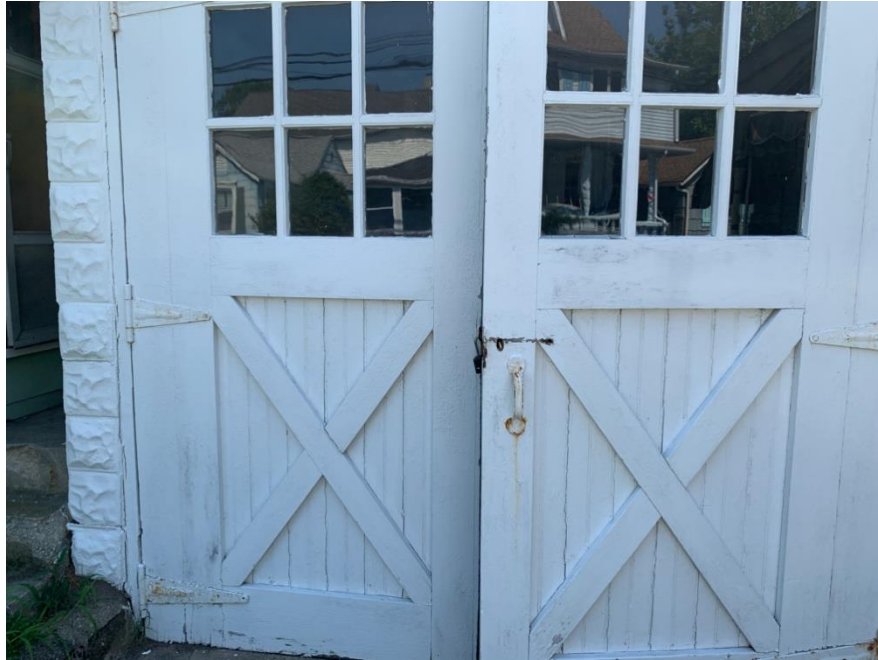
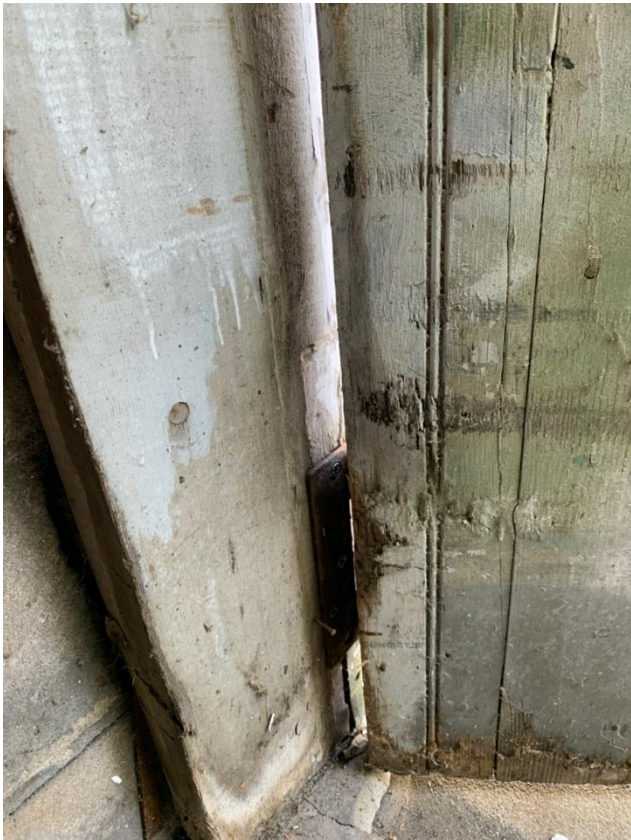
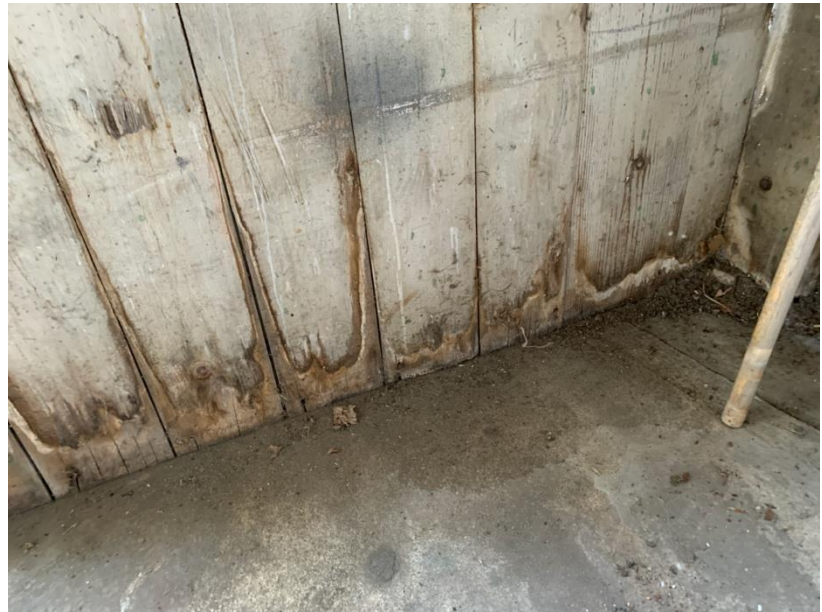
## Garage Door 113

Garage doors ... wood that is rotted .. will need replacement

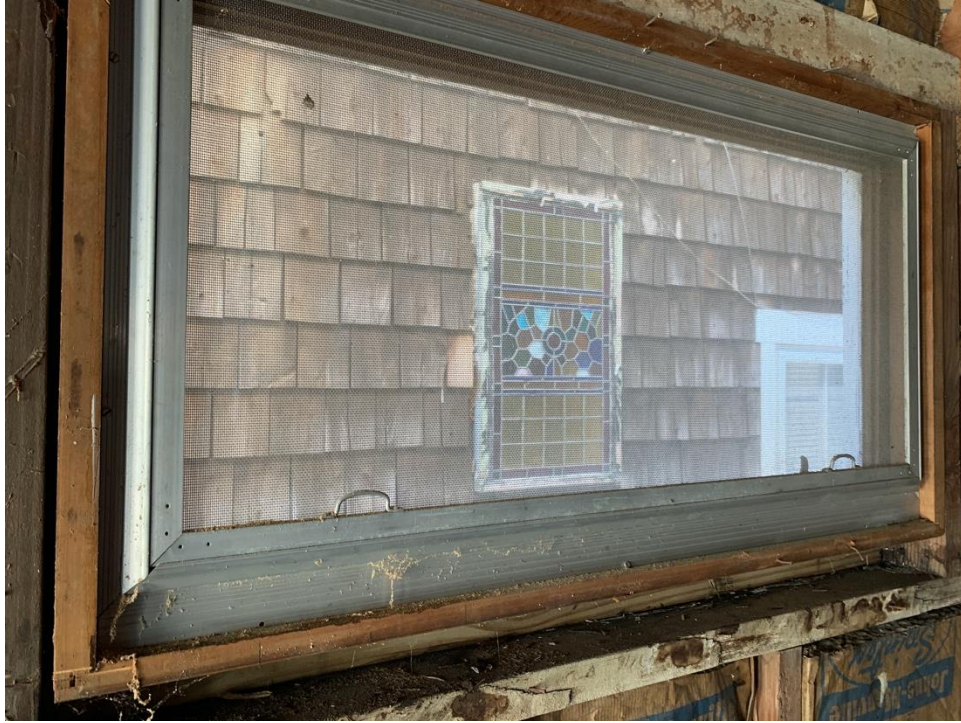
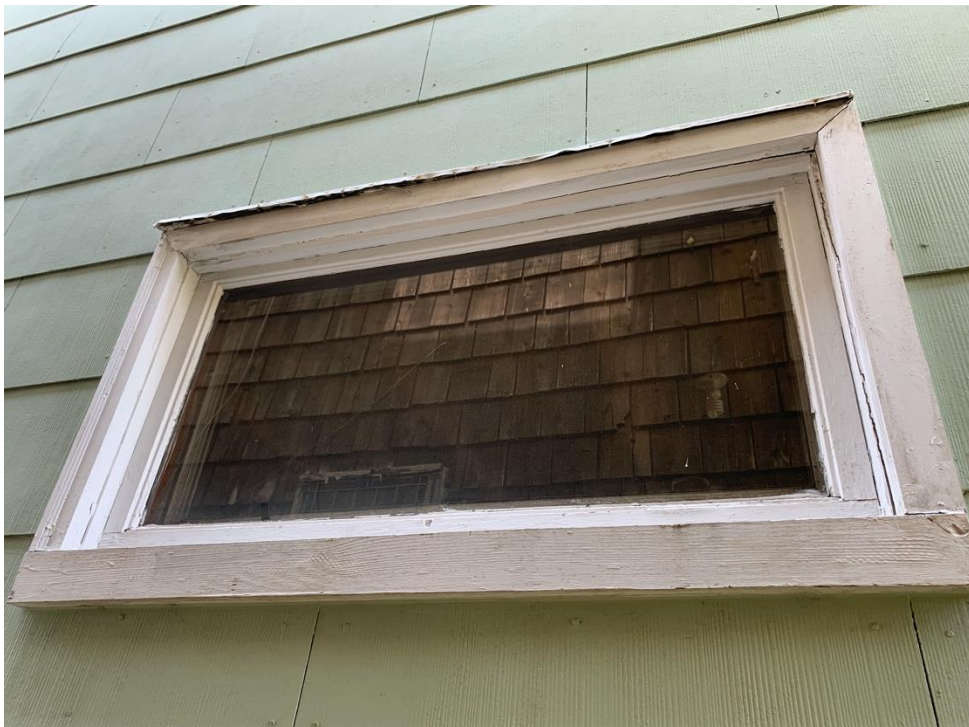
## Window 114

Aluminum awning window

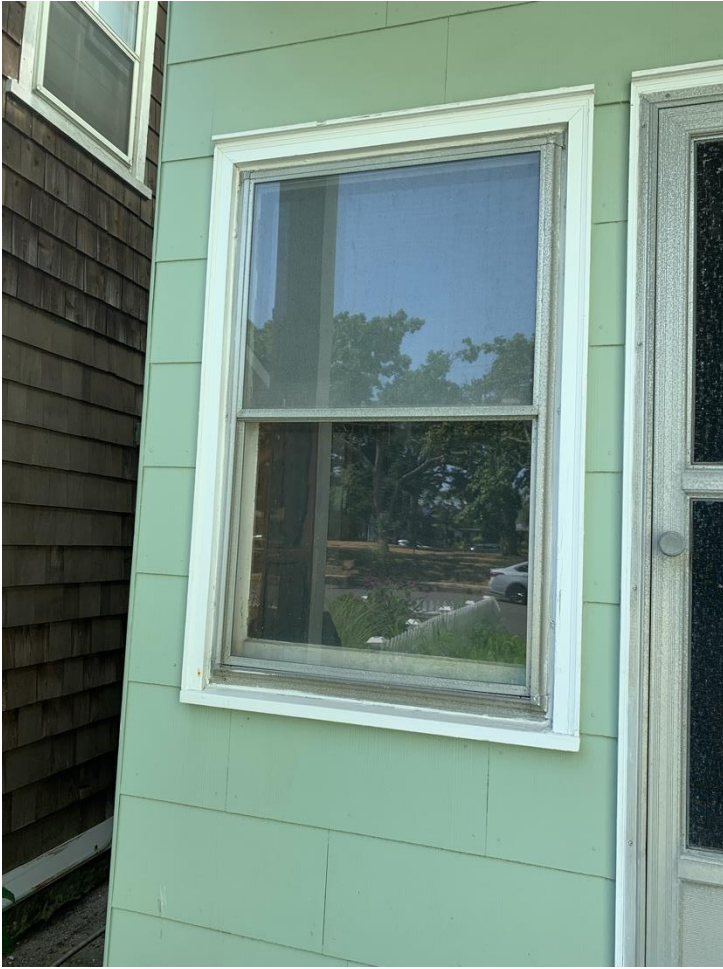
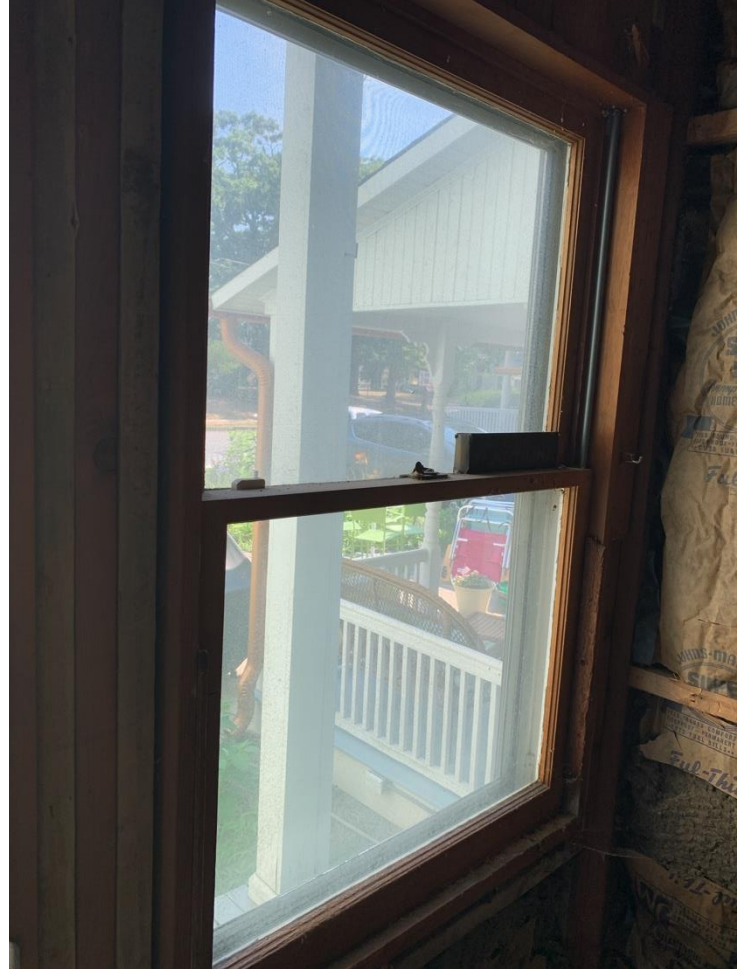
## Window 115

Wood double hung
