## EXISTING WINDOW , SIDING & STRUCTURAL OBSERVATIONS -90 CLARK AVE.

Gannon Building & Remodeling has worked on hundreds of homes and other structures in and around Ocean Grove since 1985 . We have rebuilt countless Victorian era windows and doors over the last 35 years. We also have extensive experience in overall renovation of historic structures including but not limited to salvaging, repairing, weaving in of existing wooden clapboard siding. Mr. Heil , owner of 90 Clark Ave, at the request of the Neptune Township HPC, instructed us to prepare this report based on several site visits in 2019 and 2020. The architect, Brian Berzinskis, has numbered the windows, delineated areas of original siding on the attached elevations and provided photographs of same. We will refer to those items in this report.

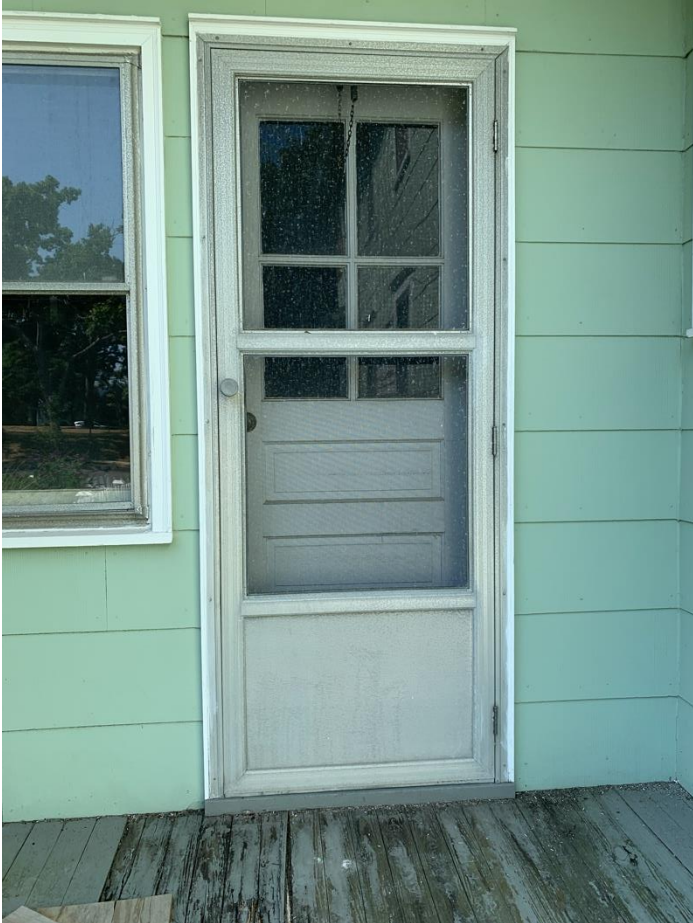
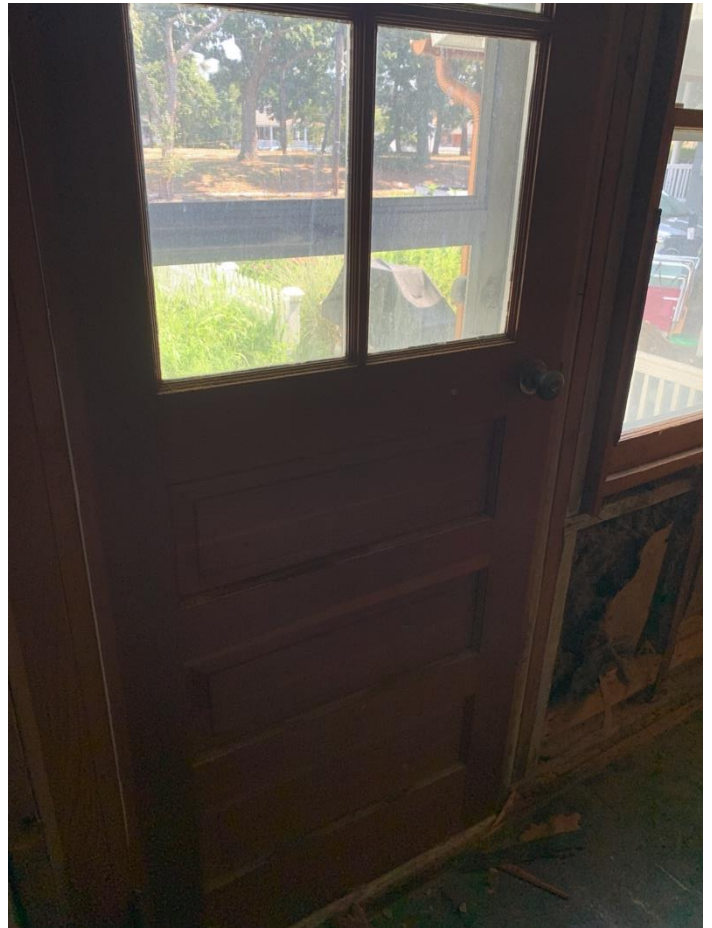
## Side Door 116

Wooden Door

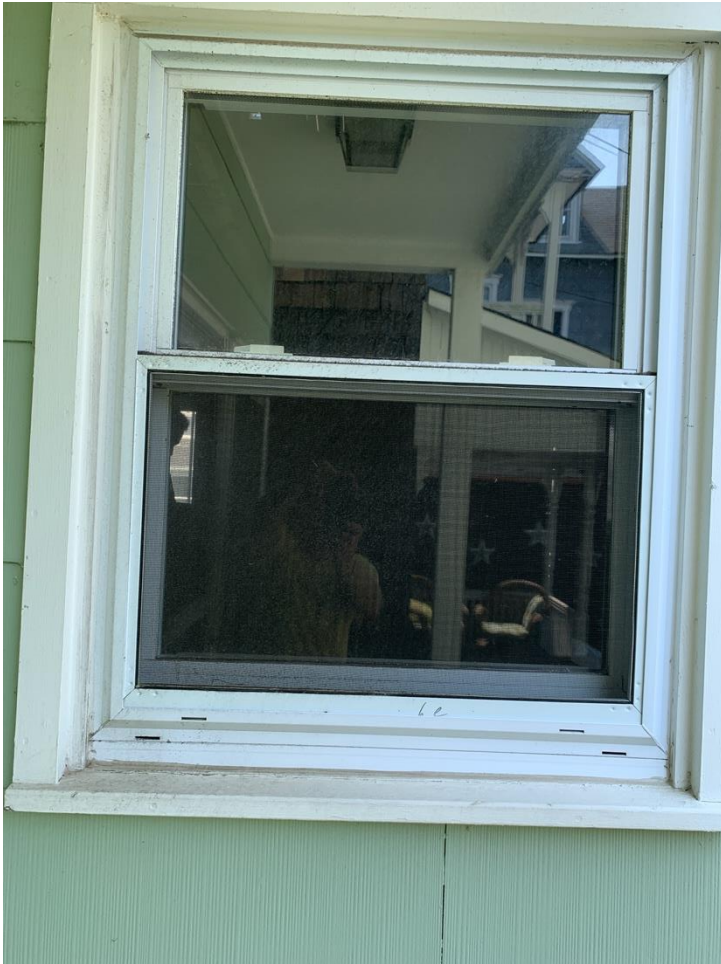
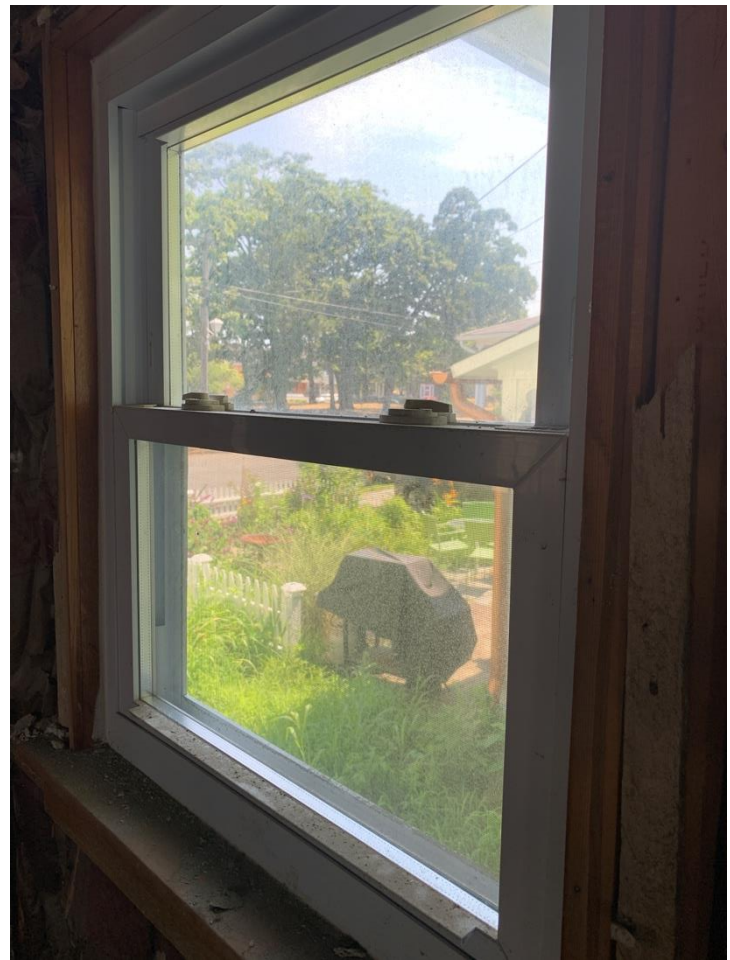
## Window 117

Vinyl replacement window

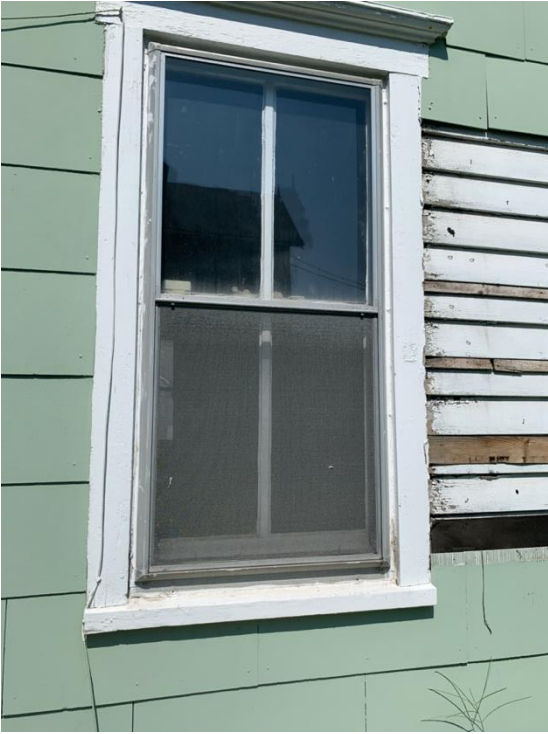
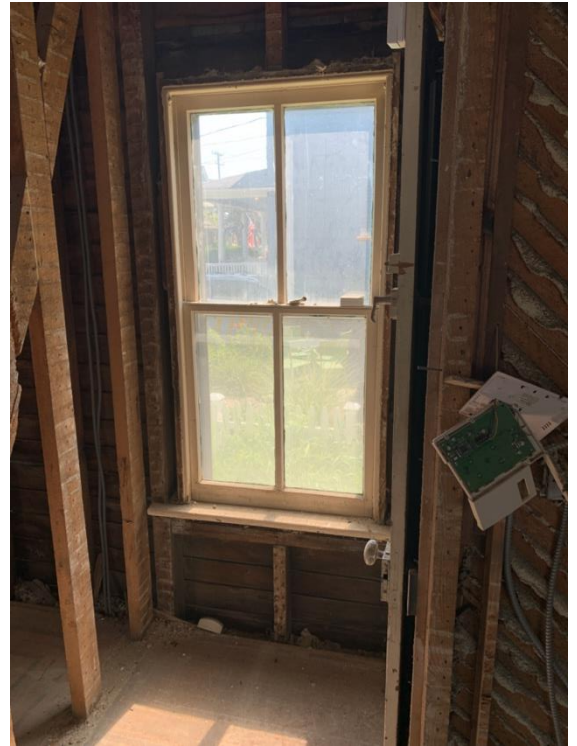
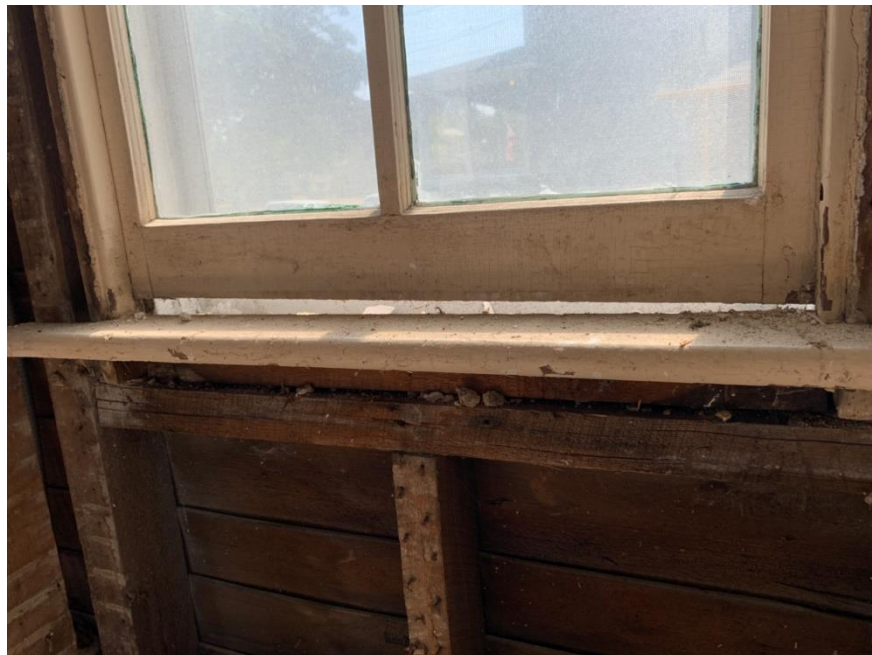
## Window 118

WEST SIDE FRONT — Double Hung 2 over 2 single pane 5/4" frame wood window. Settlement and lack of headers caused both the window frame and sash to be out of square. Window is non- operational and appears to have been that way for many many years. Needs complete glass removal and dismantling requiring plane of old wood and wood replacement

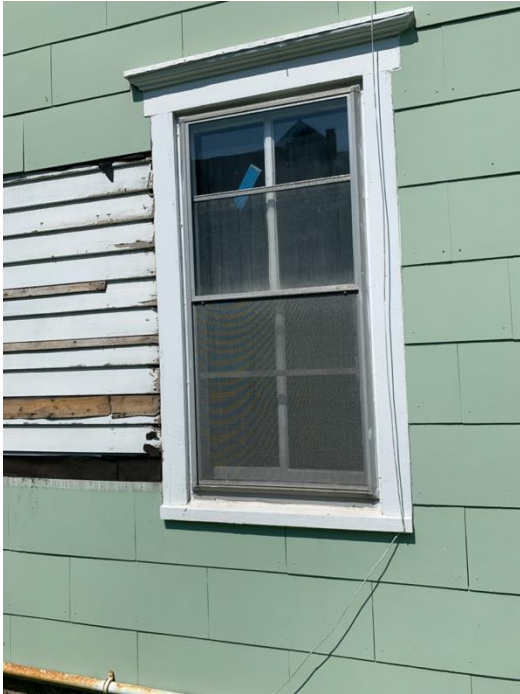
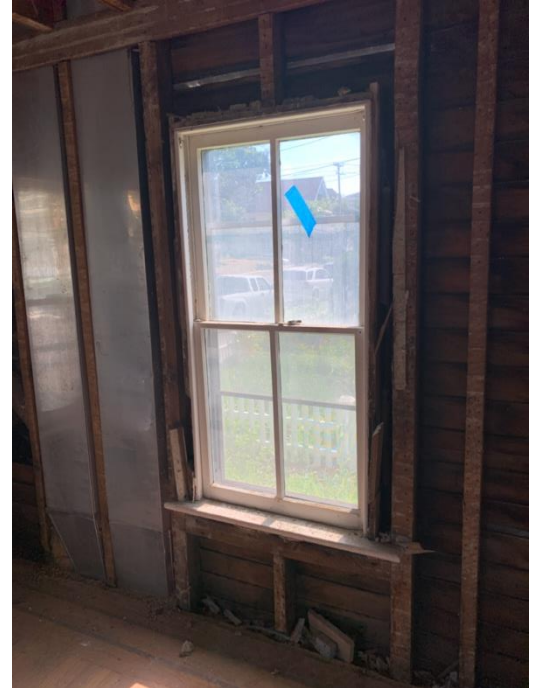
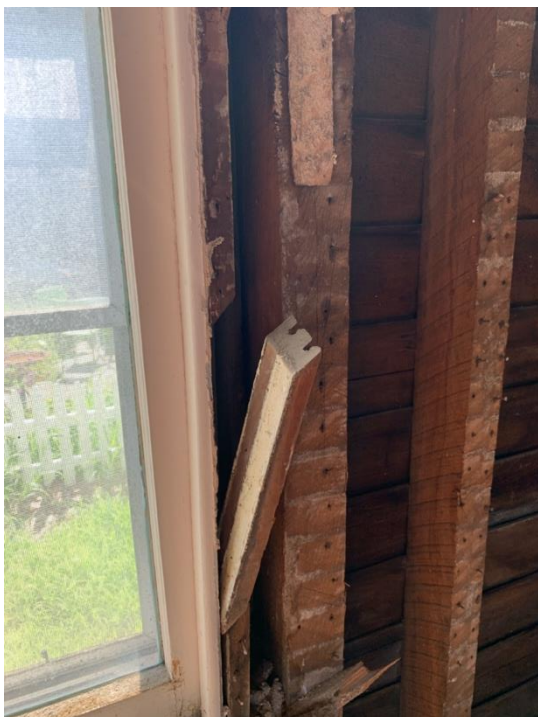
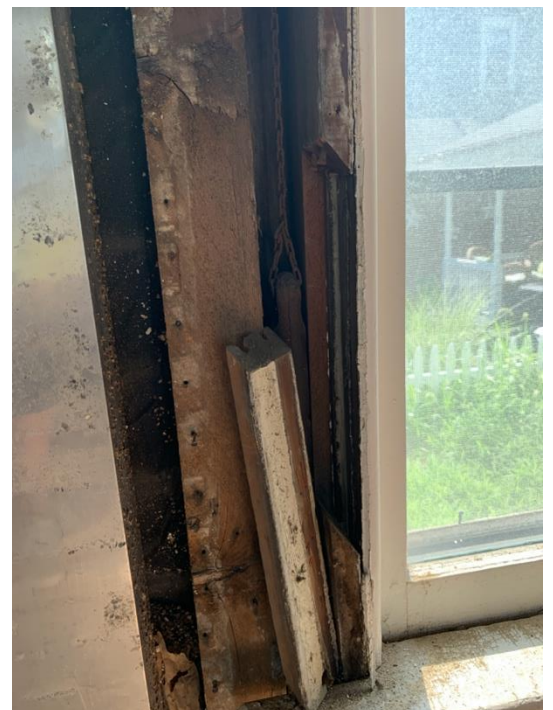
## Window 119

ORIGINAL - Double Hung 2 over 2 single pane 5/4" frame wood window. Settlement and lack of headers caused both the window frame and sash to be out of square. Window is non- operational and appears to have been that way for many many years. Needs complete glass removal and dismantling requiring plane of old wood and wood replacement

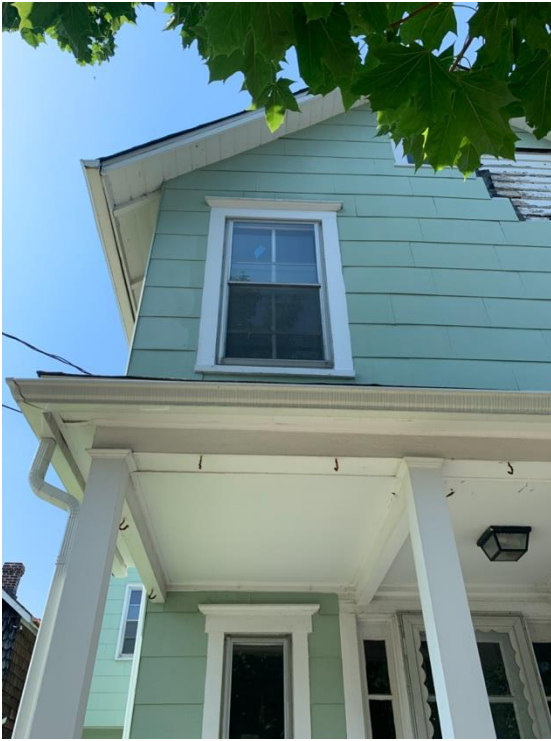
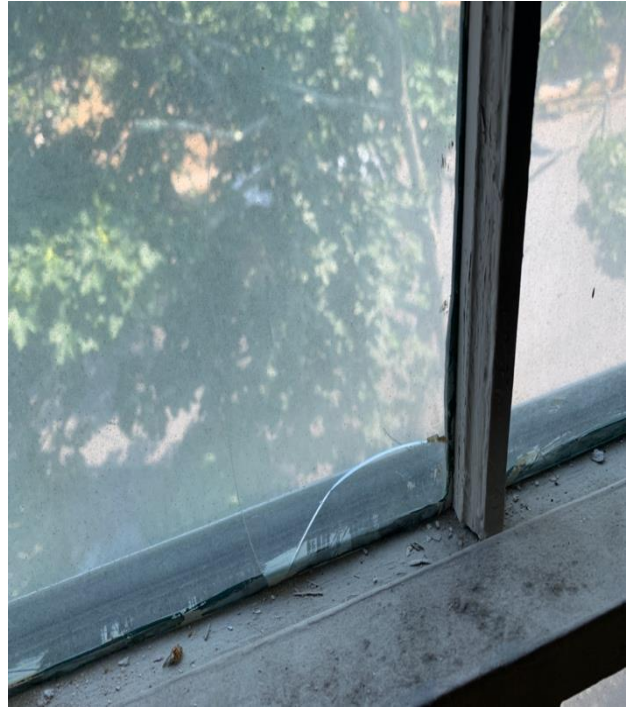
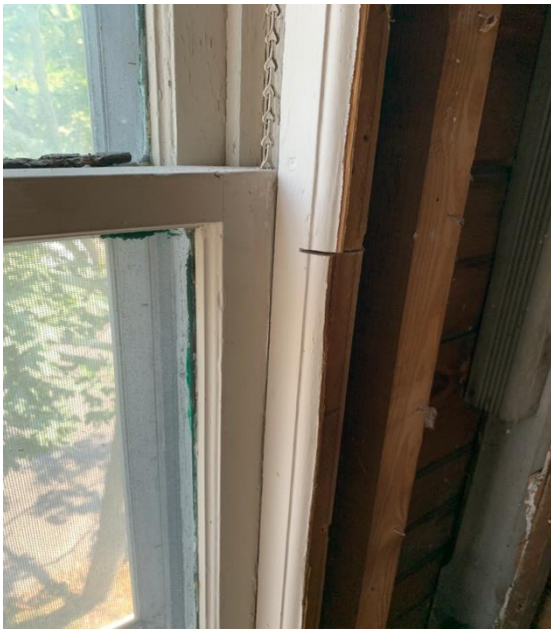
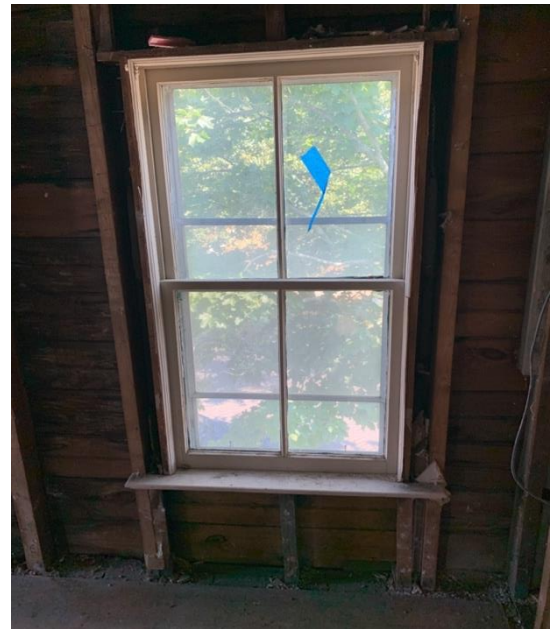
## Window 201

Addition closed in porch Not Original – thinner mullions  
. Severely out of square condition similar to 101

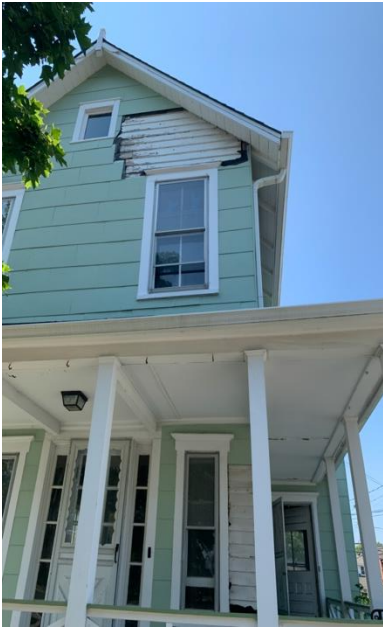
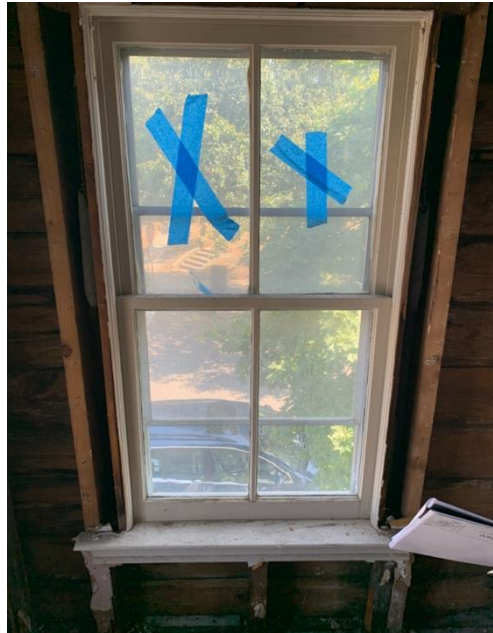
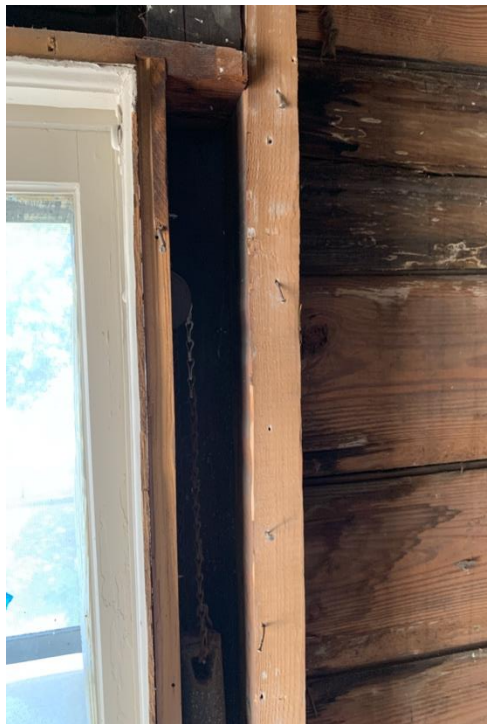
## Window 202

Not Original – thinner mullions . Severely out of square condition similar to 101

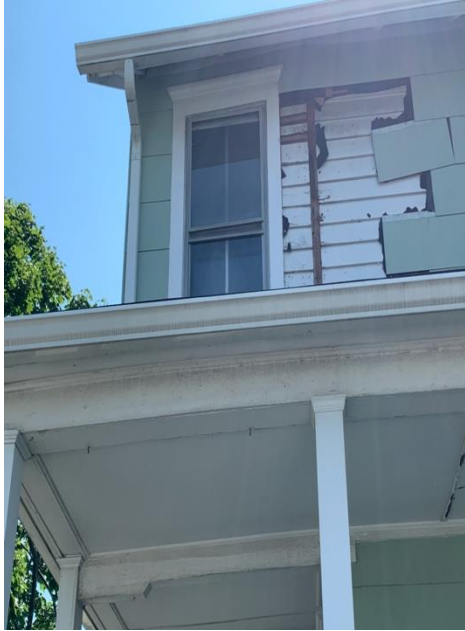
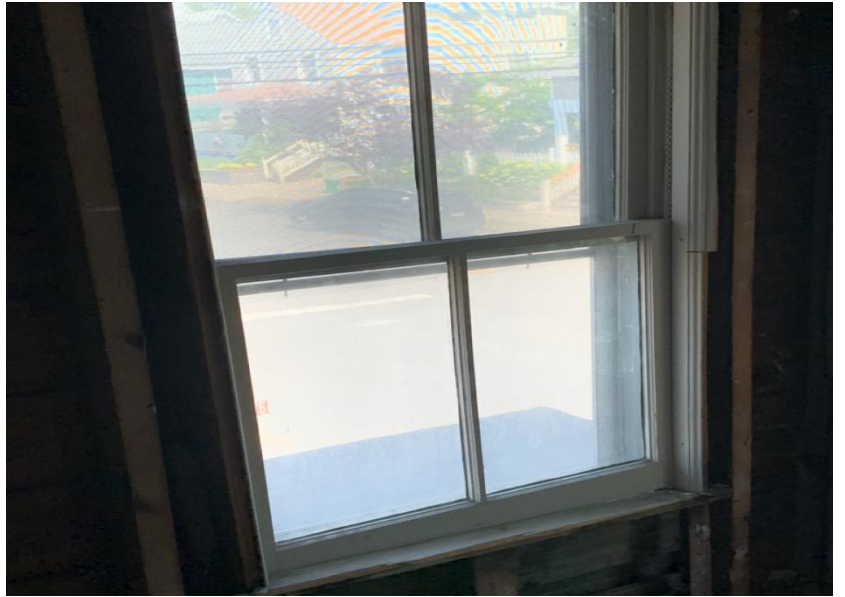
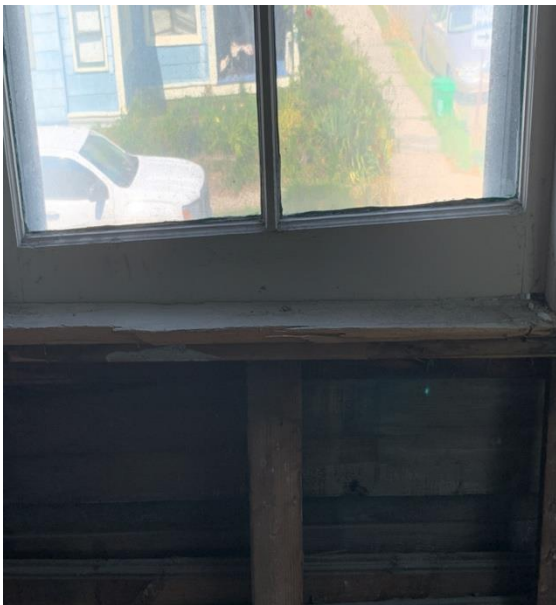
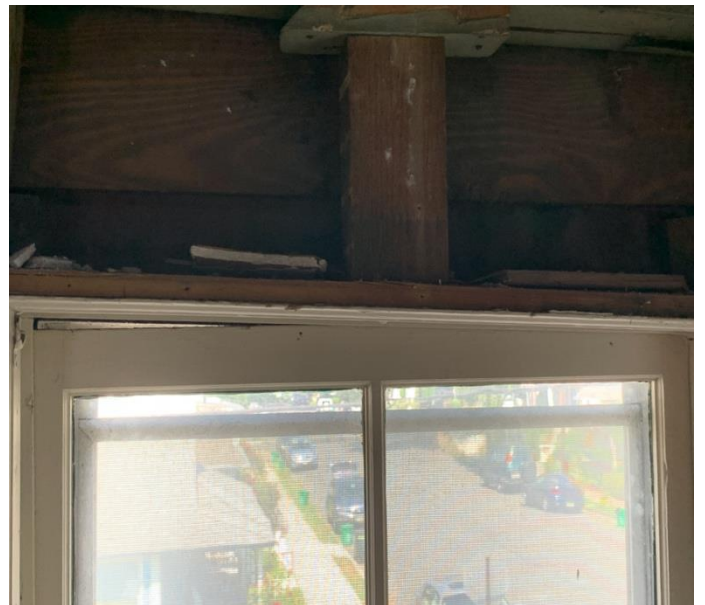
## Window 203

Not Original – thinner mullions . Severely out of square condition similar to 101

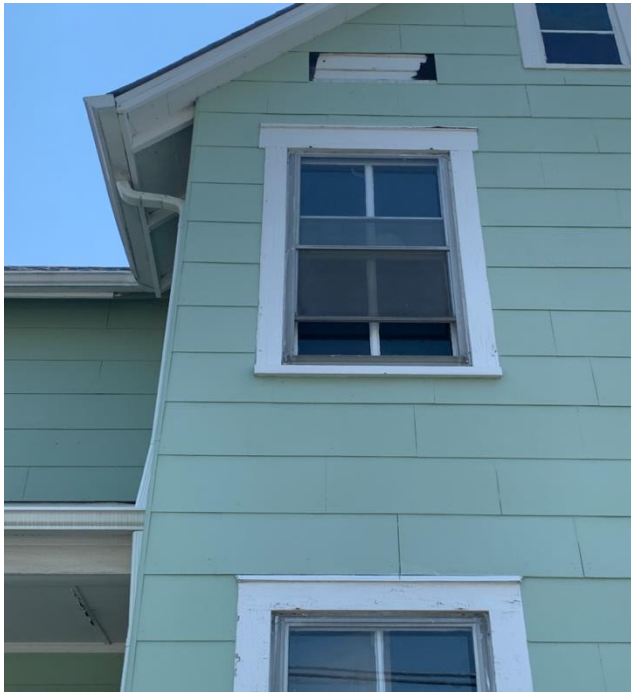
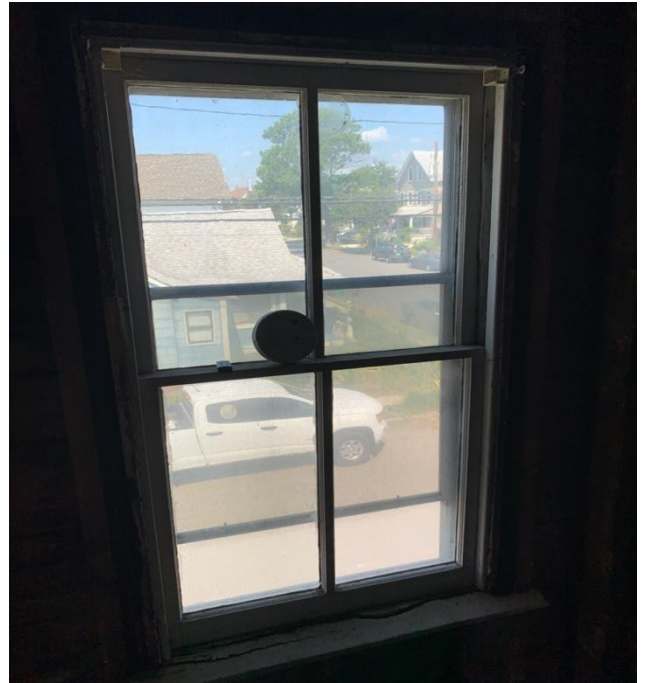
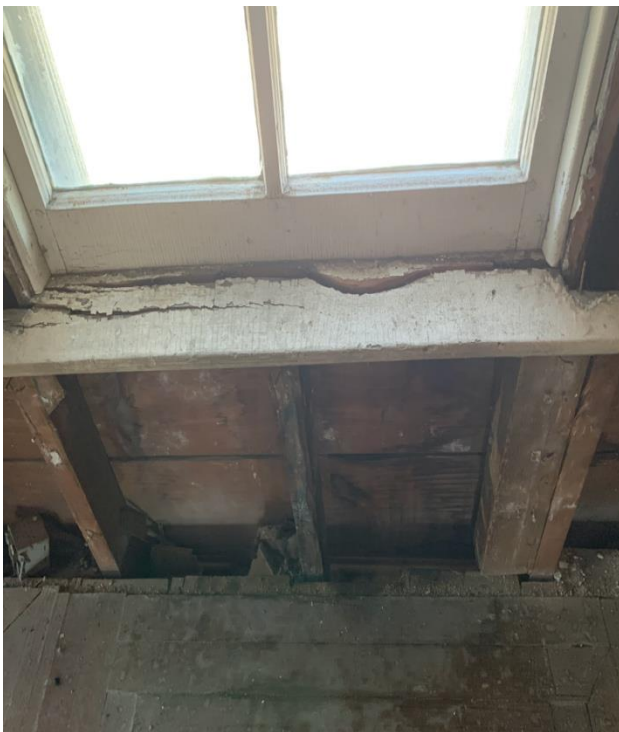
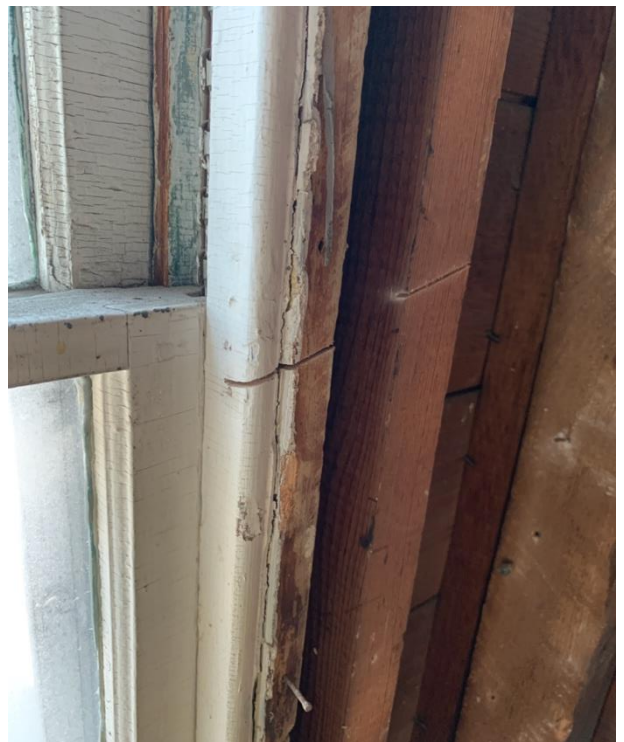
## Window 204

West Addition : Not original different size mullions, damaged sashes , out of square

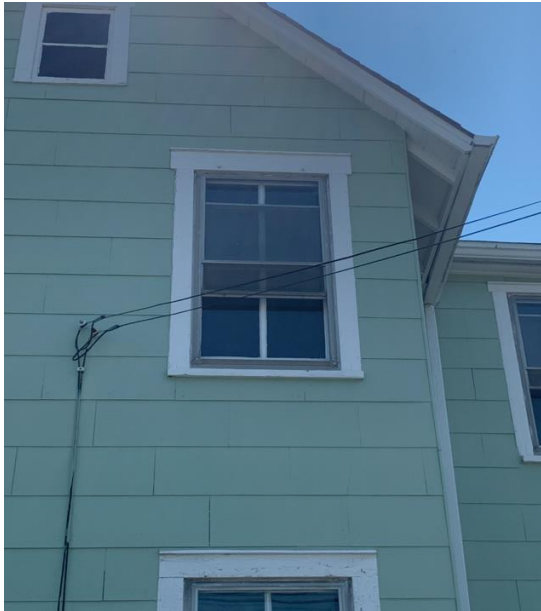
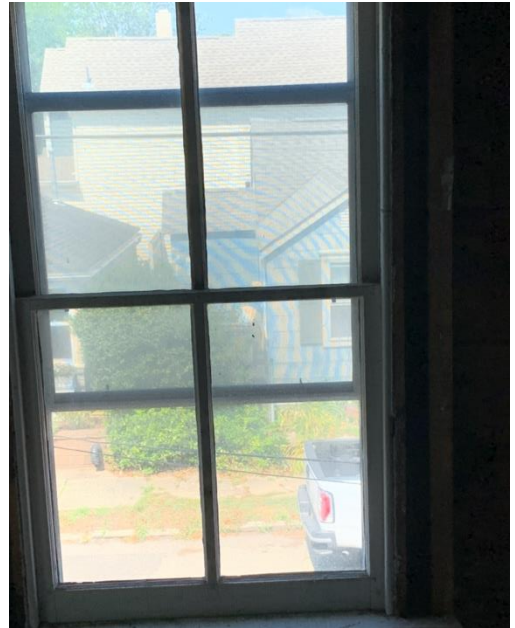
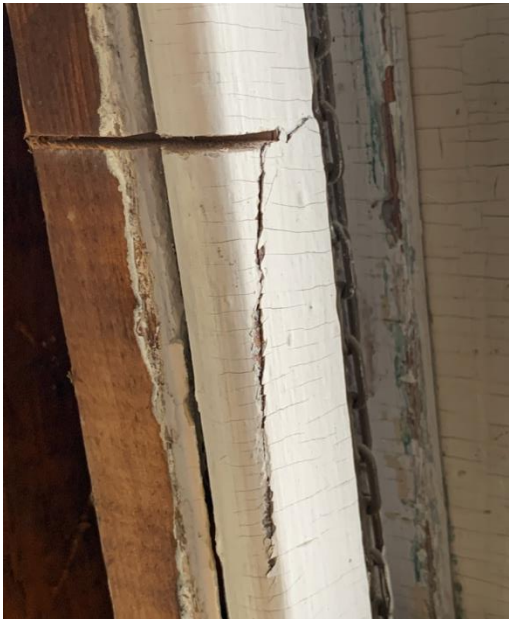
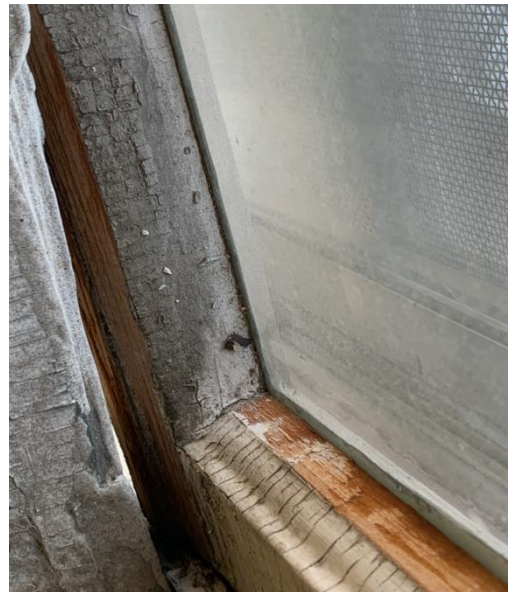
## Window 205

Not original different size mullions, damaged sashes , out of square

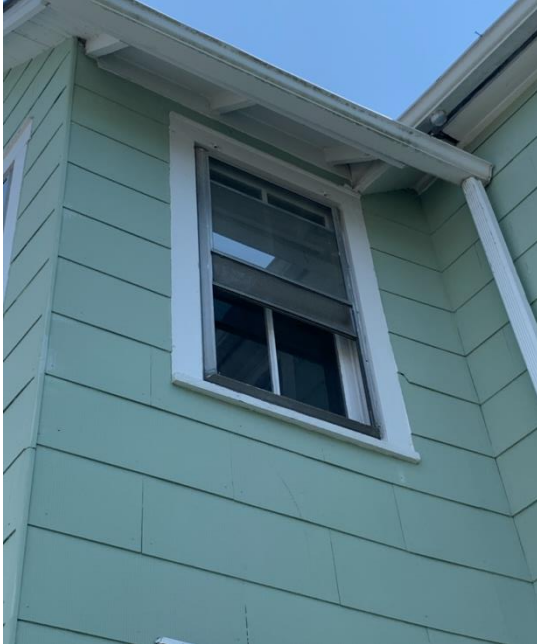
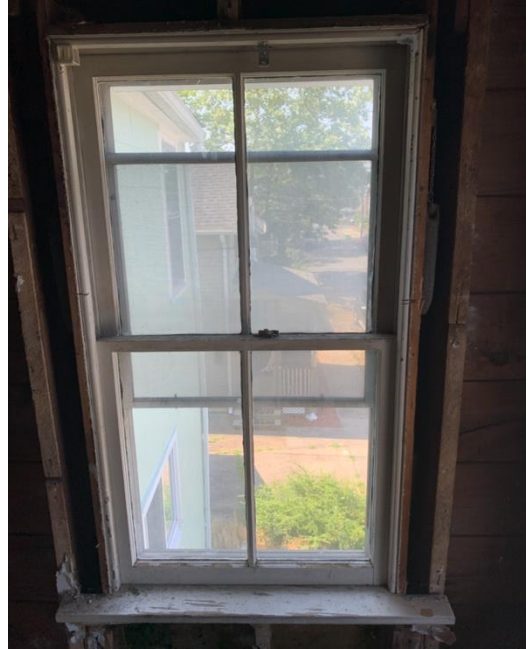
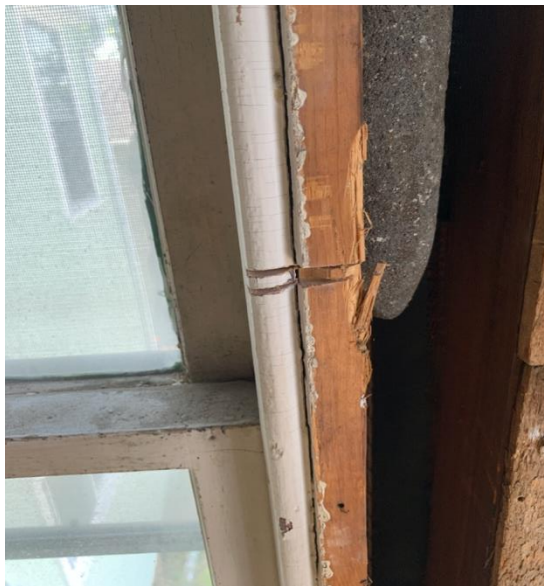
## Window 206

Not original different size mullions, damaged sashes, out of square..... One of these windows must be a fire egress as it is an existing bedroom to bring it to fire safety code. Owner offers to replace 206 with a fire egress casement window with mullions to mimic the proposed new double hung 2 over 2 wood windows at 204 and 205
