**REVISIONS OF APPLICATION BASED ON HPC INPUT
SUMMARY and CONDITION REPORT
80 Mount Hermon Way
BLOCK 162 LOT 62**

80 MOUNT HERMON
OCEAN GROVE

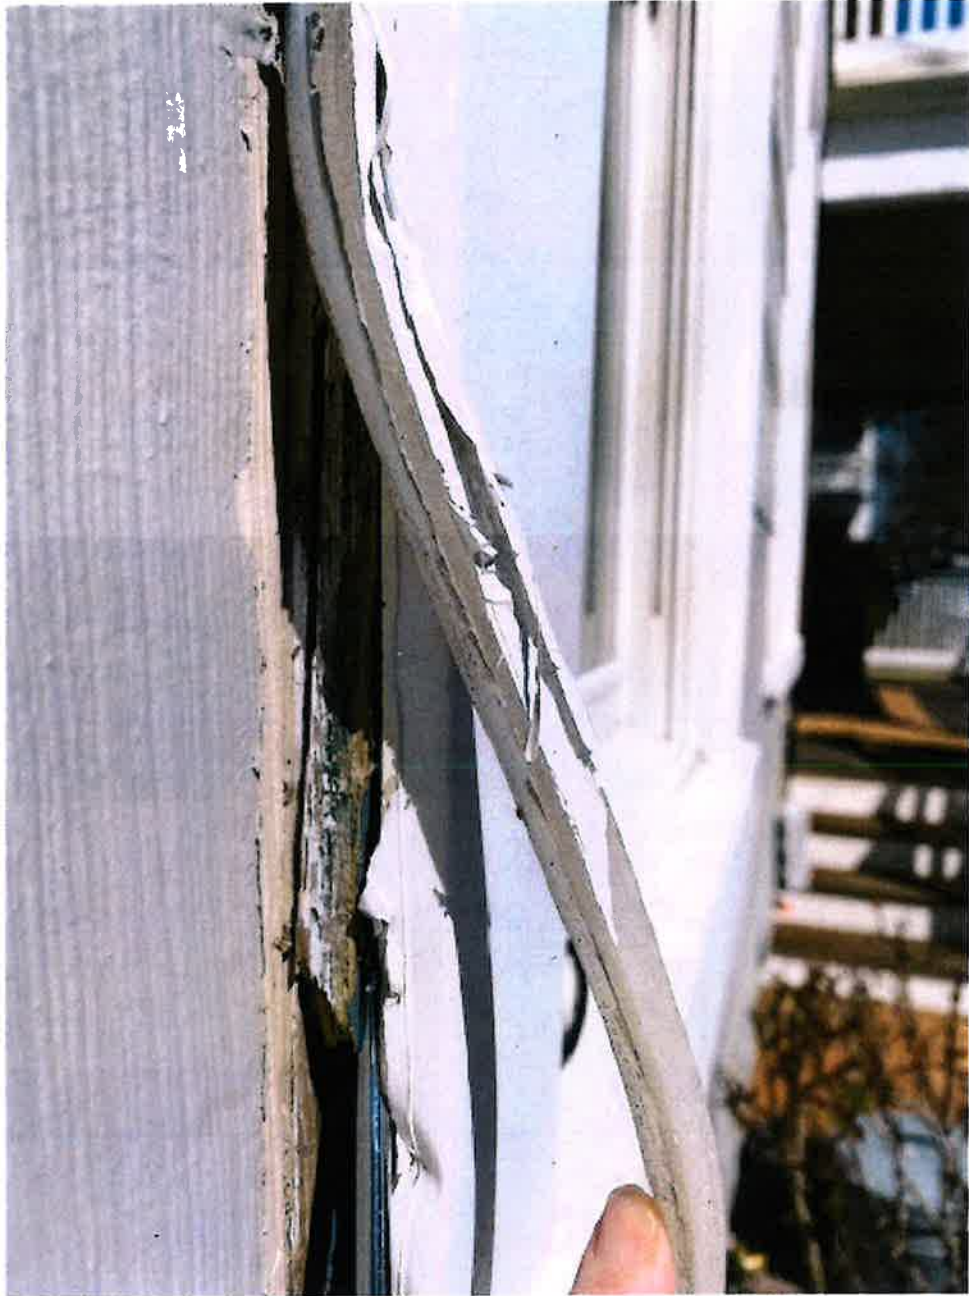
#1 1st Floor Elevation

Window molding rotted & unrepairable
Aluminum wrapped

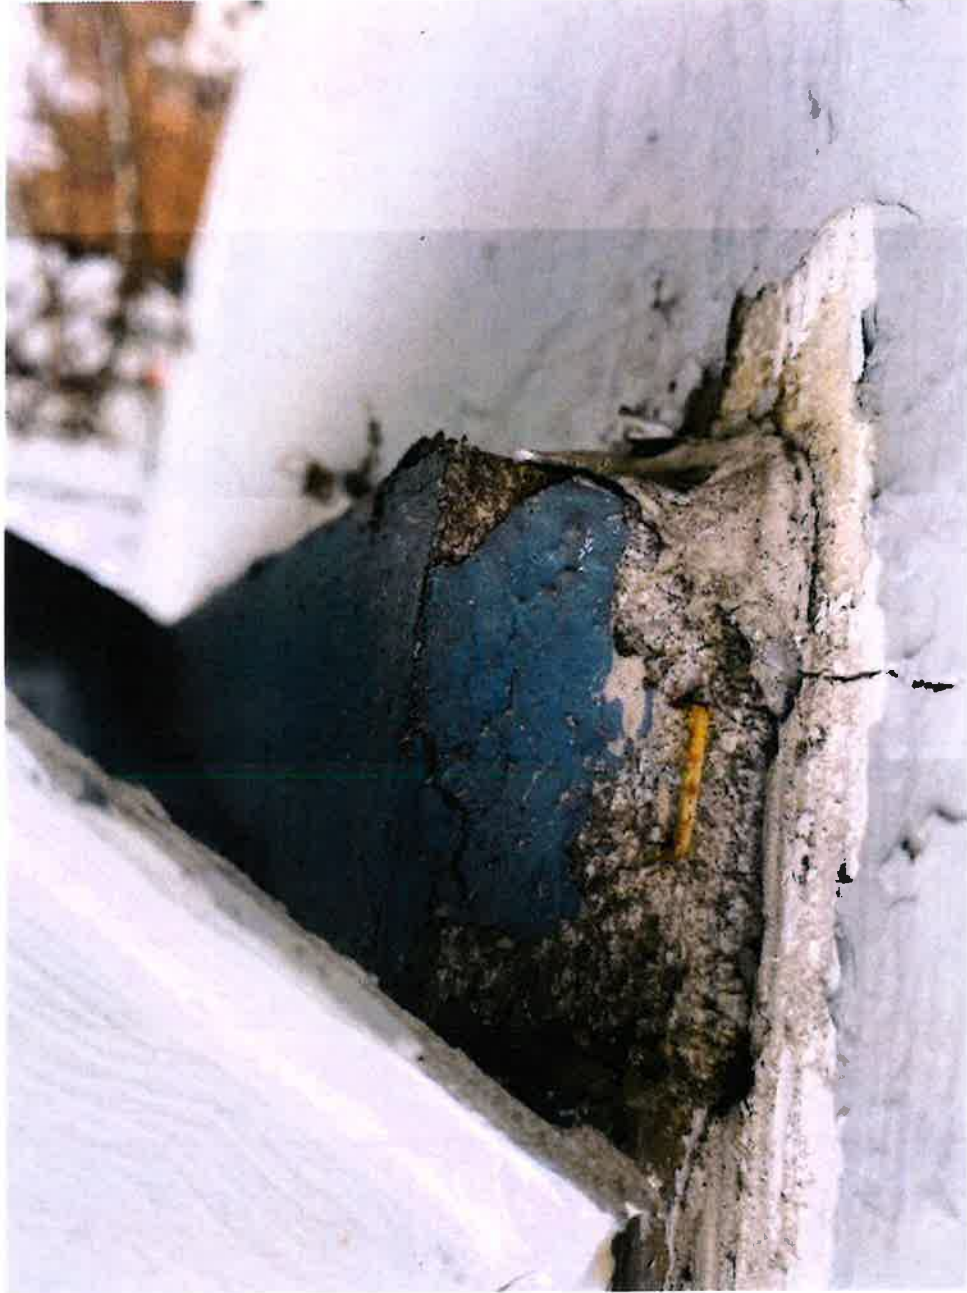
#2 1st floor elevation
Horn sills cut
Aluminum wrapped

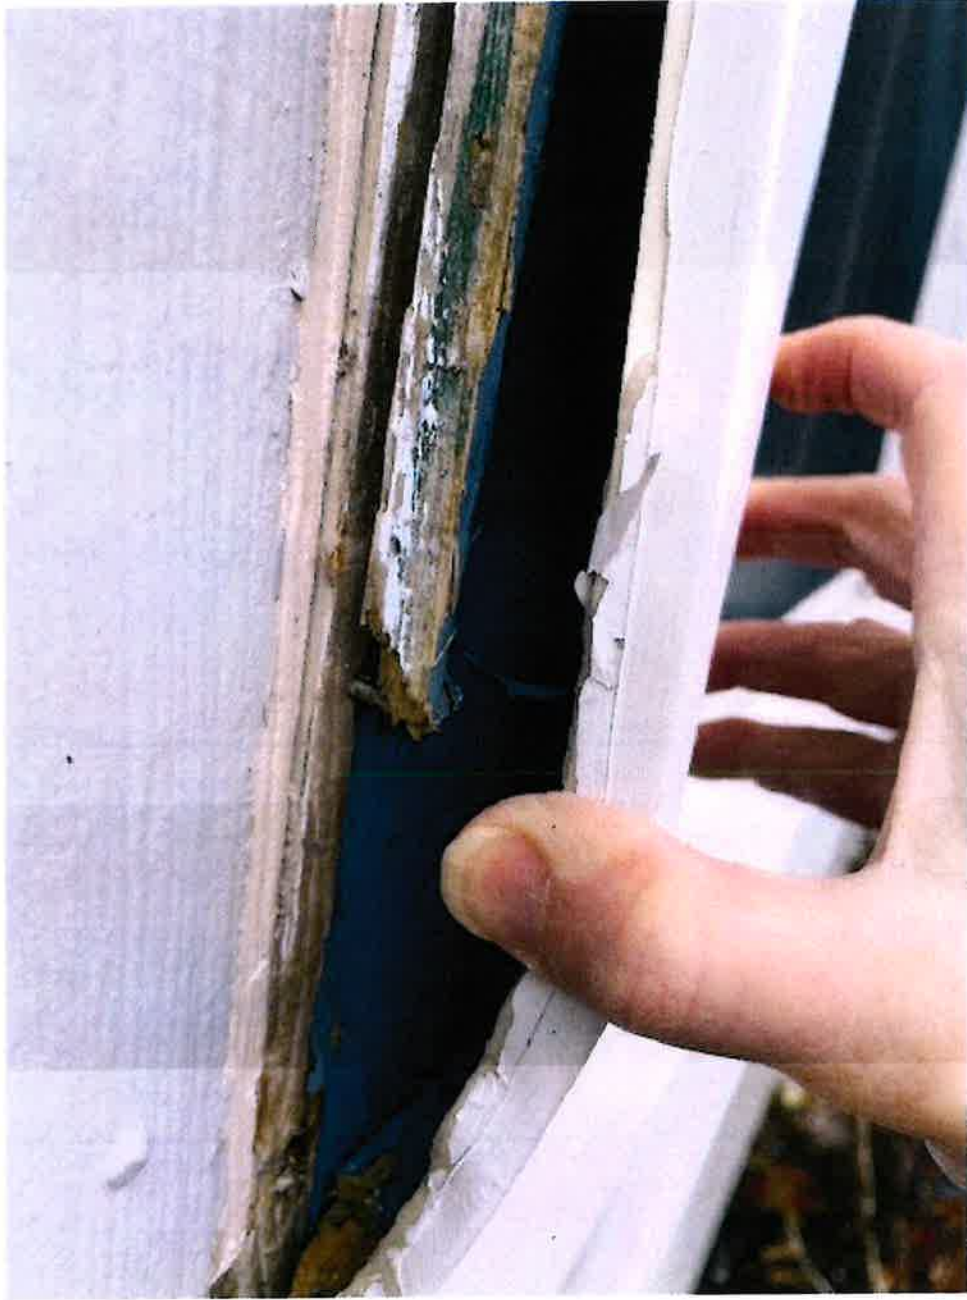
#4 2nd Floor Window
Casing / Molding Rotted
ALUMINUM WRAPPED

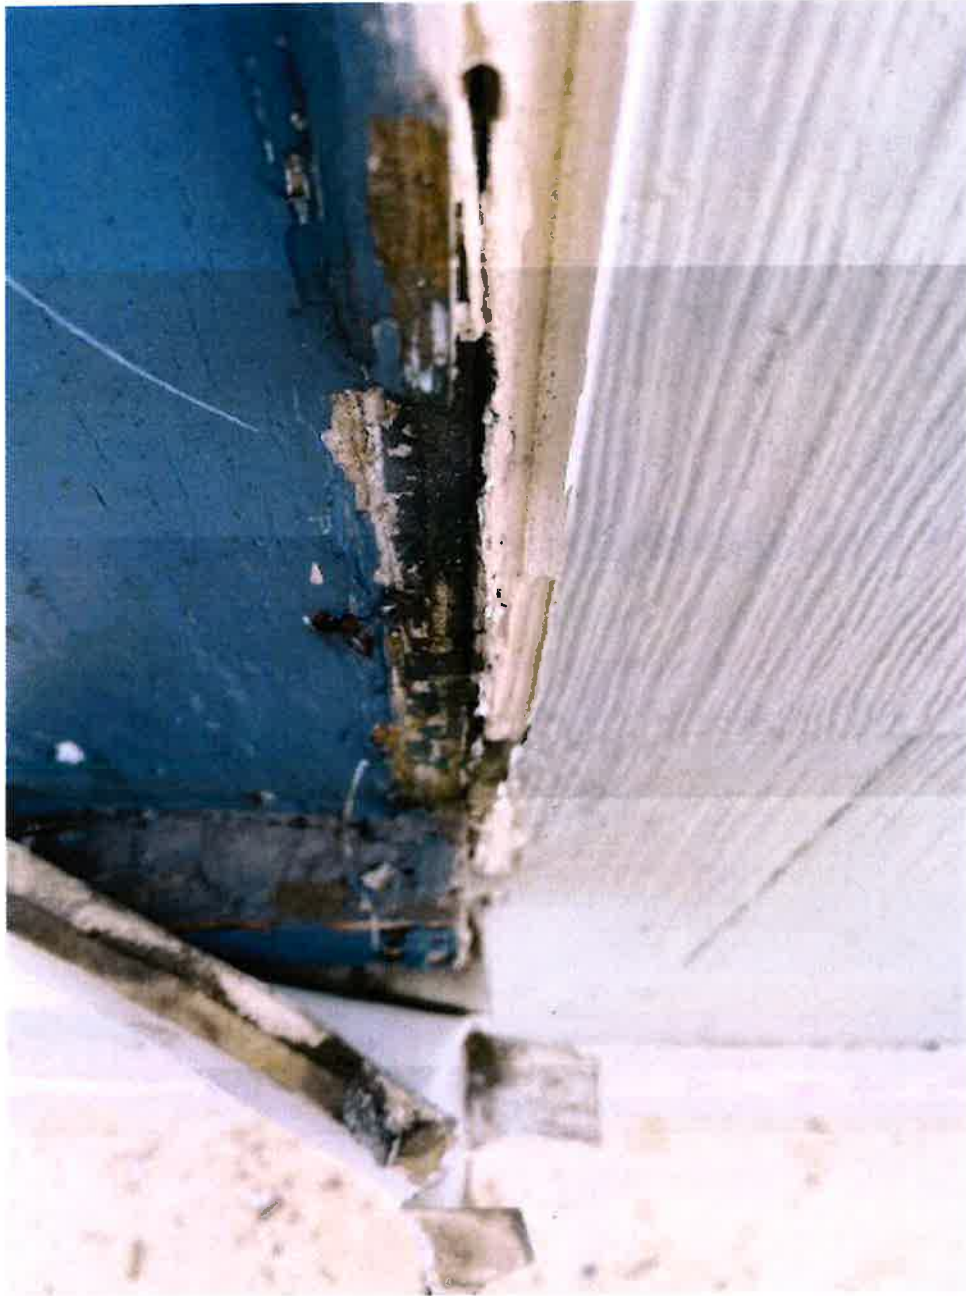
#5 2nd Floor Window + Elevation
Rotted + Aluminum wrapped

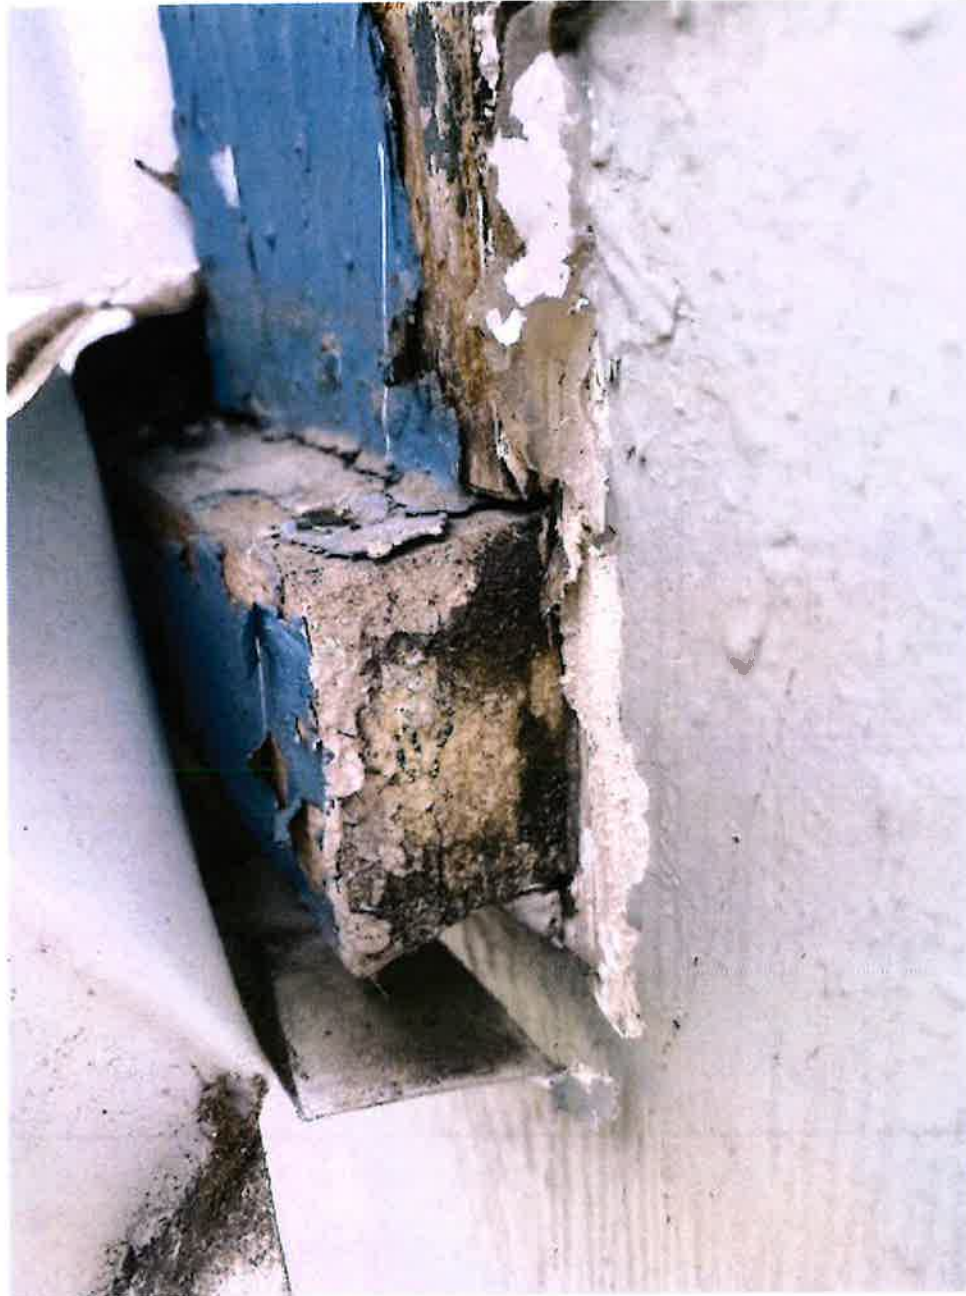
#6 2nd Floor Elevation
Sill cut
