# SHORE POINT ARCHITECTURE, PA

## DEMOLITION APPLICATION TEXT

Date: May 5, 2023  
SPA Job Number: 2023-11 (Martin Residence)  
Property Address: 76 Mt. Tabor Way (Block 149, Lot 2)

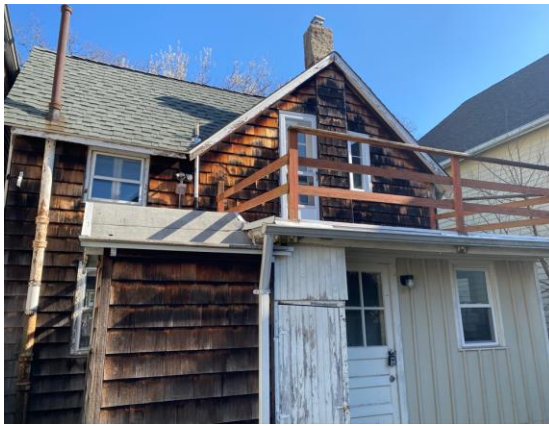
Rear Elevation

The Sanborn maps suggest the rear of the house was constructed sometime between 1905 and 1930, however it has been expanded and modified numerous times, and now includes a large, inappropriate, cantilevered, uncovered second floor roof deck. Within the rear area proposed for demolition, there are four windows and a door, as outlined below:

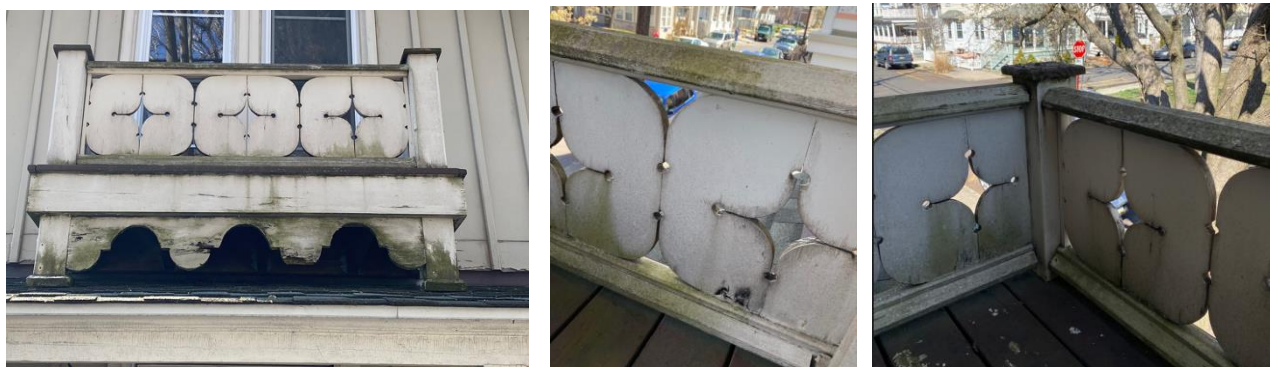
Portions of the front porch and balcony are newer replacements. They were constructed from wood species that are not durable, and are showing signs of rot and deterioration. Demolition would allow for appropriate replacement of such components, utilizing the historic photographs as the basis for design. The porch columns may be older and historically significant, and are therefore scheduled for repair work only (including removal and replacement of the bottom portion of the column).

Evidence of rot and deterioration of the 2<sup>nd</sup> Floor Balcony's wood components

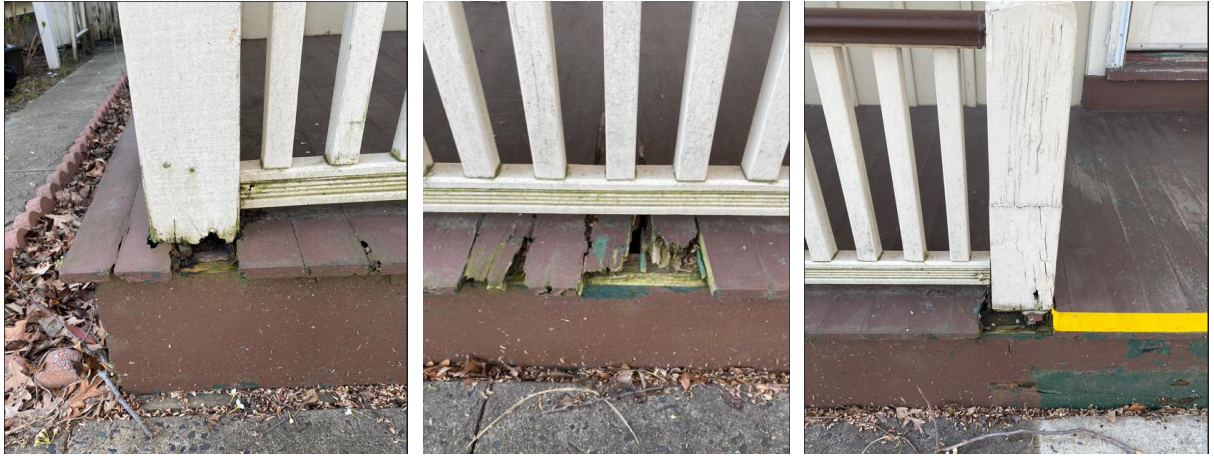
Evidence of rot and deterioration of the 1<sup>st</sup> Floor Porch
