04. Condition Report of Historic Cladding

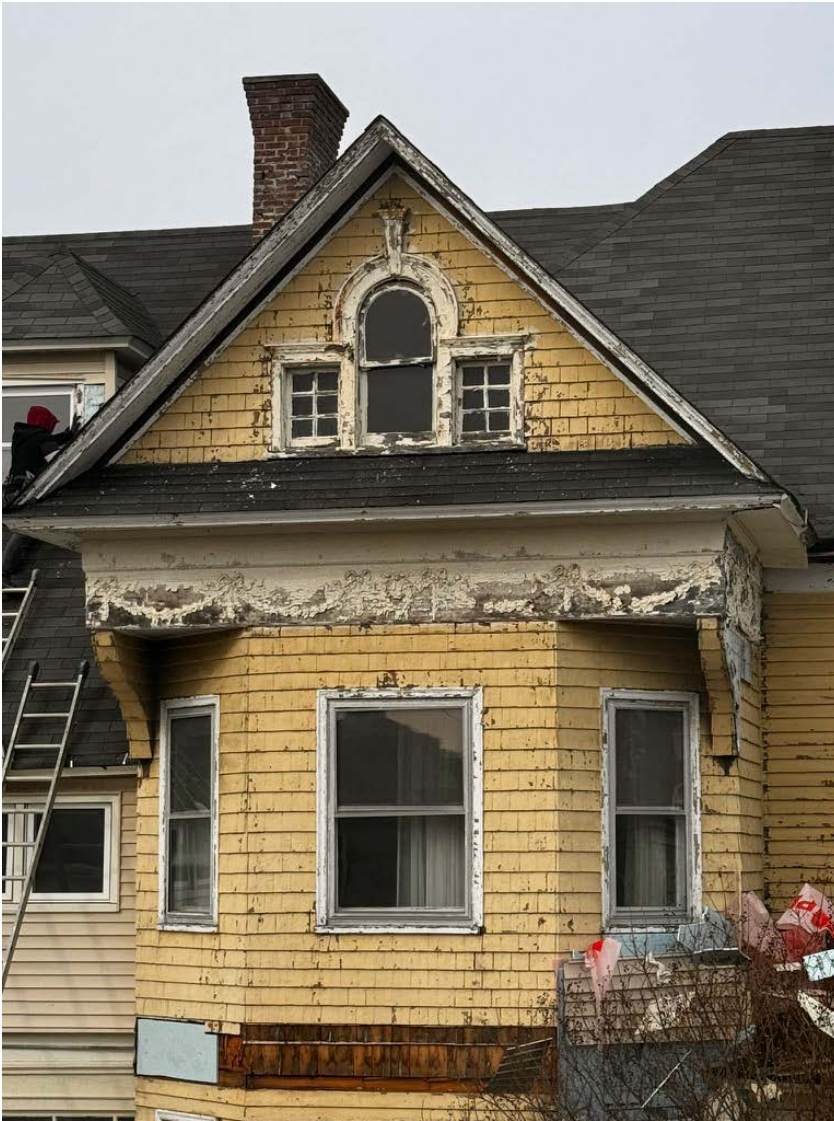
Initial impressions suggested all that was needed was some scraping and painting of the existing cladding.

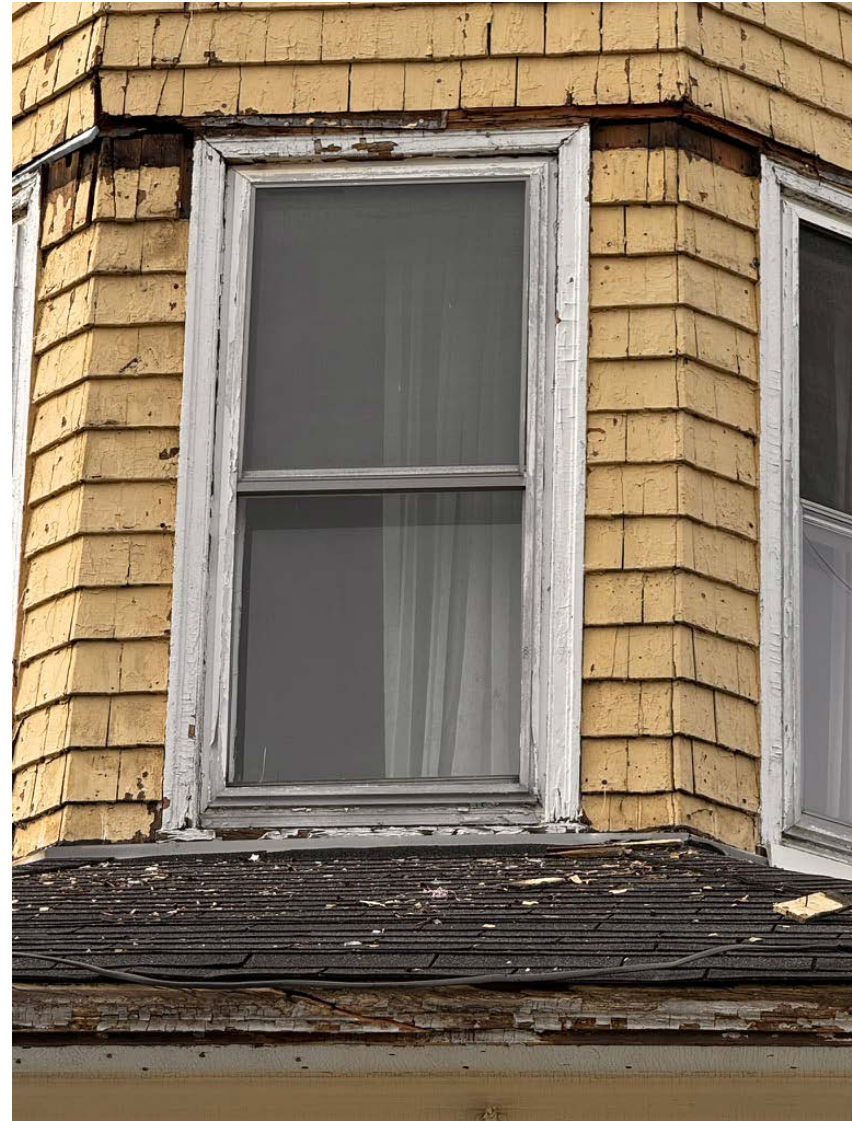
Closer inspection revealed multiple coats of paint disguising the countless split shingles and rotted wood.

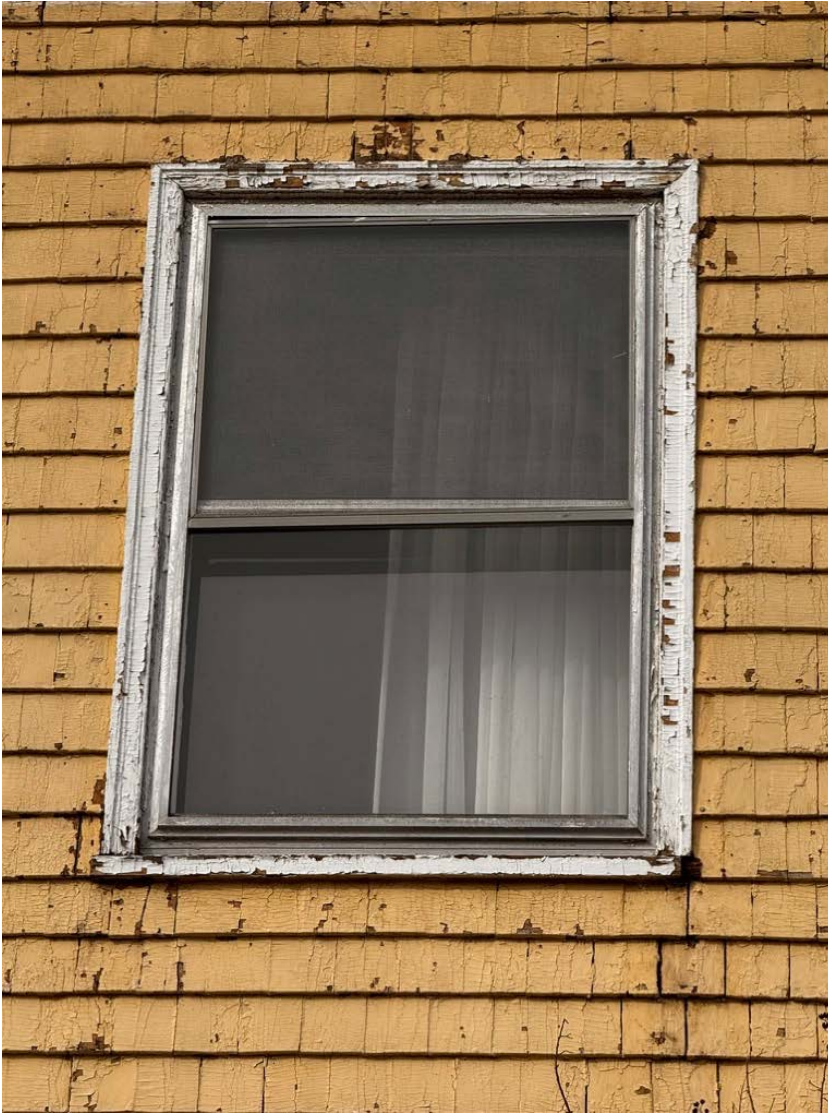
Severely cracked and rotted shingles are held together and in place by many layers of old paint. Non-conforming, non-original, mitered window trims of indeterminate age are broken, rotten, and have had all of their sill ears lopped off.

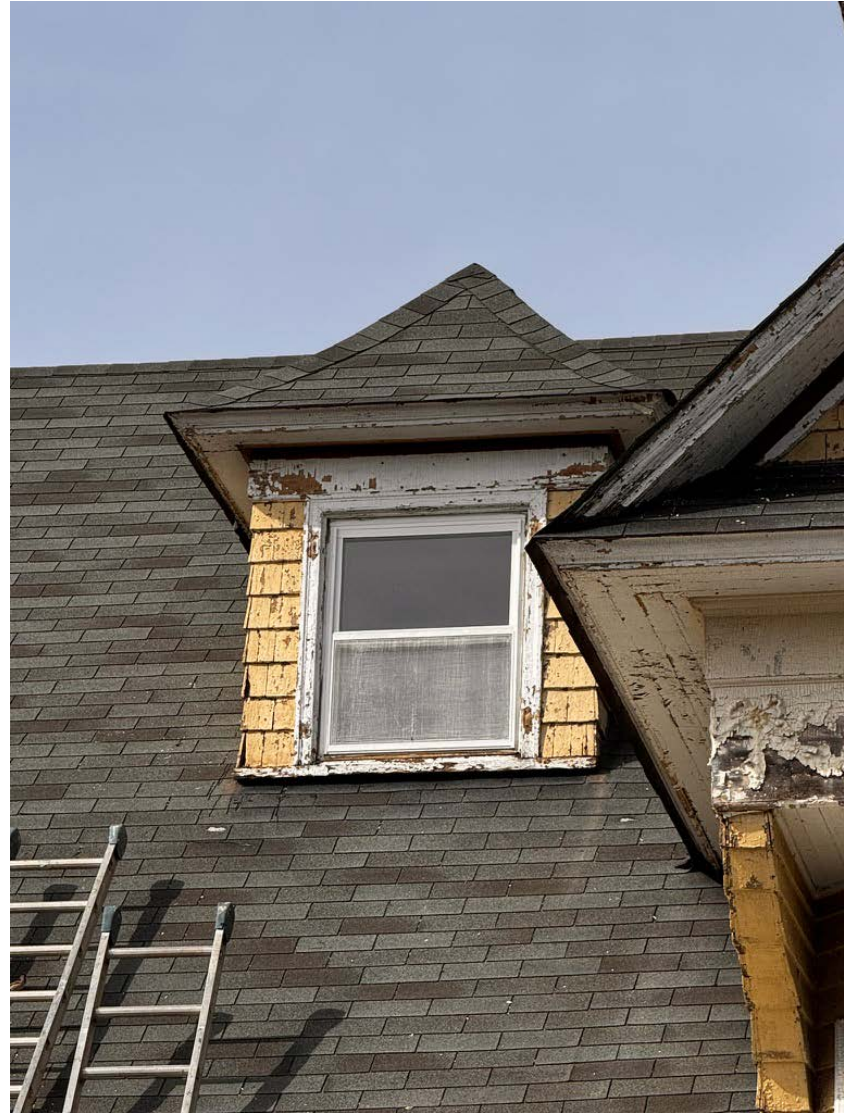
Dormers are clad in similarly damaged shingles. Water damage visible inside the building attest to the long-term water penetration around existing rotten wood window frames, and bottom sills.

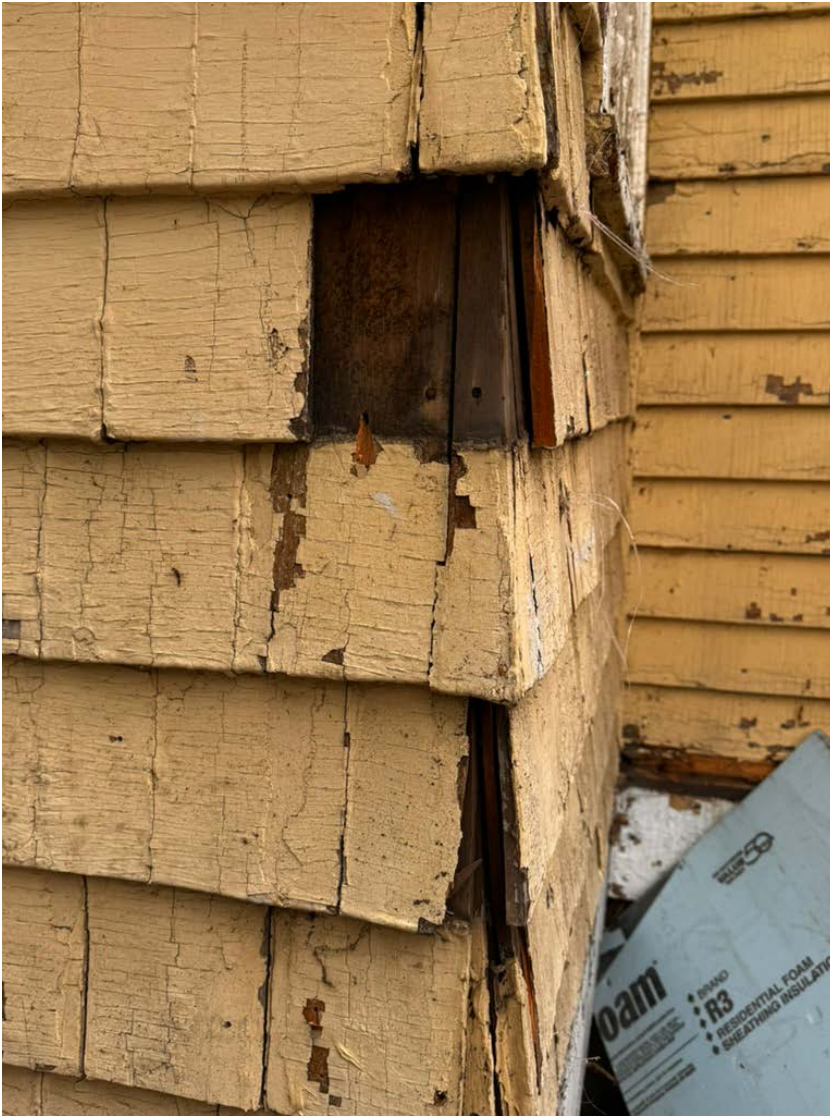
A detail of shingles at one of the woven corners.

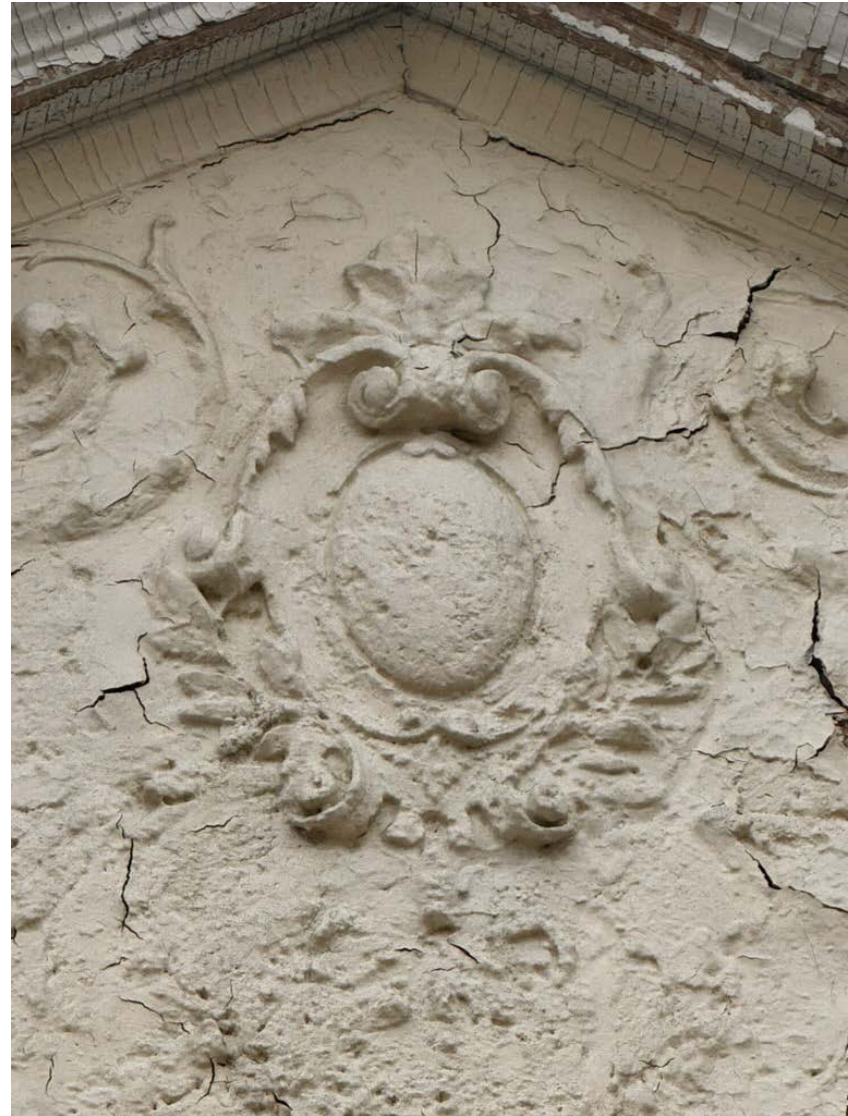
Original plaster bas-relief ornamentation in the pediment over the entry stairs is crumbling. The underlying supports appear to have been undermined by years of water penetration into the plaster and horsehair material.

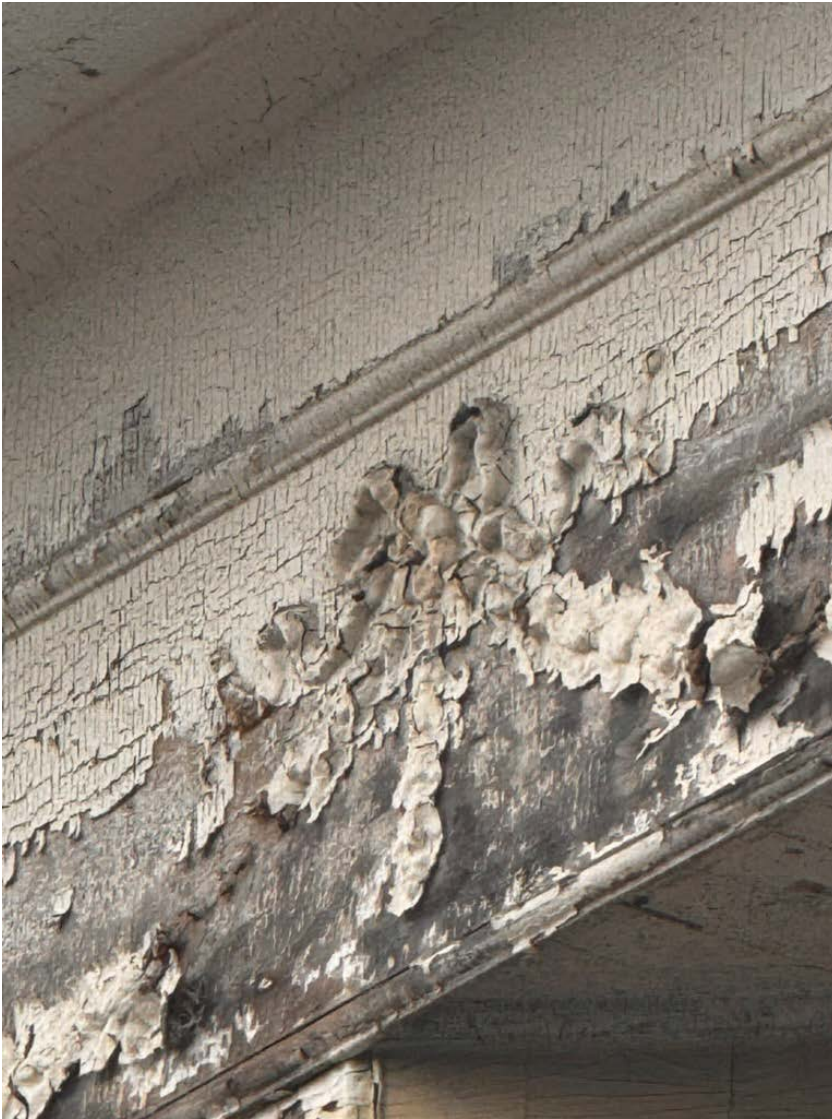
The bas-relief ribbons and swags of the ornamental frieze are almost complete deteriorated, with elements completely missing in areas where material has flaked off and been lost. The wood appears to have mold in areas.

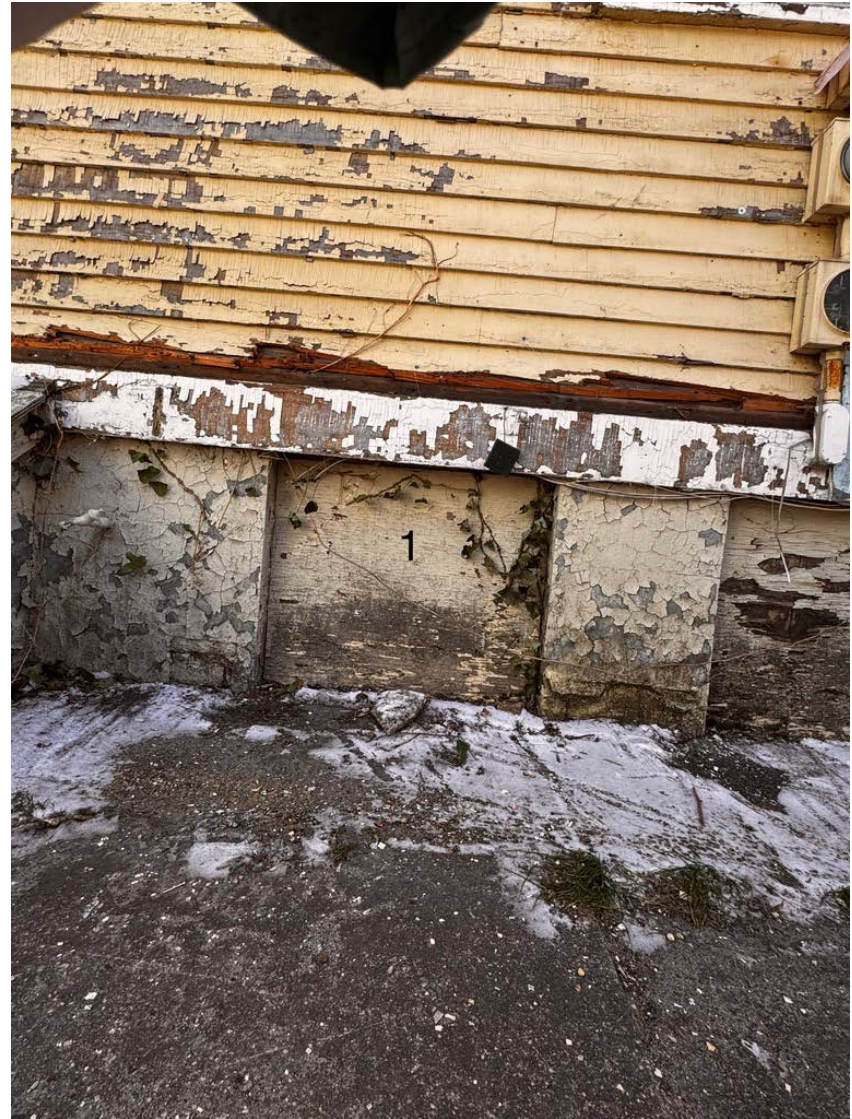
The west elevation is representative of the condition of clapboard throughout: split, cracked, cupped, and spongy with moisture (wet and fibrous as seen in the lowest course of boards, above).

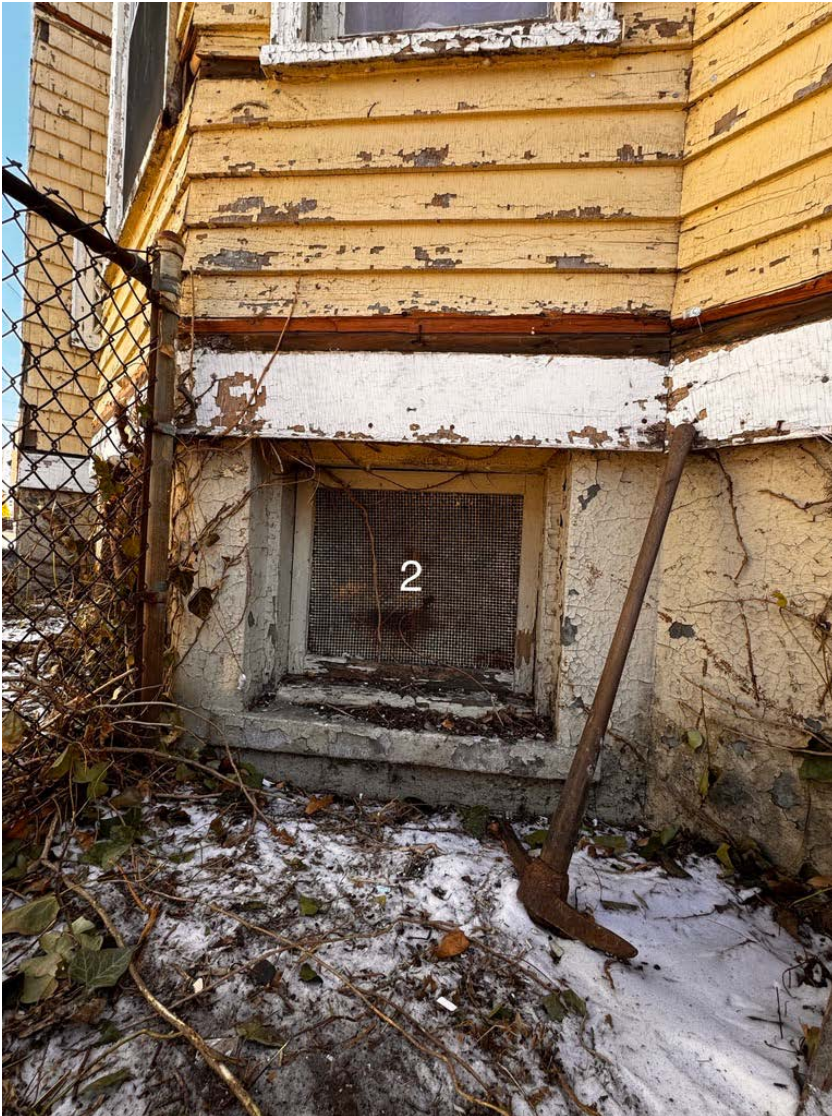
Lower cladding revealed to be wet after removal of vinyl cladding. Parged foundation is cracked in areas and basement windows rotted in the frames.

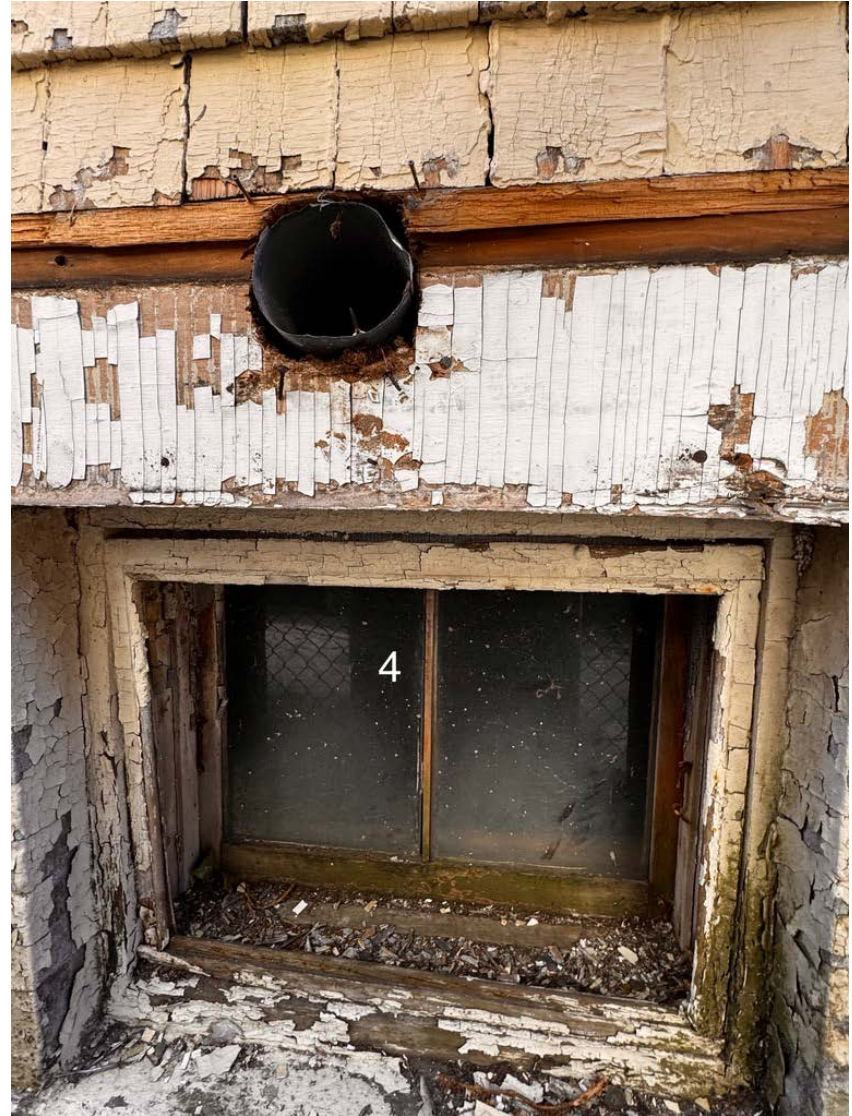
A detail of the condition of one of the basement windows.

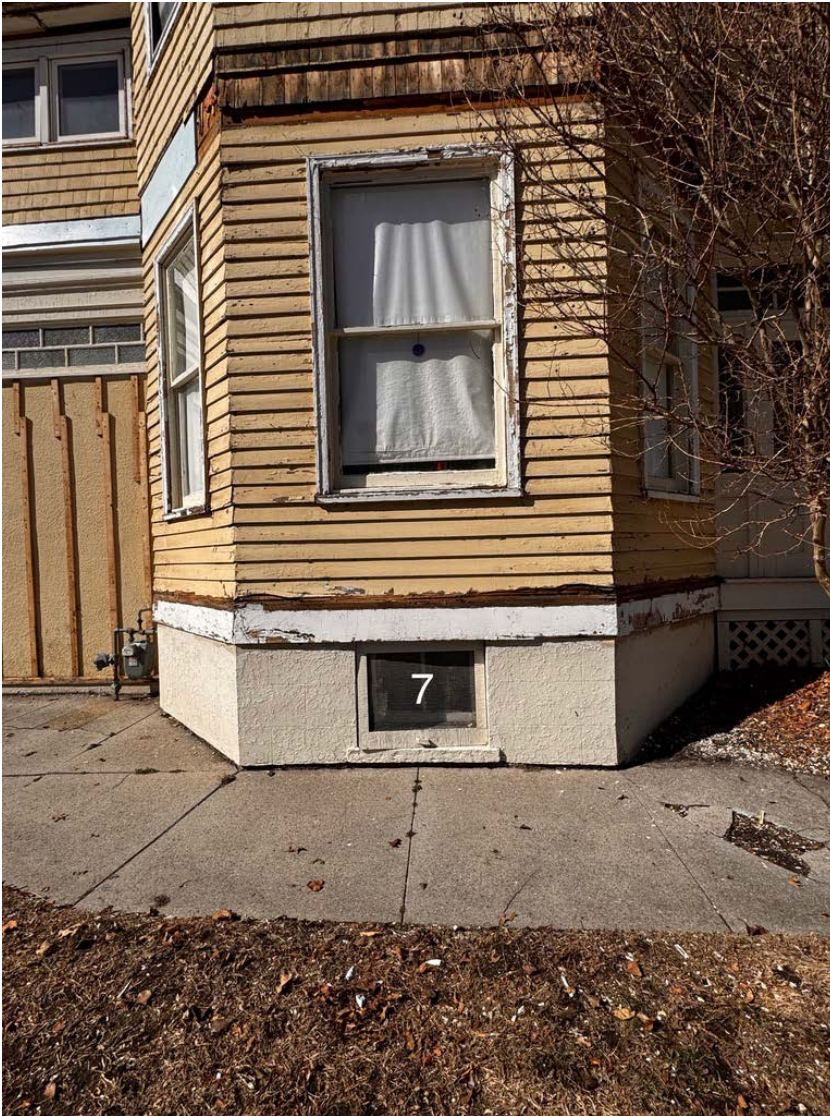
Level 1 of the east elevation bay. Note how clapboard is woven at edges around the bay bends.

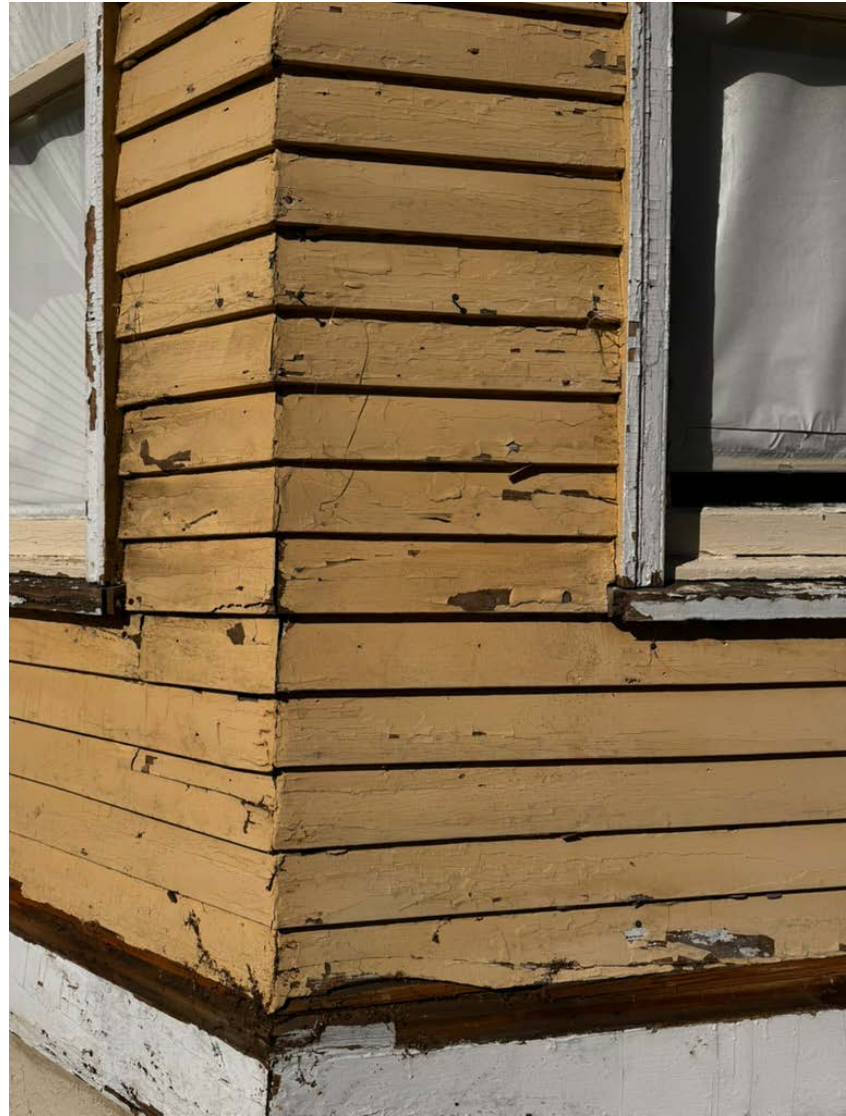
A detail of the woven corners. Such craftsmanship is found on both the east and west bays.

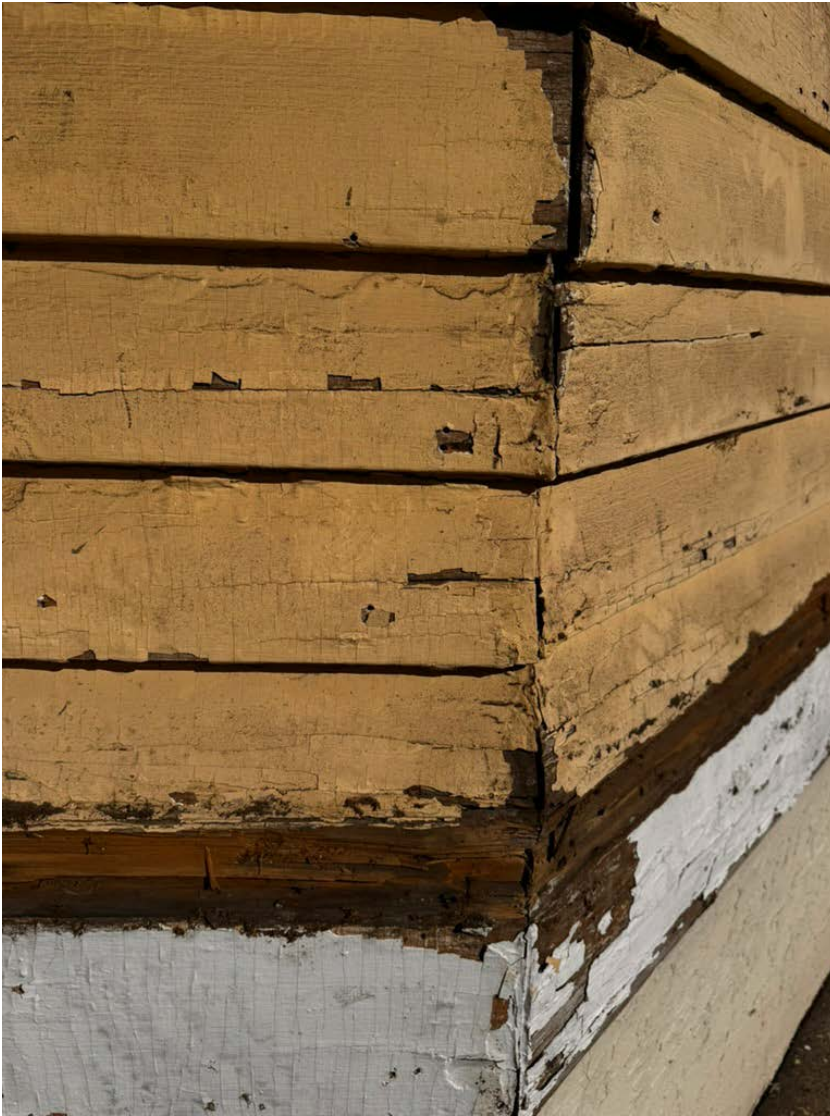
It is only upon close inspection the true extent of the deterioration becomes evident.

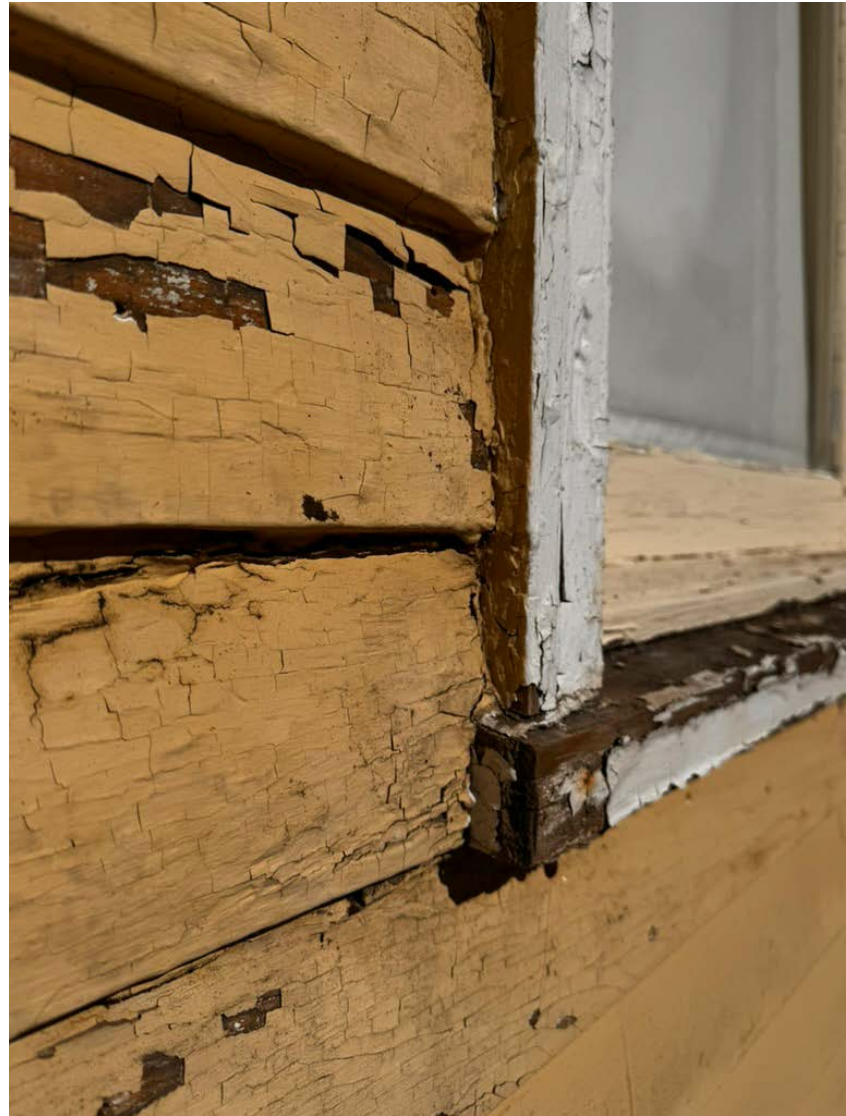
In areas clapboard has dried and shrunk so much the boards no longer overlap.

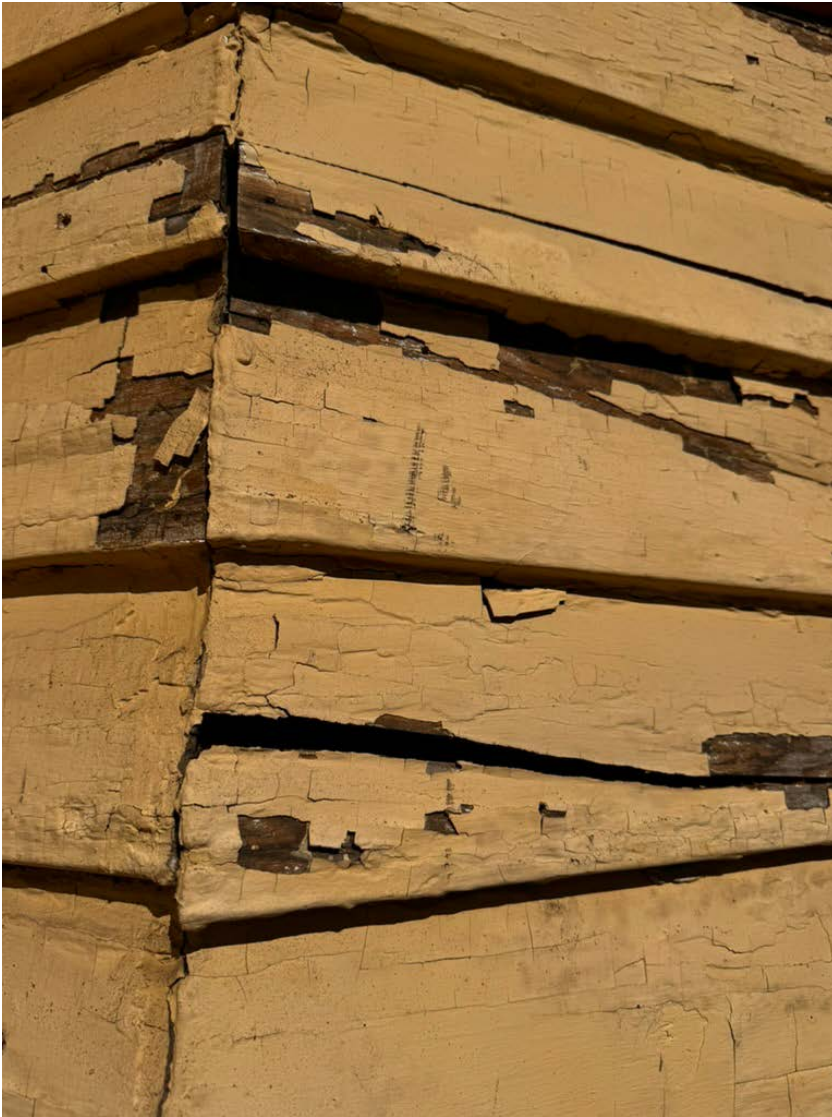
At the west elevation which gets the worst weather and blazing evening sun, the damage is even more pronounced with large gaps opening across the entire elevation

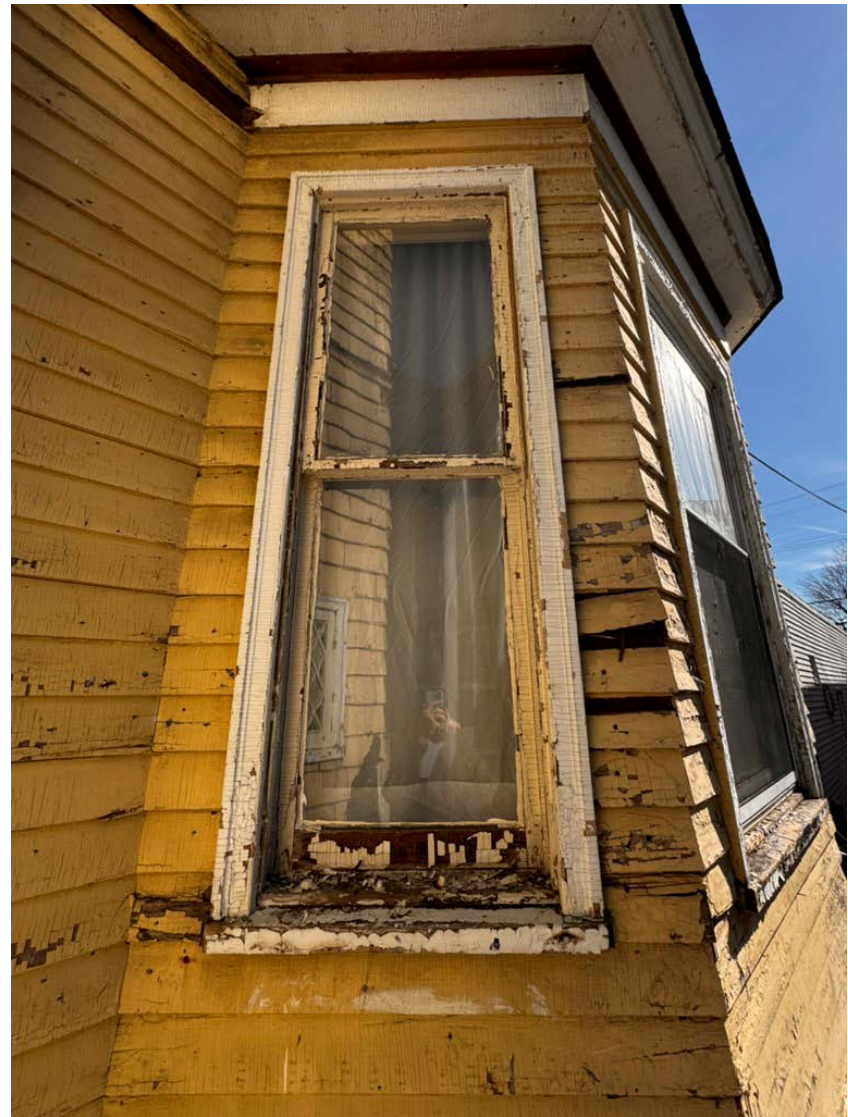
Window, trim, and cladding share a similar degree of decay.

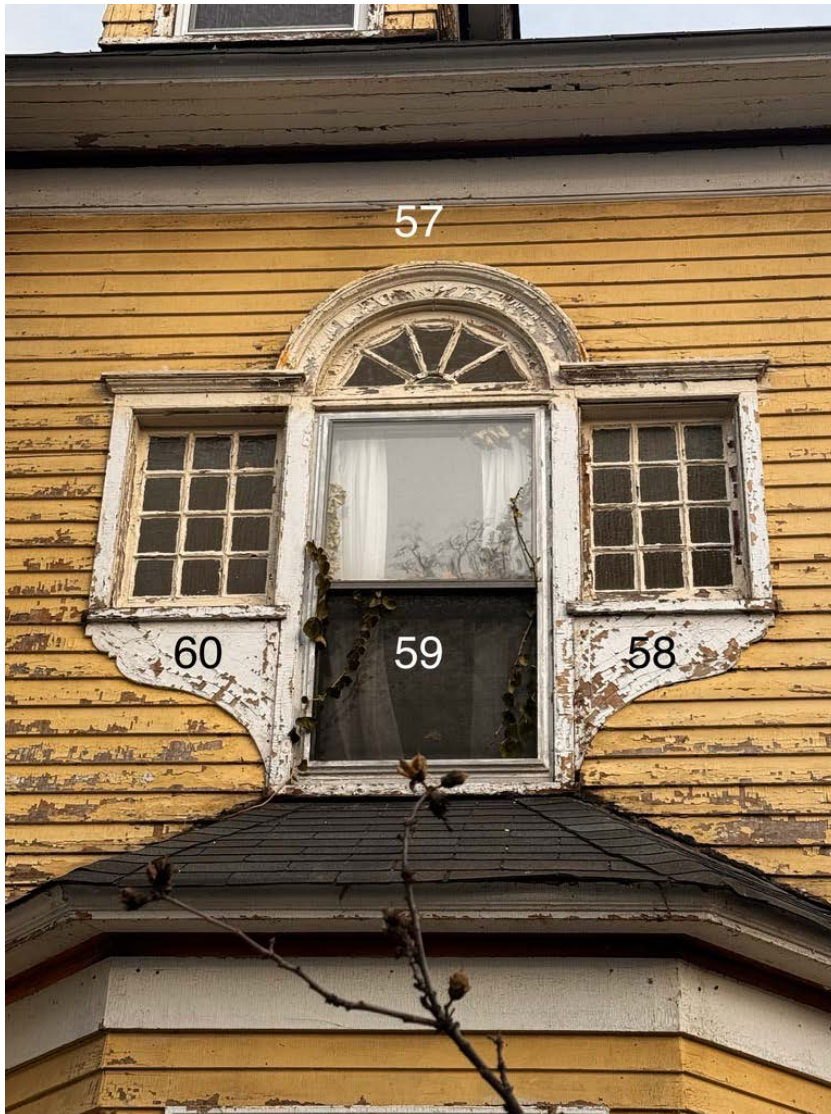
The trim around this ornamental window-set at the west elevation is rotting. Water is also penetrating behind this trim from the rotted sill pans.

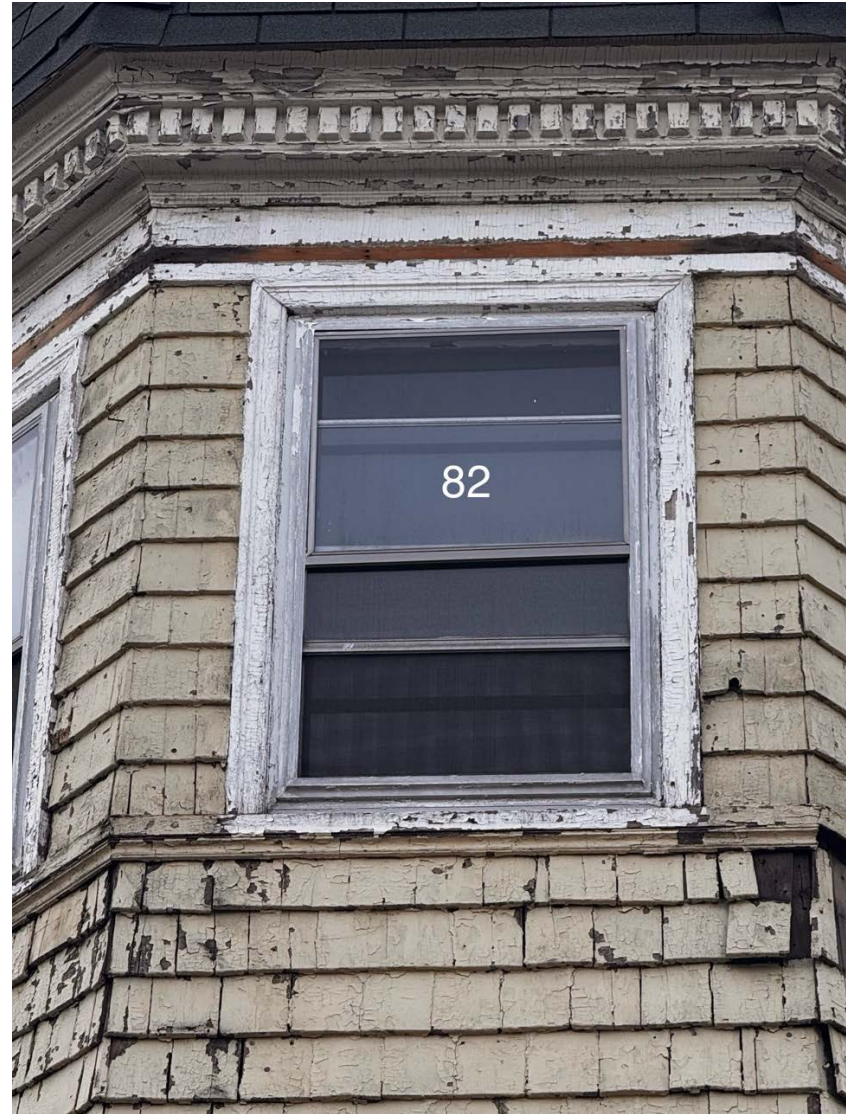
A view of the Level 3 tower showing deterioration in the crown and dentil molding beneath the dome of the turret.

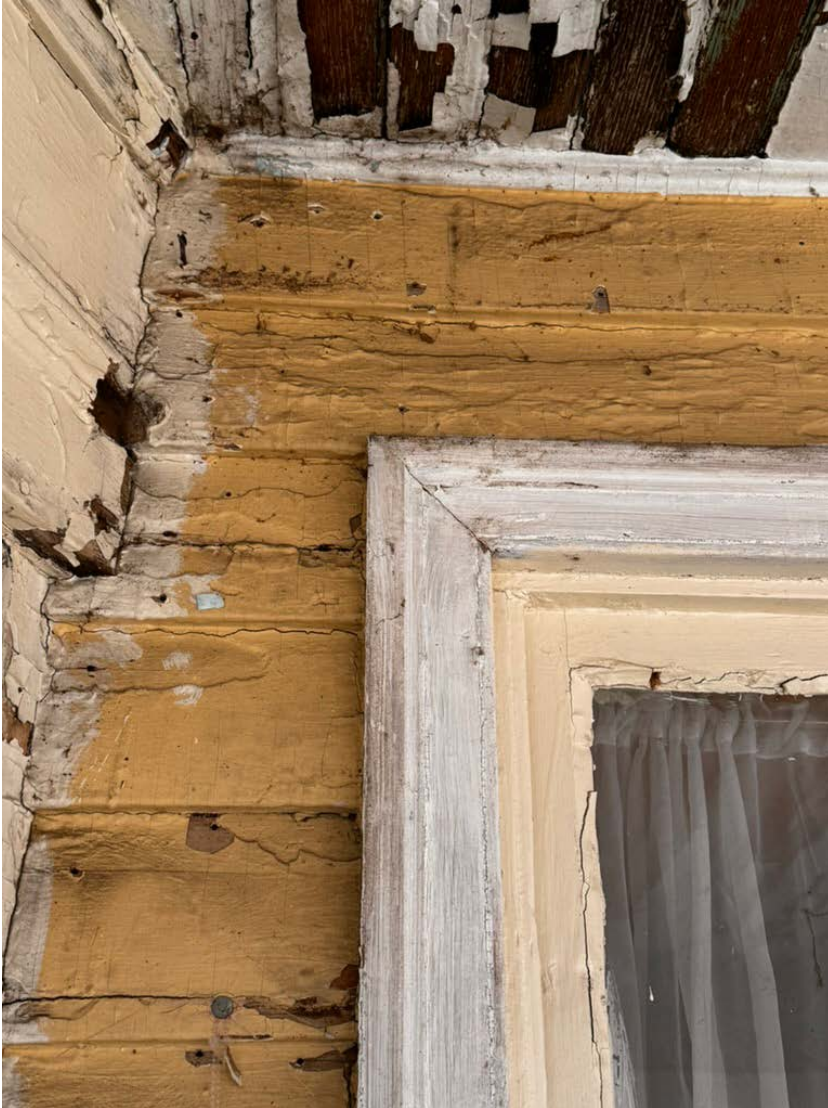
At the north elevation, under the porch roof (and area normally protected from weather and water) signs of severe damage near the roof indicate water penetration from above.

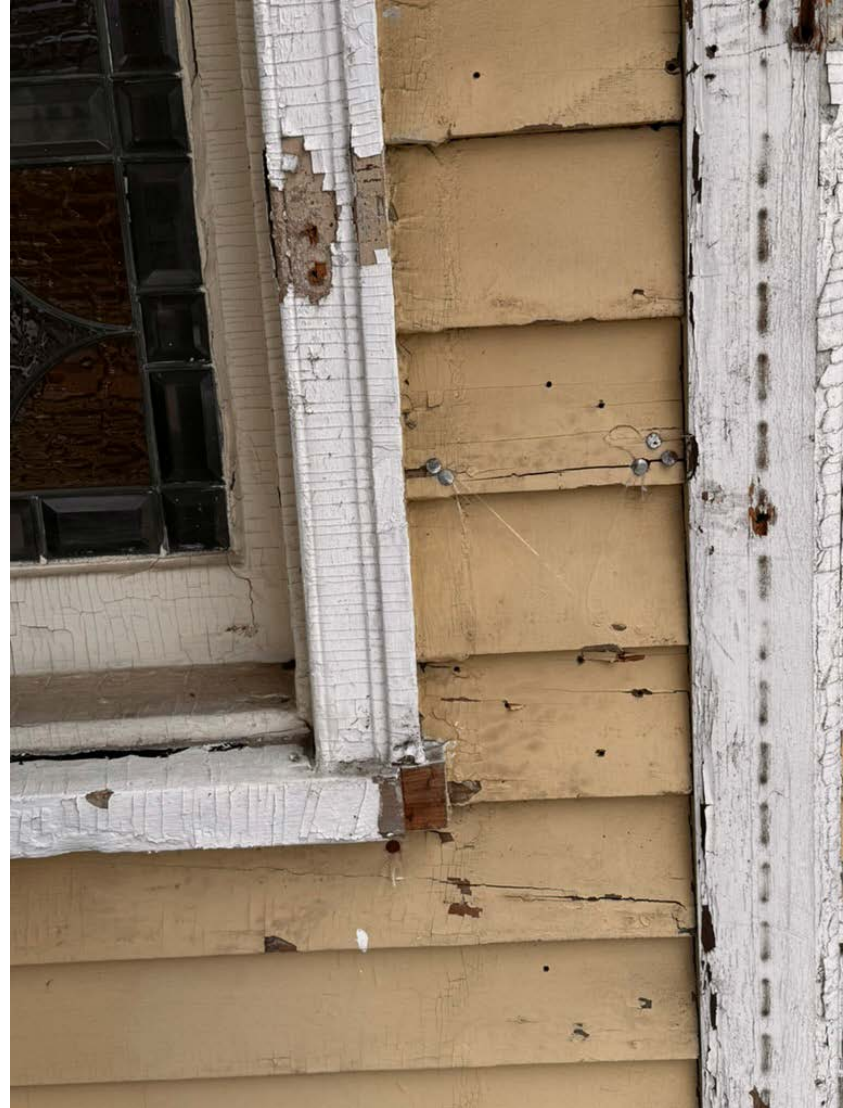
To the west of the entry doors (at window #21) damage exacerbated by nails used to attach vinyl siding the underlying clapboard is evident. Sill ears have been lopped off.

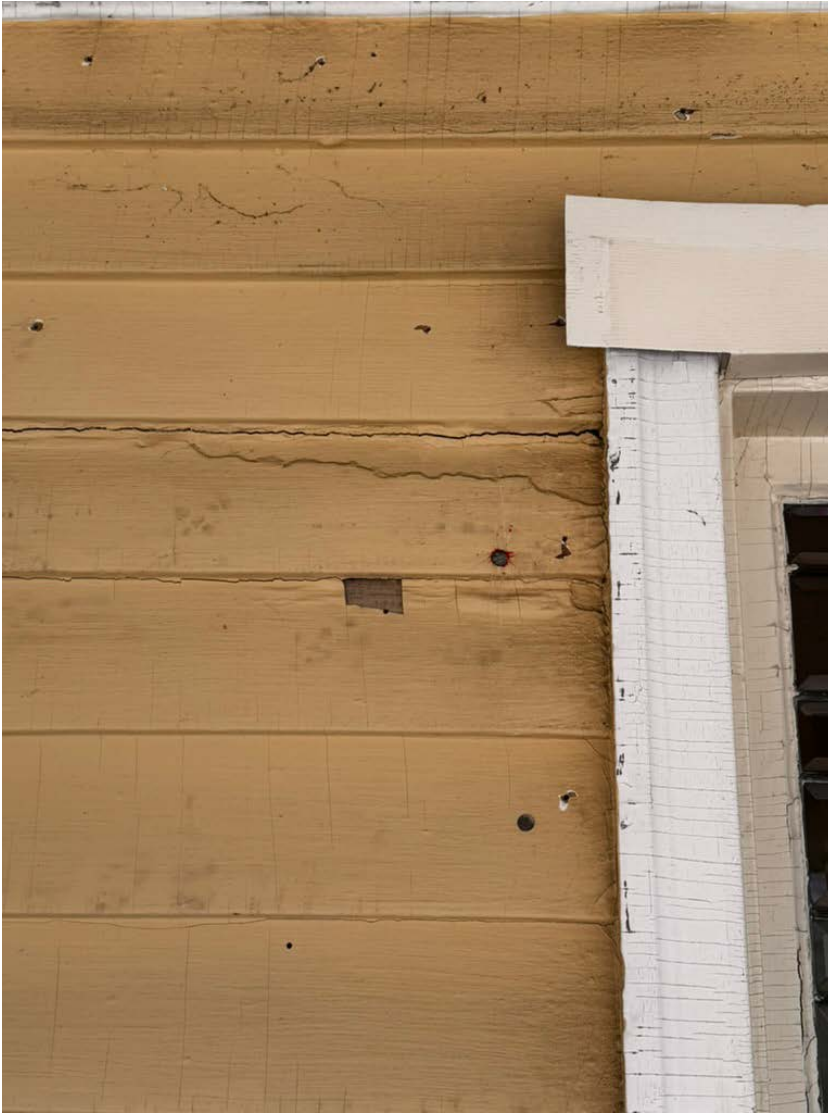
In a small area at the north elevation, beneath the porch roof where the clapboard is not obviously split, there are signs of pronounced cupping, suggesting underlying water penetration.

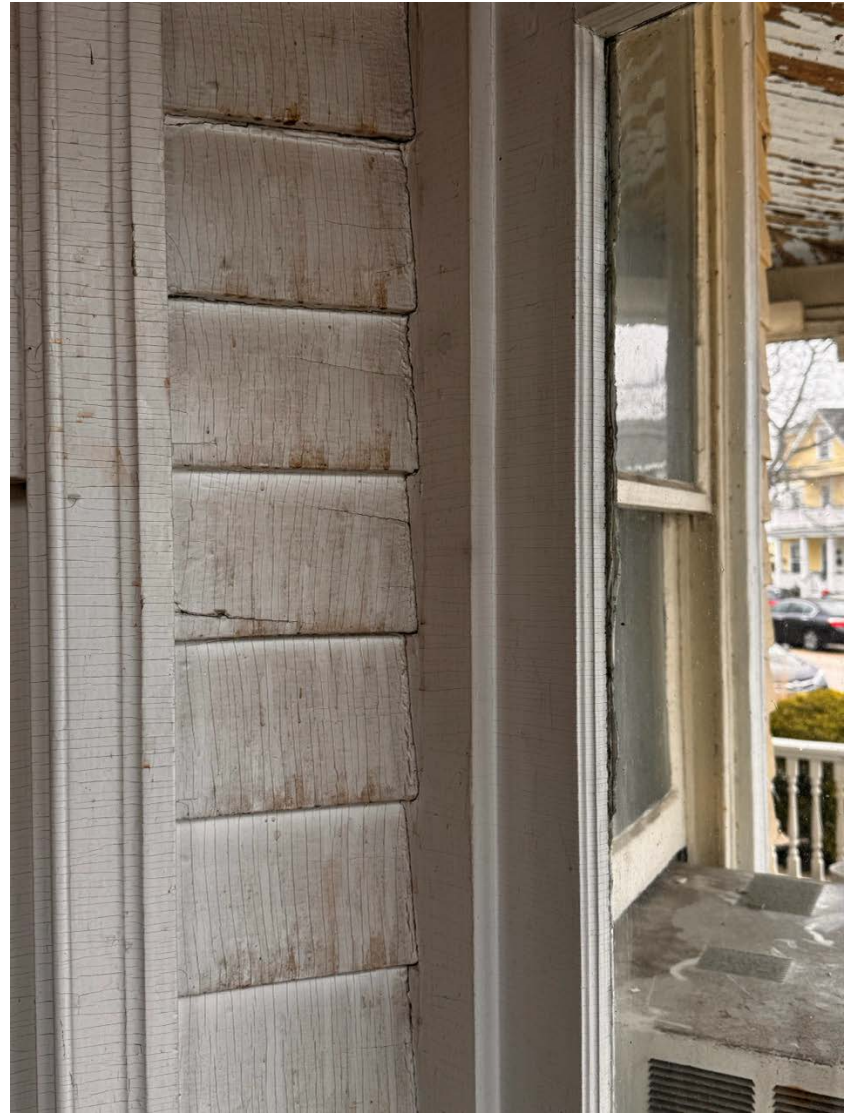
A short run of siding in the enclosed portion of the porch, though protected from weather, still show signs of deterioration caused by water penetration from turret windows above.
