SHORE POINT ARCHITECTURE, PA

ELEVATION REPORT

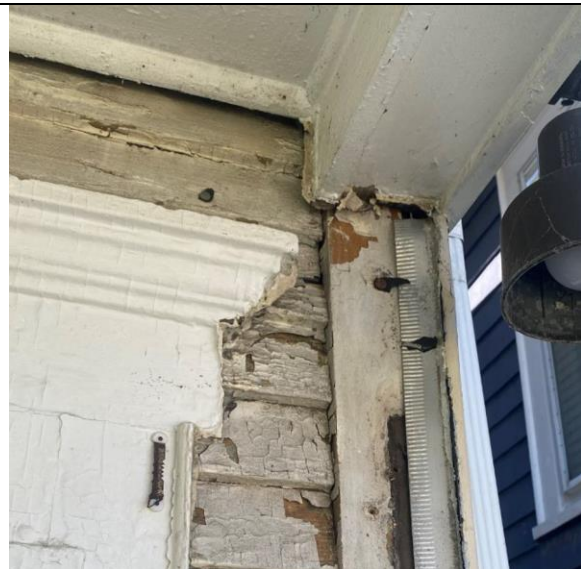
4: Evidence of rot and deterioration around the porch framing and corner of the structure on the first floor.

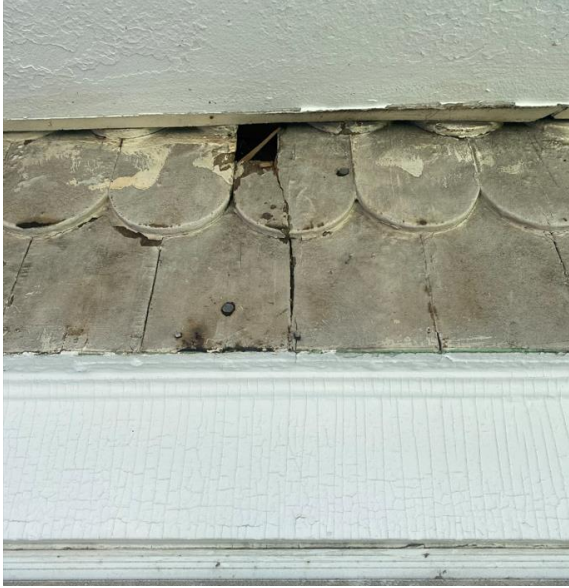
5: Cracked scalloped shingle as evidence of damage over the course of exterior alterations to the original house.

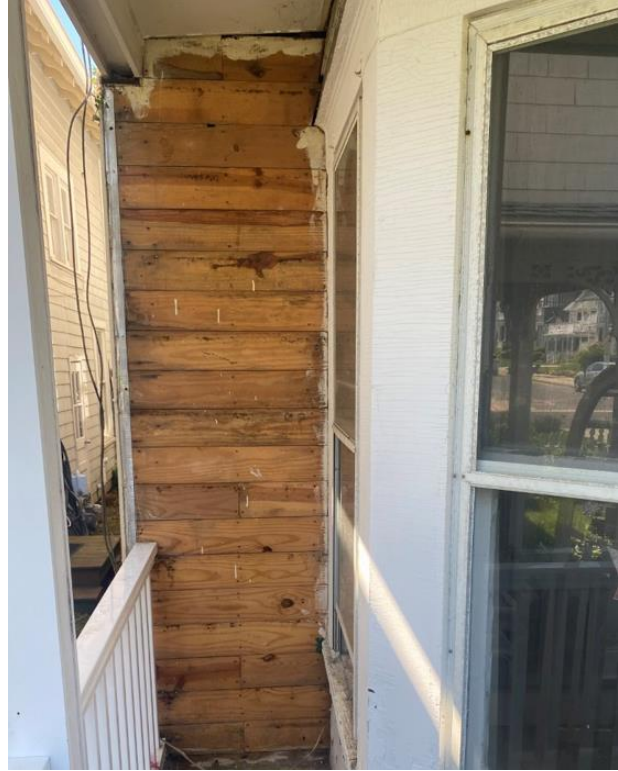
6: Evidence supporting the porch was enclosed as an addition. There was no siding behind the removed asbestos shingles.

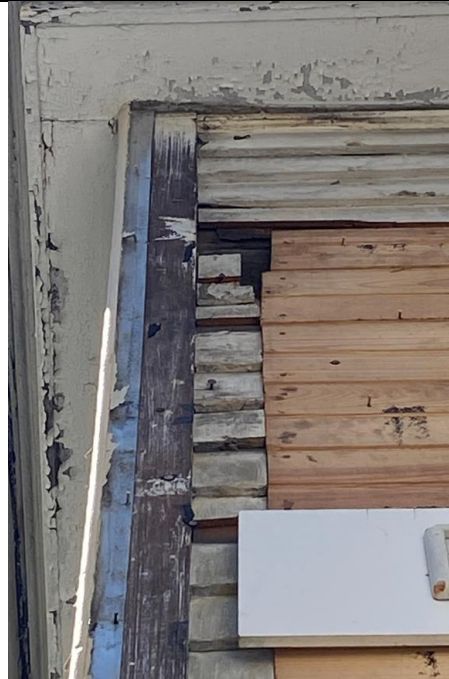
8: Clapboard around patch on rear second floor projection appears to match primary material used throughout the structure but has been damaged and cracked over the course of the structures history.

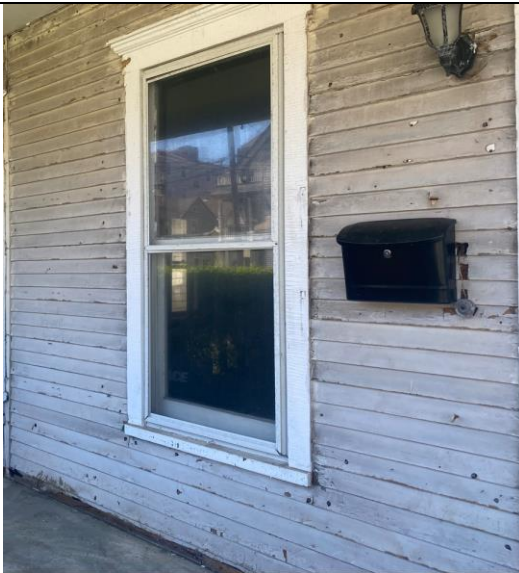
9: 3" Exposure Wood Clapboard in fair condition below porch. Damaged boards around edges and many nail holes from "layering" of siding

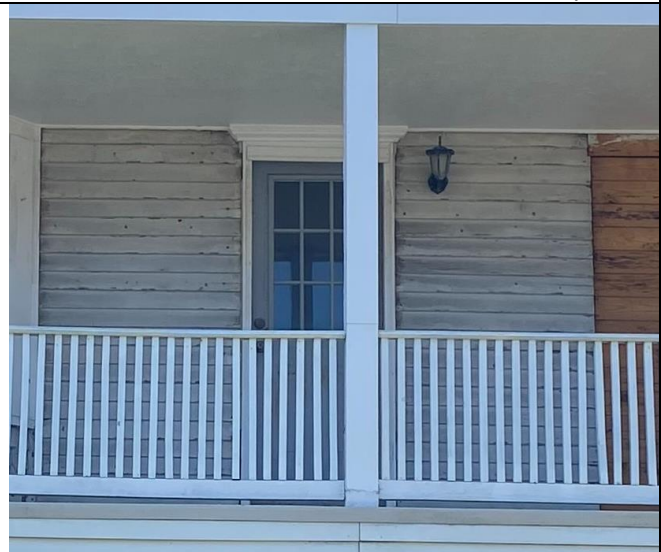
10: 4" Exposure Wood Clapboard in fair condition below porch but many nailholes, rot around edge boards, and large patched areas where windows/doors were relocated

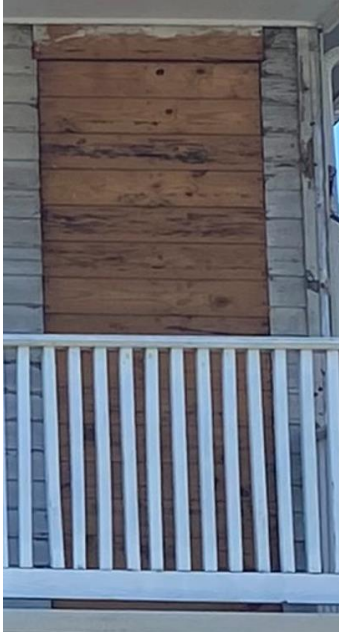
11: window/door openings patched with wood sheathing boards

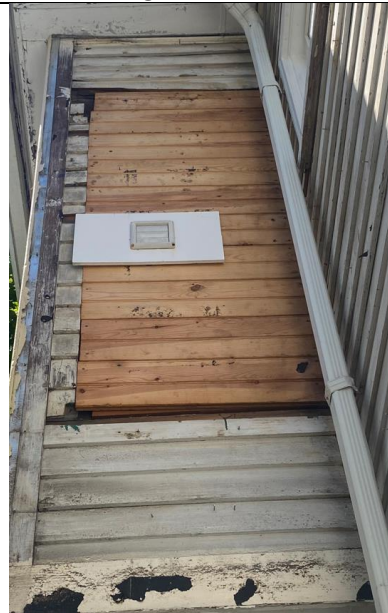
14: siding cut/in poor condition

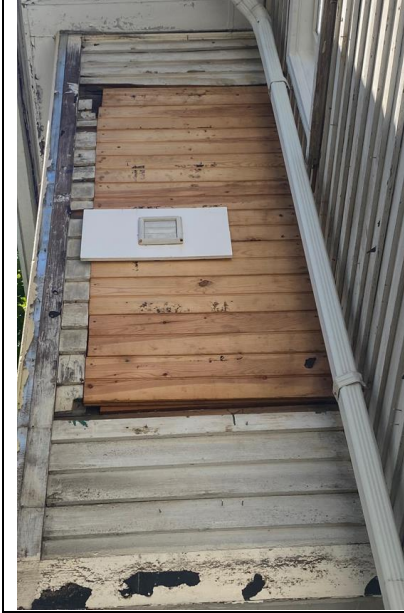
15: window opening infilled with newer sheathing boards

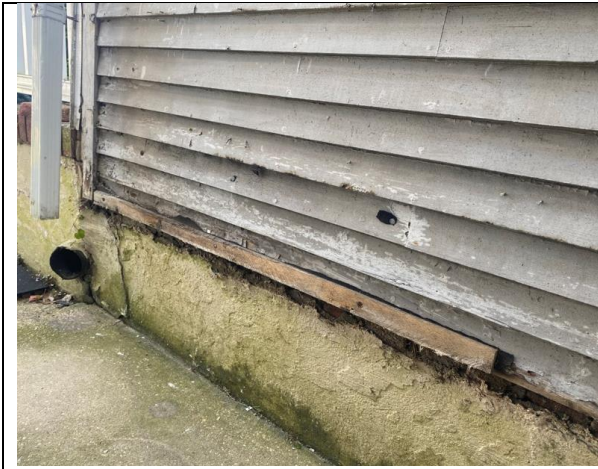
1: rot/deterioration at base. Excessive nail holes. Rot at corners.

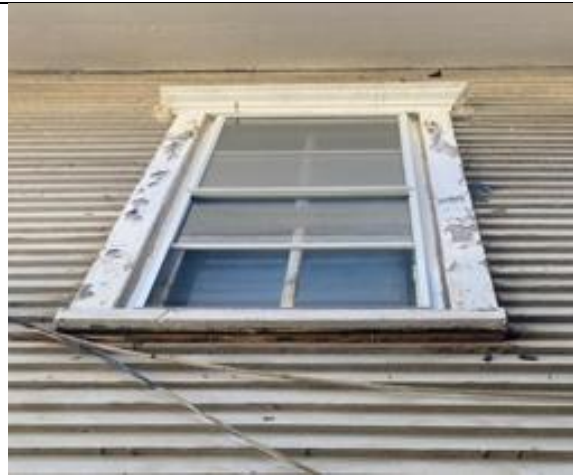
2: window casings in poor/fair condition. Rot at underside of sill indicates signs of water infiltration.

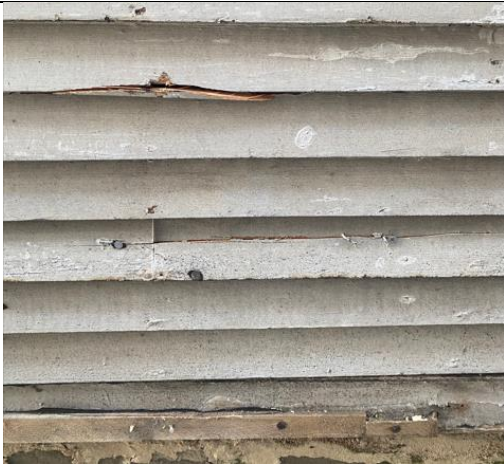
3: Cracked boards throughout

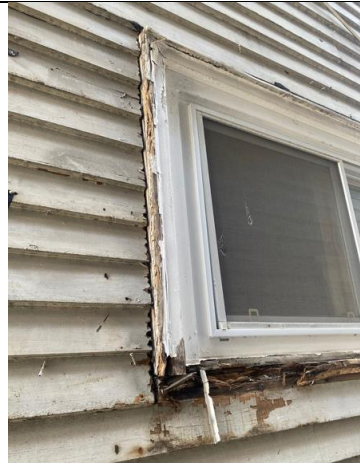
4: significant window frame rot. Edges of siding cut haphazardly to accommodate newer window opening

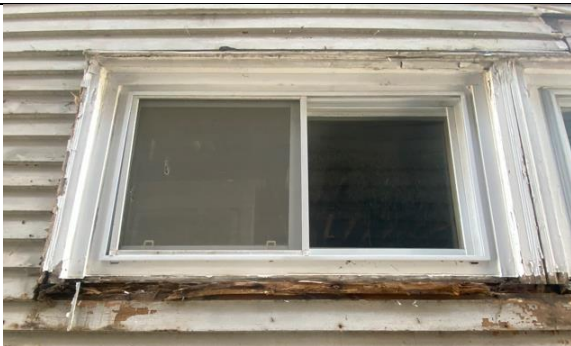
5: significant window frame rot

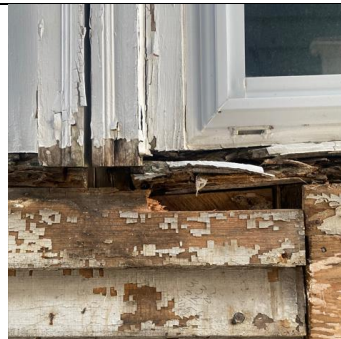
6: significant window frame rot

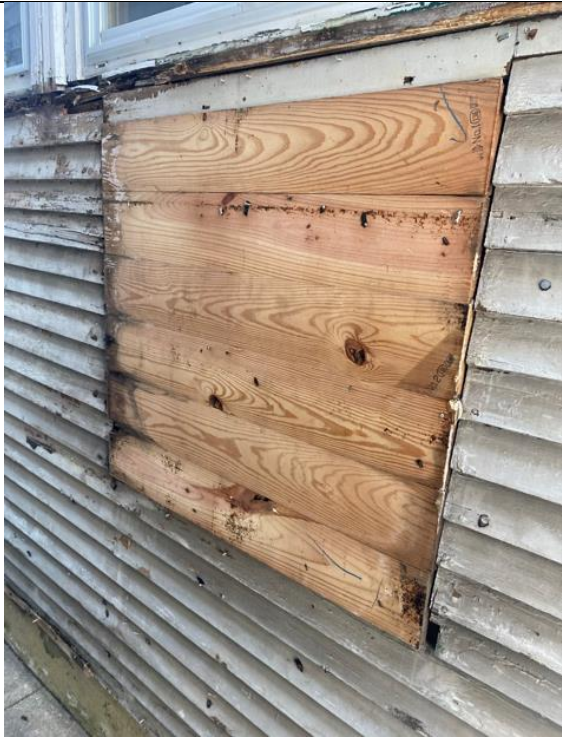
7: recent wood patch where window size was modified. Rot/siding damage

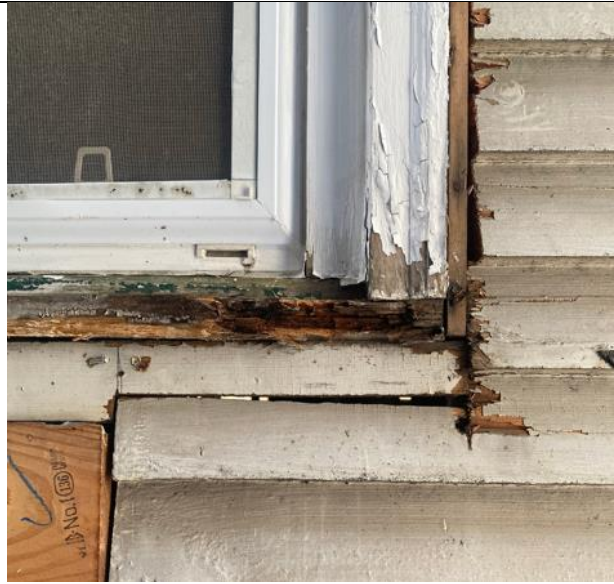
8: significant window frame rot. Cracked siding boards. Haphazard cuts at siding edges to accommodate modified window openings

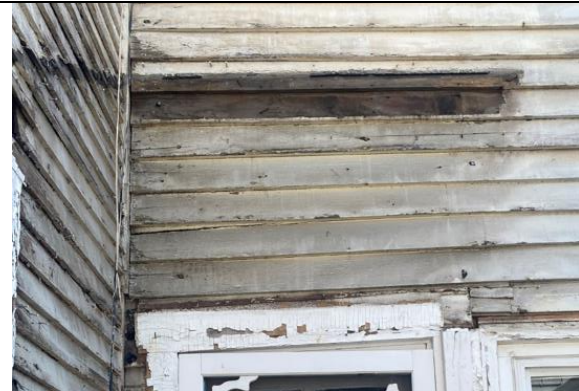
9: significant rot/deterioration at door casing and siding.

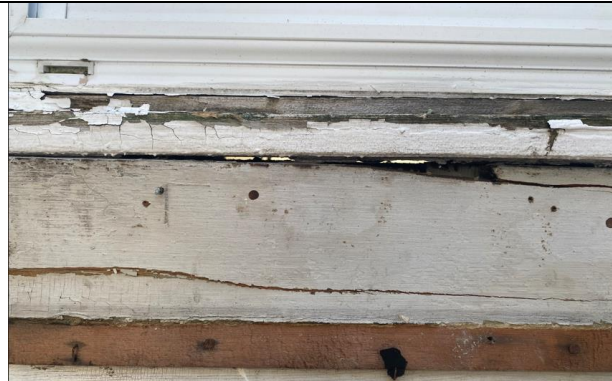
10: significant rot/deterioration at door casing and siding.

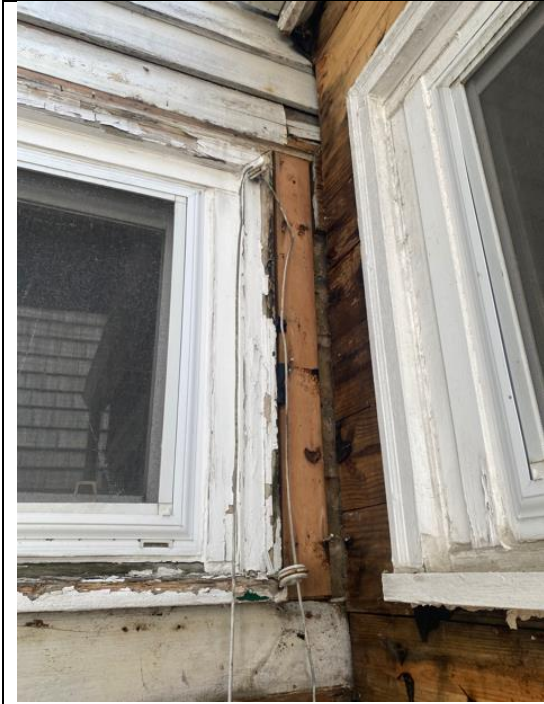
11: excessive rot/patchwork and infill of openings

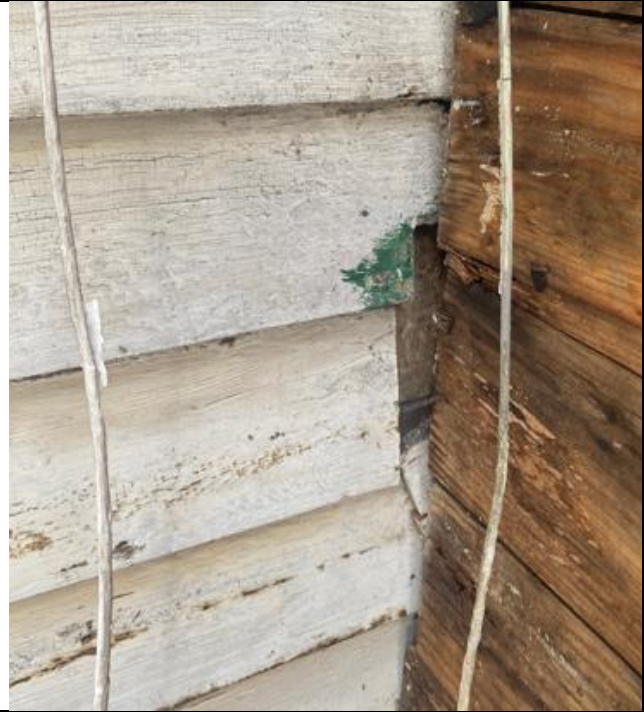
12: haphazard cuts showing excessive damage to siding. New materials improperly joined with older materials allowing for water infiltration.

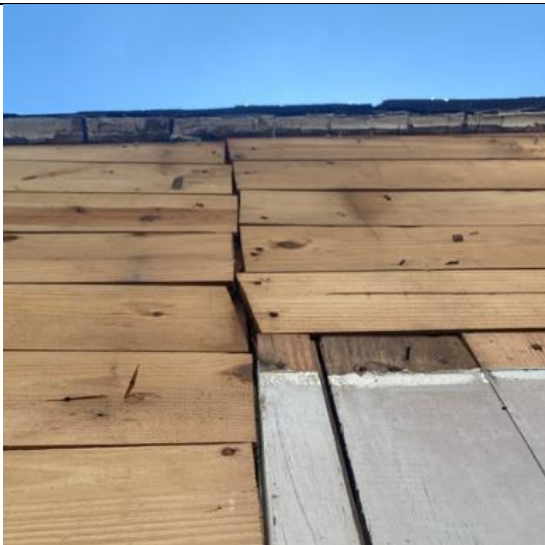
13: newer sheathing boards at recent additions

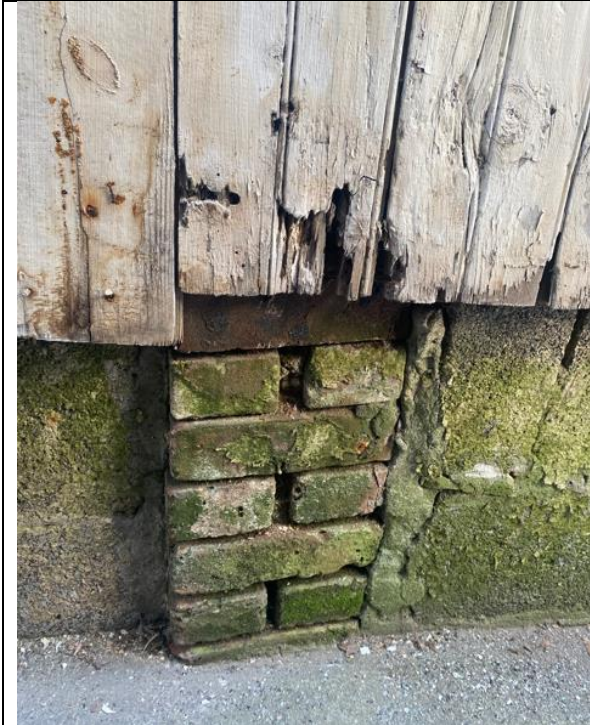
15: beadboard siding at rear in very poor condition

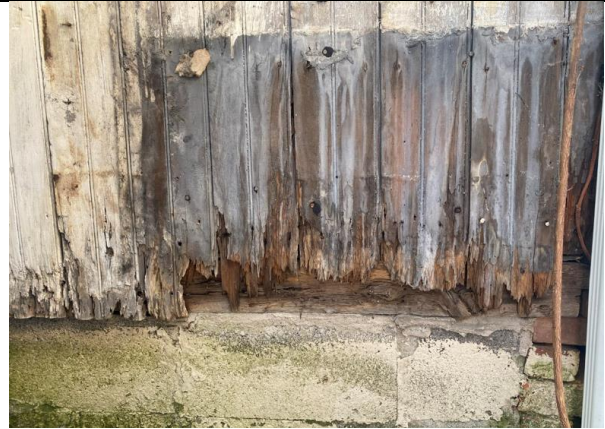
16: beadboard siding at rear in very poor condition

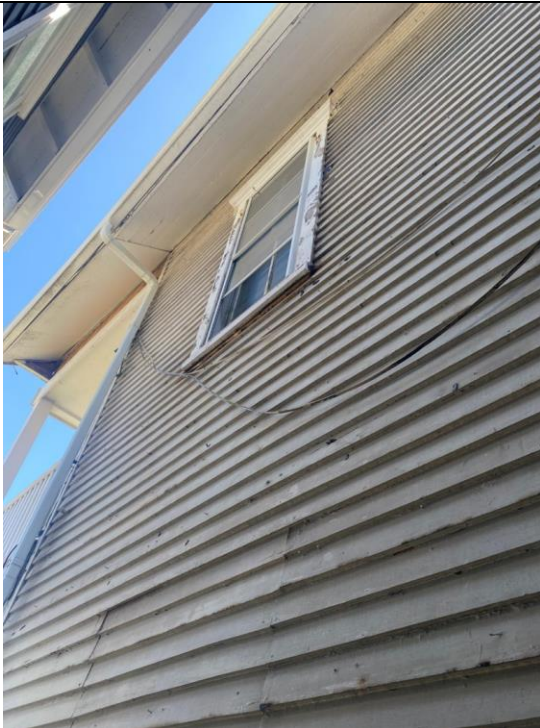
17: Siding in poor condition. Excessively nailed, patched, and cracked

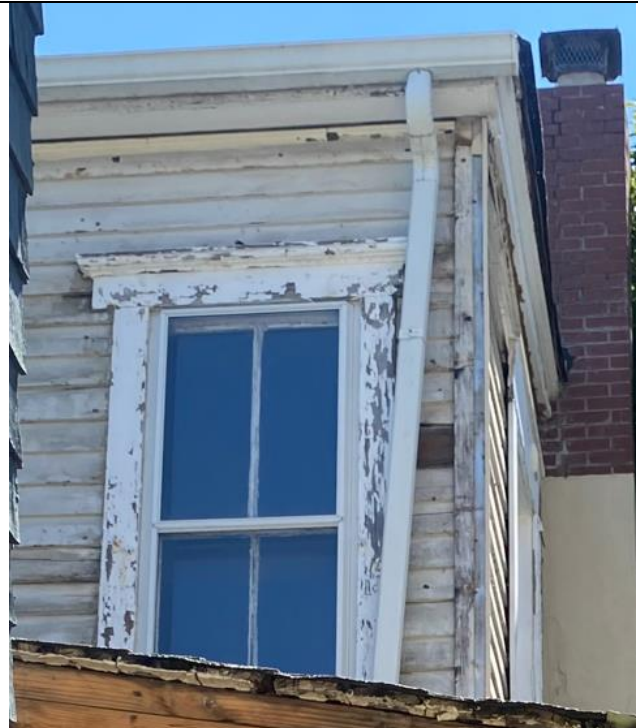
18: Siding in poor condition. Excessively nailed, patched, and cracked. Window casings improperly installed, likely poor repair work.

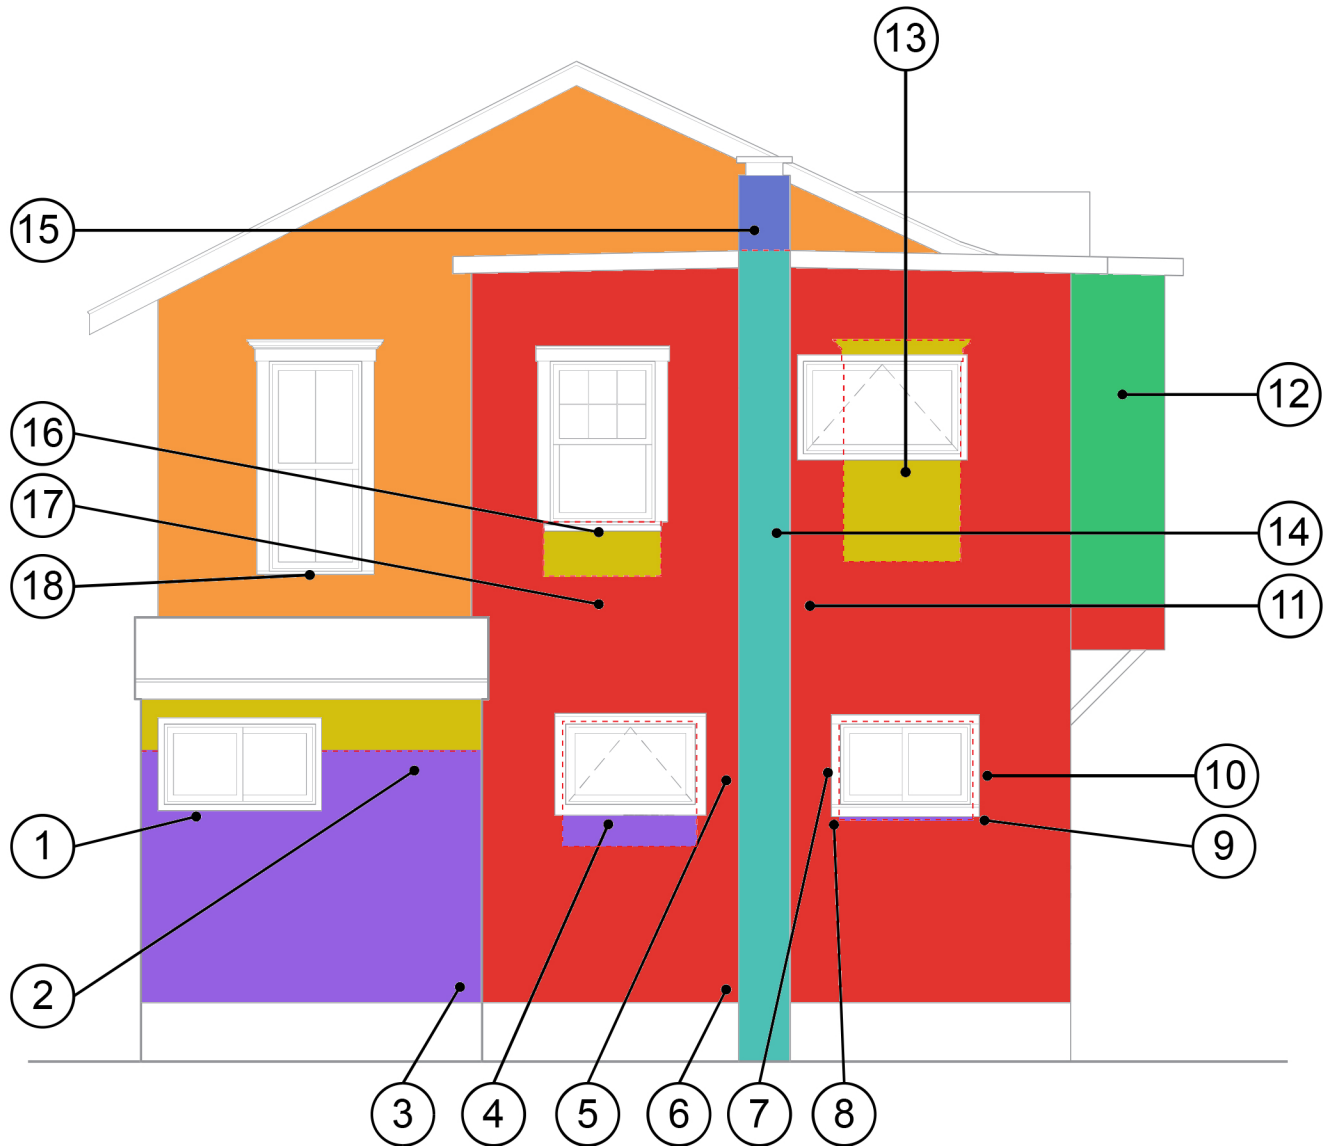
- 4" EXPOSURE WOOD CLAPBOARD**
- 3" EXPOSURE WOOD CLAPBOARD**
- 1X6 P.T. SHEATHING BOARDS**
- 1X4 TONGUE AND GROOVE WOOD**
- 5-1/2" WOOD BEADBOARD**
- BRICK**
- STUCCO**

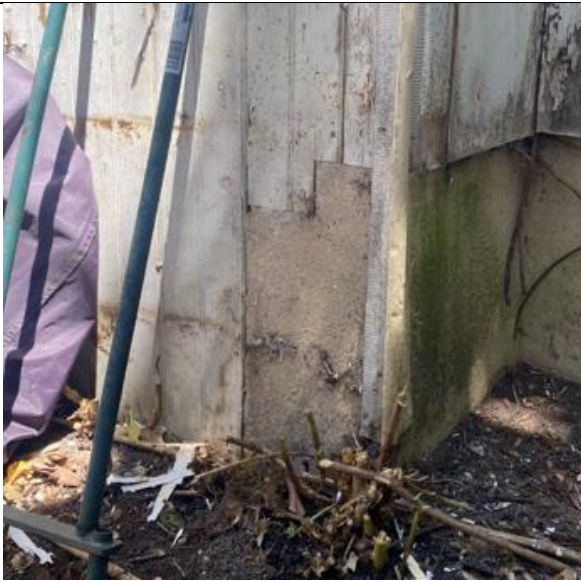
3: Siding in poor condition and cut/notched in many locations.

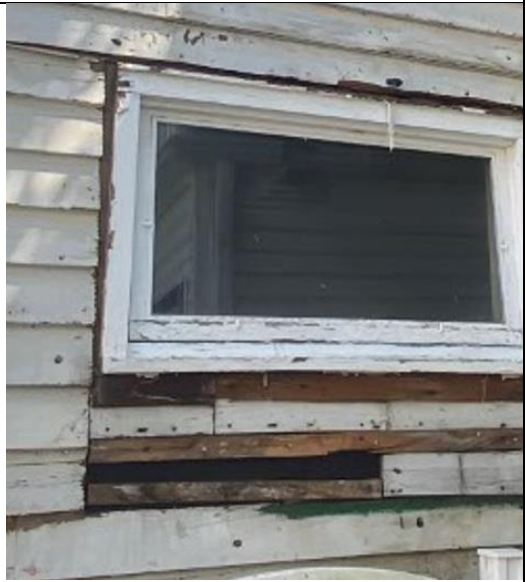
4: patching around window opening. clapboard cut to accommodate window installation.

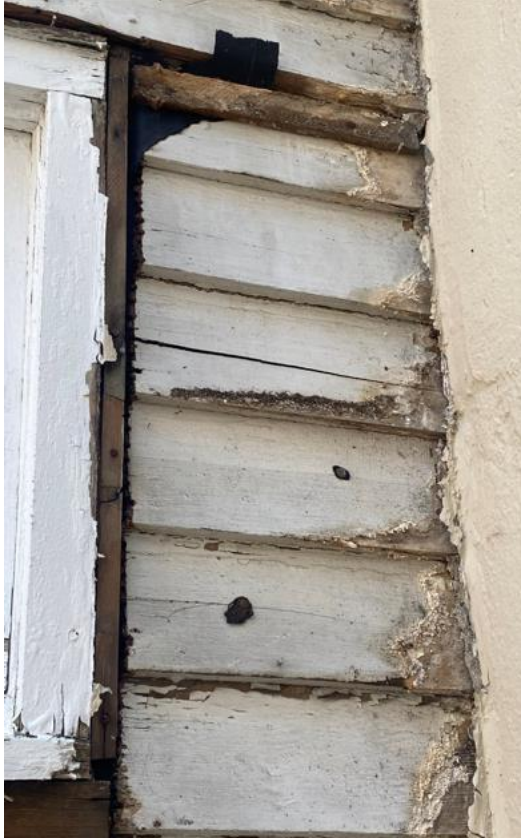
5: cracked, rotted, and deteriorating siding between window opening and stucco chimney.

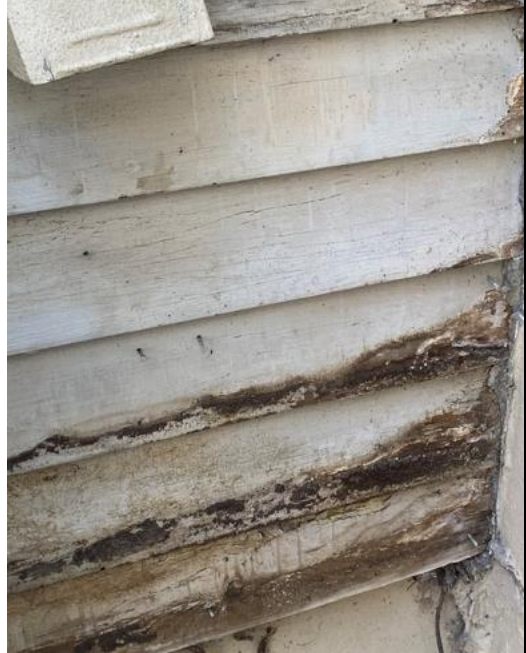
6: evidence of rot/deterioration severe at lowest courses of siding and around the chimney.

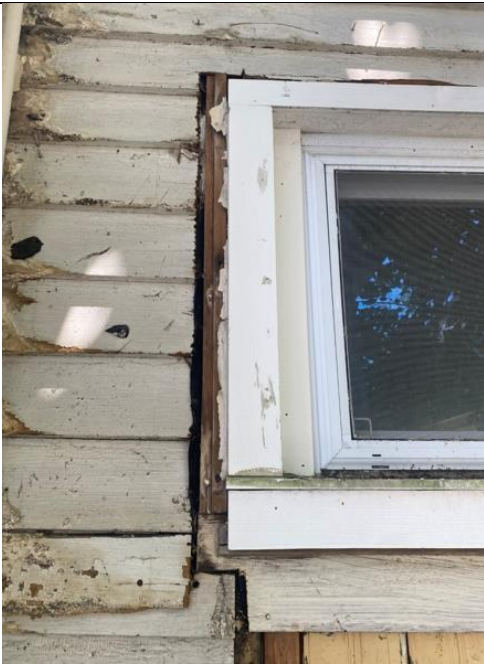
7: wood clapboard cut for window installation, split boards present, damage/rot along stucco chimney.

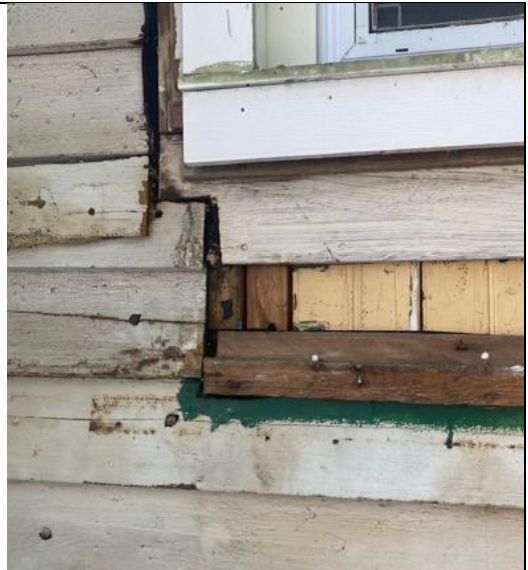
8: patched area around window opening with cut and split wood clapboard.

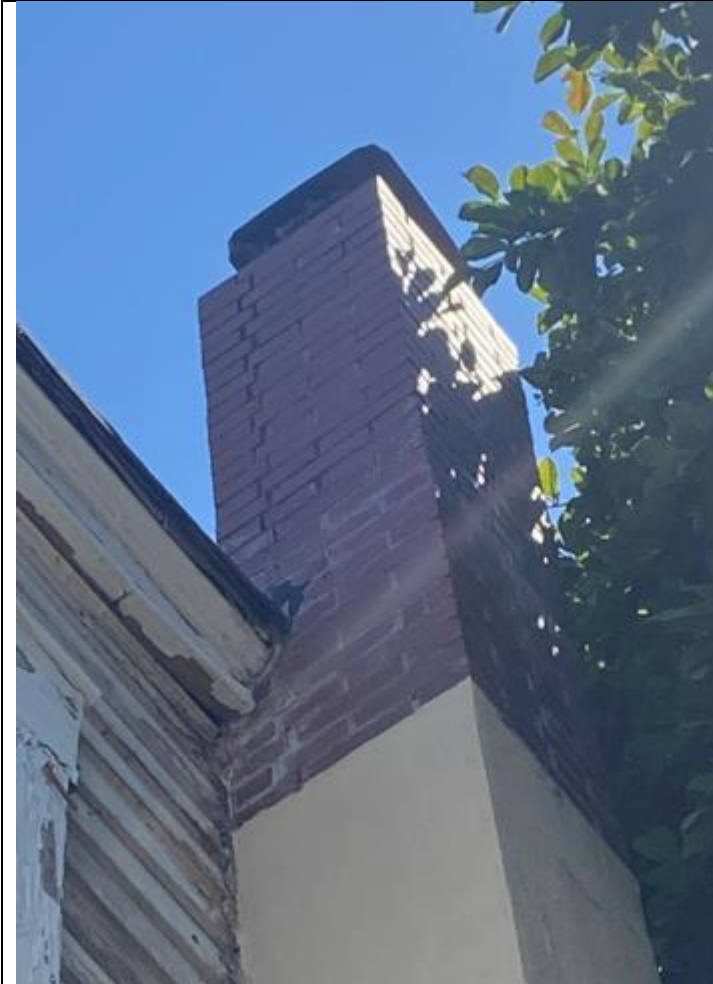
15: Exposed brick at top of rear (non-historic) chimney in poor condition

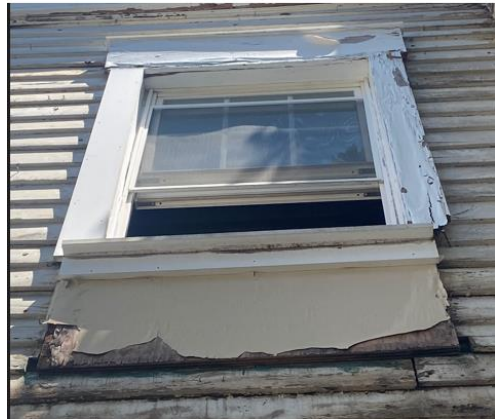
16: recent wood patch where window size was modified. clapboard cut for sill extensions around original opening. trim cut for asbestos siding installation.

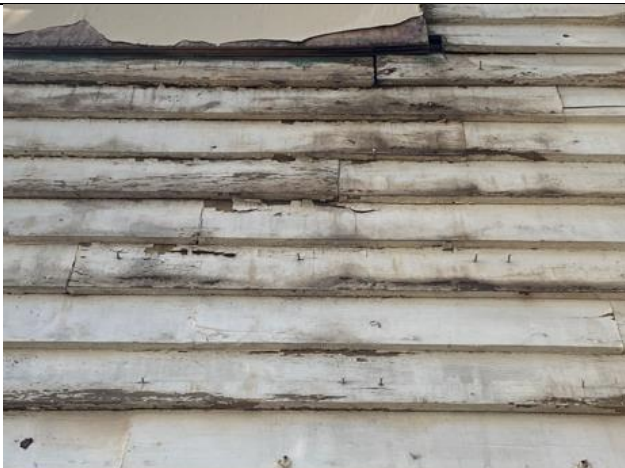
17: siding in poor condition, excessively nailed, patched, and cracked.

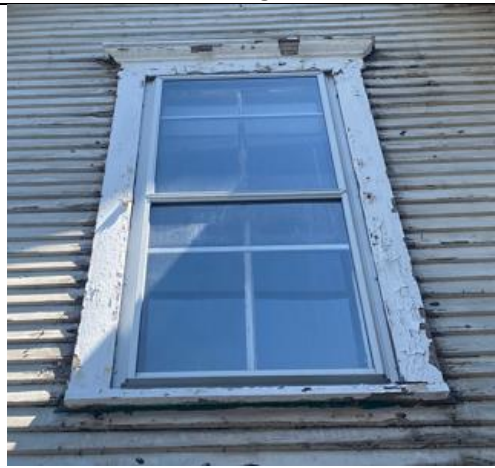
18: existing trim with deterioration and cut sill extensions to accommodate asbestos siding.

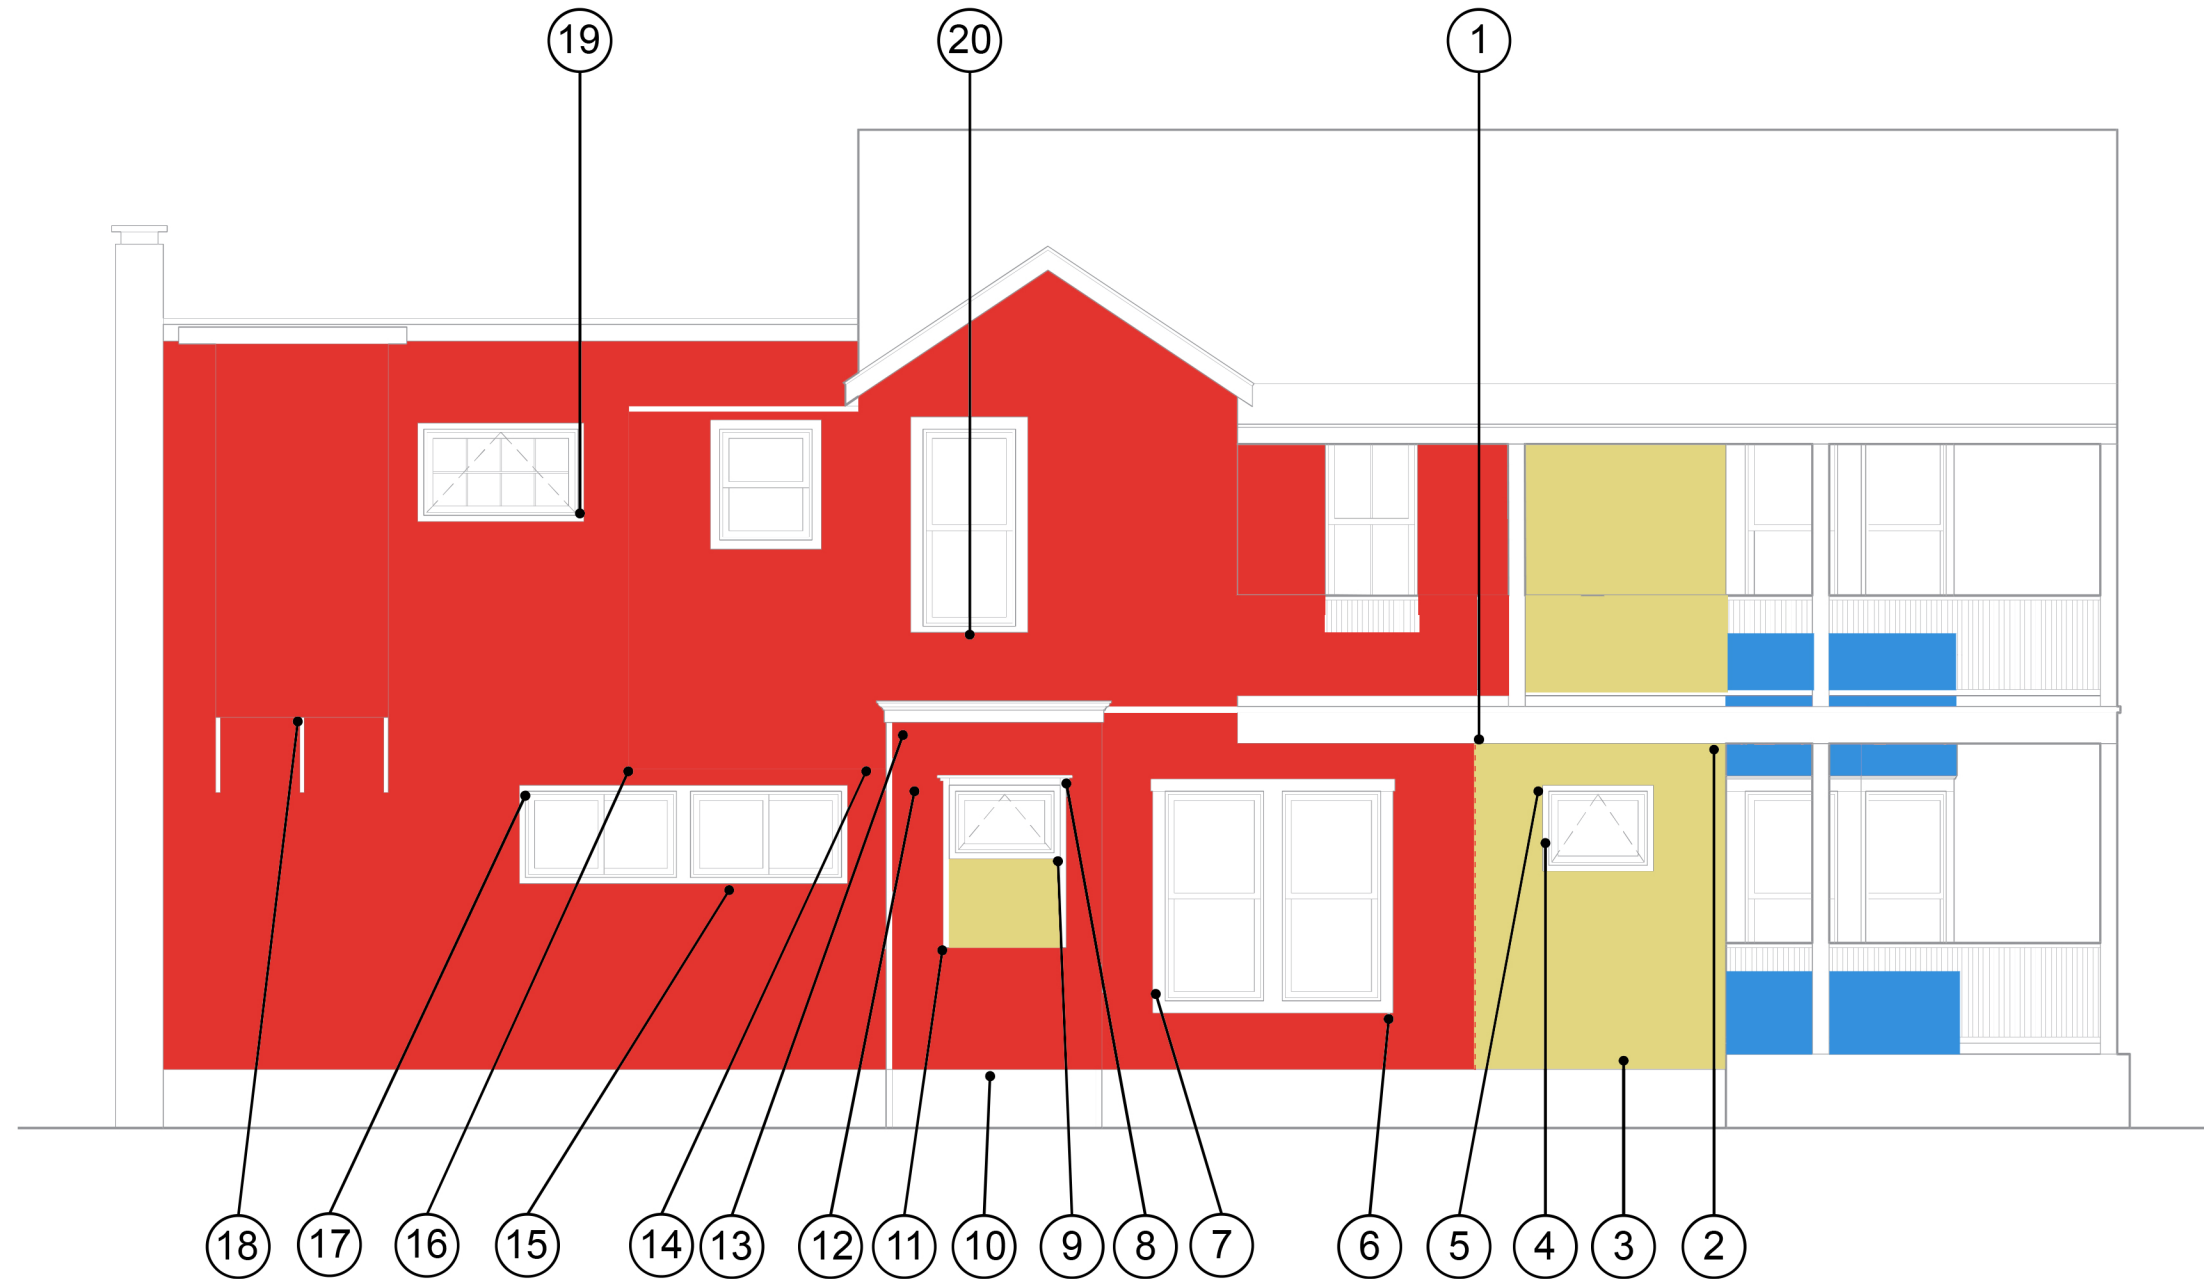
4" EXPOSURE WOOD CLAPBOARD
1X6 P.T. SHEATHING BOARDS
WOOD SCALLOP SHINGLES

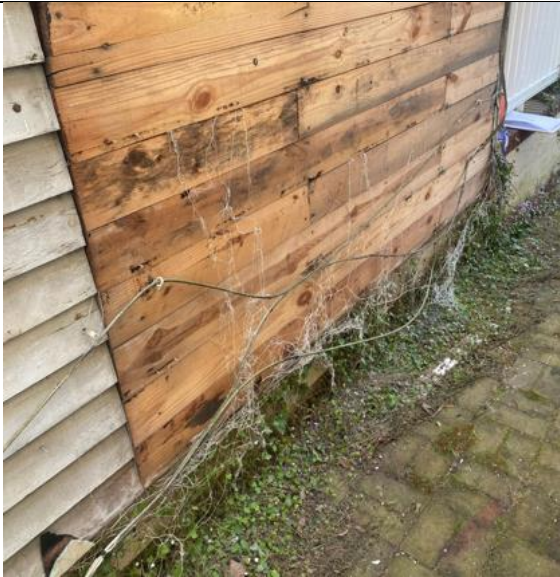
3: wood clapboard cut and patched. Excessive nailing. Rot evident at lowest courses and around windows/doors.

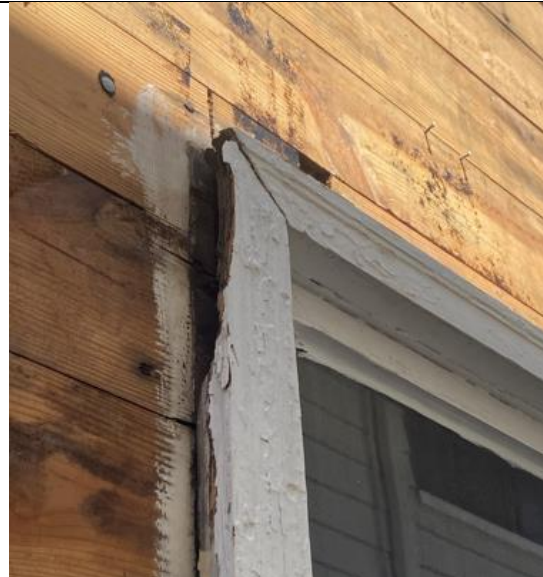
4: cracked, deteriorating window trim. Not original.

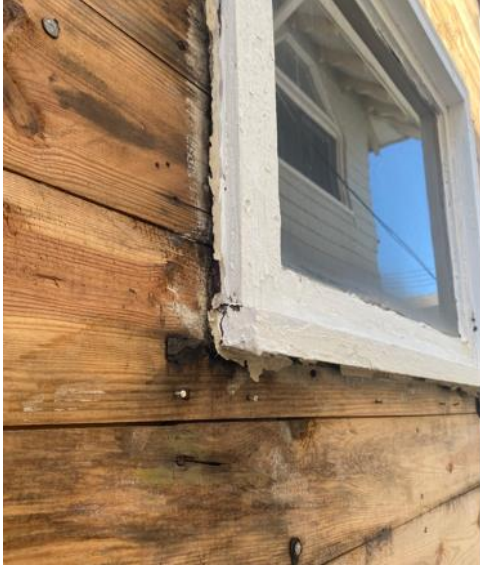
5: Windows in additions (newer wood sheathing) are in poor condition as well

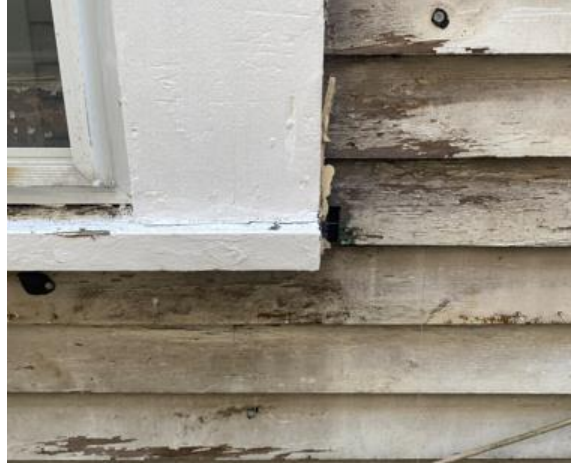
6: sill extensions cut to accommodate asbestos siding installation. Rot around window casings.

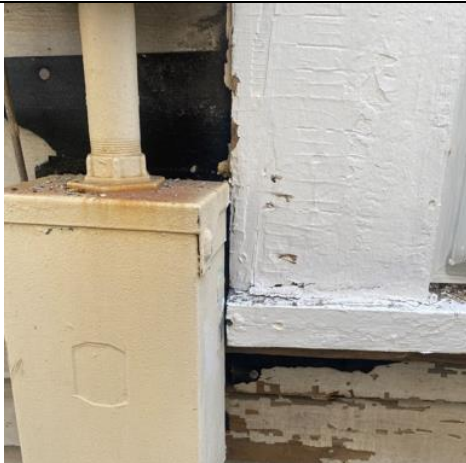
7: Siding/trim is cut/notched around exterior utilities.

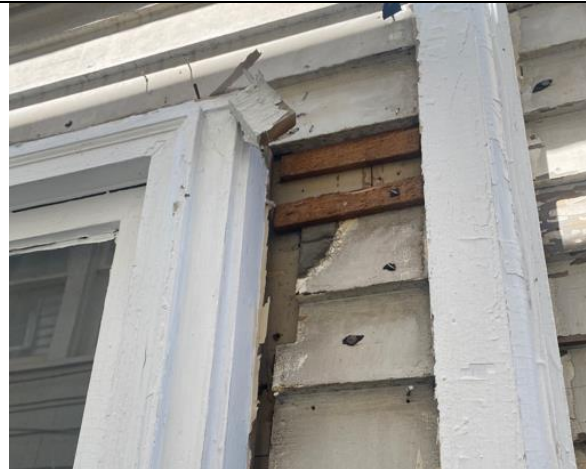
8: clapboard is cut, cracked, and missing. clapboard shows evidence of original window trim profile. Current trim is deteriorating and broken, most likely designed after asbestos siding installation.

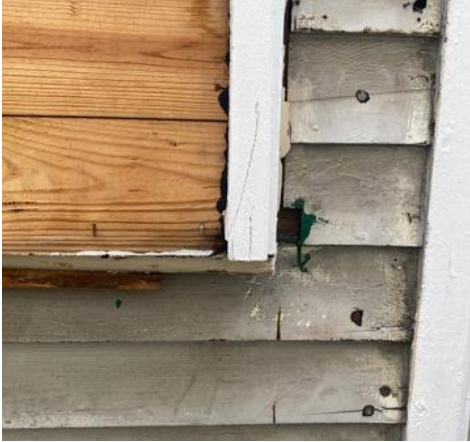
9: sill profile not present, original opening most likely patched and trim designed to accommodate asbestos siding.

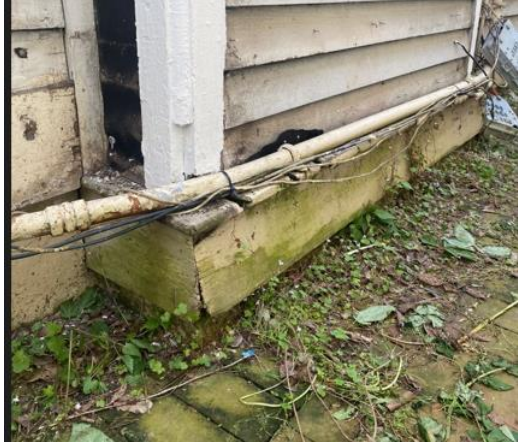
10: Old porch closed in to become living space. Poor condition

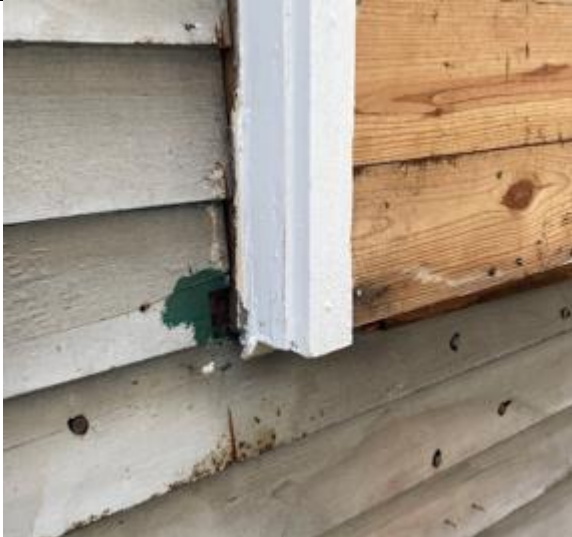
11: sill extensions of original window trim cut. window opening was patched/modified and new trim accommodates asbestos siding

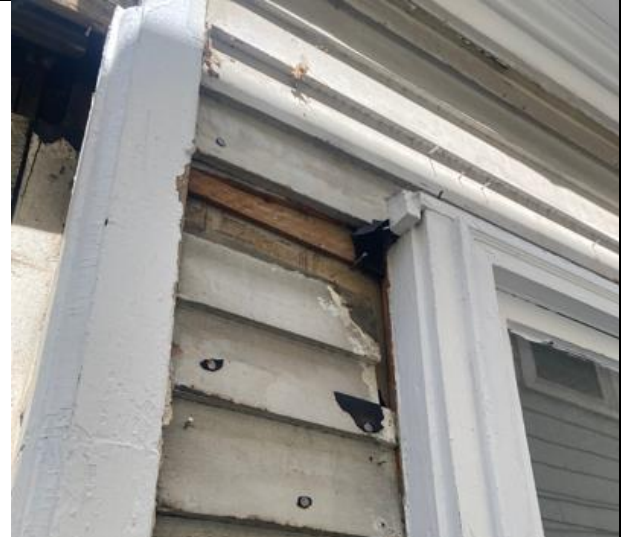
12: clapboard siding cracked and missing, original profile of trim shown, suggesting opening was modified

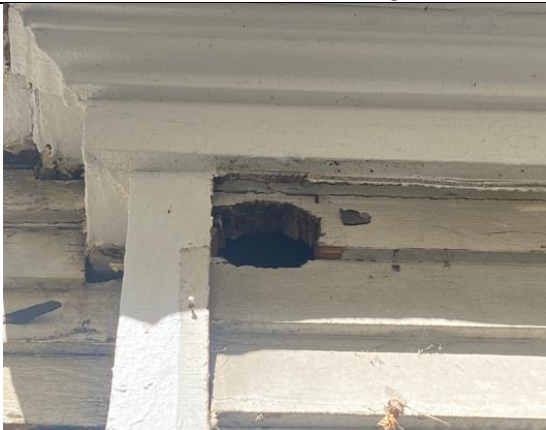
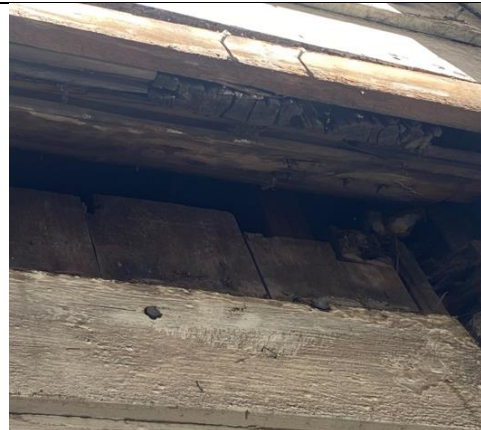
13: cuts in clapboard for penetrations

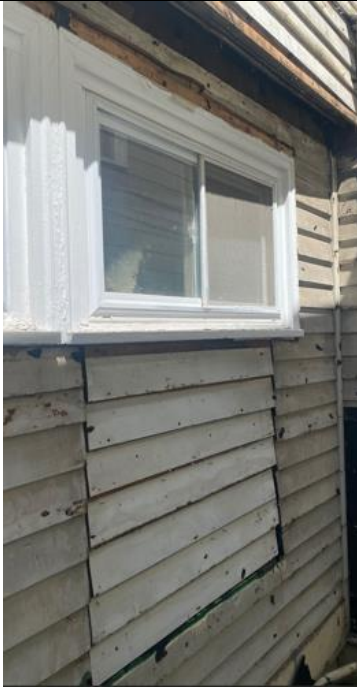
14: severe deterioration and rot of elements around area. daylighting is occurring at bottom of projection.

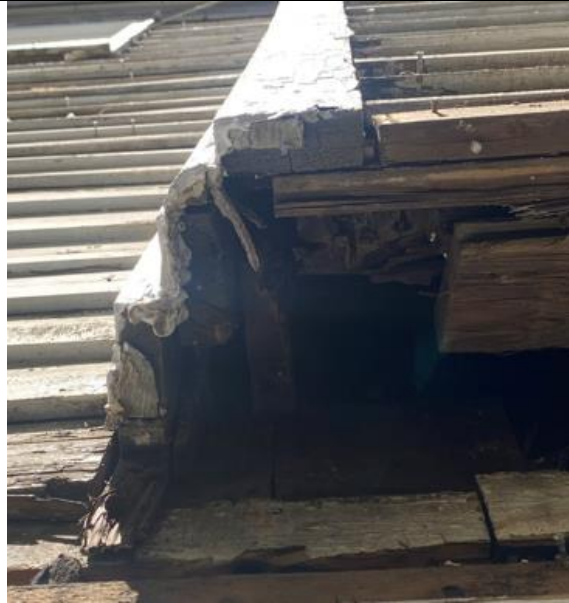
15: siding haphazardly patched, courses are not aligned, proportions suggest an original window opening that was modified.

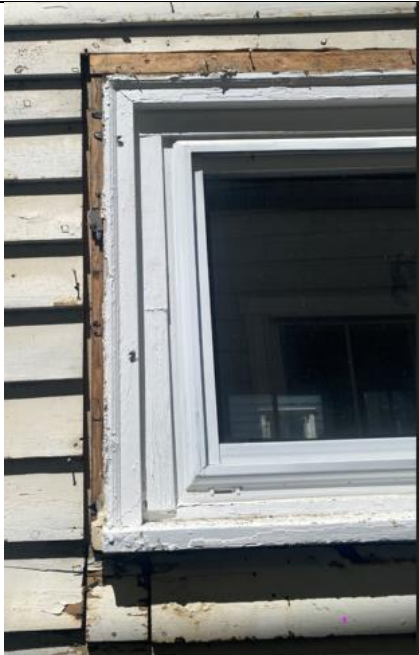
16: severe deterioration and rot at bottom of projection creating a daylighting condition.

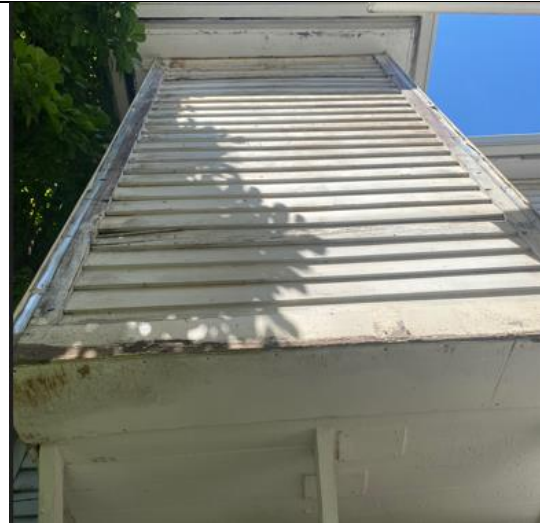
17: patchwork around frame in poor condition. siding was cut to accommodate new window opening.

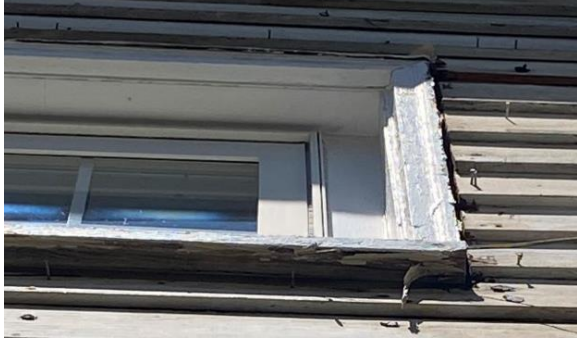
20: window frame showing rot and deterioration. sill extensions not present, trim is proud of siding and does not match historic profile, suggesting a newer window opening.

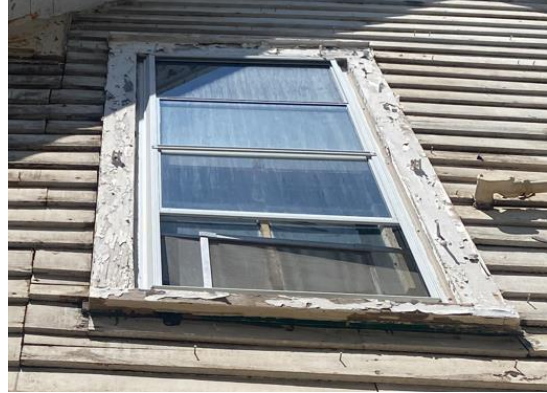
21: window trim in poor condition and was cut to accommodate asbestos siding.
