21 Bath Ave. Condition Report: Windows  
16 June 2023  
Jenny Shaffer and Kurt Cavano

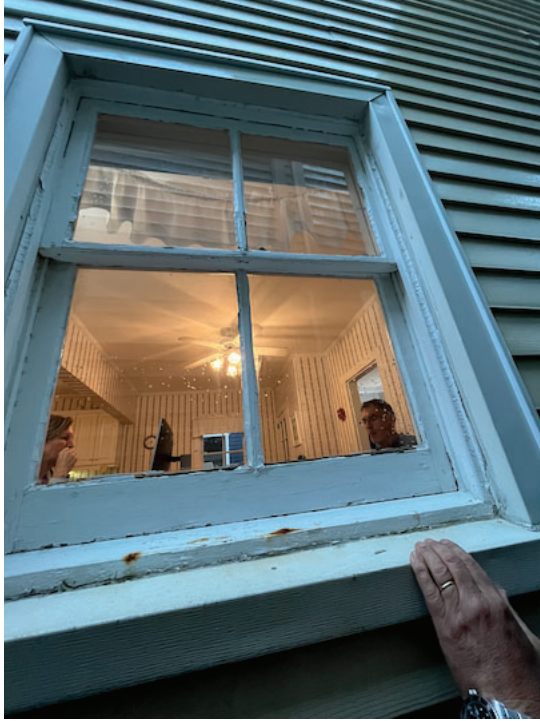
window 114 exterior

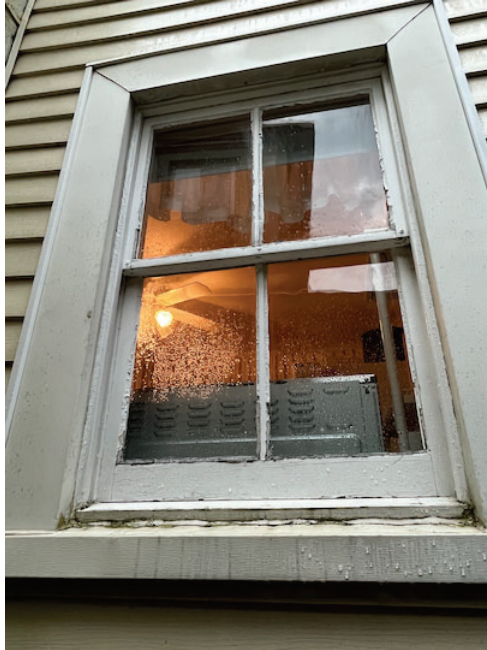
window 112 exterior

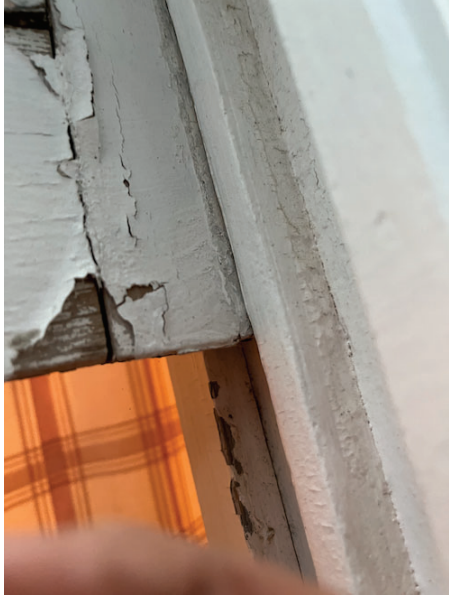
exterior of window on east side showing splitting sashes

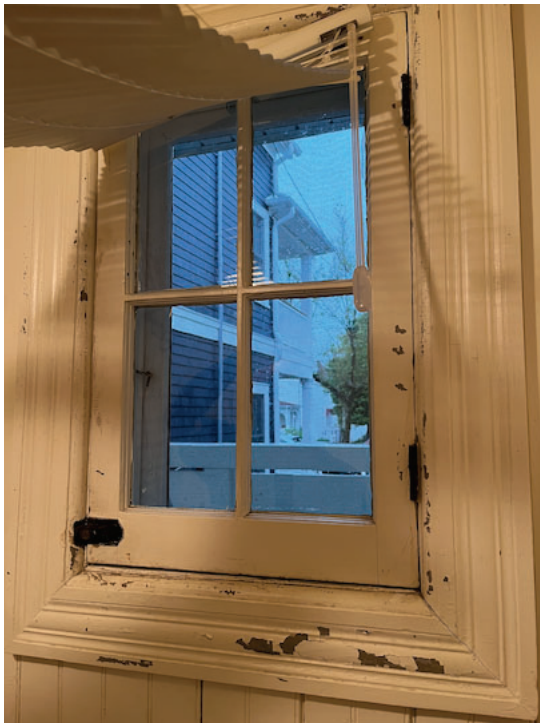
small window on first floor

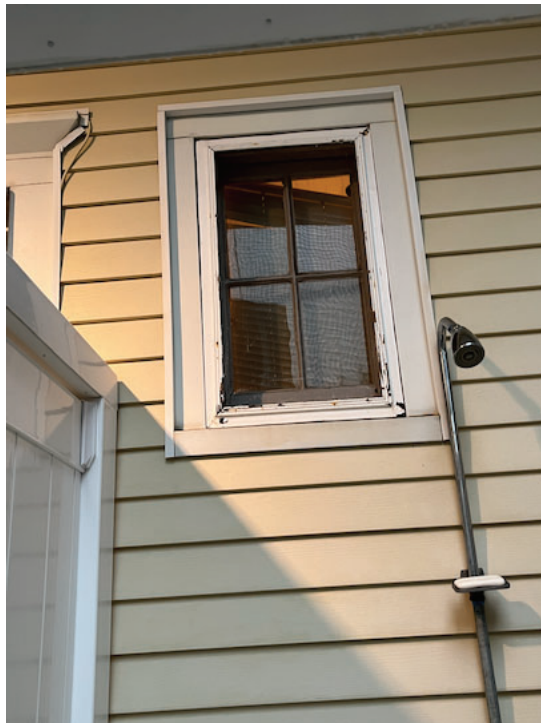
exterior from shower
