110 Main Ave. Condition Report: Rear Deck and Fire Escape

4 September 2023

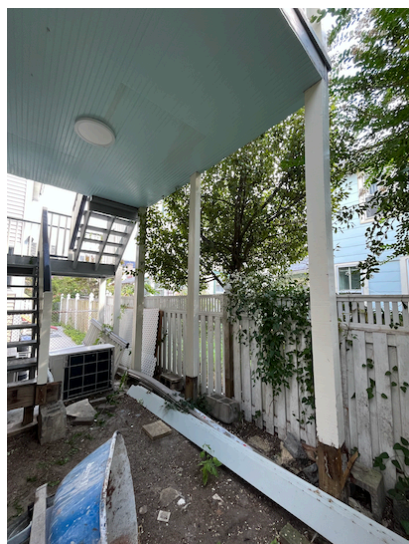
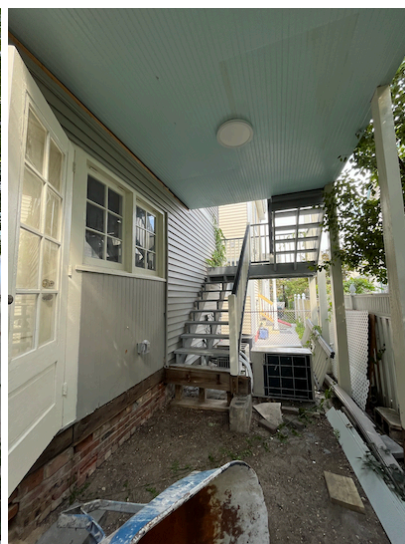
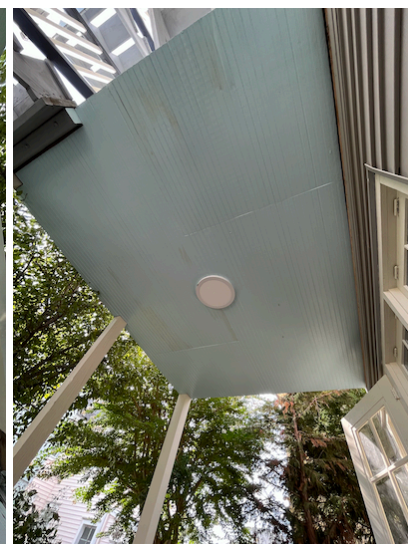
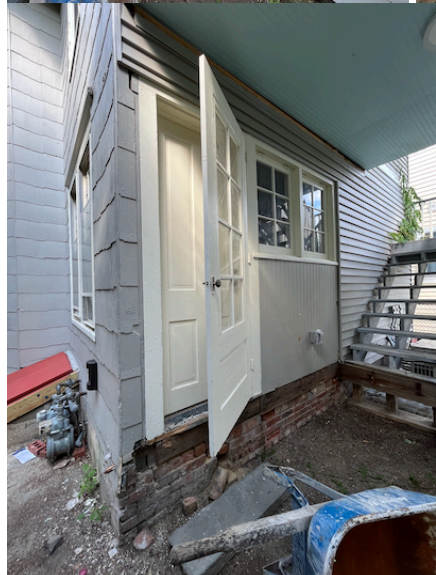
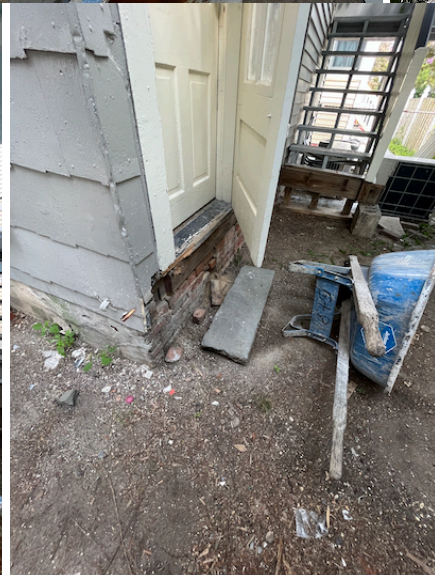
- At ground level/first floor, there is a large, open space.
- There was at one point an elevated deck.
- There is what appears to be a patched, new(er) ceiling with a modern light fixture.
- A piece of slate, perhaps part of a set of stairs, is on the ground by the door.

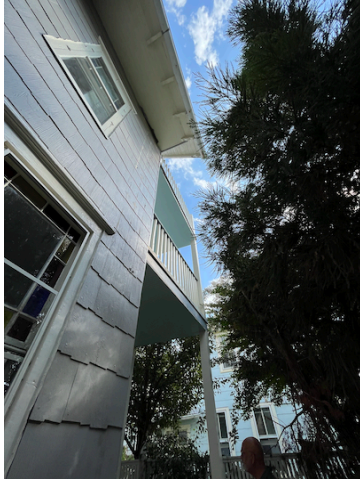
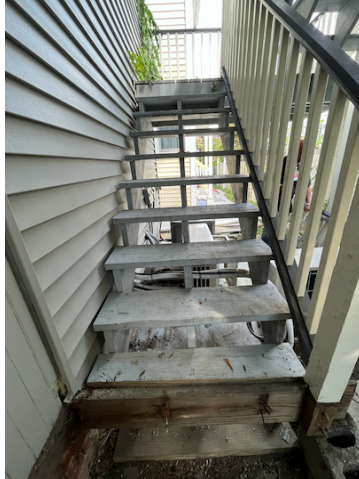
- The second floor of the structure is reached by a set of older stairs.
- The stairs currently are far off the ground.

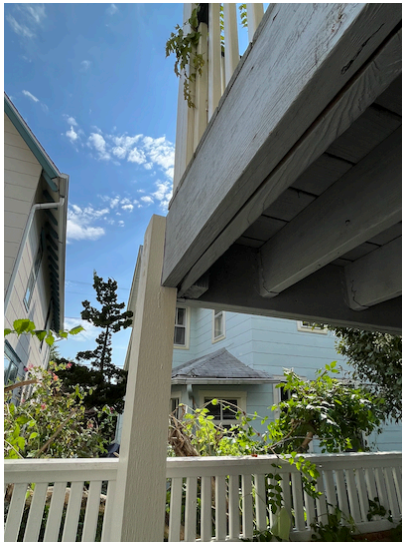
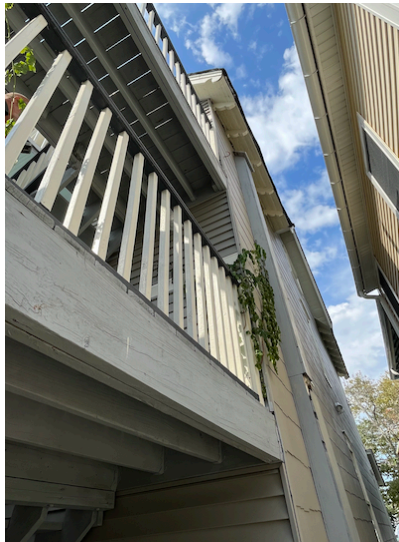
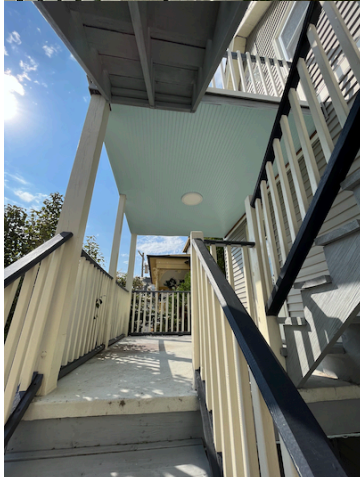
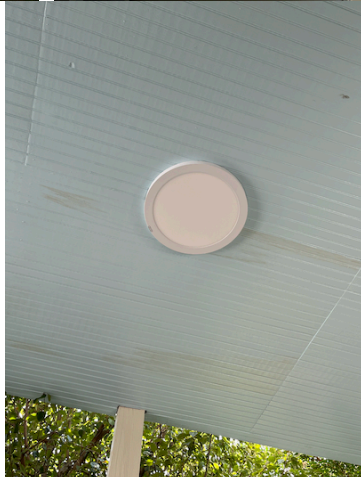
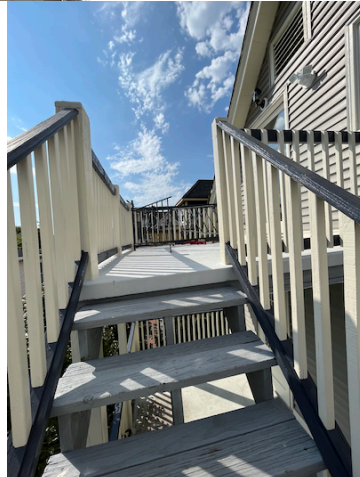
- The second floor is supported by a square post at the southeast corner.
- The second and third floors abut the house, here on the west side.
- The second floor has a ceiling and light fixture as on the first floor.
- The third floor is open.
