NOTE: This report supplements an earlier site report of 21 November 2022, and concerns only the siding, which now has been largely exposed by the applicant.

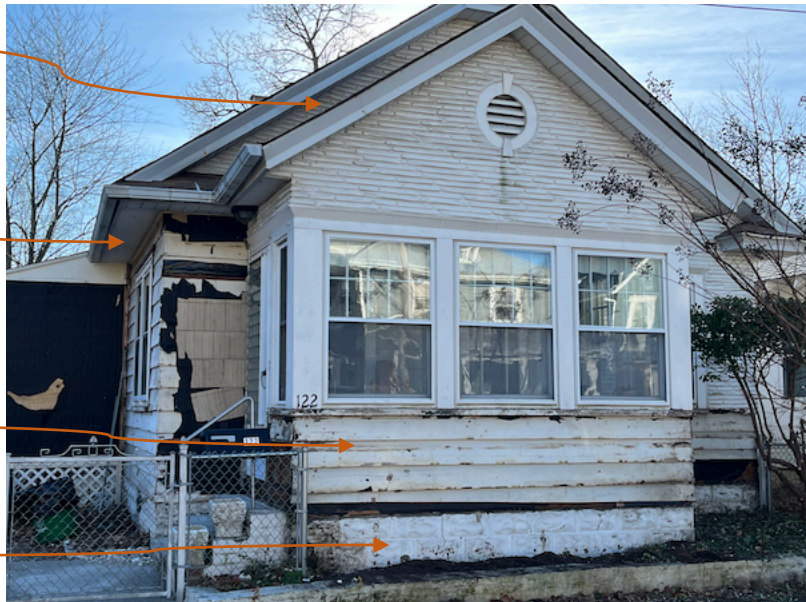
main/north facade

- The clapboard on the lower north/front façade is unsalvageable.
- Unsheathing what was the small, original front porch on the front/north façade revealed the original shadow block foundation; it also revealed that the original porch appears to have had a clapboard half wall, though the clap is unsalvageable.

as yet unexposed

vinyl fascia
(goes around entire
house)

damaged clap of half-
wall

shadow block foundation

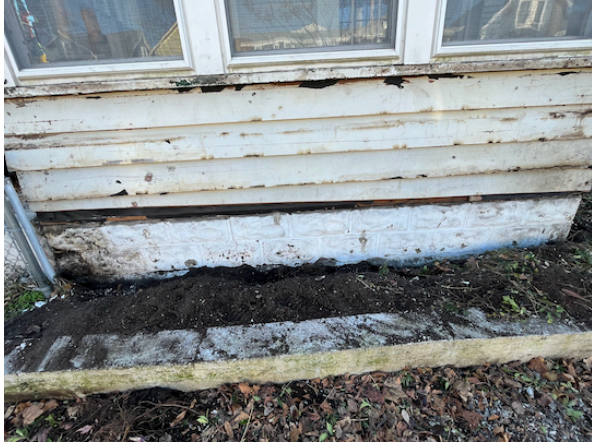
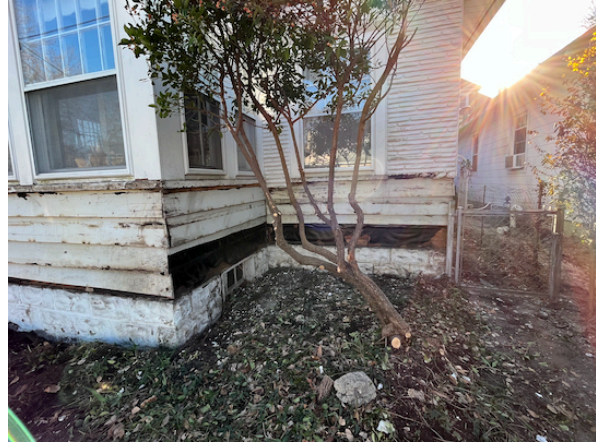
split/damaged clapboard on “sunroom”/porch and lower north elevation with woven corner

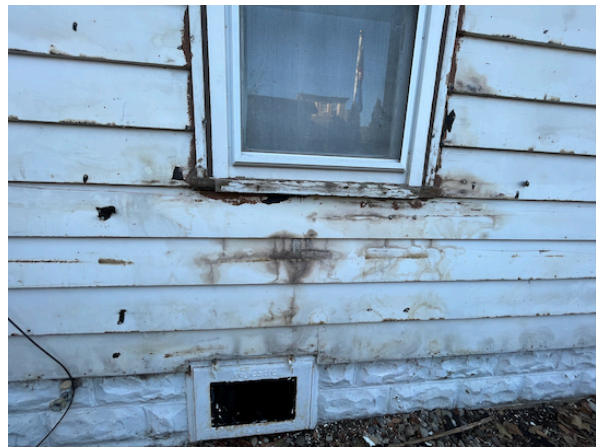
- The distinctive wide clapboard used on the exterior is in varied condition, with about two-thirds in fair to good condition (mostly on the east and west sides) and about a one-third unsalvageable: split boards; lower edge of boards damaged when later layers applied and removed; and water damaged boards (especially towards the south/rear under windows).

window to east rear with water damage below

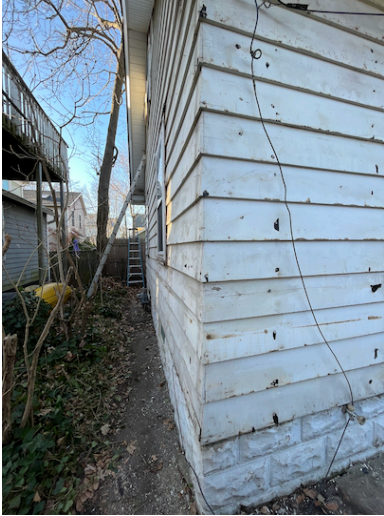
southeast corner with woven corner

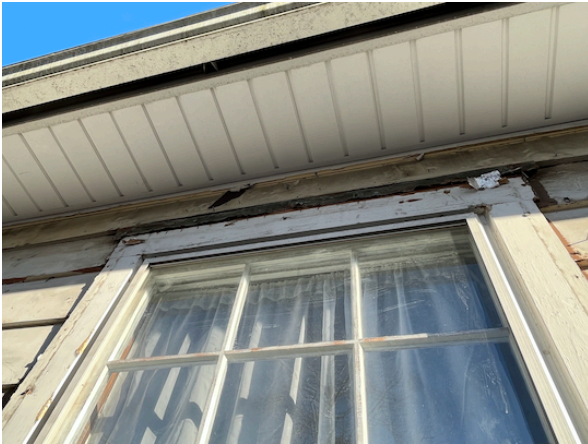
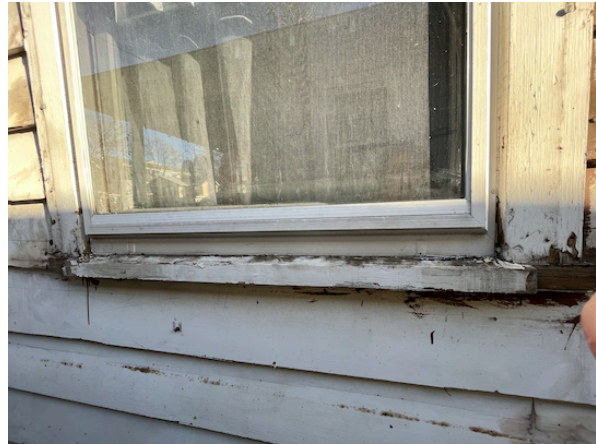
- The corners are woven.
- All sills were cut and window headers removed to apply later siding.
- The vinyl fascia remains in place, so it is unknown what is beneath it.

west elevation window with surround extending at top and missing header, cut sill below

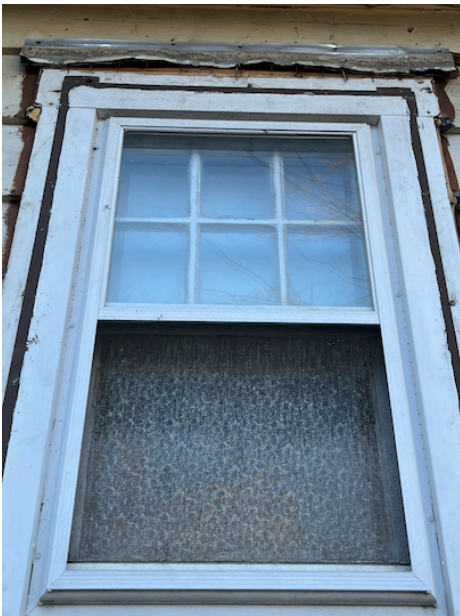
another typical window surround
