The applicant is proposing to remove all existing windows and replace them with new conforming, wood-core windows. They are also proposing to remove all existing cladding and replace it with Hardie Board with an exposure to mimic the existing.

The property has 116 windows and doors. Of the existing windows, 27 are vinyl and are automatically candidates for replacement with a conforming wood window.

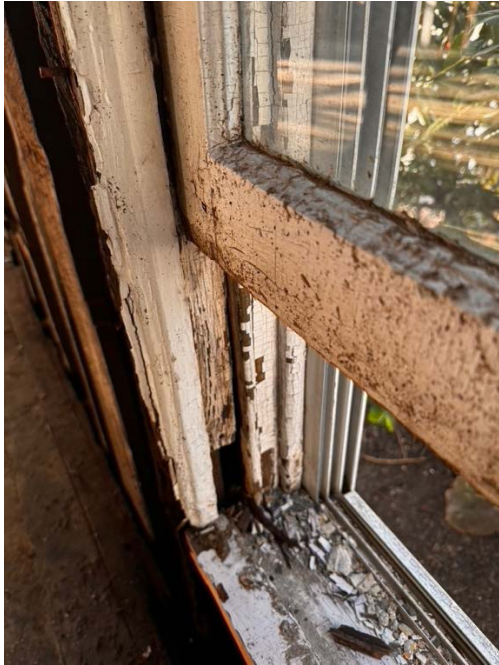
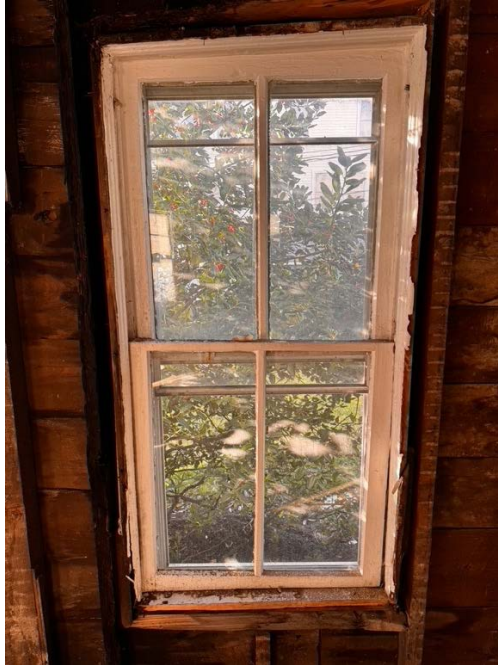
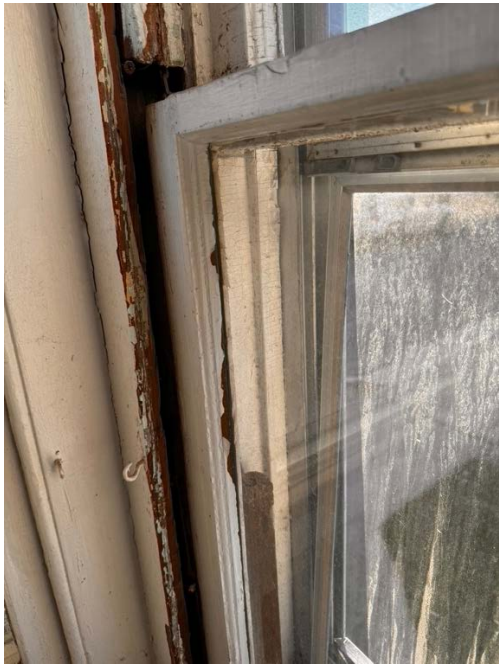
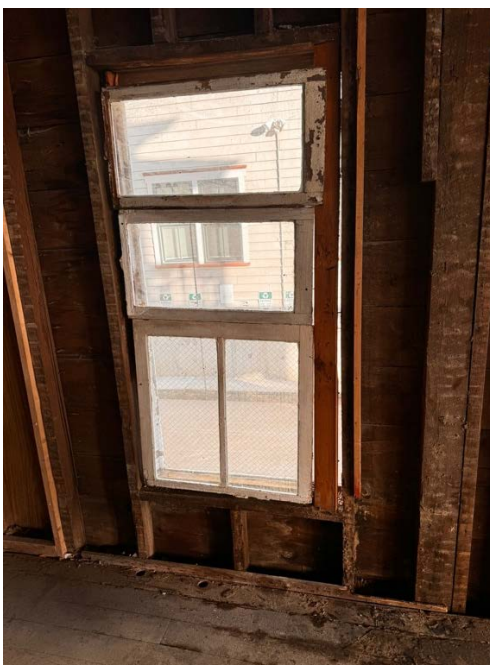
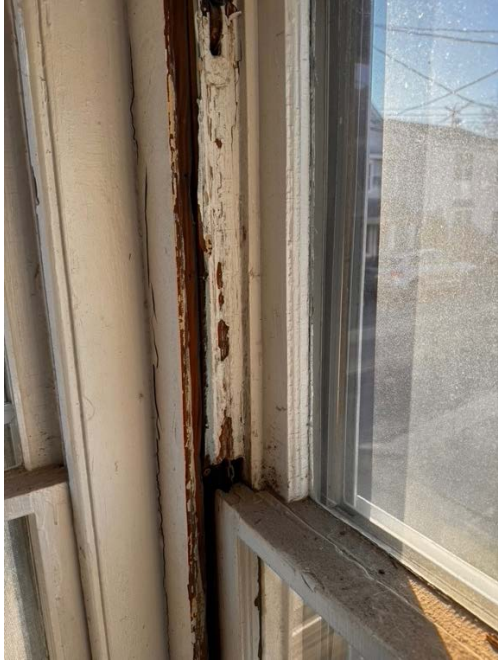
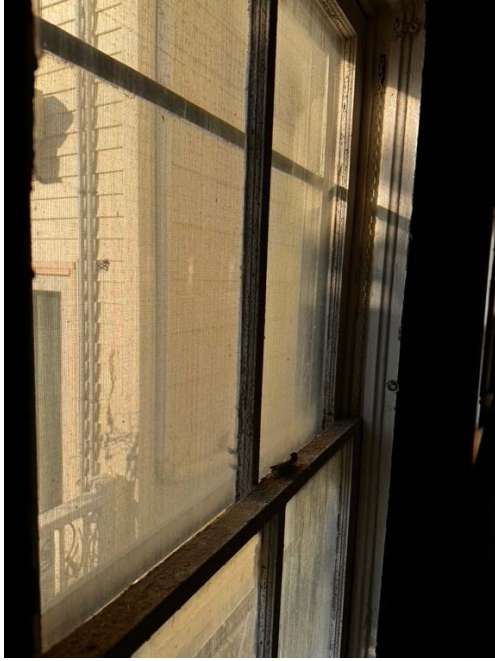
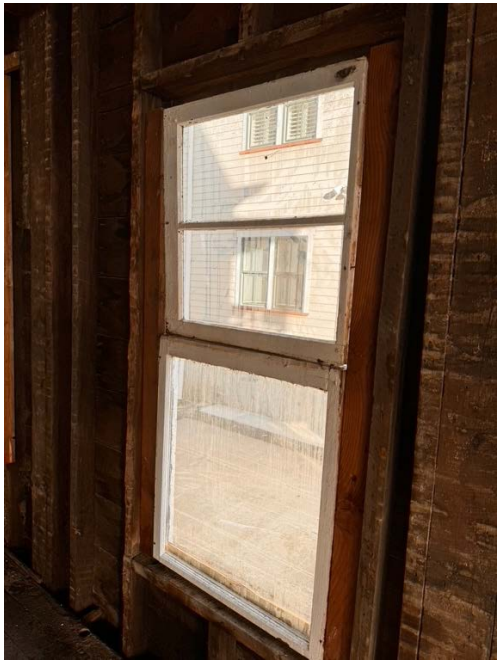
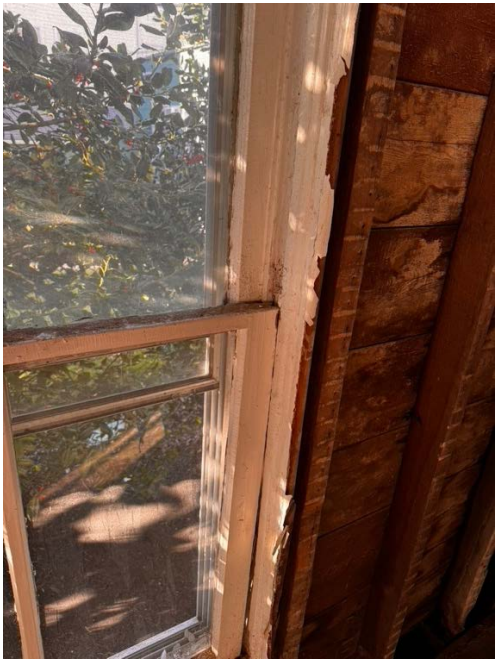
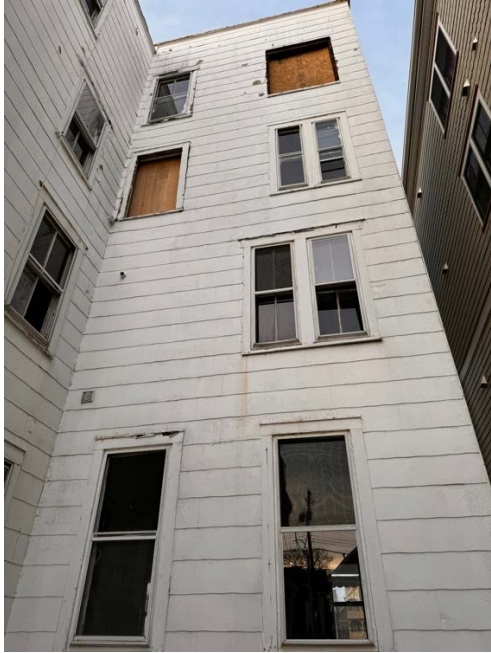
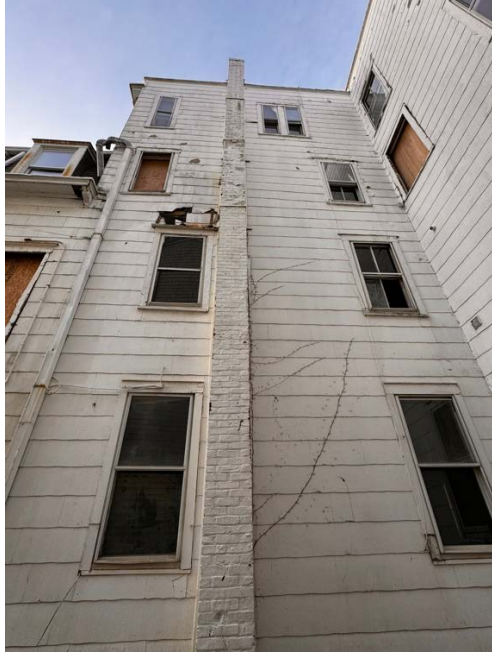
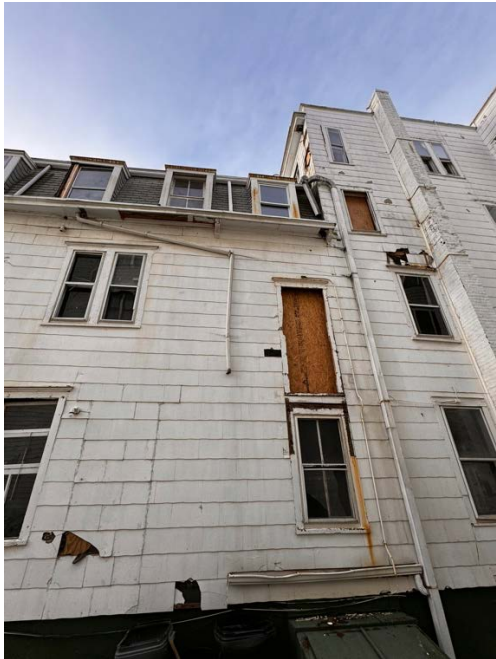
We inspected each of the other fenestration and found them to be in an advanced state of deterioration. Windows sashes were in pieces, rotted, missing components. Muntins showed evidence of being bowed and distorted due to water and weather damage, splintered, dry-rotted, and in many cases, missing completely.

The window cases/frames were falling apart, water-damaged, patched together with scrap wood in many places, and in all instances, were deteriorated beyond repair.

Of the 116 windows inspected, all are in very poor condition; none are salvageable or restorable. The inspectors deemed a complete photographic inventory unnecessary since the degree of deterioration is adequately conveyed by the following few photographs, which are representative of the whole.

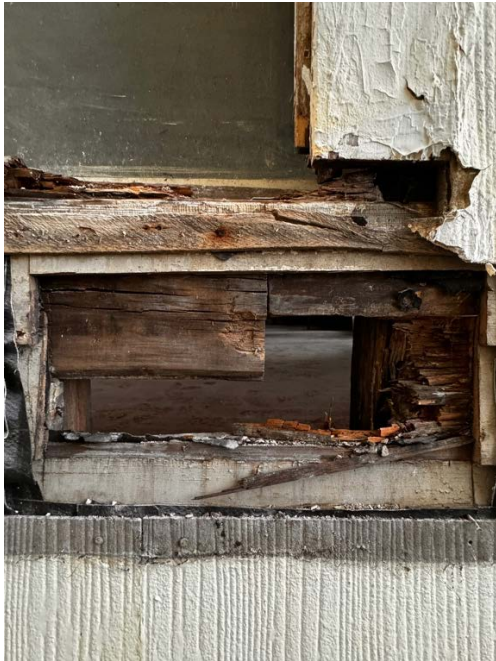
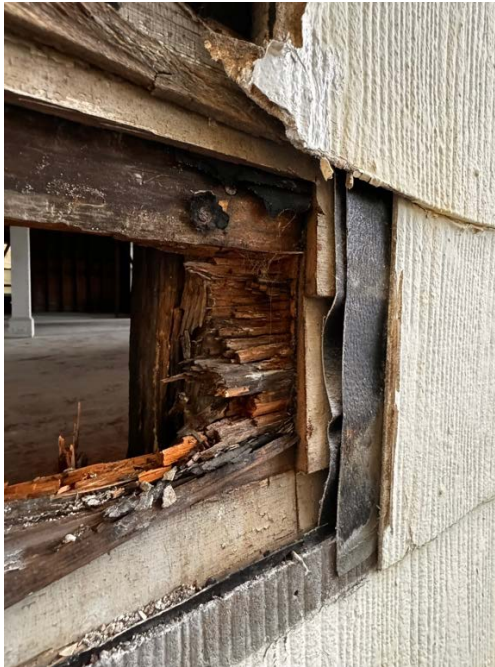
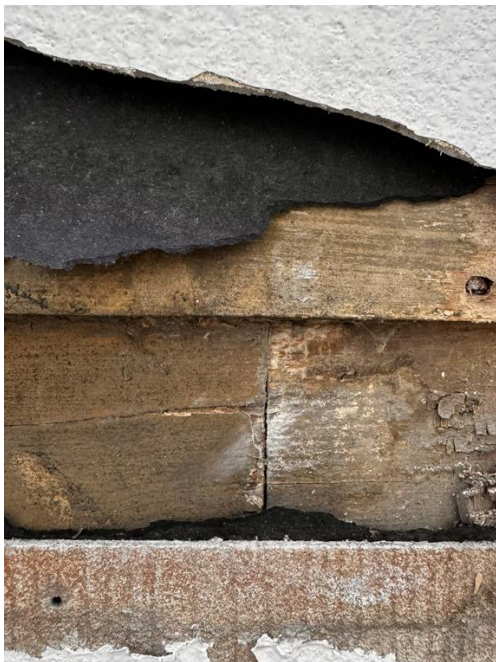
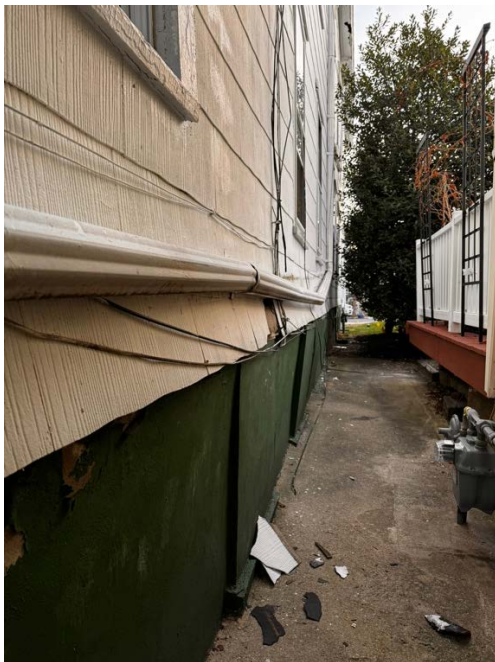
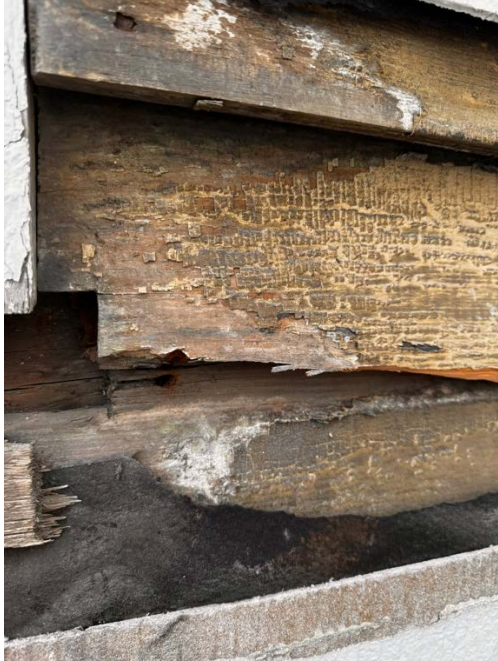
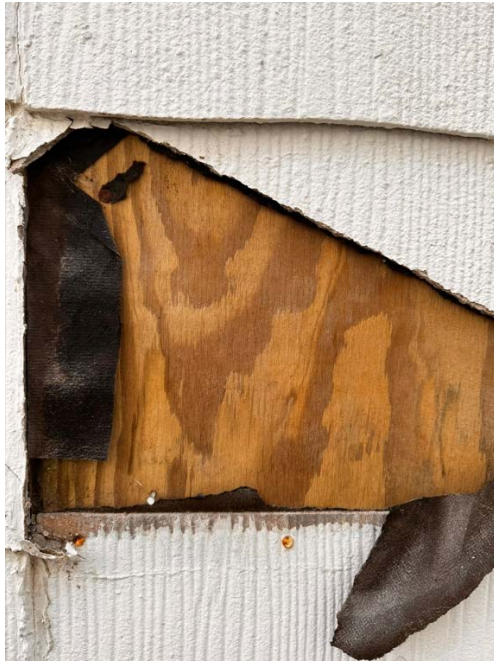
Siding

Exterior ceramic tile siding had been removed on all facades to reveal underlying cladding. In a number of locations there was no evidence of clapboard at all, only in-fill lumber. Where wooden clapboard was visible, it exhibited signs of extreme wear and deterioration, with cupping, bowing, splintering, and cracks throughout. In certain unshielded areas the clapboard was spongy and showed signs of dry-rot. Of particular note, the conditions UNDER the existing clap showed pervasive rot and deterioration (see first photos under “Siding”)
