HPC Site Inspection — 07 June 2023
140 Broadway, Window Inspection
Deborah Ospechuk, & Jeffery Rudell

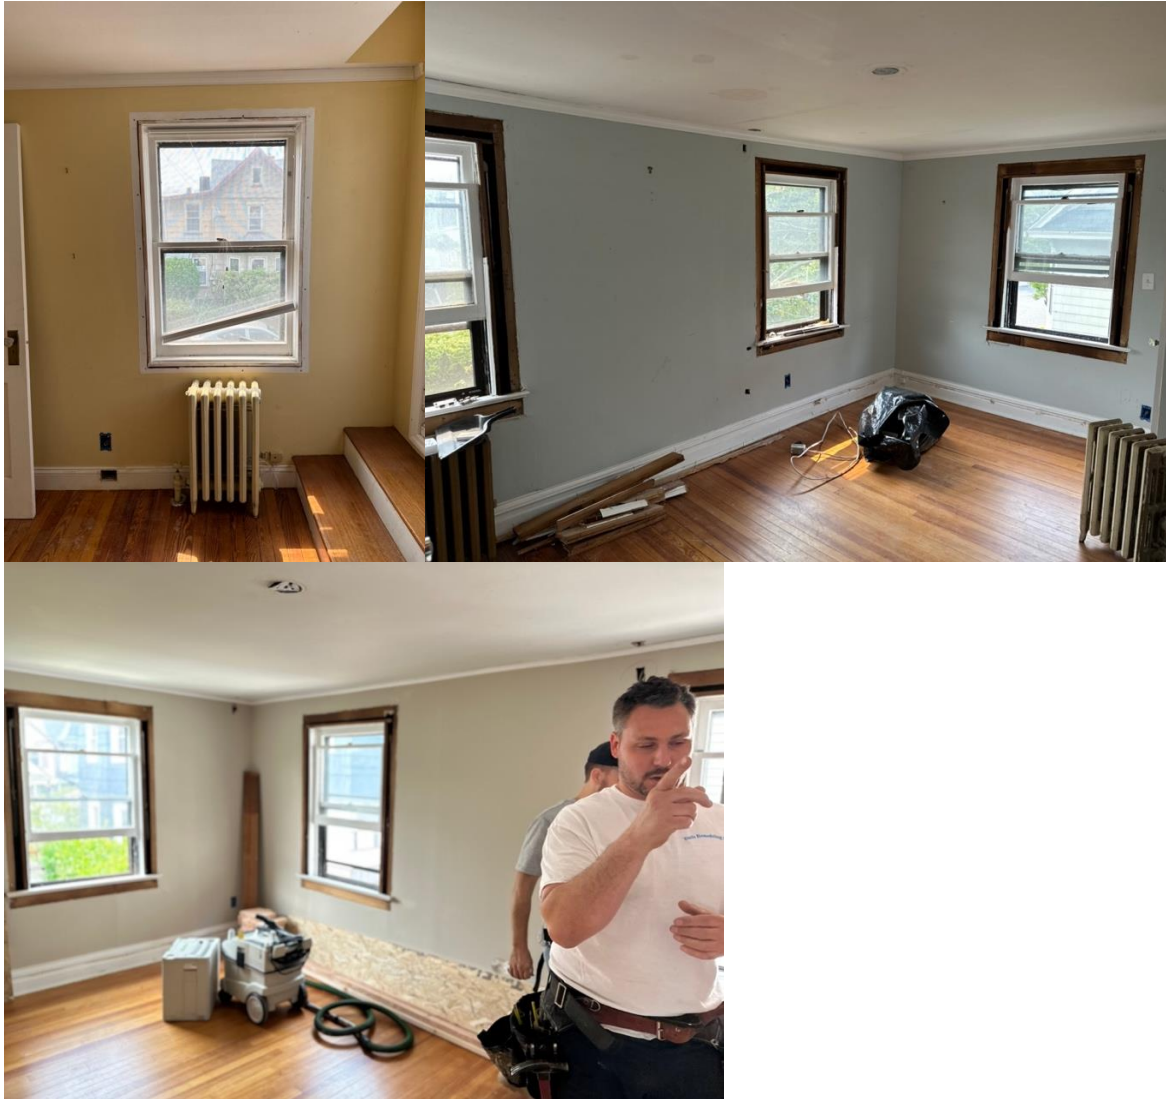
Second Floor Windows

Windows on the 2nd floor had sashes that were in good condition. A some windows had loose stops and a few showed water damage and deterioration at the inner sills.

Findings: All twelve windows appeared to be in fair to good condition and are candidates for restoration. Some windows were painted shut and could not be closely inspected, but based on the condition of the material we saw, we recommend all existing windows be retained.

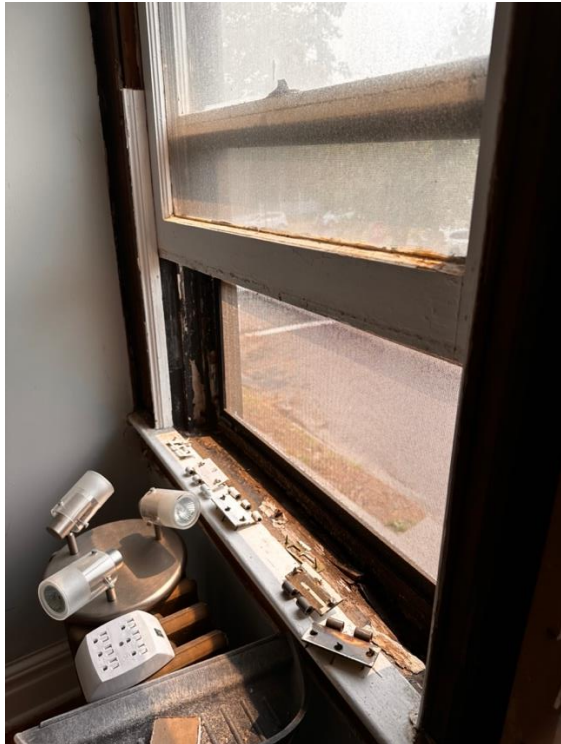
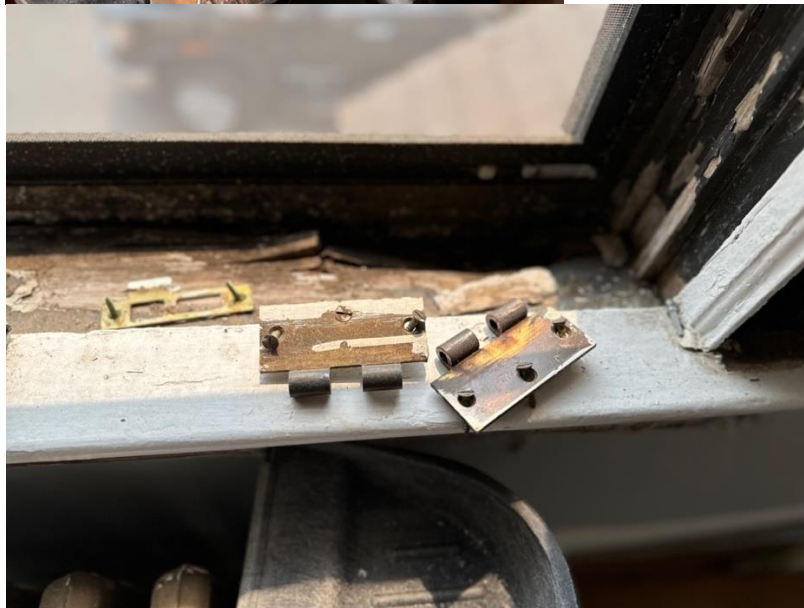
Windows are in need of stripping and sanding and conditioning but did not appear rotted or beyond restoration.

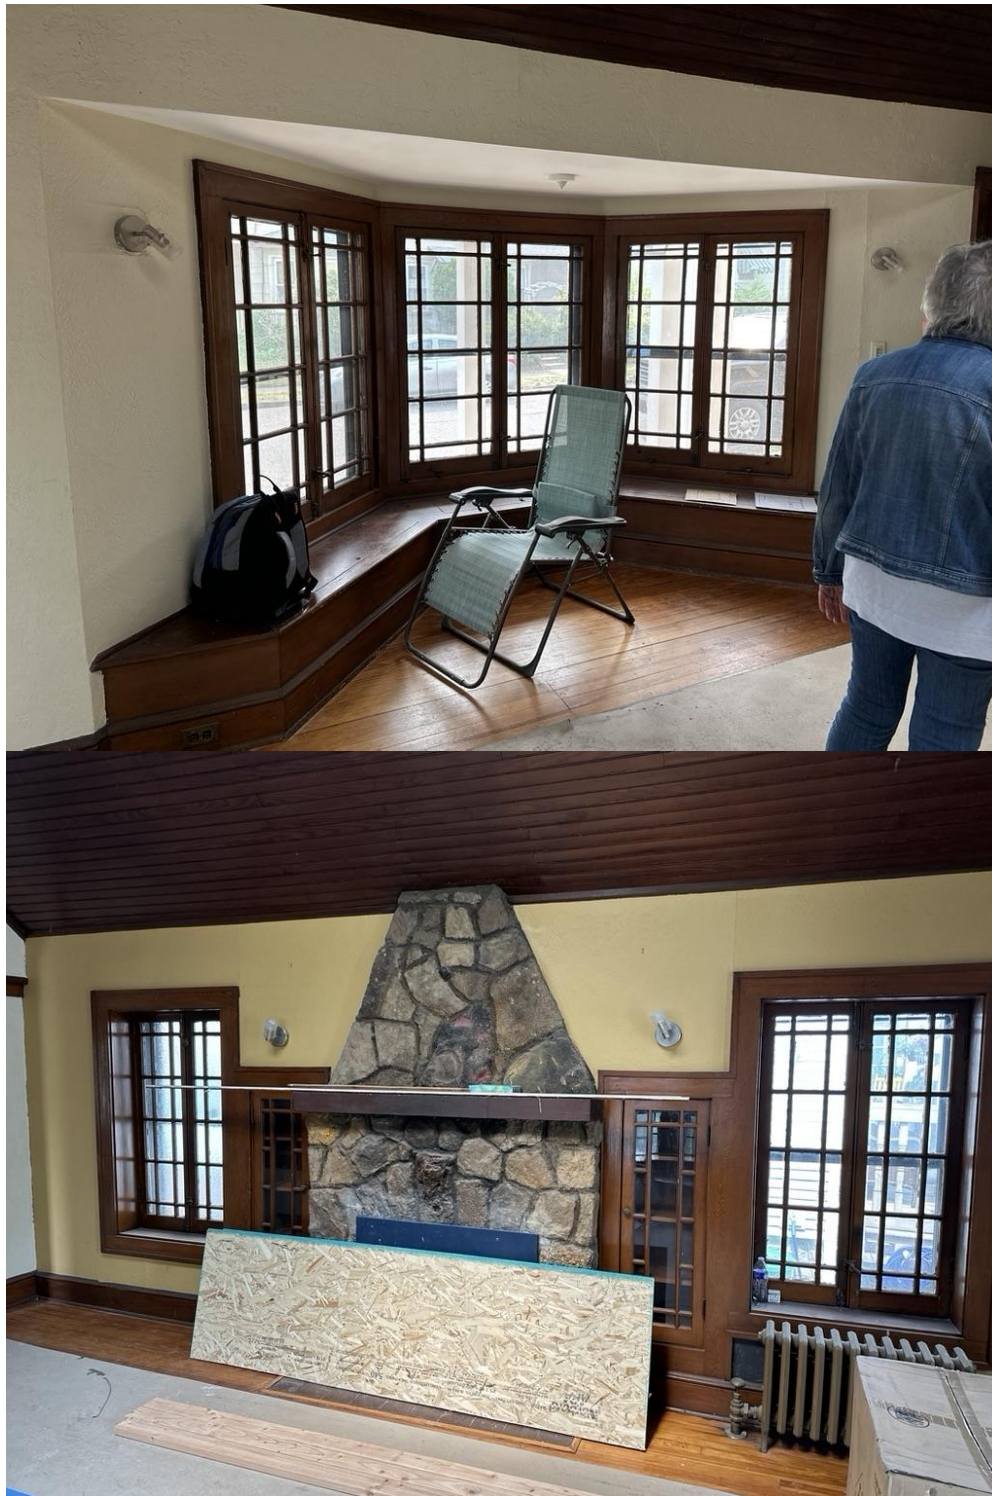
Windows in the front of the house are original and have distinctive patterning. See below.
