18 Embury Ave. Condition Report

7 October 2022

Joe Wierzbinsky and Jenny Shaffer

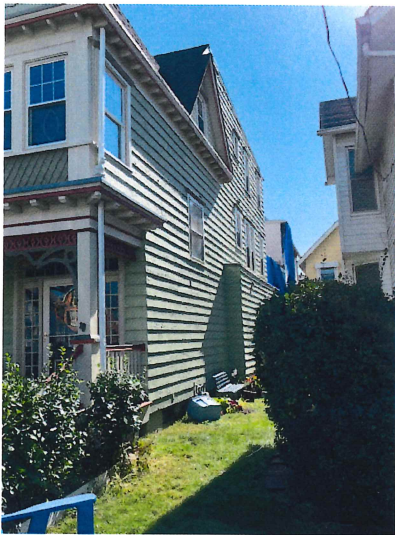
- The clapboard on the west and south elevations (with the exception of the lower third of the south wall) is in poor condition.
- The rest of the clapboard on the house is generally in good condition, with some in good to excellent condition, particularly on the first and second floors on the north and east elevations that are under the wrap porch.

west elevation damaged clapboard

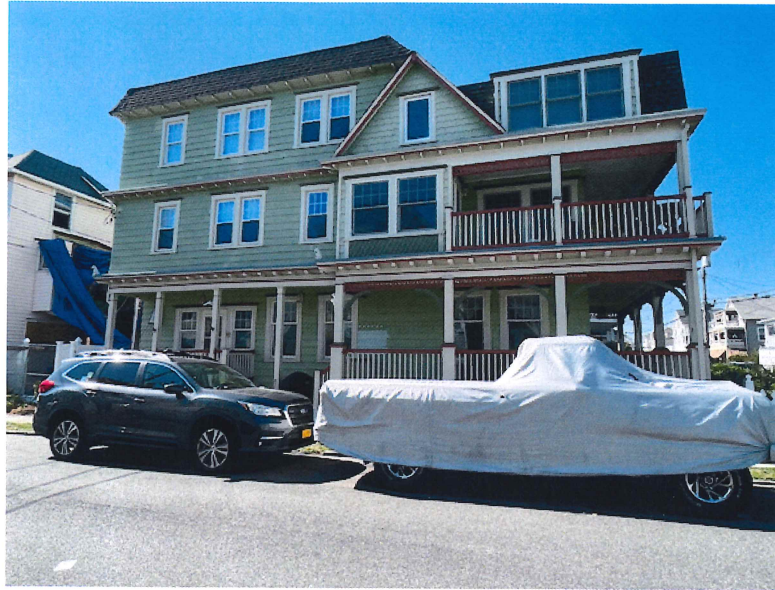
east elevation (note gable from nineteenth-century building, three story addition to south with false mansard on east side only, and third-floor, gambrel addition to north); note some peeling paint and irregular board on second and third floor clap to the rear

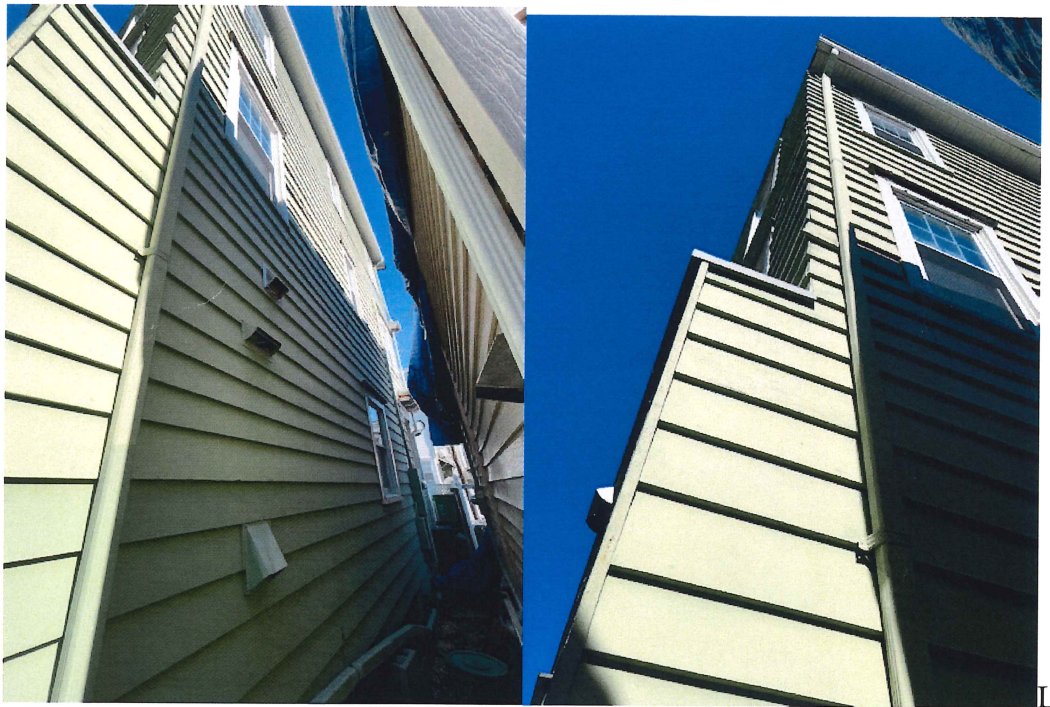
lower south wall of replaced clap; upper south wall with compromised clap
