140 Broadway Condition Report: Windows
16 June 2023
Jenny Shaffer and Kurt Cavano

NOTE: This report supplements a prior window inspection carried out on 7 June 2023 by Deborah Ospechuk and Jeffery Rudell. The current inspection verified the general conditions of the windows described in the earlier report. This report includes as well a discussion of the roof per the applicant's request.

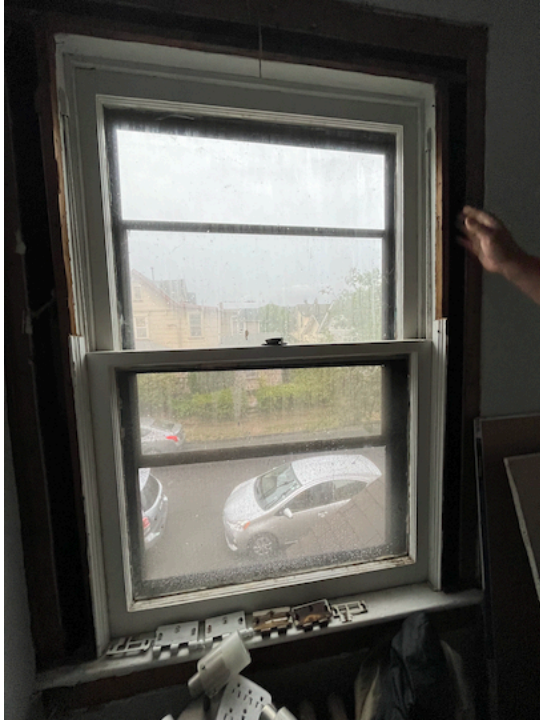
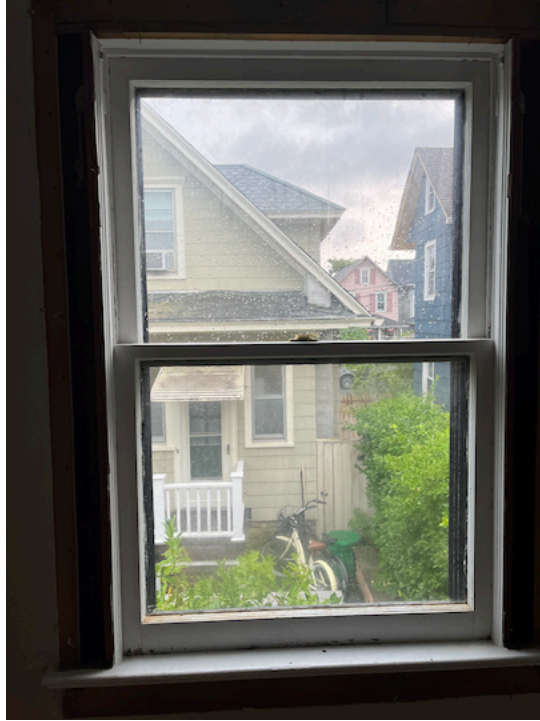
- The applicant directed us to look at windows in the rear, two story portion of the house: in the three upstairs rooms and in the bedroom in the southwest corner of the first floor (note that the first floor windows were difficult to see because the room was being drywalled)
- The windows all are wood 1/1s with original sash weights
- They appear to date from around the mid-twentieth century, probably around the 1950s
- This is supported by the paste-over in the 1930s Sanborn map, which shows a later addition to the rear of the Craftsman bungalow
- The windows sashes are generally in good condition
- Most of the sills are in fair to good condition, though some are rotted in spots due to leaks

examples of second-floor windows

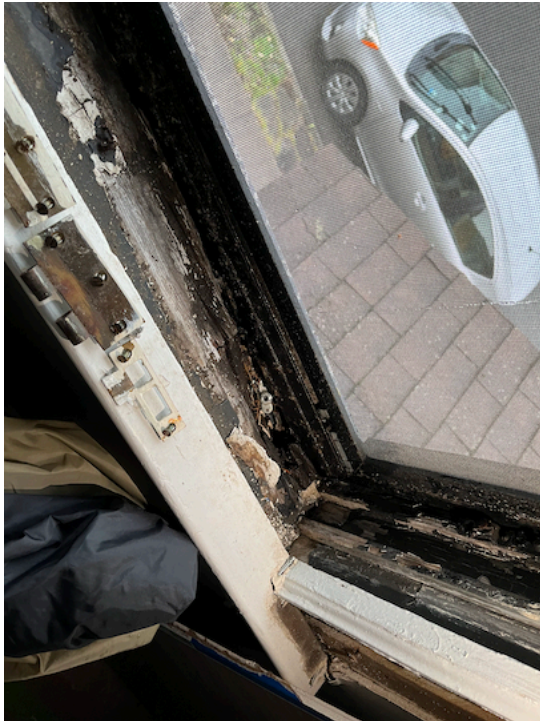
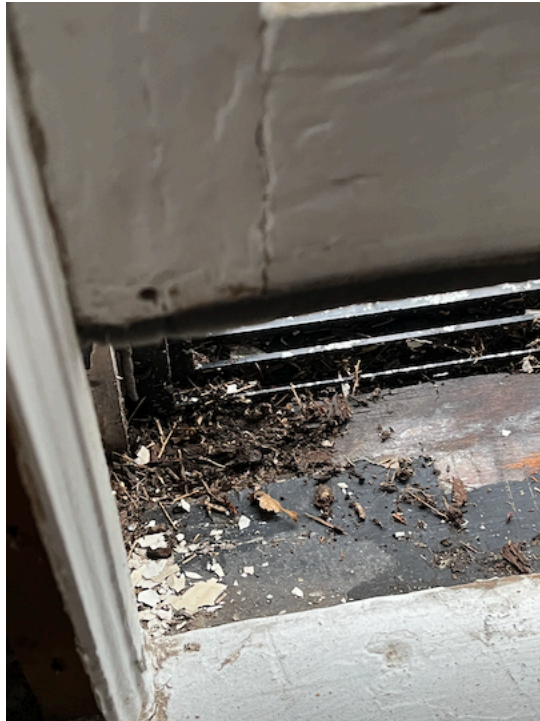
rot in sills of two second-floor windows

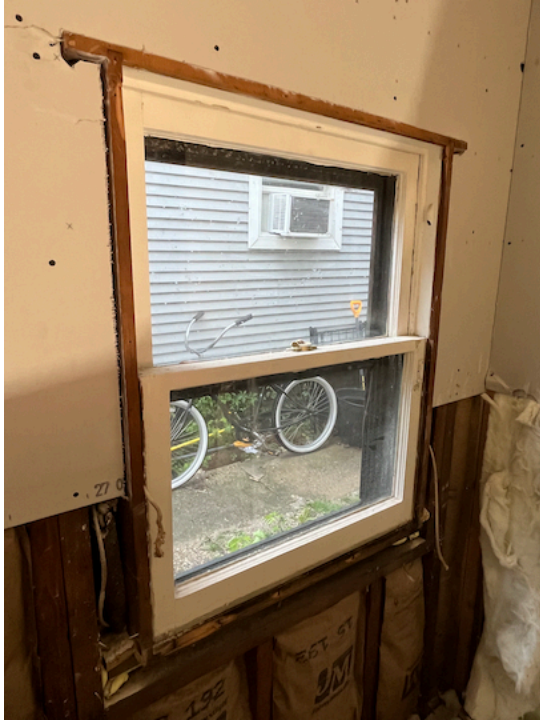
example of first floor window in bedroom in southwest corner

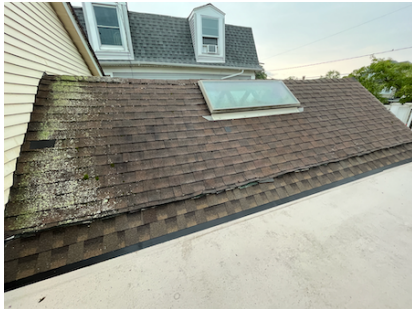
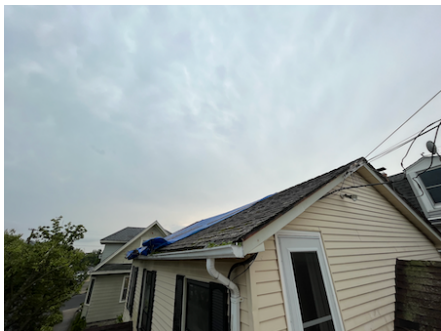
- The brown shingle roof is in poor condition, with about a third of the back section of the house under a tarp because of leaks
- Shingles are breaking and rotting in the front section of the roof.
