76 Mount Tabor Condition Report: Siding, Doors, and Windows

20 December 2023

Jenny Shaffer and Kurt Cavano

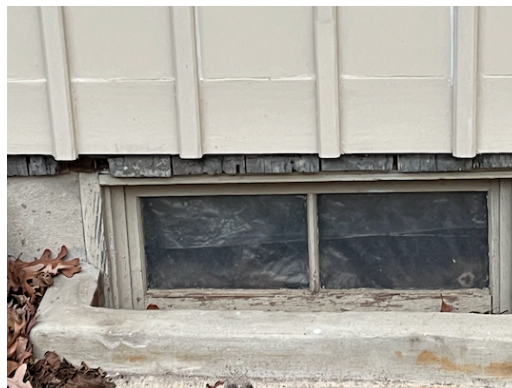
- The wood siding dates ca. 2009 and is in good condition; deterioration is visible in places.
- This siding was applied directly over historic board and batten that is in very poor condition; this historic siding peeks out below the newer siding on the rear/south elevation of the building.

south elevation with newer board and batten on top of deteriorated board and batten

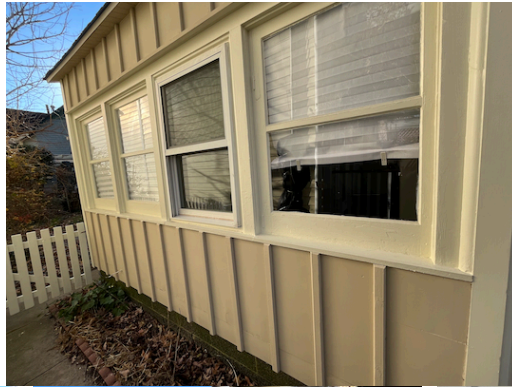
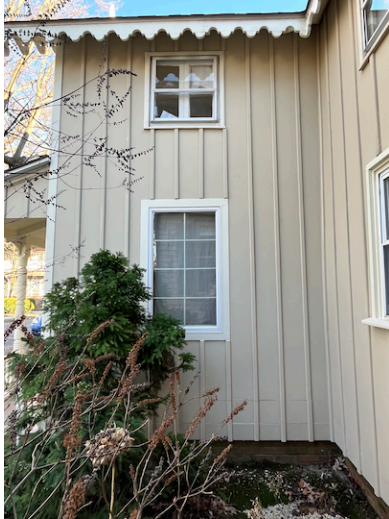
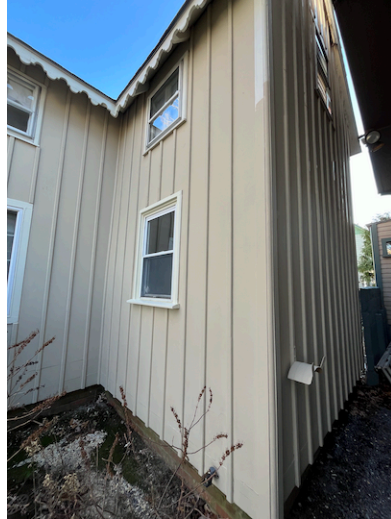
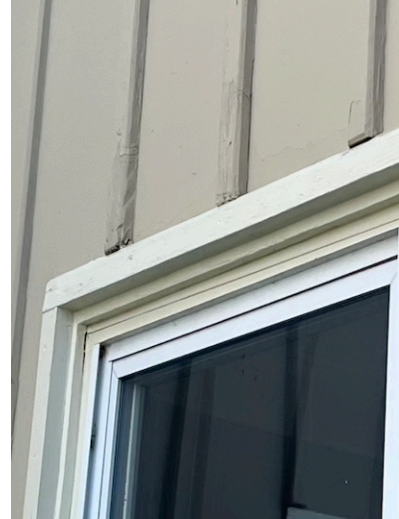
northwest corner elevations/damage above first-floor, north-facing window

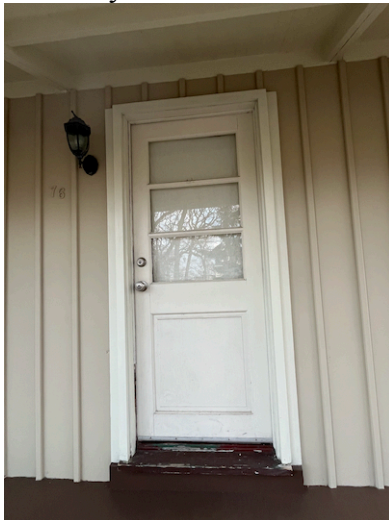
front door

Doors: The front and back doors are wood, in good condition, of different configurations, and relatively modern in date.

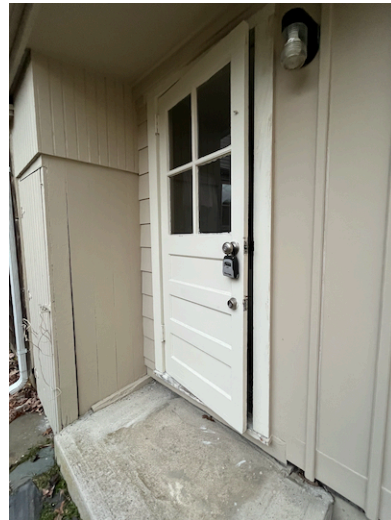
back door (this entry will be lost in the partial demo)

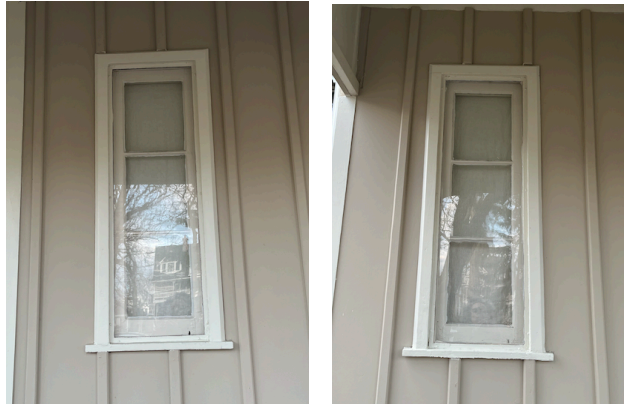
- The applicant proposes to retain only the two historic windows flanking the front door.

windows to east and west of front door

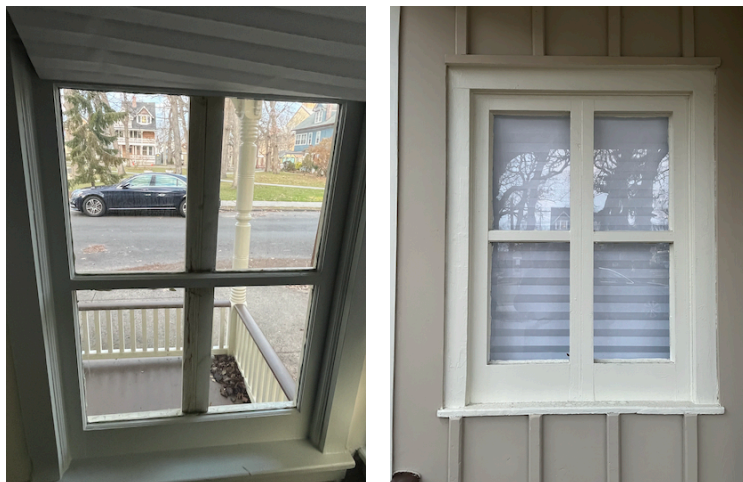
- There are older wood windows (and one replacement window) on the north and west elevations where the wrap porch was enclosed at some point after 1930.
 - The wood windows in fair to good condition, but are almost all fixed in place and thus inoperable.
 - They perhaps were inserted at different times, given their slightly different sizes.

single window facing north appears to be a casement to the exterior and a 1/1 on the interior, both fixed in place.

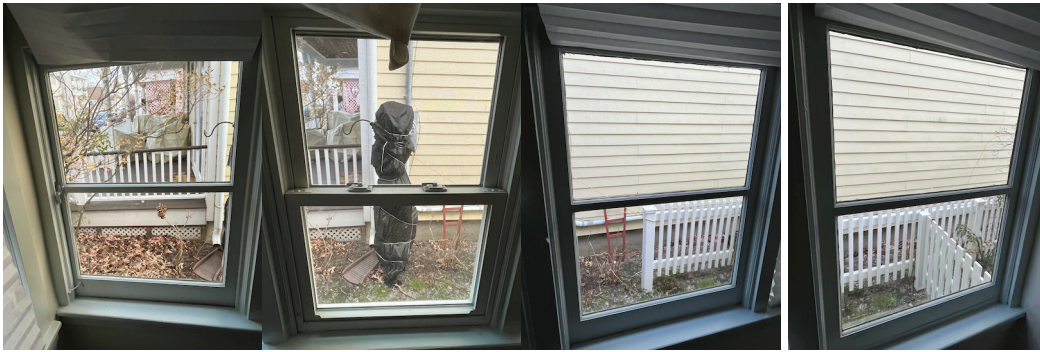
The bank of 4 windows on the west wall are wood (except for the second from the left, an operable replacement window) and fixed in place, except for the window at the far left, which may tilt out, but that is unclear

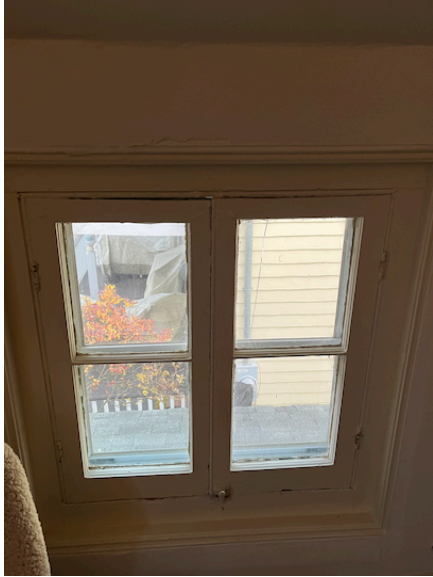
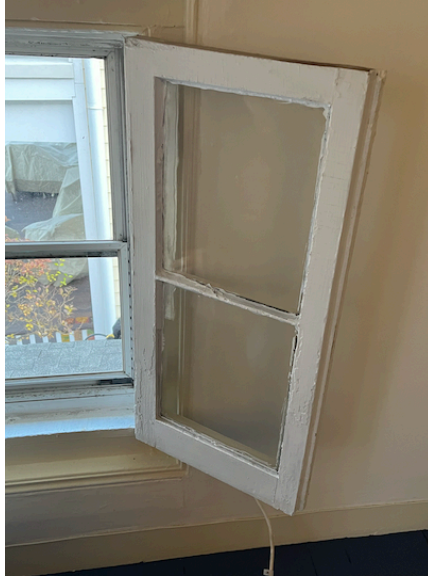
#203

- The second-floor windows are a mix of primarily historic French casements and modern replacement windows.
- The 6 historic wood windows that the applicant proposes to replace are shown below and follow the numbering system in the application.
- The historic windows are small in size and of an unusual form for Ocean Grove.
- They are in poor condition: They seem fragile, have been painted many times (including their hardware) making them difficult to operate, and the muntins and glazing compound are deteriorated.

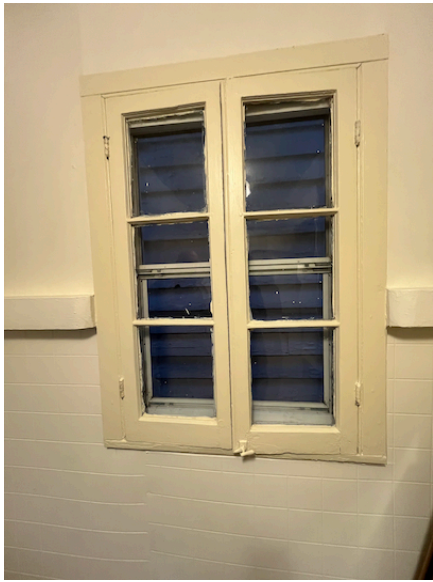
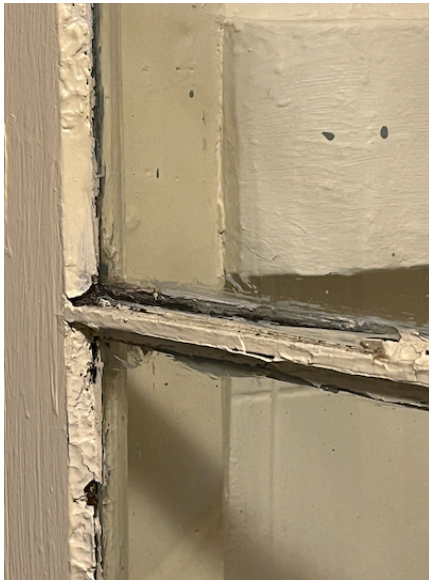
#209 and detail of muntin (too close to neighbor to take exterior photo)

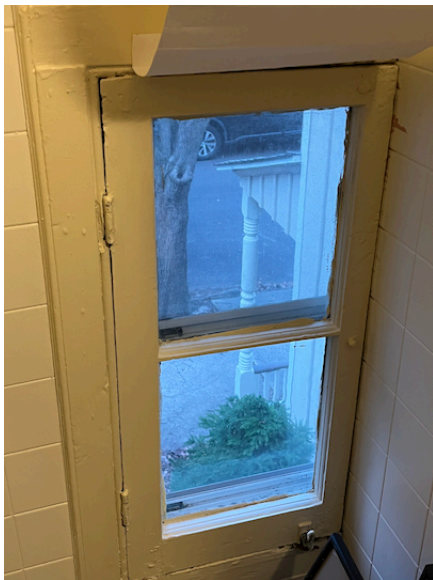
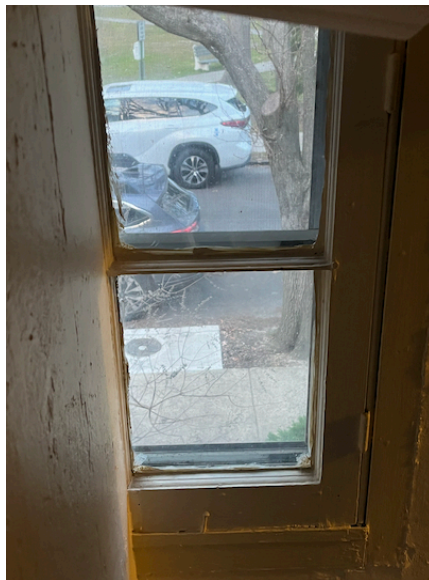
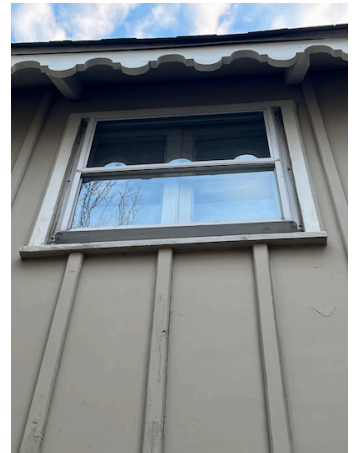
#210 (bisected in interior by a thin wall)
