78 Broadway: Siding and Windows  
3 December 2023  
Jenny Shaffer and Kurt Cavano

NOTE: There was a previous window inspection on 6 June 22.

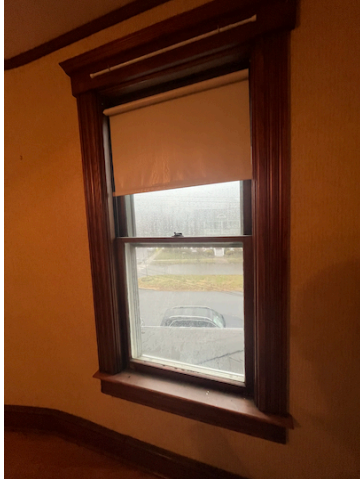
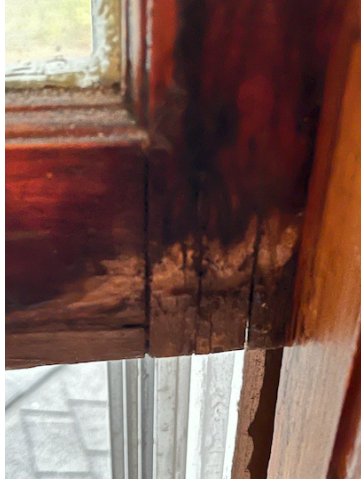
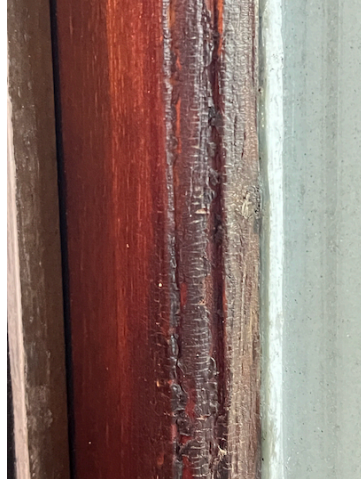
1. **Windows 1-1, 1-2, 2-9, 3-1, and 3-2 confirmed as vinyl replacement windows.**
2. **Windows 2-1 through 2-8 and 2-10 are old/historic double-hung windows.**
  - All are 1/1s with chains.
  - All are operational and generally open and close readily.
  - All are in similar fair to good condition.
  - All are repairable, but show similar issues:
    - The sills and upper sashes are generally in good condition.
    - The bottom sashes exhibit effects of sustained water damage; some are split and show some rot in the lower corners.
    - Some windows do not sit properly in their openings.
    - The finish in places is bubbling.

window 2-1: view, lower left corner of bottom sash and upper sash detail

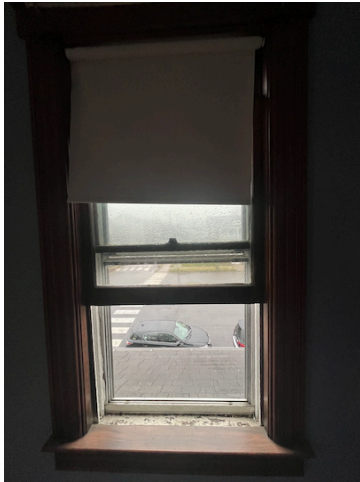
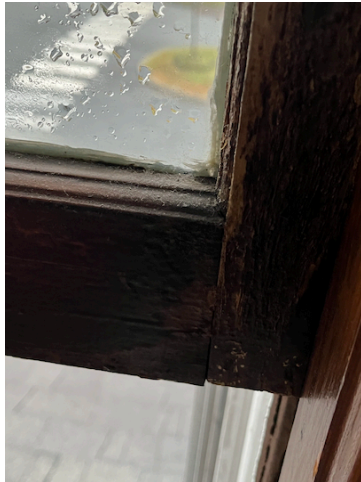
window 2-3 and detail of lower left sash

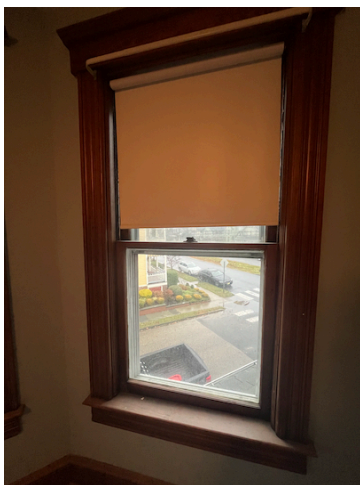
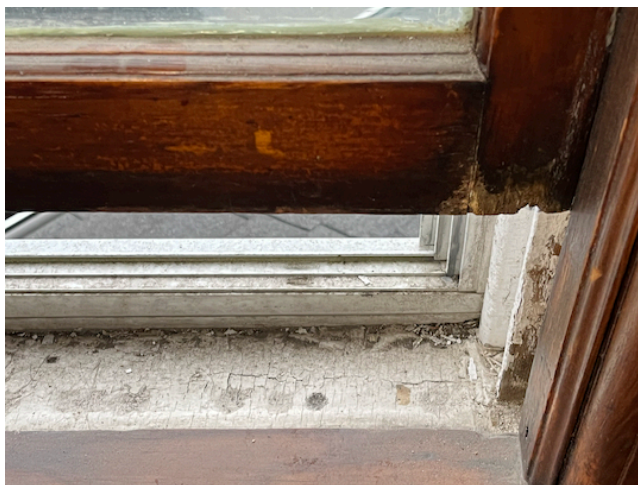
window 2-6 with detail of lower left sash (perhaps the most damaged)

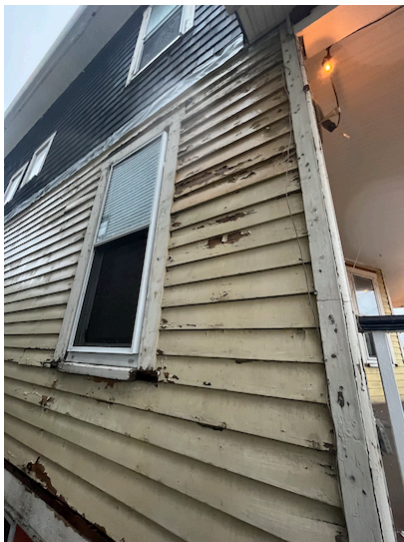
northeast corner with damaged clap;  
note cut sills/missing crowns

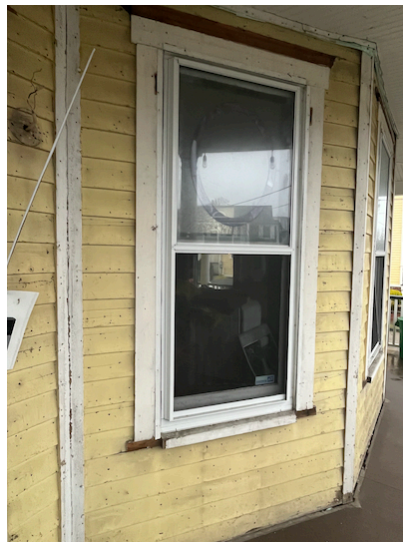
front/north elevation (note cut sills)

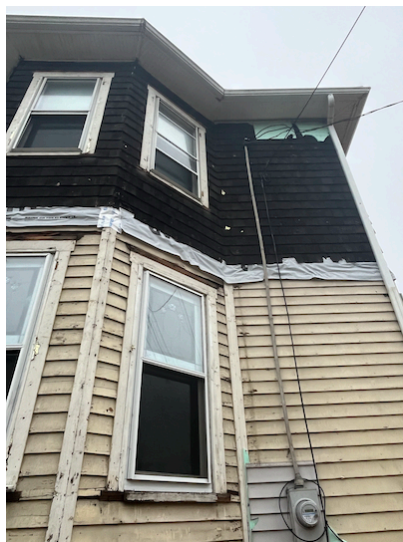
west elevation towards south;  
note damaged window surrounds
