140 Broadway (1900)

20 June 2023

Tech Review with Deborah Osepchuk, Lucinda Heinlein, and Jeffery Rudell

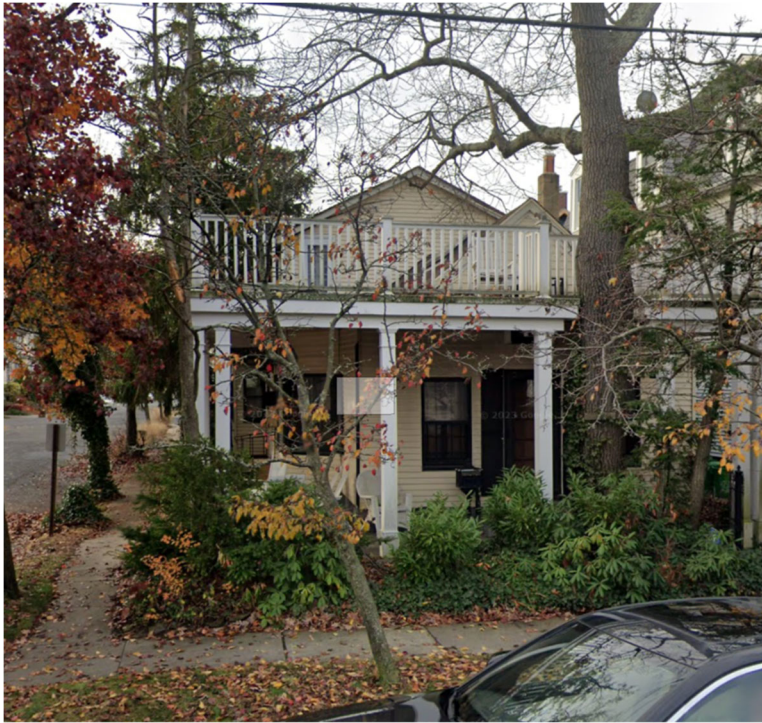
A window inspection on 7 June 2023 determined the windows are not in extreme disrepair, though there is evidence of sill-rot in areas and window pulleys and window stops may need restoration or adjustment.

This second report reiterated that the windows appear to NOT be in extreme disrepair. However, the investigators consulted Sanborn maps and determined that the windows in question MAY date from the 1950s, making them not original to the structure.

We spoke with the applicant's by Zoom and they propose bringing this application to the full Commission for a determination. If windows are determined to be causing damage to the dwelling (due to leaks, improper installation, or some other reason), AND if the windows are

deemed NOT to be original, the Commission may consider replacement of these windows with conforming new windows.
