92 Cookman Ave. Condition Report: Windows
14 August 2023
Jenny Shaffer, Jeffery Ruddell, and Scott Moyer

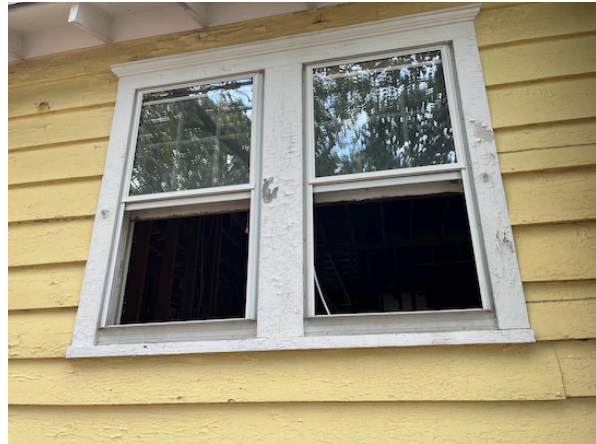
windows 3 and 4 (typical exteriors)

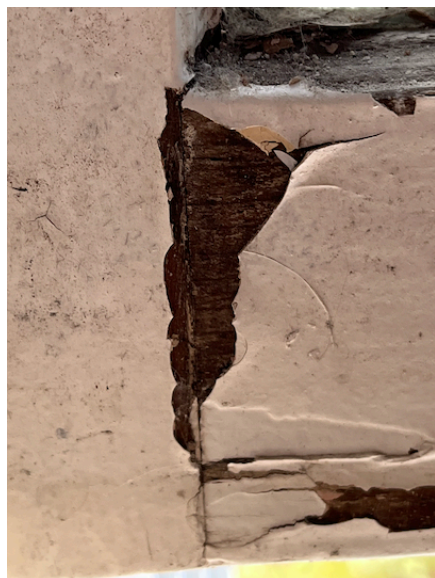
detail of typical chipped paint as on sash of 17
