- Scope of work 92 Cookman Ave
- HPC Application to remove and replace NON Historic windows from existing House and replace with Anderson 400 series True divided light windows, to match existing grill pattern.
- The existing windows were been replaced in 1951 when the house had been remodeled.
  During the 1951 renovation the scope of work looks to have been, New windows, New Siding, New doors, Fire Place, New Front steps, Side yard addition, New front porch.

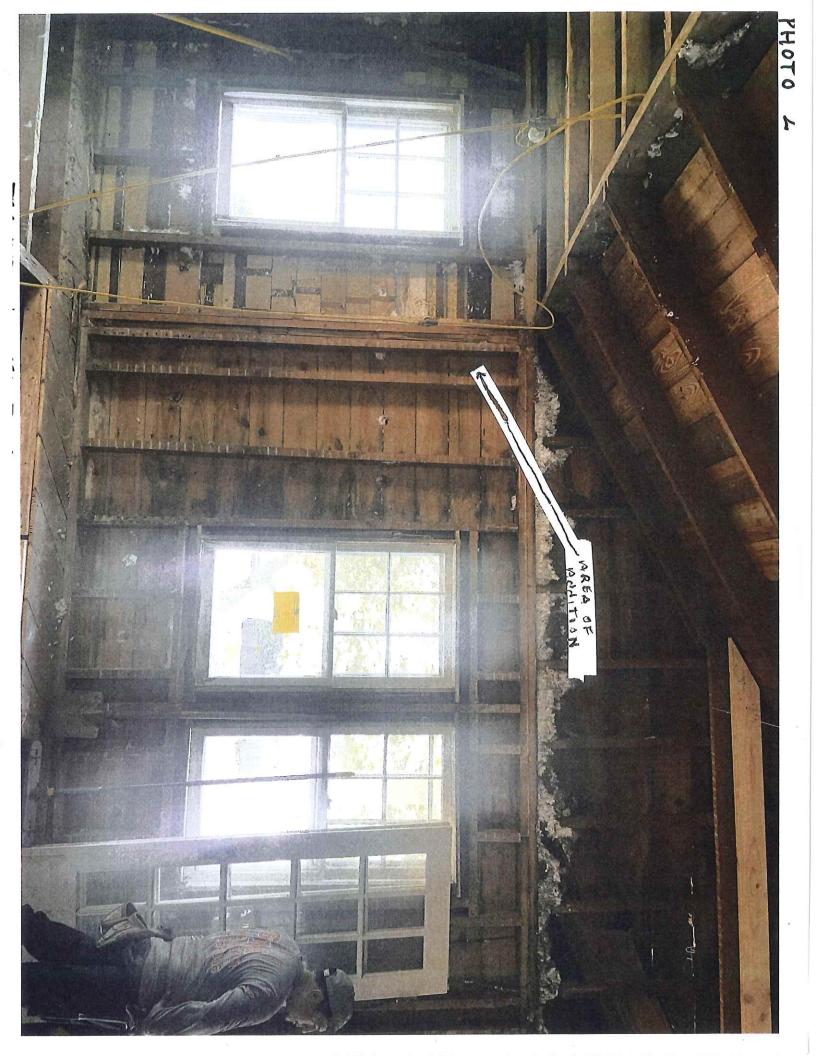
#### Photo 1-

This shows the area of addition. From the outside there are no seams in the siding. This is evidence that the siding was replaced after the addition was added.

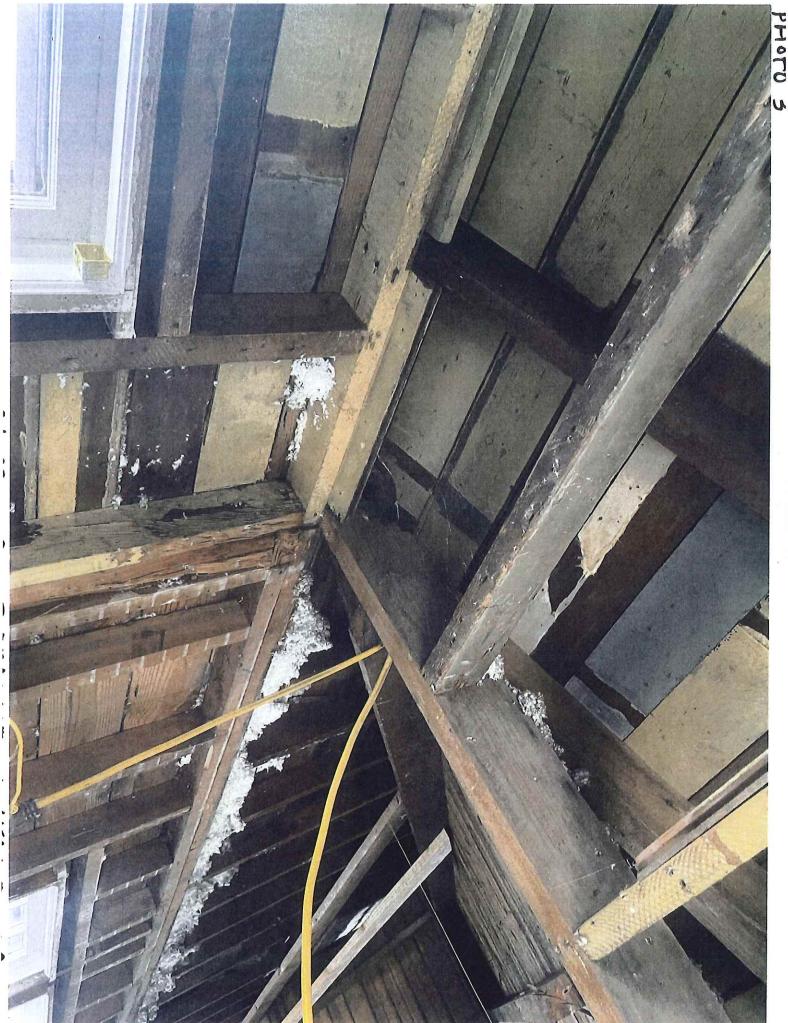
## - Photo 2

This shows an interior photo of where the original house was added on to. See the original sheathing boards are wood colored and the add-on has reclaimed painted boards.

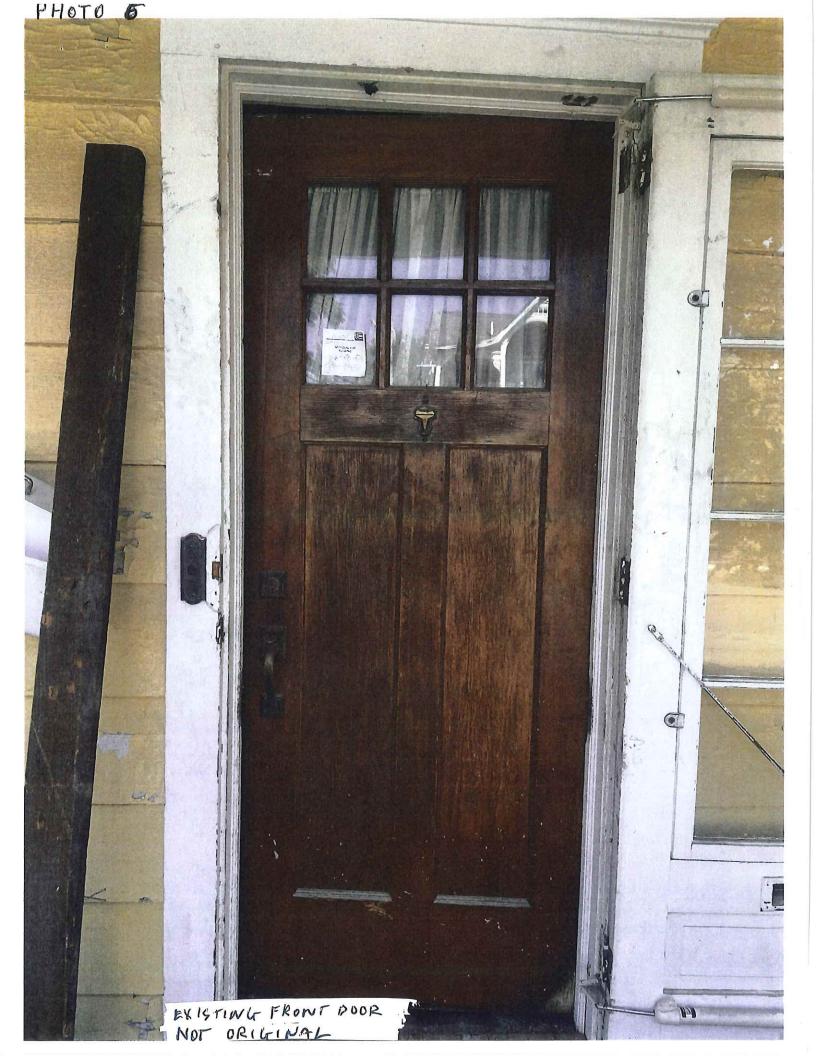
# - Photo 5

This photo show the method of installation for the front door. The photo shows that the original floor sheathing has been cut away to install the existing door. This is common when the door being used, to replace ,is larger that the original opening. Typically in 1919 the door heights would varry. In 1950-current day we use standard sizing. The Existing front door is a standard height 6'8". We have also found a door on the rear of the house that has a more appropriate door style and grill pattern for the area of this house.
