# **92 Cookman Avenue Window Assessment Report**

92 Cookman Avenue, Ocean Grove, New Jersey  
Block #262, Lot #5

**The Architect's Studio**

October 16, 2023

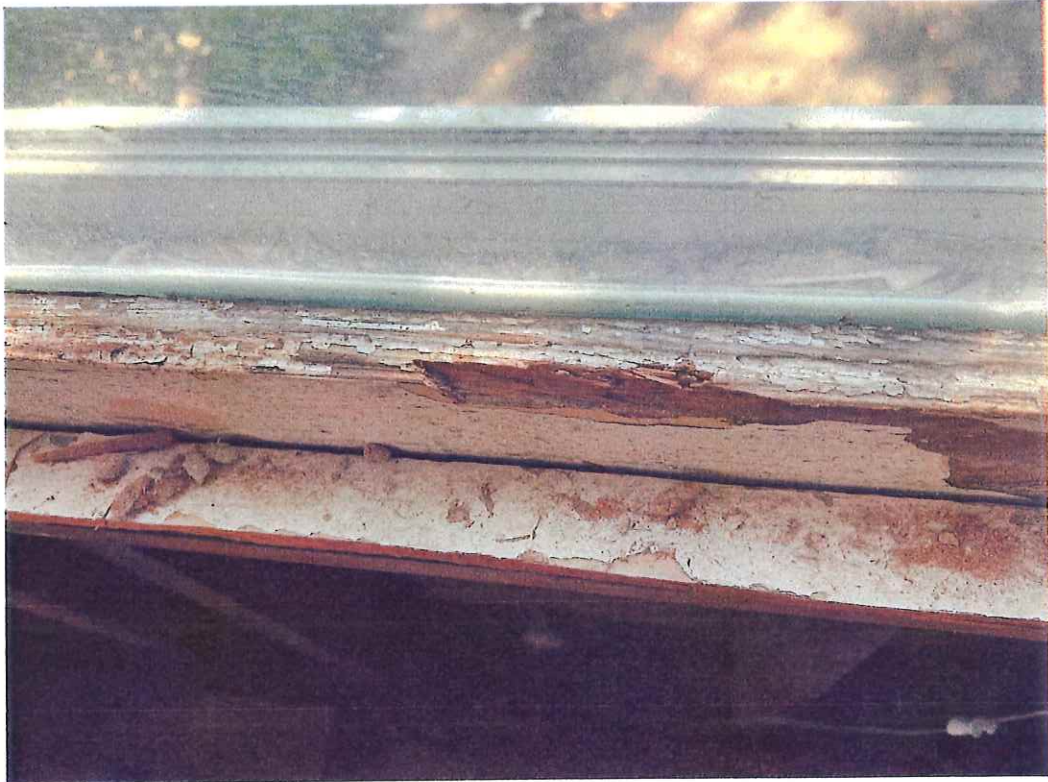
TYPICAL INTERIOR WOOD SASH CONDITIONS

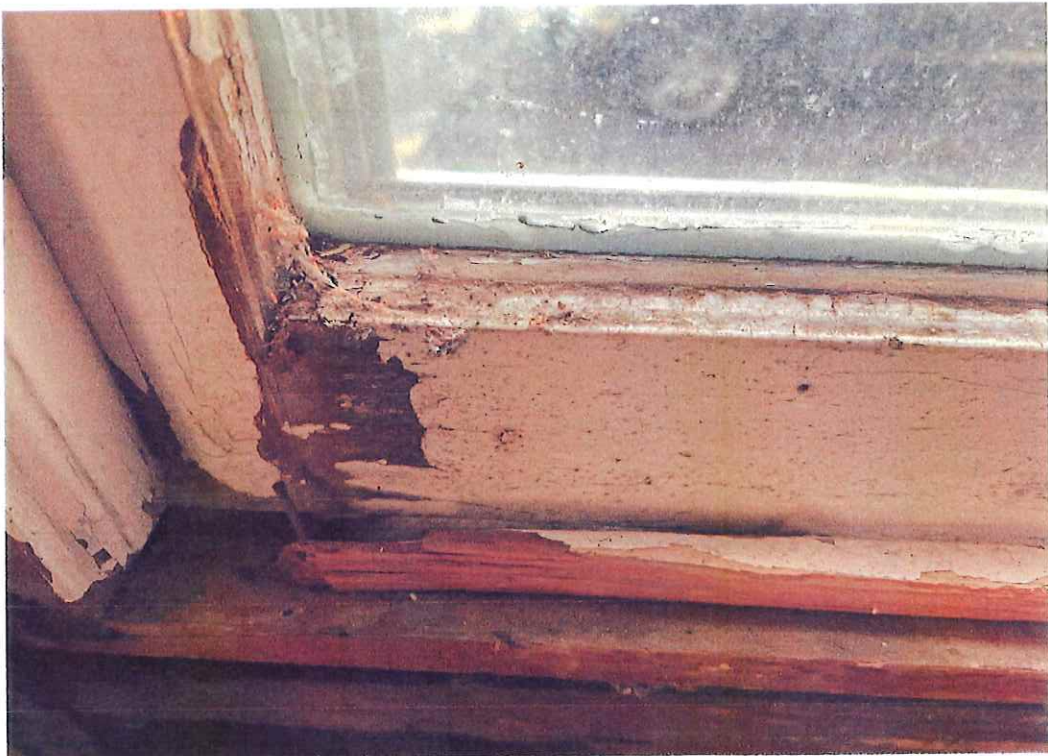
NOTED USE OF EXPOSED NAILS TO SECURE WINDOWS WITHIN JAMBS

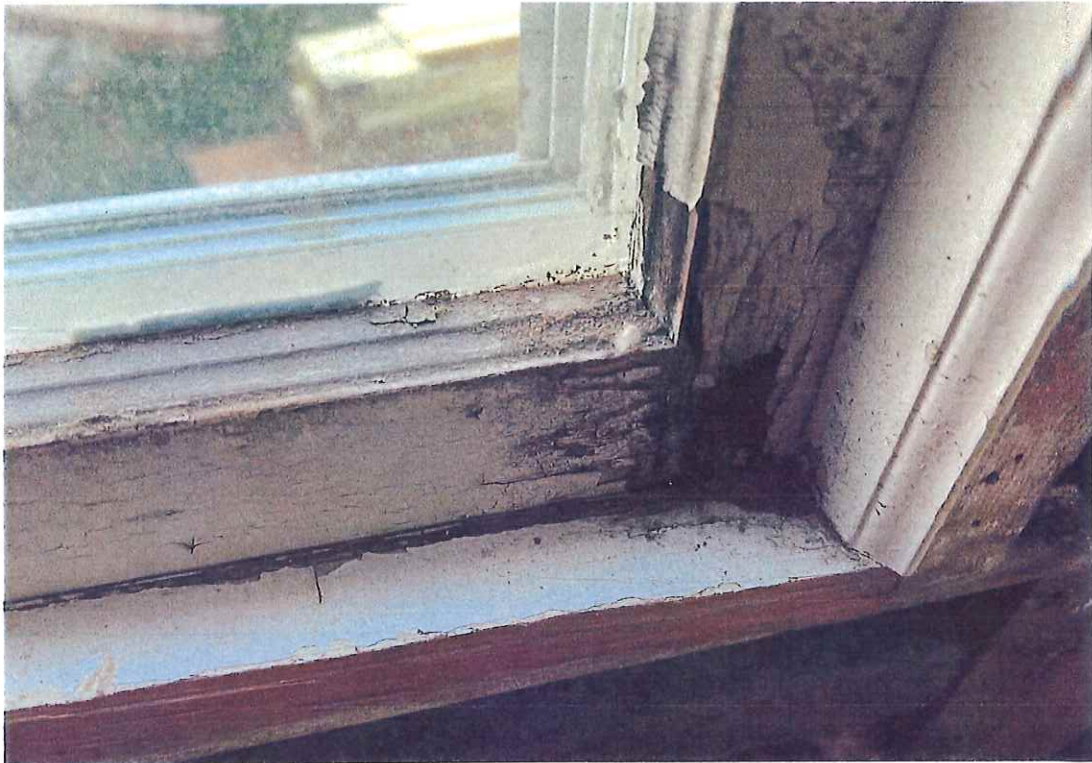
**TYPICAL LOWER CORNER SASH WATER DAMAGED CONDITIONS**

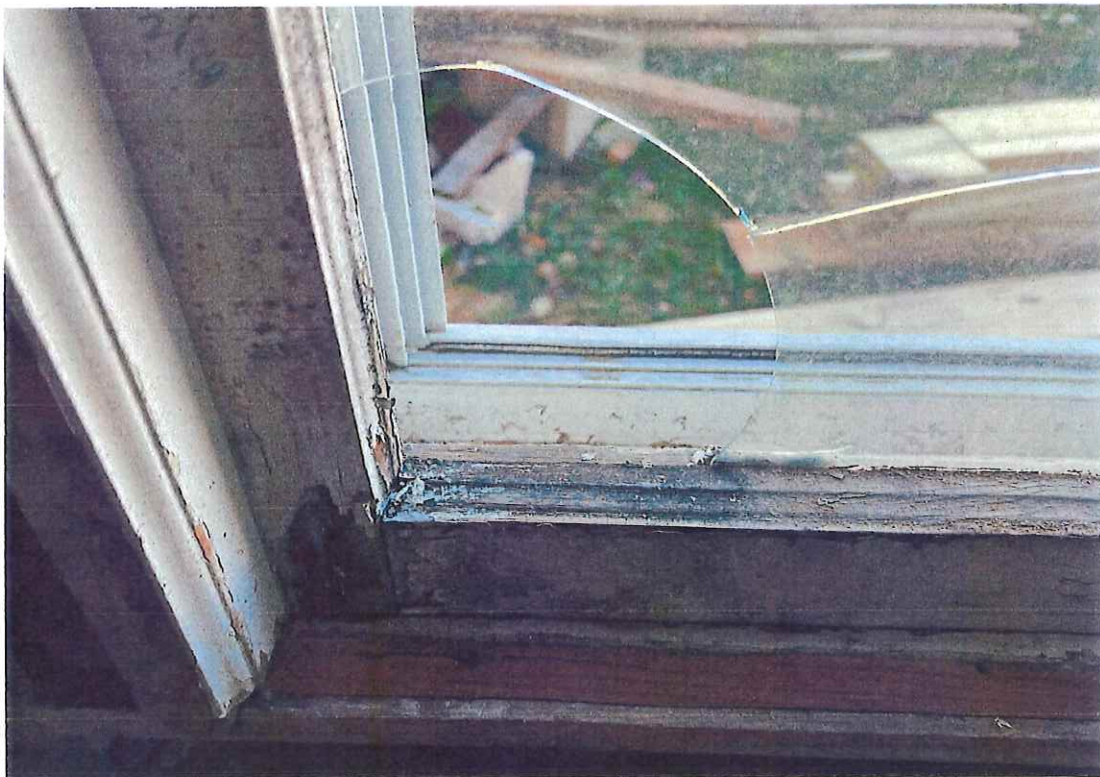
**INTEGRITY OF SASH WOOD FIBERS AND CORNER JOINTS FULLY COMPROMISED**

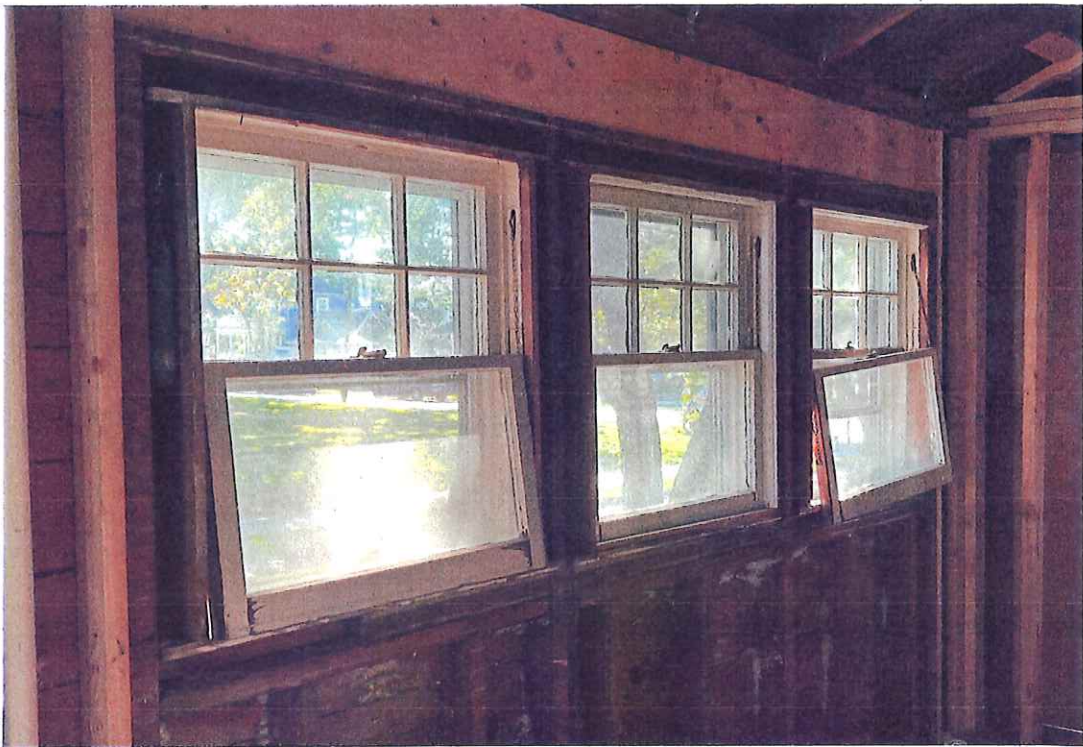
EVIDENCE THAT EXISTING WINDOWS WERE REPLACED WITHIN LARGER OPENINGS

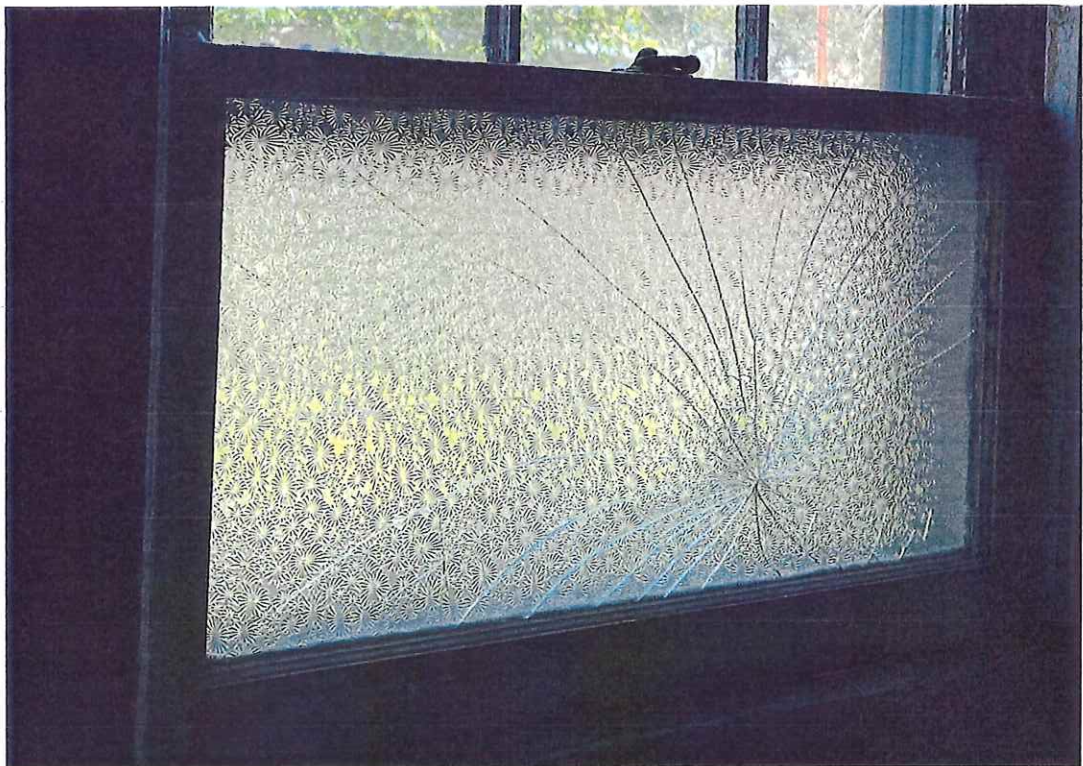
EVIDENCE OF BROKEN AND NON-ORIGINAL GLASS IN VARIOUS WINDOWS

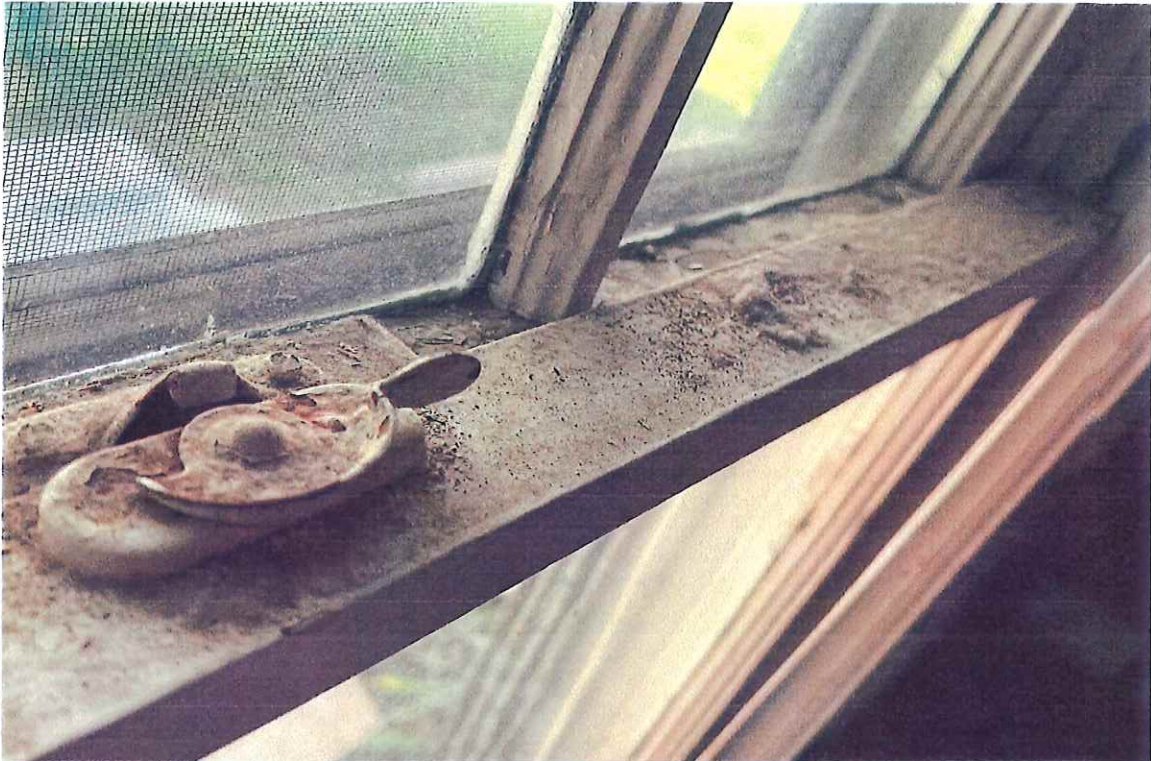
**SASH MEETING RAILS ARE TYPICALLY MISALIGNED DUE TO DEFORMITY AND DEFECTS**

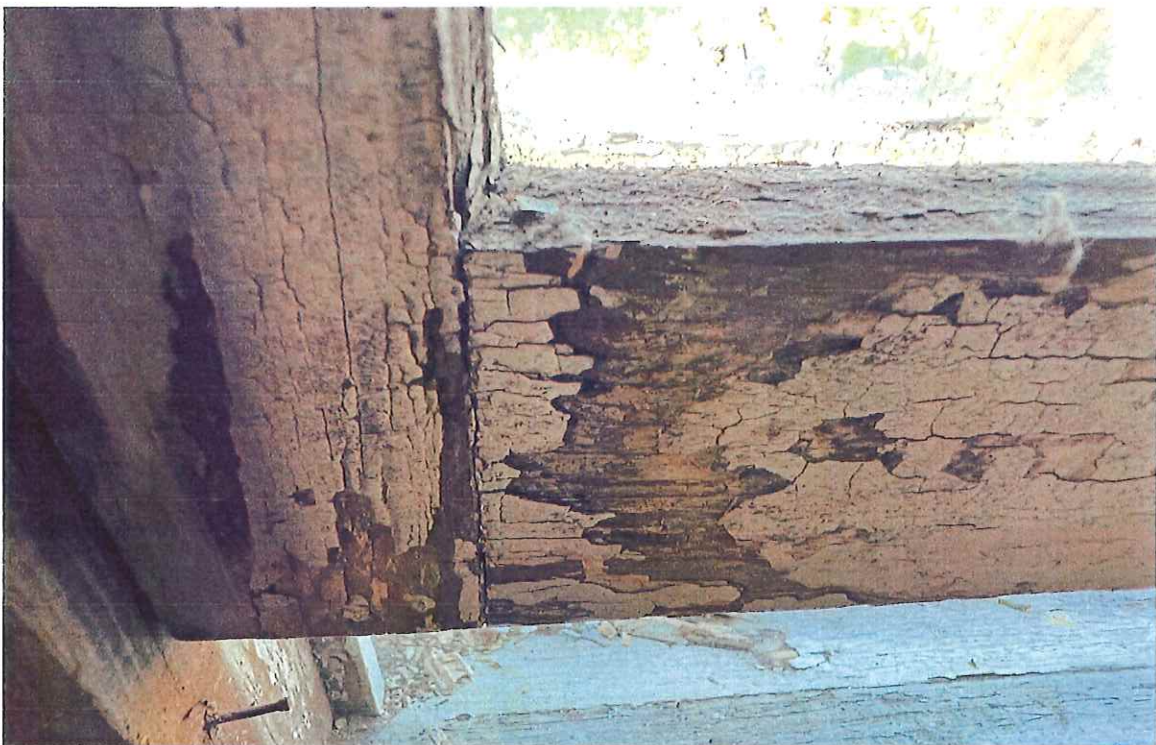
**WINDOWS SASH AND FRAME HAVE BEEN PERMEATED WITH MOLD, FOUND TO BE SEVERELY COMPROMISED FROM WATER DAMAGE AND GENERALLY INOPERABLE WITH MISSING, RUSTED AND BROKEN HARDWARE**
