FACTS

AS BUILT - FLOOD WATER DAMAGES WOOD CONSTRUCTION

REASONS FOR CODE COMPLIANCE AND LIFT TO EL 13.25

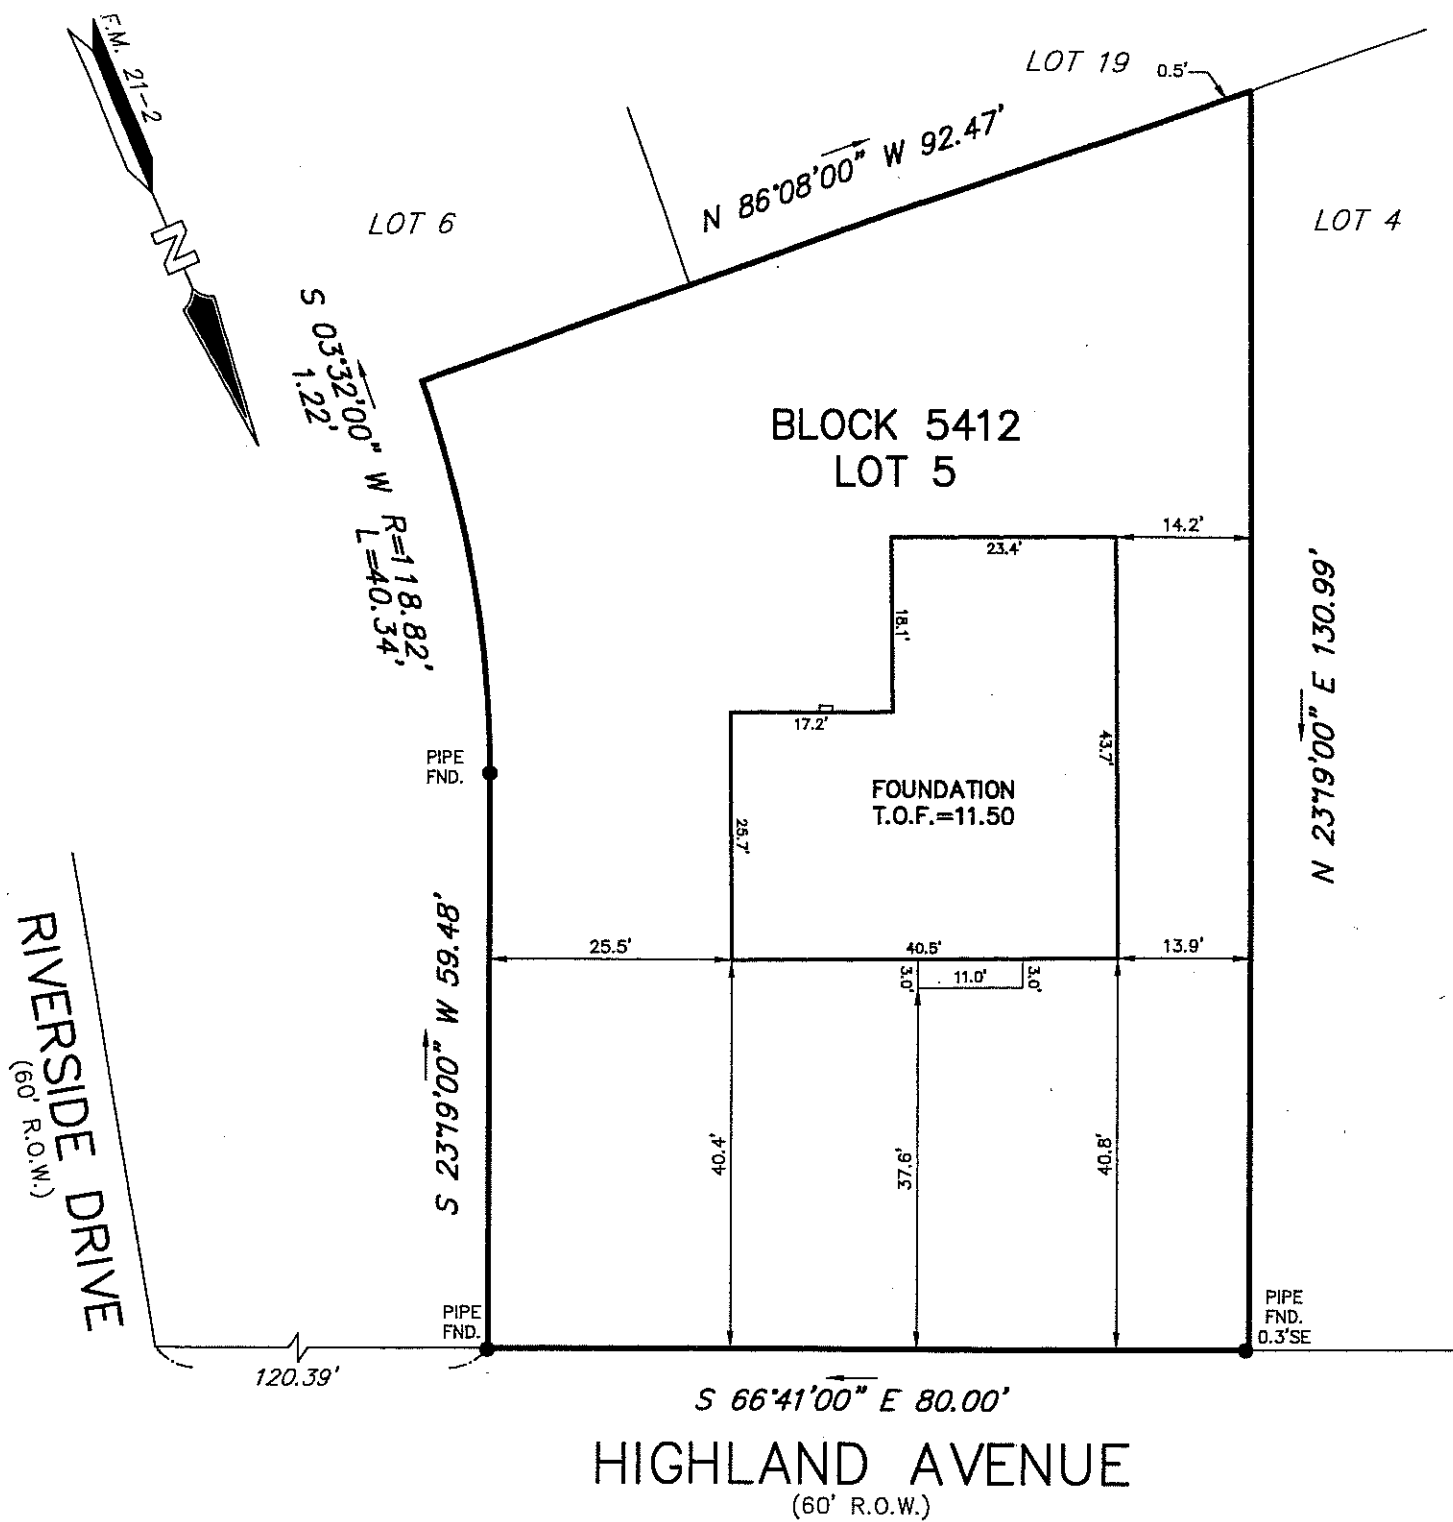
- 13.25 The approved Plans specified the Finished Floor Elevation ("FFE").
- 12.50 FFE from Flood Certificate.
- 12.44 Finished floor elevation, as calculated based on existing construction and the Surmonte 04/06/16 Foundation As-Built Survey [$11.50 + 0.12 + 0.76 + 0.06 = 12.44$].
- +0.06 *plus* the 3/4-inch subfloor.
- 12.00 Neptune flood elevation. Half of the floor joist height and the floor insulation is in the flood water.
- +0.76 *plus* the 9-1/2 inches tall engineered wood floor joists that are *not treated*. Half the joist is in the flood water.
- +0.12 *plus* the only 1-1/2 inch thick sill plate.
- 11.50 Surmonte 04/06/16 Foundation As-Built Survey and top of block elevation.

- 10.83 The bottom of the 9-1/2 inch deep engineered lumber beams that are set one course of block below the top of wall. There is no evidence that the engineered beam is *treated*.
- 10.50 Bottom of insulated HVAC main duct, flex lines droop lower.
