SHORE POINT ARCHITECTURE, PA

RESPONSE TO “INCOMPLETE” ITEMS

Date: May 31, 2024
SPA Job Number: 2023-21 (Stone Residence)
Property Address: 14 Abbott Avenue, Ocean Grove (Block 247, Lot 3)

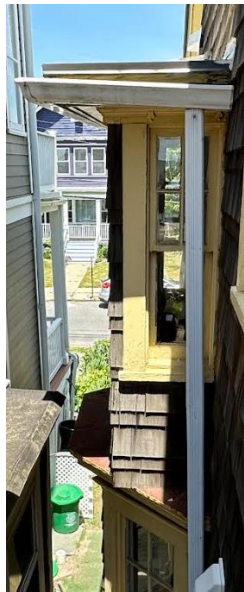
- (a) Roofing occurs between the first and second floor addition, suggesting the second floor addition occurred after the first floor addition.
- (b) Inside of the bump out (facing north) was cut in later, as shown by the clapboard in the wall.
- (c) Inside of the bump out (facing south) was cut in later, as shown by the clapboard in the wall.
- (d) Framing on flat bump out cut into existing framed wall, with sheathing and metal framed roof.

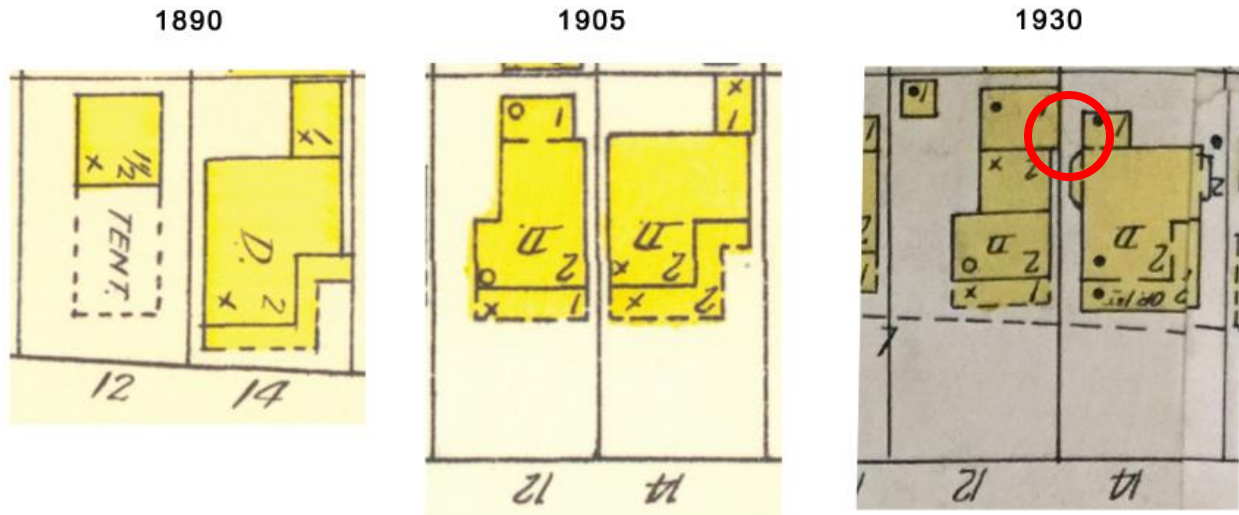
SPA Response: (a) Per the Sanborn maps provided, the Juliet balcony exists in an area that was historically an open alleyway (circled in red, below), therefore it is not original or historic. It was likely constructed when the houses were joined, sometime in the 1990's.

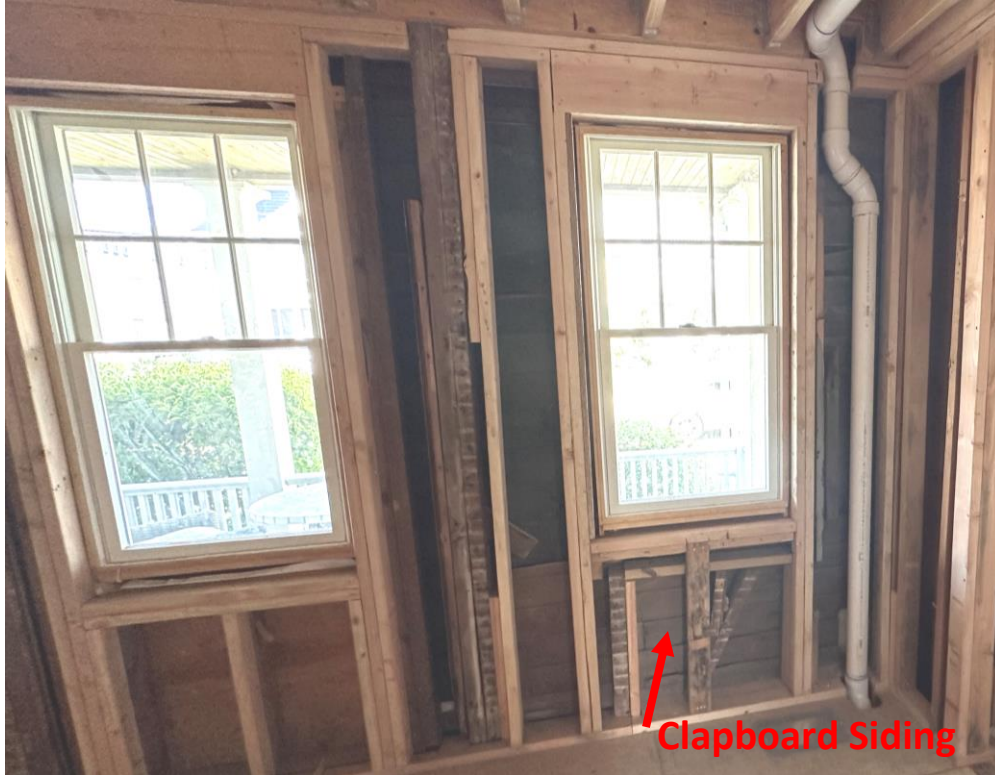
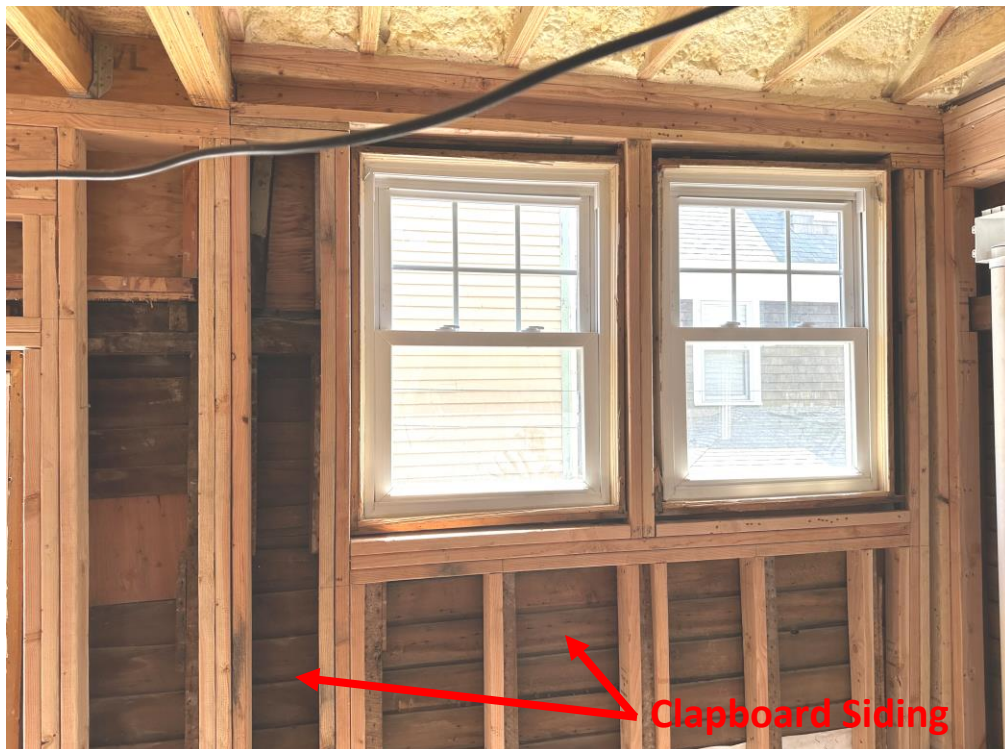
SPA Response: The house identified as #14 on the Sanborn map currently has standard pattern cedar shake on the front and rear façade and variable pattern shake on the west side façade only. The shake on the front and rear façade was done in the 1990's when the houses were joined together. The variable pattern shake on the west side was done earlier than that most likely in the 50's, 60's or 70's and is not the original siding on the house. The original siding on the house was clap board and approximately 50% is still present below the cedar shake on all 3 sides and can be seen throughout since the house was gutted. The existing clap is in non-salvageable condition. The areas that were modified over time which are the closing of the first and second floor north/west wrap around porches, the west side first and second floor bump outs referenced in item#5, the change of roof line in the south/west corner, third floor dormer, second floor newly created porch entry and the first floor rear addition with a shed style roof have either plywood sheathing or individual 1x6 or 1x4 slat sheathing. Pictures provided. The house identified as #12 on the Sanborn map currently has standard pattern cedar shake on the front, rear and east façade. The shake on the facades was done in the 1990's when the houses were joined together which is evident by the amount of design changes to the structure and the presence of plywood sheathing under all shake except (1) approximately 7'x 8' area on the second floor east side which appears to be the original siding which is a combination of 1x8 vertical board and 1 x 4 horizontal board. The variable pattern shake that is shown in the series of pictures (pictures from 70's or 80's) provided to SPA and J.Urig Contracting was most likely done in the 50's 60's or 70's and was not original. Pictures provided.

Original Clapboard Siding (Sanborn # 14)

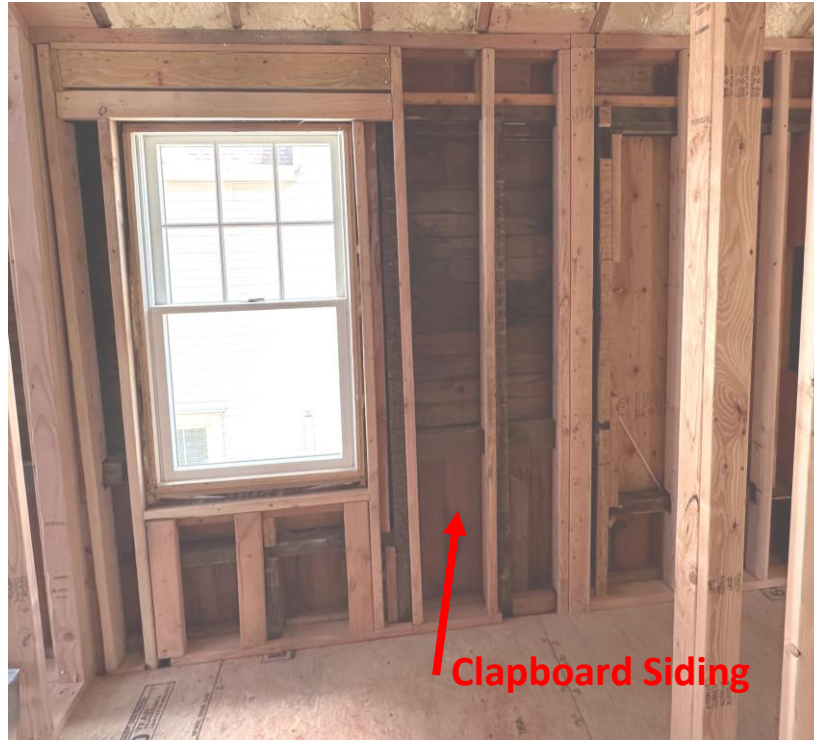
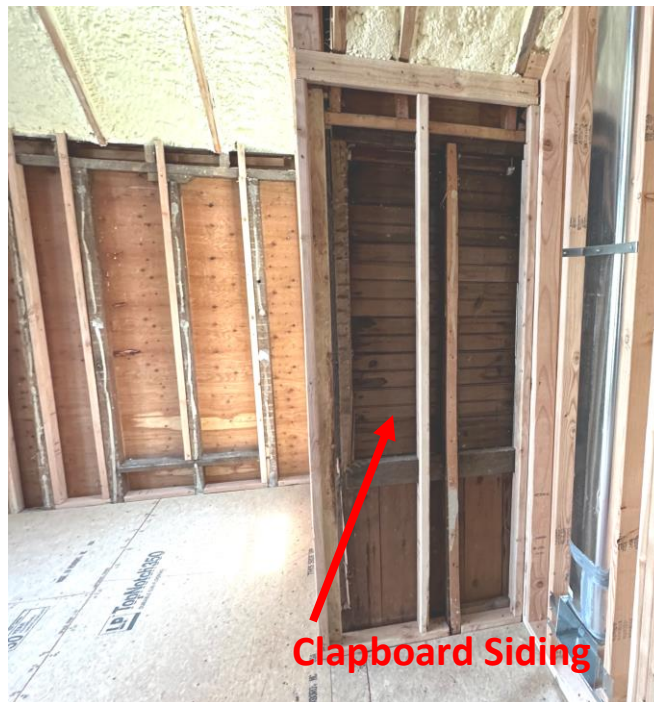
Original Calpboard (Siding Sanborn #12)

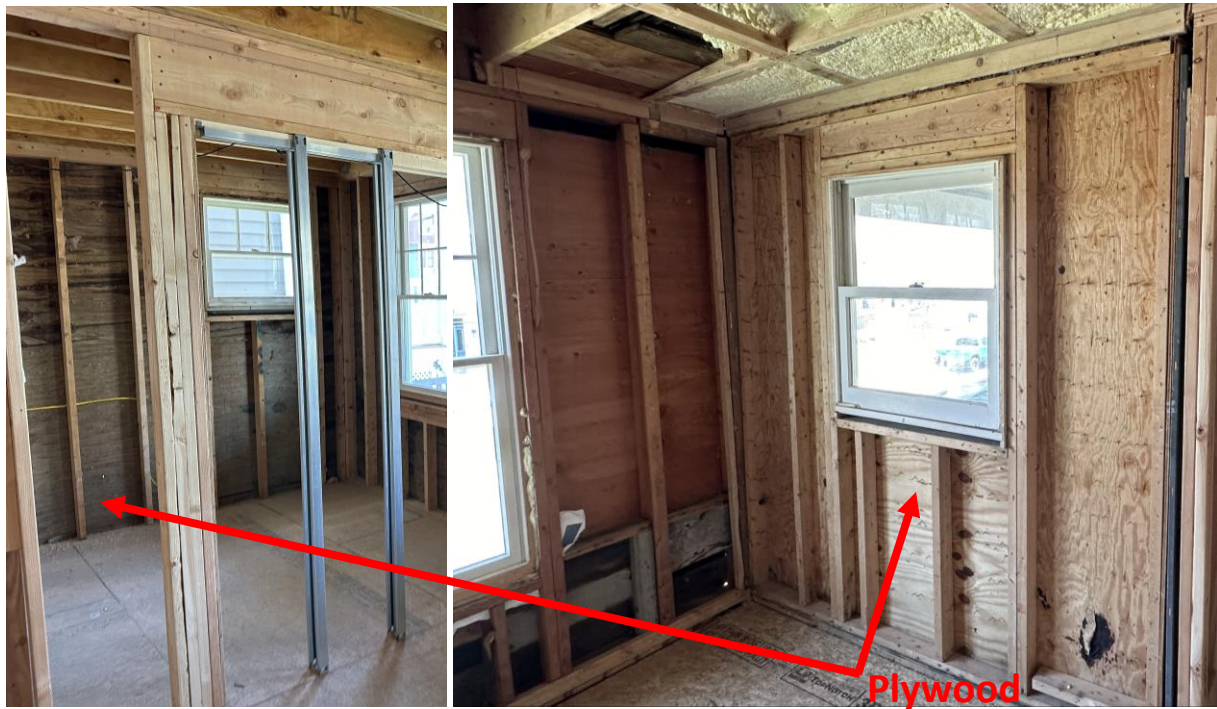
**Closing of First and Second Flor North/West Wrap Around Porches
(Plywood Sheathing)**

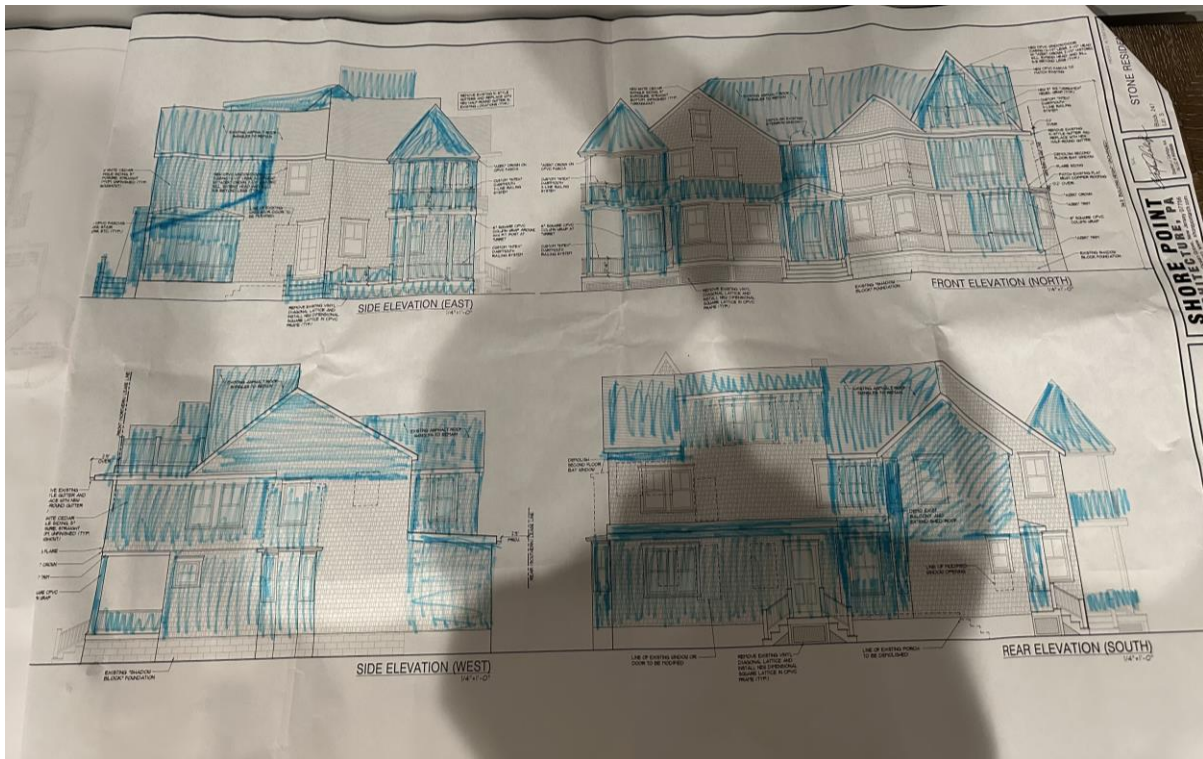
**Markup of New Additions/Alterations to Home
(All Blue Markings Are Unoriginal to Home)**
