Re: Wesley Lake Rehabilitation Plan  
Wesley Lake Commission  
Township of Neptune & City of Asbury Park  
Monmouth County, New Jersey

Wesley Lake Rehabilitation Plan  
March 18, 2008  
Page 2

STRUCTURAL WALL SURVEY  
WESLEY LAKE - SOUTH WALL  
TOWNSHIP OF NEPTUNE, NJ

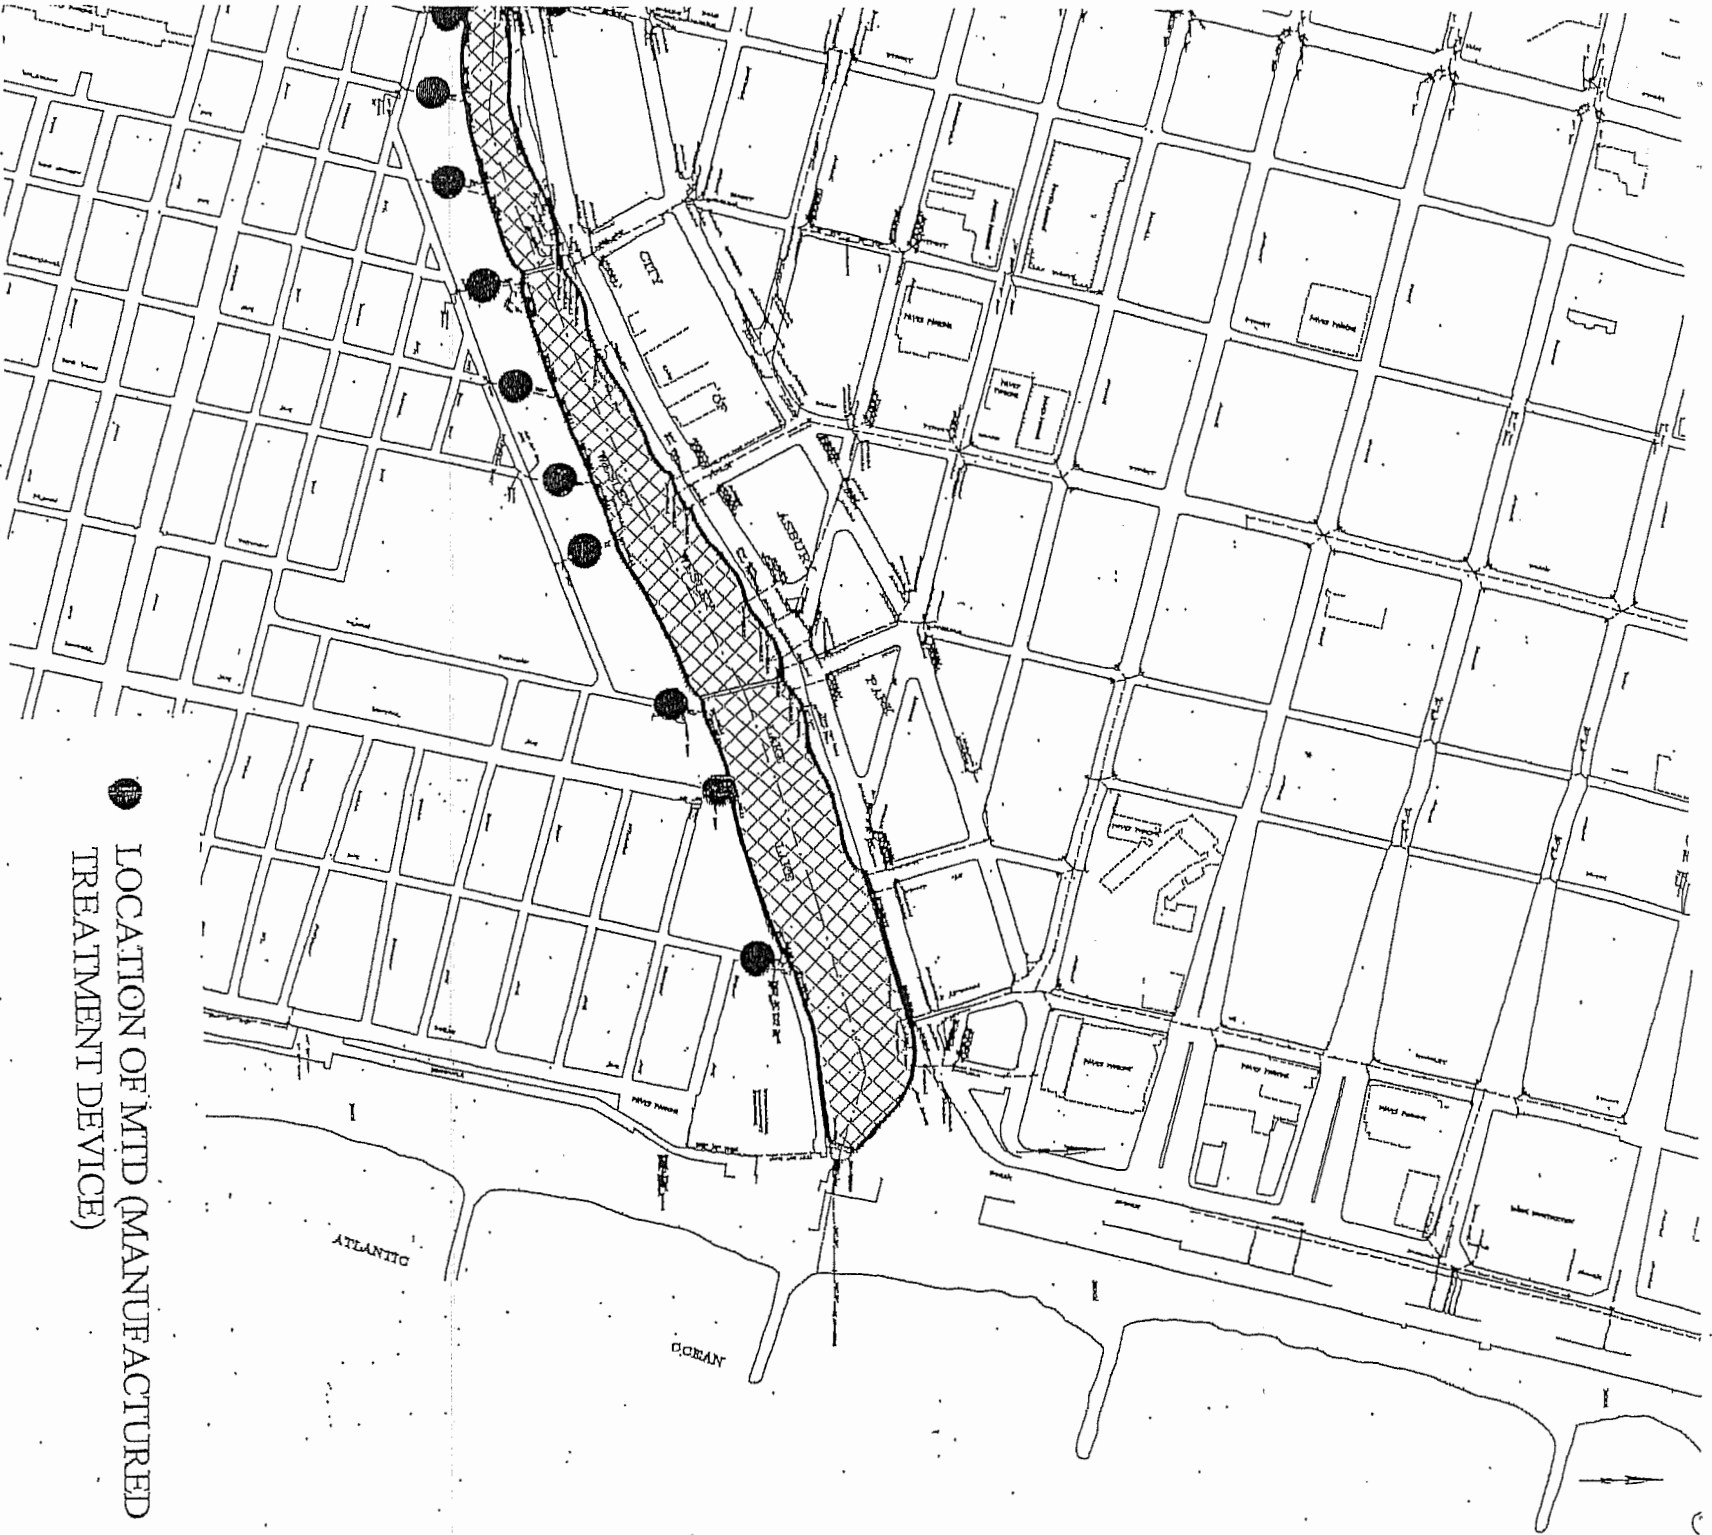
WESLEY LAKE STORM

SEWER MANAGEMENT PLAN

● LOCATION OF MTD (MANUFACTURED TREATMENT DEVICE)

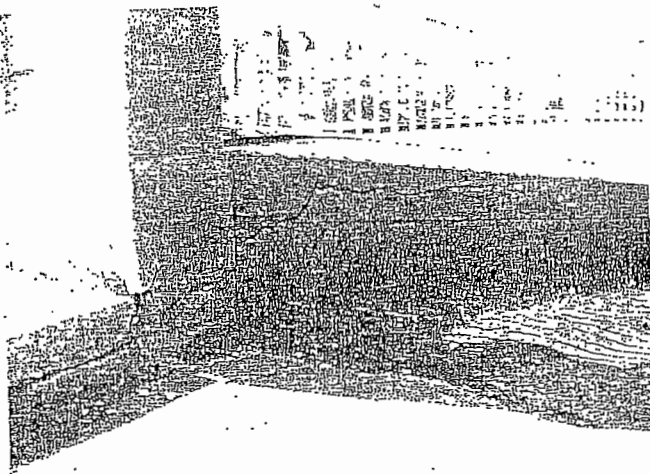
The breakdown is most notable due to the plenitude of cracks and flaws such as that shown, in the photo, at left. As will be seen in other images presented, these imperfections are numerous, and in their numbers somewhat daunting. However, when probing the concrete with a metal blade, the material itself proved to be hard and the aggregates well bonded.

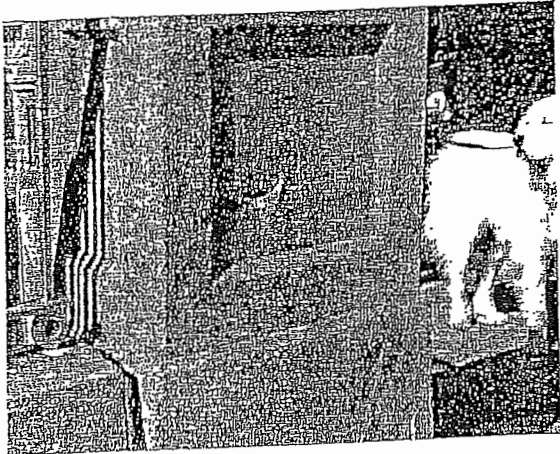
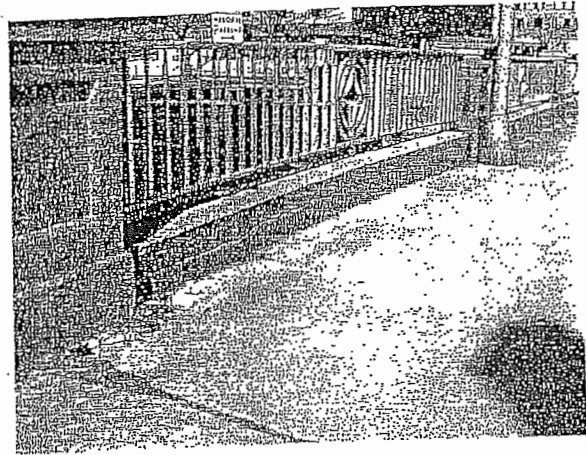
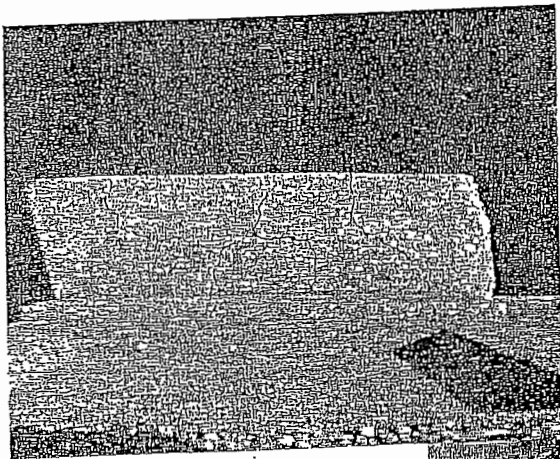
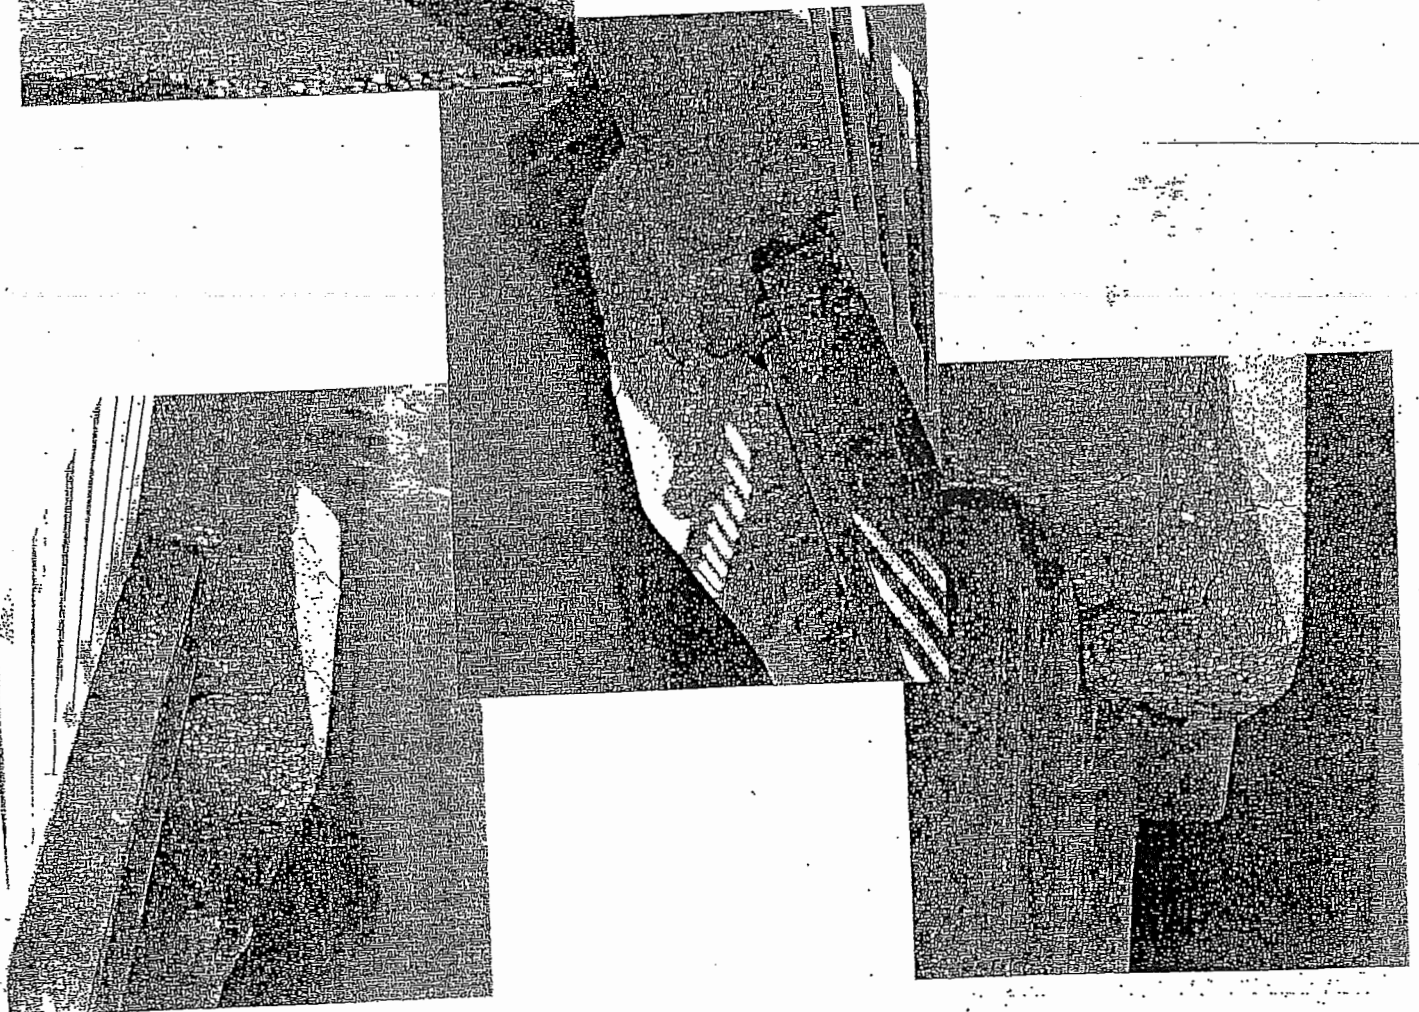
The two photos above, taken at the same approach as the first, are further examples of a similar decay. The four in the lower half of the page are indicative of the conditions prevalent among the piers that support the roadbed.

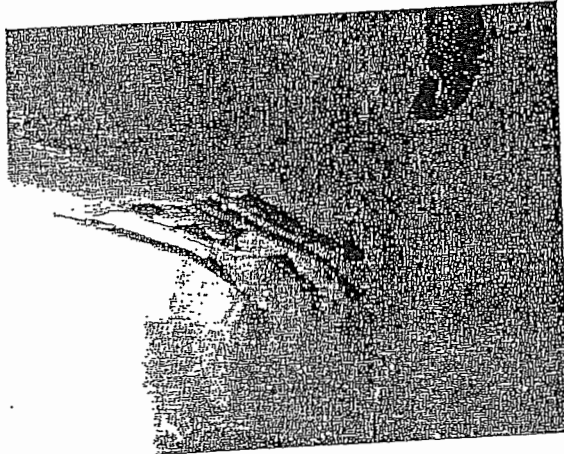
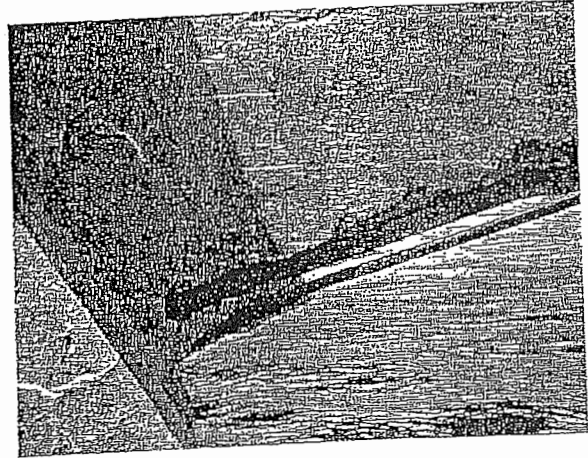
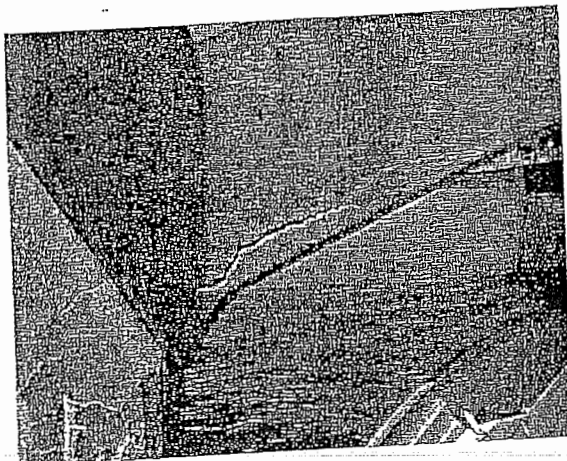
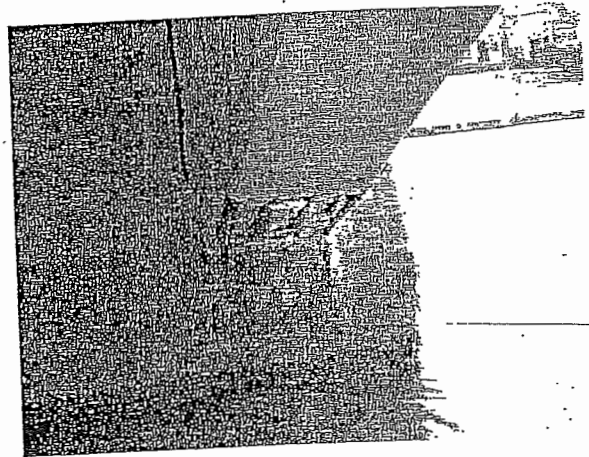
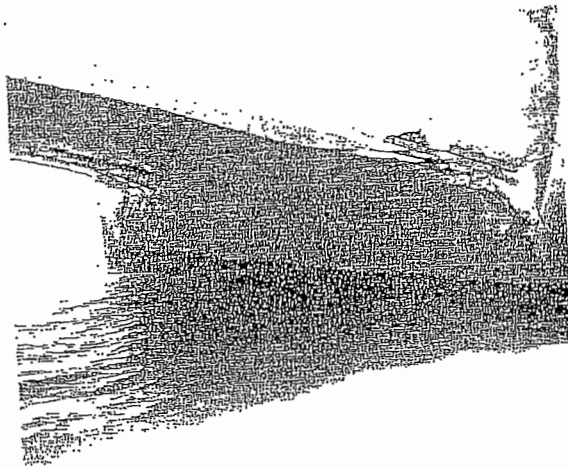
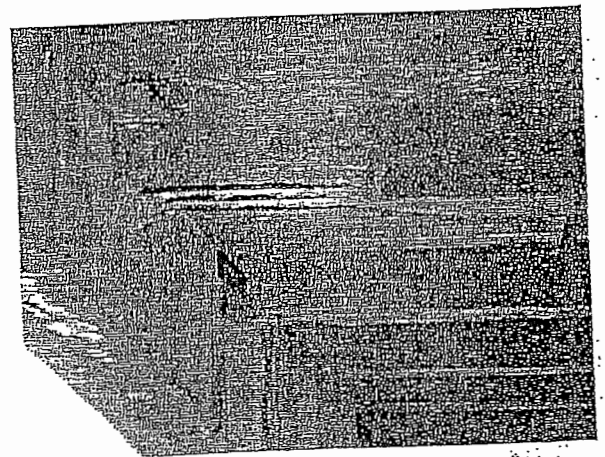
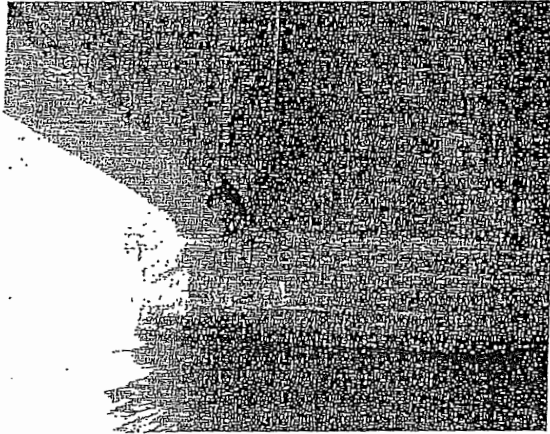
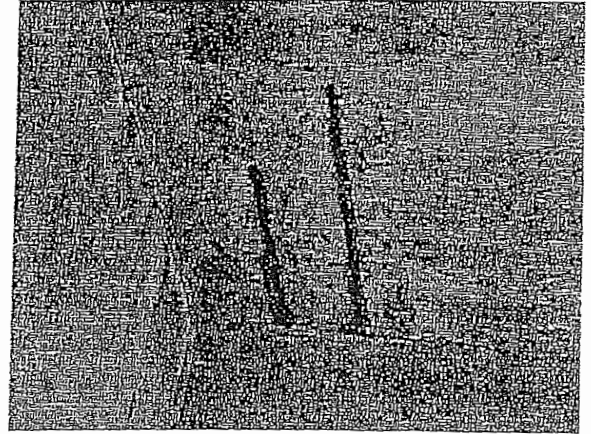
In order to gain a more complete understanding of the situation, an appointment was made to obtain the use of a boat, and examine the undersides of the bridges. On May 30, 2004, the following photos were taken.

Using these photos as reference, it is possible to make these observations:

- a) As with most problems in concrete structures, a major contributor is probably water infiltration.
- b) The concrete itself, although exhibiting many fractures and flaws is still for the most part hard and intact.

Water infiltration in reinforced concrete construction attacks in two ways: One causes the breakdown of the concrete itself through accretion of salts and acids, and the other, which seems more applicable to this particular situation, causes corrosion of the reinforcing rods. The oxides created by this corrosion occupy a larger volume than the intact metal and the expansion of the mass supplies sufficient internal pressure to crack the concrete. Once these cracks occur, increased ingress for moisture accelerates the corrosion, resulting in further deterioration. The reinforcing rods in these last eight images appear to have been set too close to the surface of the pour, and so, expansion of the oxides has caused first cracking, as shown in the earlier photos, and then exfoliation, exposing the rods completely.

A visual inspection can only provide indicators as to the problem, and suggest possibilities as to how one might attempt to rectify the situation. However, in order to accurately assess conditions, as they currently exist, it will be necessary to probe the structures. Possibilities include intrusive procedures such as coring, or non-intrusive techniques such as ultra-sound, or boroscopy. It is commonly accepted that the services of an engineer be retained to conduct or guide this process. Rick Burke, of Becht Engineering has been contacted; he has visited the site, and is preparing a proposal recommending technique and procedure for in depth analysis.

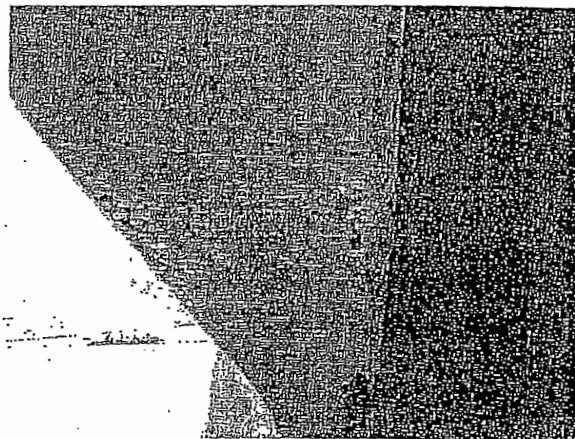
Porosity due to poor compaction during the initial pour, such as that shown, at right, probably also contributed to the decay.

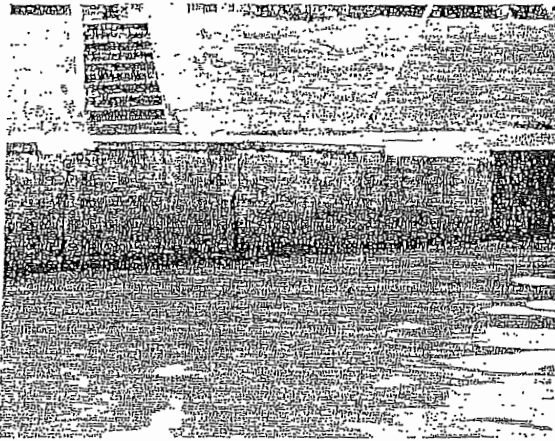
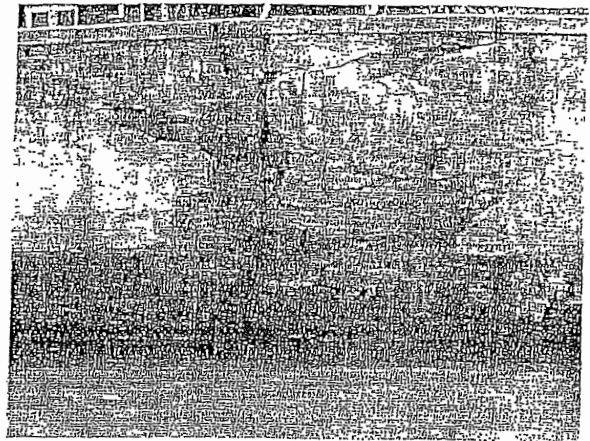
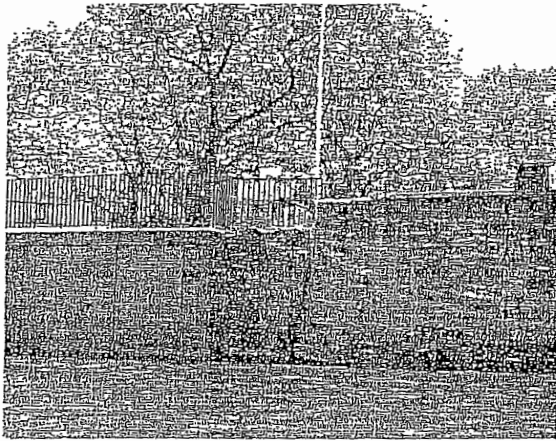
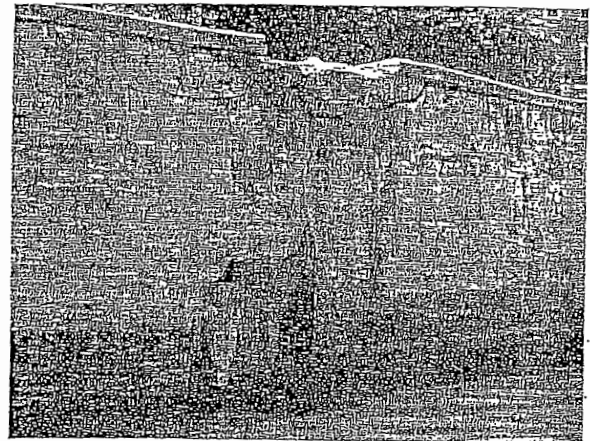
As the photos above illustrate, there has been significant decay in the concrete retaining walls that line the lake. Cracks, shifted sections, and crumbling are the major concerns. For the most part, as with the bridges, the concrete is still hard and well bonded. At this time it should not be too difficult to stabilize the segments relative to each other, and inject a grout to seal the cracks. Likewise, excision and repair, of the crumbled areas, should not present too great a difficulty.

There is noticeable rot in the metal bulkheads that line the balance of the shore. Areas have corroded to the point that soil backing up to the walls is washing into the lake, leaving potentially dangerous depressions. In addressing these problems, it is suggested that the product line and services of a company called Green Mountain International, Inc, be explored. They

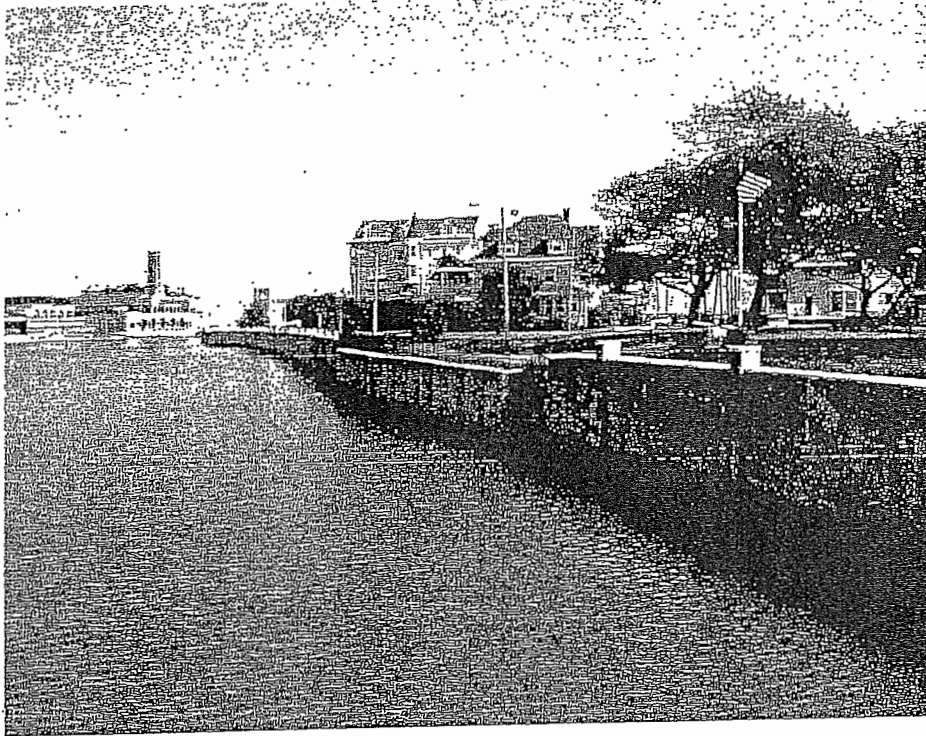
*Condition:* Newer precast concrete 'Bulkhead Style' wall. Wall contains a tie back system. Wall in satisfactory condition. No need for replacement.

Photo #1 - View looking East from East Pedestrian Bridge. Notice Segment of Newer Concrete Bulkhead Bulkhead Wall.

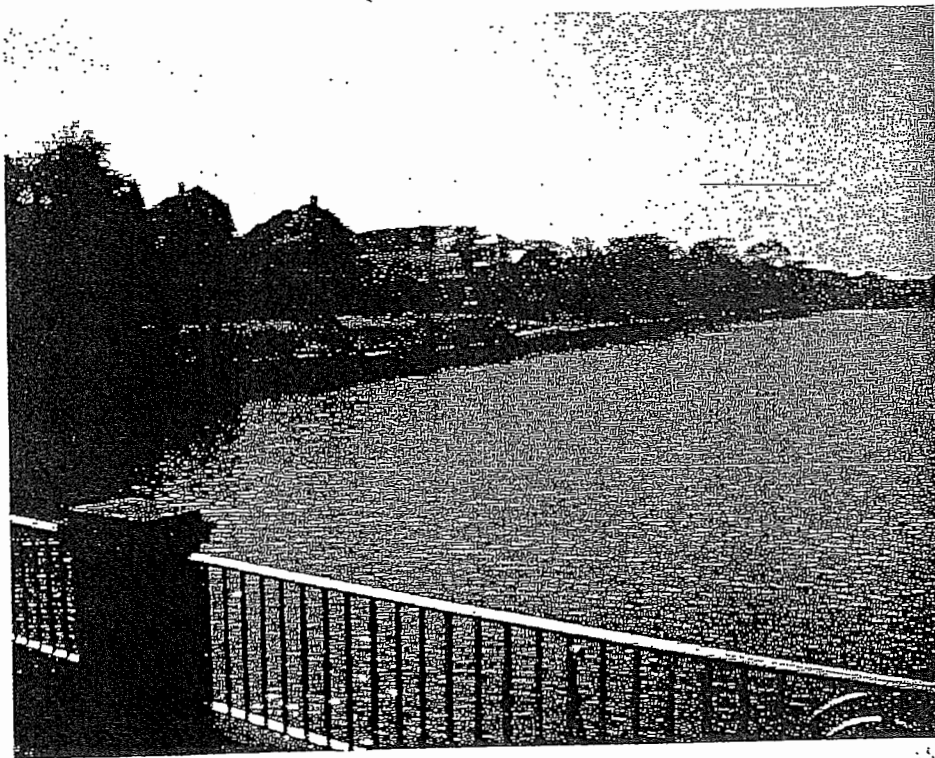
Photo #2 - View looking West from East Pedestrian Bridge.

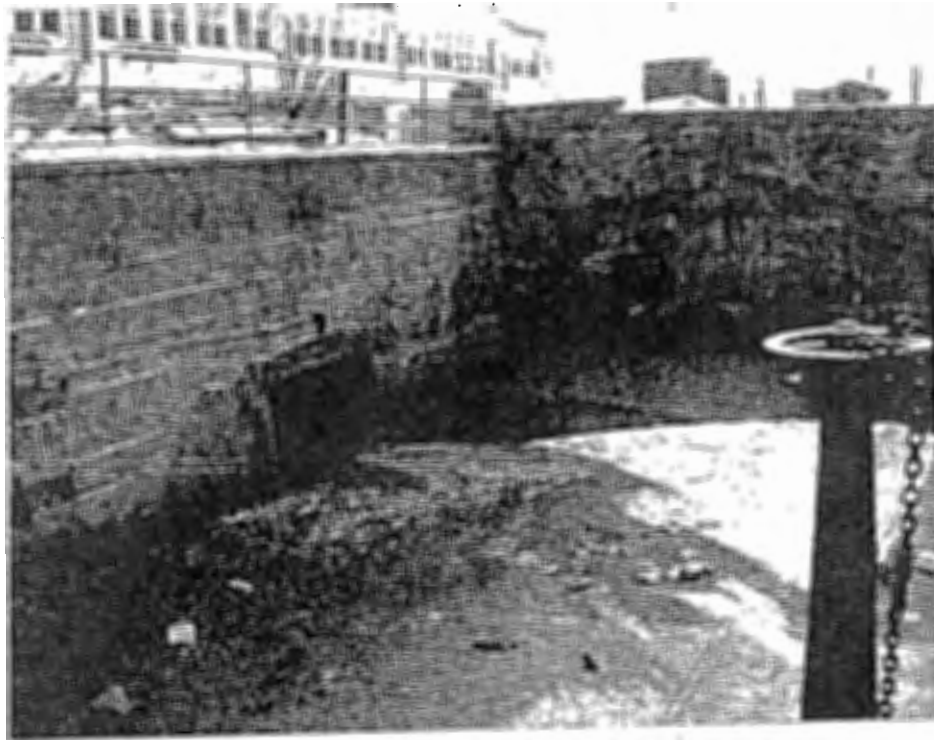
Photo #3 - View of Headwall at East End of Lake.

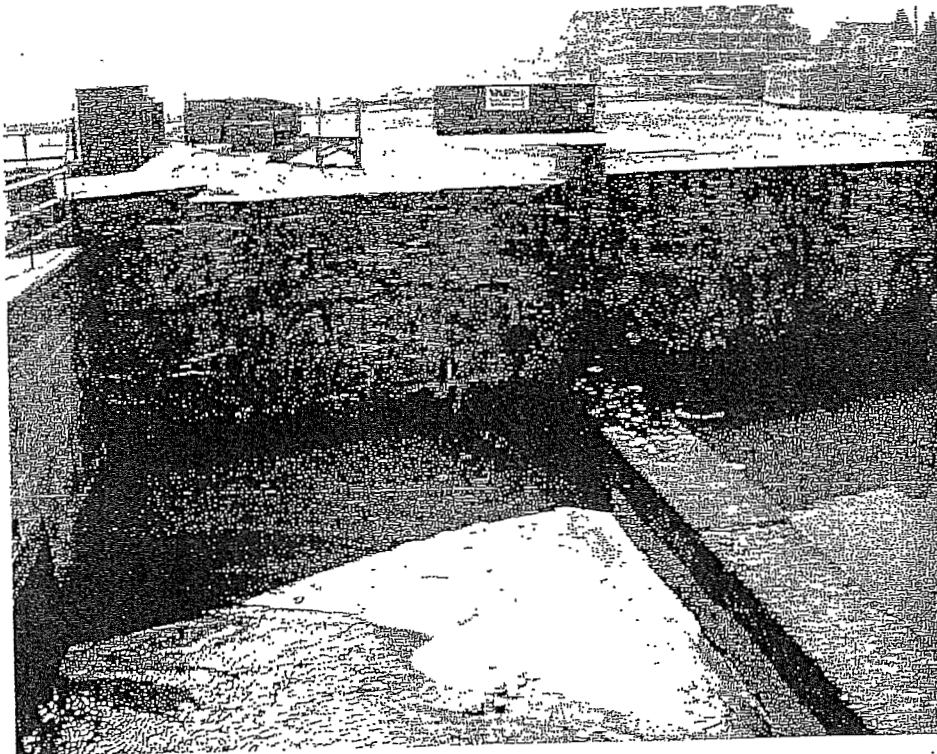
Condition: Old concrete gravity wall contains excessive thru-wall cracking and shifting that has led to large sections of wall to become unstable (See Photos No. 4 to 6). The concrete is in extremely poor condition and is in obvious need of replacement. In the interim, this segment of wall should be cordoned off due to this unsafe condition.

Photo #4 - View of Excessive Wall Shifting and Cracking at East End of Wall which has Resulted in Large Unstable Wall Section.

It is highly recommended that the Township of Neptune seek funding for reconstruction of these walls. The reconstruction of these walls should be incorporated into the Township's future Capital Improvement planning. In the meantime, regular inspections of these walls should be performed to maintain a close guard on the condition of the wall.

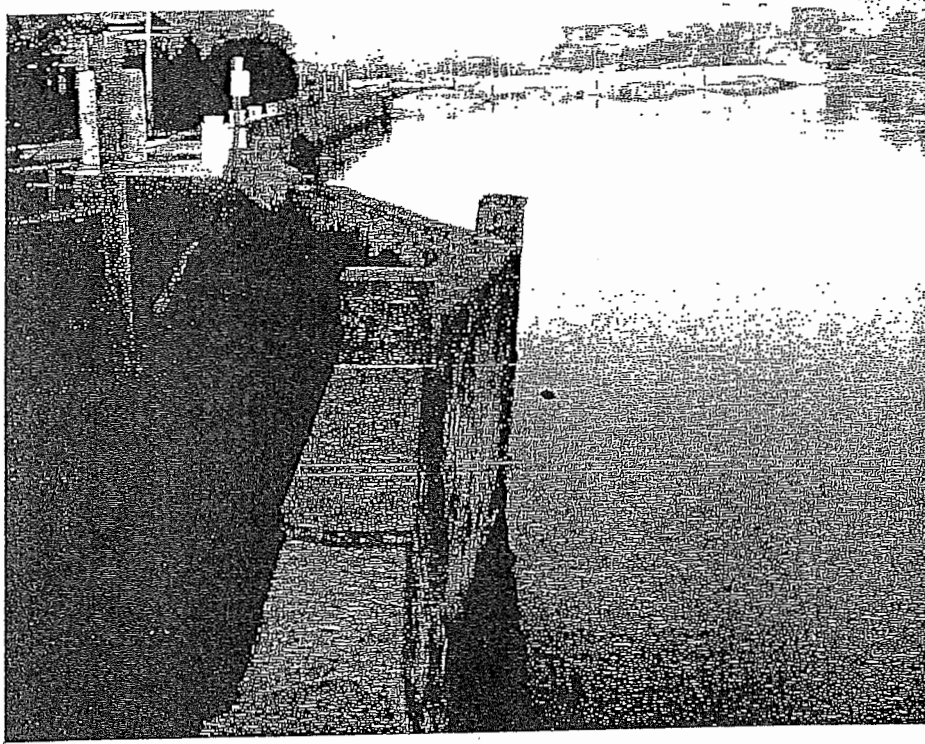
Condition: Old concrete gravity wall contains excessive vertical and lateral movement (See Photos No. 9 and 10). Wall is leaning outward and has shifted a few feet from its original position. This segment of wall is in failed condition and has the potential for continued movement and complete failure. This segment of wall obviously needs replacement. In the interim, this segment of wall should be cordoned off as the potential for further movement exists.

Photo #9 - View of Excessive Movement (Failure) in Wall at Station 29+00.

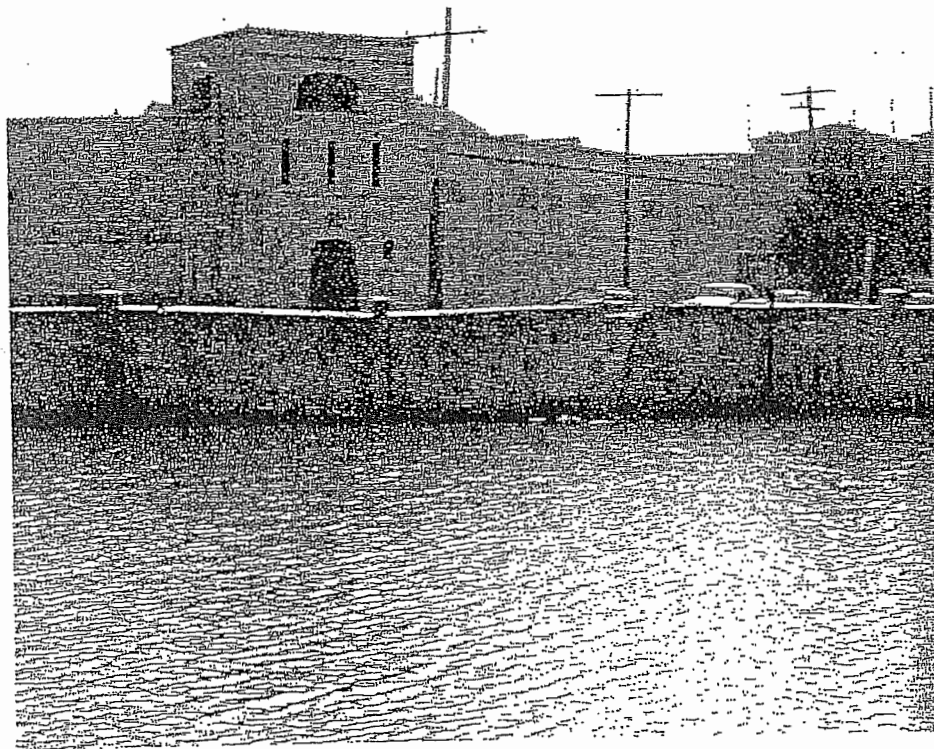
Photo #10 - Front View (Looking South) of Excessive Wall Movement (Failure) at Station 29+00.

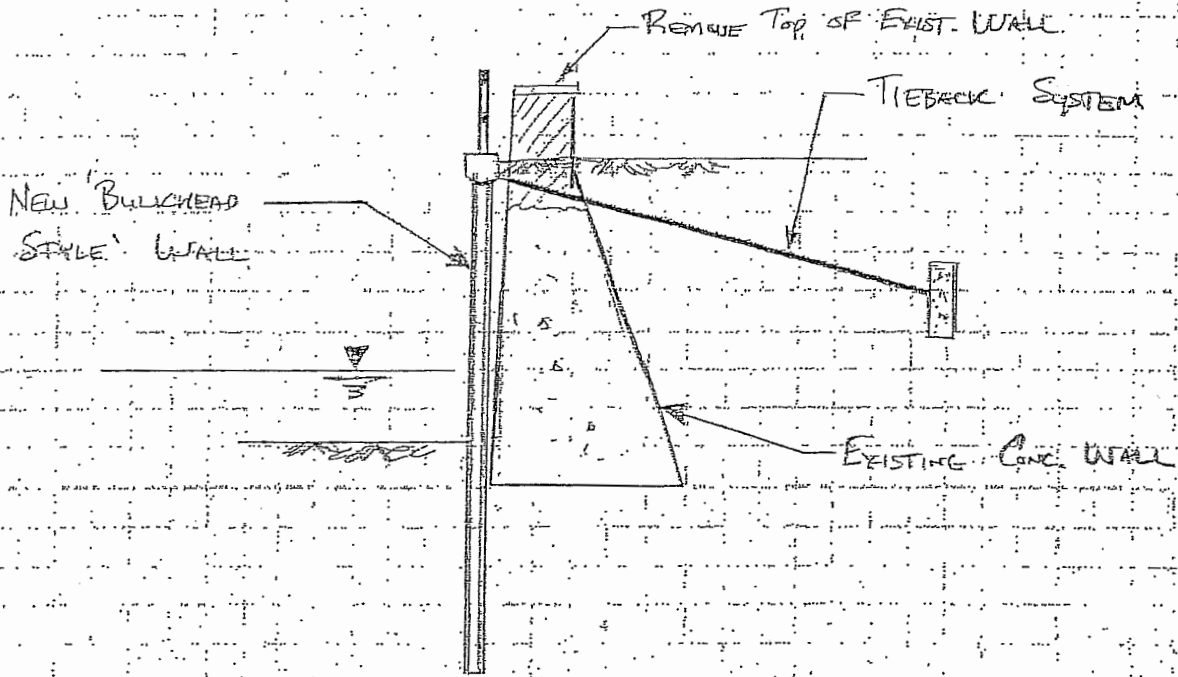
## Sketch #1

The estimated replacement costs calculated for these walls assumes that a new wall is installed directly in front of the lower steel sheeting wall. This wall is assumed to terminate at grade similar to the existing wall and will not contain a railing. The cost of the concrete wall replacement assumes that the top portion of the existing concrete wall will be removed down to several feet below grade. The new wall will then be placed in front of the remaining concrete wall and terminate at grade with a proposed railing installed on top of the new wall similar to the newer precast concrete segments of wall. Reference Appendix B for a sketch illustrating a typical new wall installation. These costs do not include any upland site improvements. It is recommended to not perform any upland site improvements until the wall segments have been reconstructed as necessary.

## A. CONCRETE WALL SEGMENTS

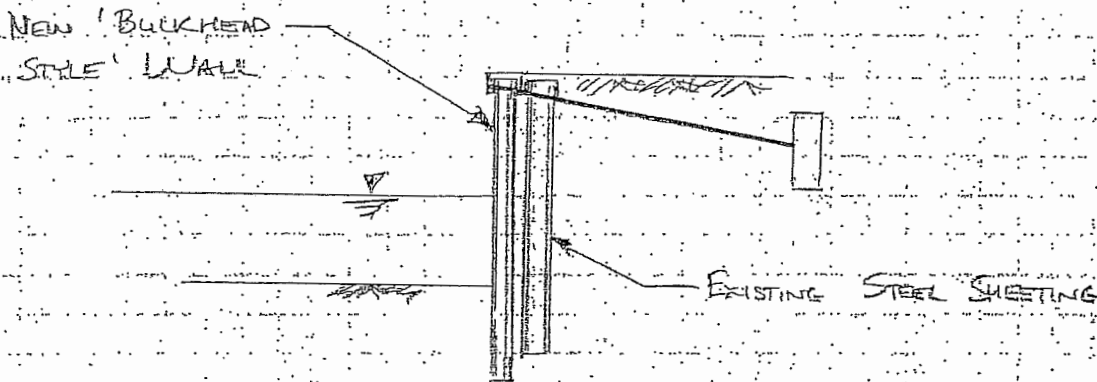
## A. STEEL SHEETING SEGMENTS

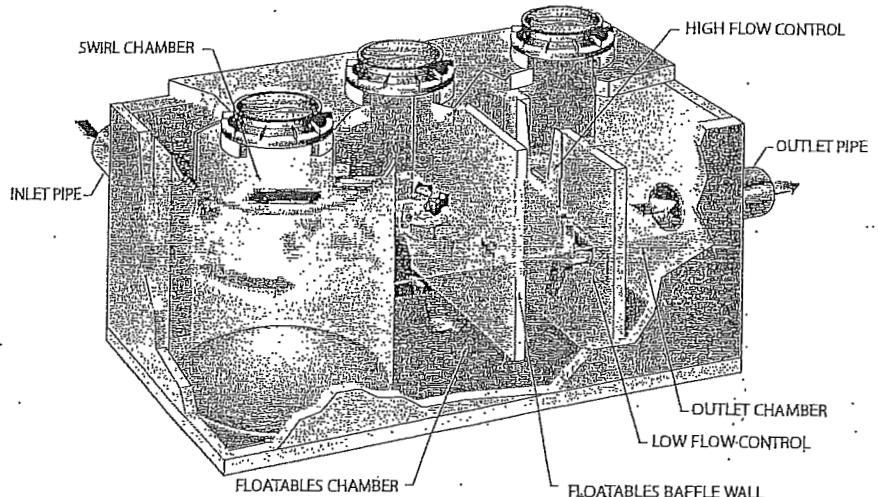
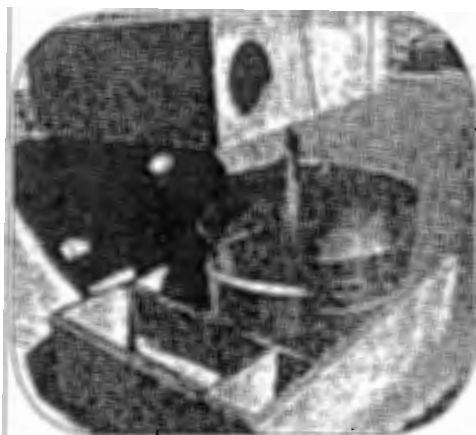
During larger storms, the water level rises above the low flow control and begins to flow through the high flow control. The layer of floating pollutants is elevated above the influent pipe, preventing re-entrainment. Swirling action increases in relation to the storm intensity, which helps prevent re-suspension. When the storm drain is flowing at peak capacity, the water surface in the system approaches the top of the high flow control. The Vortechs system will be sized large enough so that previously captured pollutants are retained in the system even during these infrequent events.

As a storm subsides, treated runoff decants out of the Vortechs system at a controlled rate, restoring the water level to a dry-weather level equal to the invert of the inlet and outlet pipes. The low water level facilitates easier inspection and cleaning, and significantly reduces maintenance costs by reducing pump-out volume.

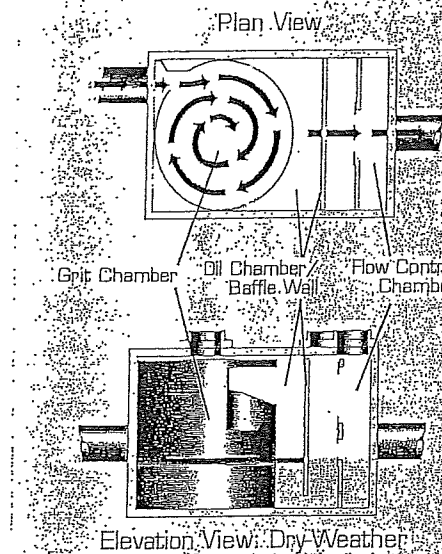
## Grit Chamber

The swirling motion created by the tangential inlet directs settleable solids toward the center of this chamber. Sediment is caught in the swirling flow path and settles back onto the pile after the storm event is over.

## Flow Control Chamber

The weir and orifice flow controls: 1) Raise level and volume in the system as flow rate increases; and 2) gradually drain the system as flow rate subsides.

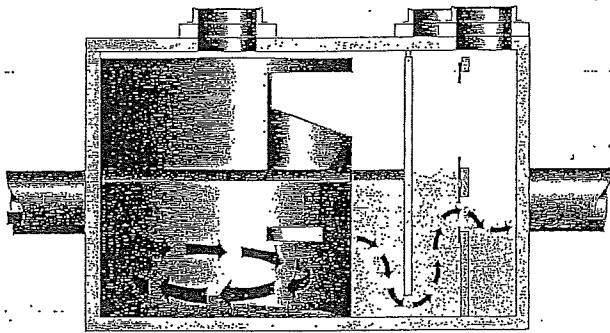
### 1) Initial Wet Weather Phase

During a two-month storm event the water level begins to rise above the top of the inlet pipe. This influent control feature reduces turbulence and avoids resuspension of pollutants.

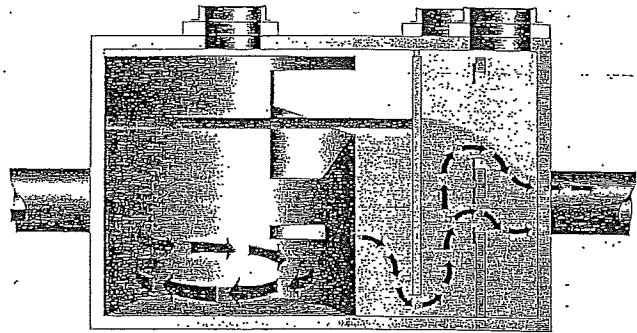
### 2) Transition Phase

As the inflow rate increases above the controlled outflow rate, the tank fills and the floating contaminant layer accumulated from past storms rises. Swirling action increases at this stage, while sediment pile remains stable.

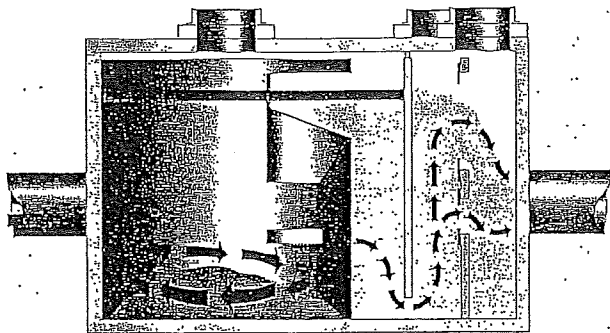
### 3) Full Capacity Phase

When the high-flow outlet approaches full discharge, storm drains are flowing at peak capacity. The Vortechs System is designed to match your design storm flow and provide treatment throughout the range of storm events without bypassing. To accommodate very high flow rates, Vortechs can assist designers with configuring a peak-flow bypass.

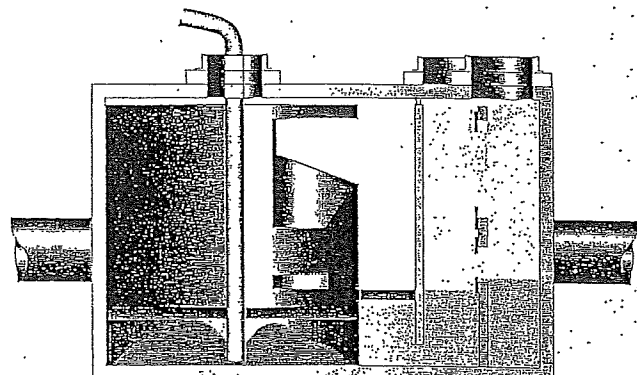
### 4) Storm Subsidence Phase/Cleaning

Treated runoff is decanted at a controlled rate, restoring the water level to a low dry-weather volume and revealing a conical pile of sediment. The low water level facilitates inspection and cleaning, and significantly reduces maintenance costs. The system's central baffle prevents transfer of floatables to the outlet during cleaning or during the next storm.
