# PHASE I ENVIRONMENTAL SITE ASSESSMENT

2419 Route 33  
Neptune, New Jersey 07753

**EMG Project Number:**  
138092.19R000-001.135

**Date of Report:**  
May 24, 2019

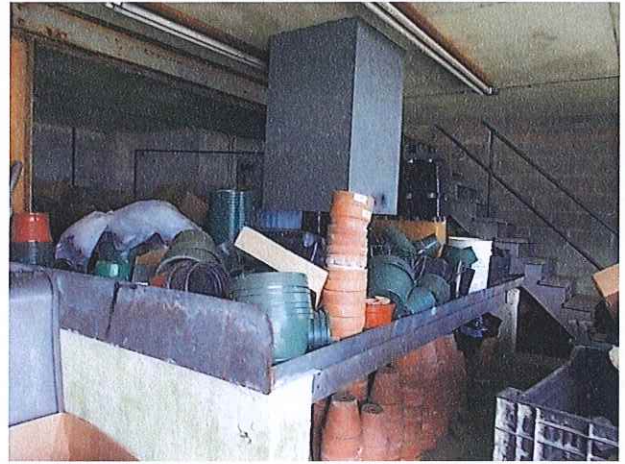
Garage interior

A moisture condition was observed in the garages on ceiling tiles. The area affected by the moisture was approximately 100 square feet in size.

***The structures are planned for demolition; therefore, no further action is recommended.***

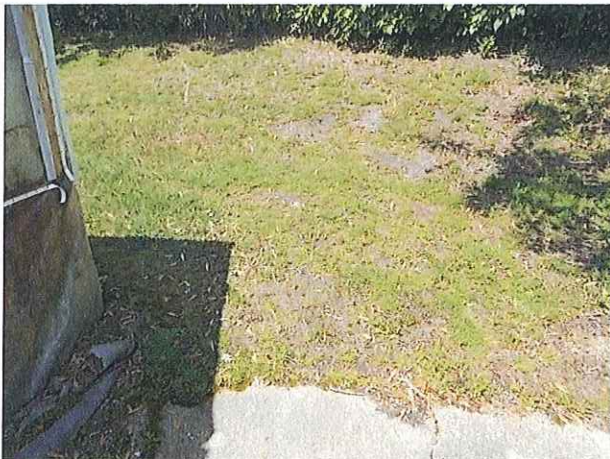
Removed AST

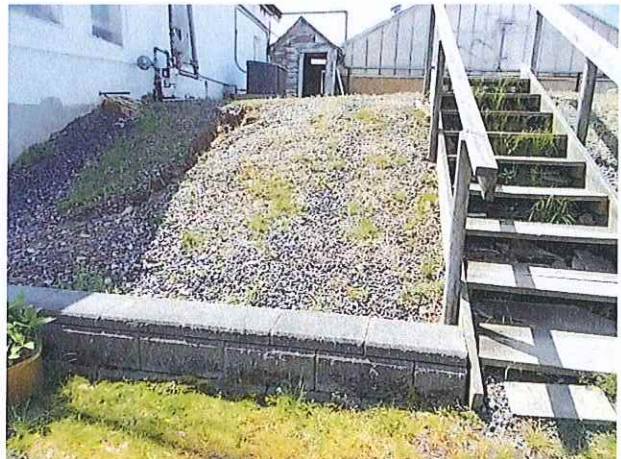
Removed central UST

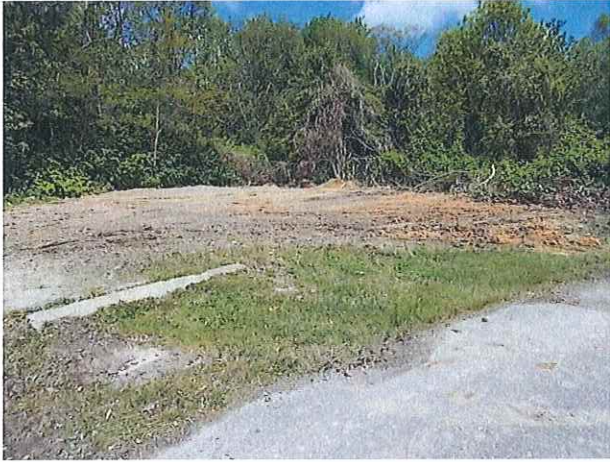
Removed NW UST

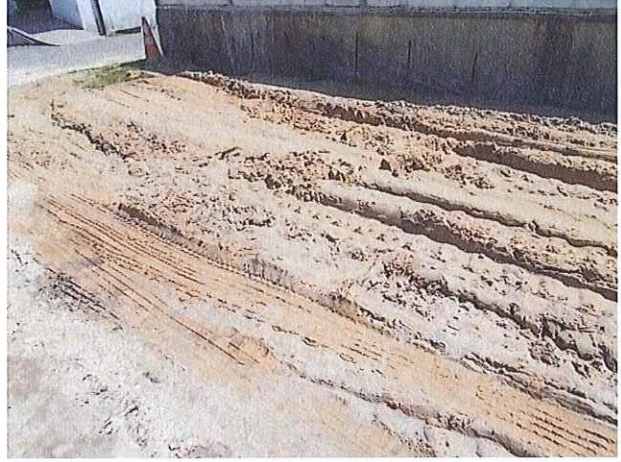
Removed west UST

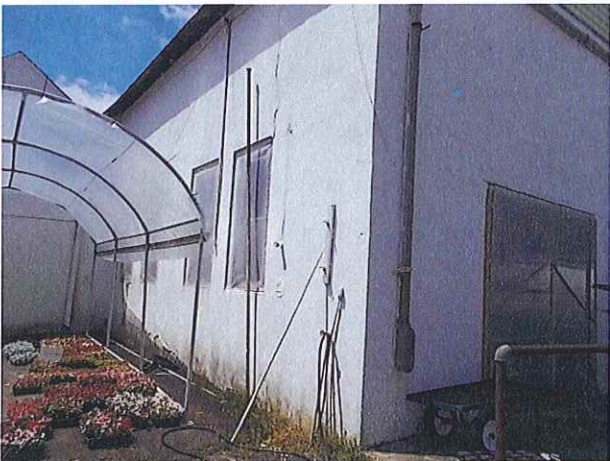
Vent pipe

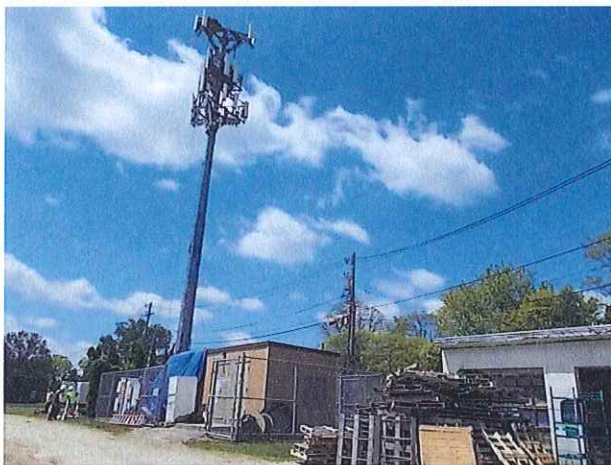
Cell tower

Cellular Communications Equipment	
<b>Location of Equipment:</b>	Western portion
<b>Equipment Owner:</b>	Unknown
<b>Access Available to Interior:</b>	No
<b>Evidence of Emergency Generator:</b>	No
<b>Evidence of Underground Storage Tank:</b>	No
<b>Staining Observed:</b>	No
<b>Listed on Regulatory Database:</b>	No
<b>Conclusion:</b>	Based on the information provided above, this Project use does not represent a recognized environmental condition.

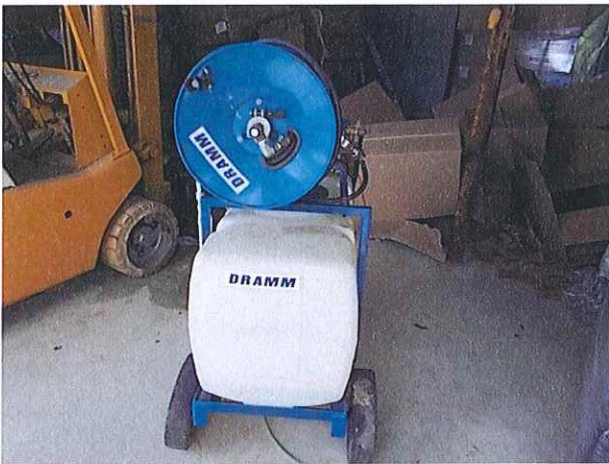
Pesticide applicator

Drums and Small Containers			
Material	Quantity	Storage Location	Spills or Leaks
Janitorial and maintenance supplies	Retail-size containers	Janitor closets and other designated areas	No
Propane	3-gallon containers	Garage	No
Pesticides	Retail-size containers	Storage cabinet in garage	No

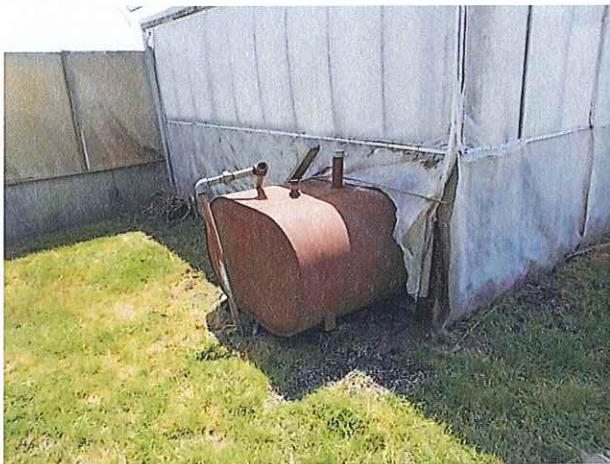
Aboveground Storage Tanks	
<b>Tank #:</b>	1
<b>Owner:</b>	Property
<b>Year Installed:</b>	Unknown
<b>Contents:</b>	Heating oil
<b>Use of Contents:</b>	Agricultural
<b>Capacity:</b>	275 gallons
<b>Visually Observable:</b>	Yes
<b>Weep Holes Present:</b>	Not Applicable
<b>Secondary Containment:</b>	No
<b>Location:</b>	Northwest portion
<b>Tank Construction:</b>	Single-wall steel
<b>Registered With State:</b>	Not required
<b>Leaks Observed:</b>	No
<b>Leaks Reported by POC:</b>	No
<b>Conclusion:</b>	The Key Site Manager was unaware of any past releases from the AST. Furthermore, the AST appeared to be in good condition, with no evidence of current or past releases.

AST

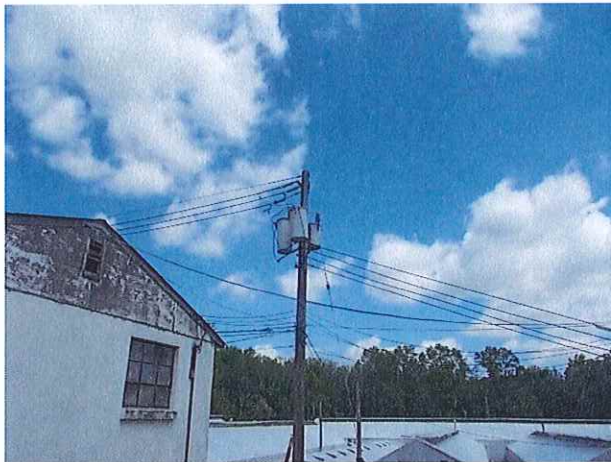
Oil Cooled Transformers	
<b>Type:</b>	Pole-mounted
<b>Number of Units:</b>	4
<b>Owner:</b>	Utility company
<b>Labeled:</b>	Not labeled
<b>Age:</b>	Appears to have been installed after 1979
<b>PCB Status:</b>	Unlikely to be PCB-contaminated based on the apparent age of the equipment.
<b>Spills or Leaks Observed:</b>	No
<b>Conclusion:</b>	Based on the information above, the presence of this equipment does not represent a recognized environmental condition.

Pole transformers

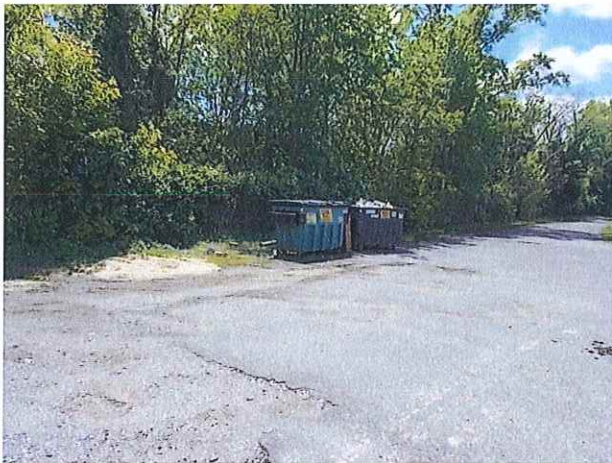
Waste Generation			
Waste Type	Disposal Method	Storage Location	Spills or Leaks
Domestic sewage	Septic system	Not applicable	No
Municipal trash	Contracted waste hauler	Dumpsters	No

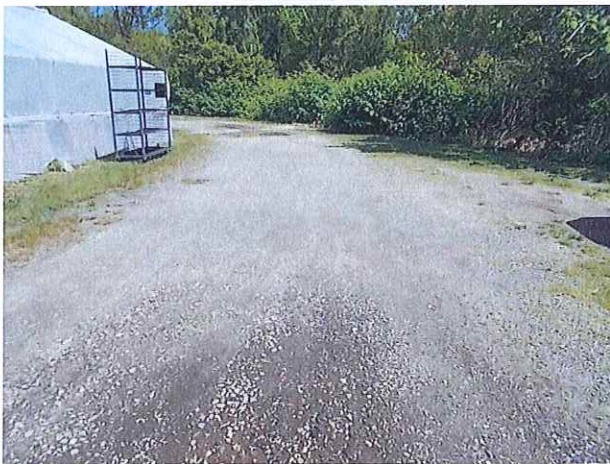
Septic System	
<b>Type:</b>	Tank with leach field
<b>Wastes:</b>	Domestic sewage
<b>Year Installed:</b>	Unknown
<b>Currently Active:</b>	Yes
<b>Reported Condition:</b>	Good
<b>Leach Field Location:</b>	Adjacent east to each tank
<b>Tank Location:</b>	Shop tank central Residence tank east of house
<b>Health Department Violations:</b>	A written request for information has been submitted. A response is currently pending. A copy of the request is included in Appendix F.
<b>Conclusion:</b>	Based on the information above, the presence of the septic systems do not represent a recognized environmental condition.

Leechfield

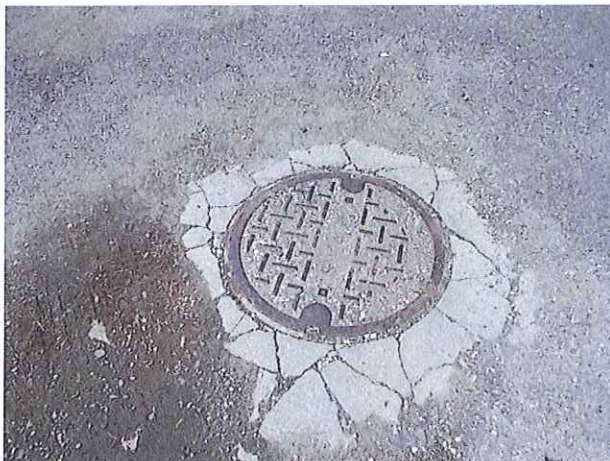
The Project utilizes two septic systems. One is associated with the residence at the Project and the other is associated with the commercial operations and is located on the eastern portion of the Project. Based on the commercial use of the Project and unknown disposal practices, the septic system represents a recognized environmental condition associated with the Project.

Septic

***EMG recommends that a Phase II subsurface investigation to include GPR be conducted to further evaluate the identified recognized environmental conditions. Additional actions may be recommended based on the results of the subsurface investigation.***

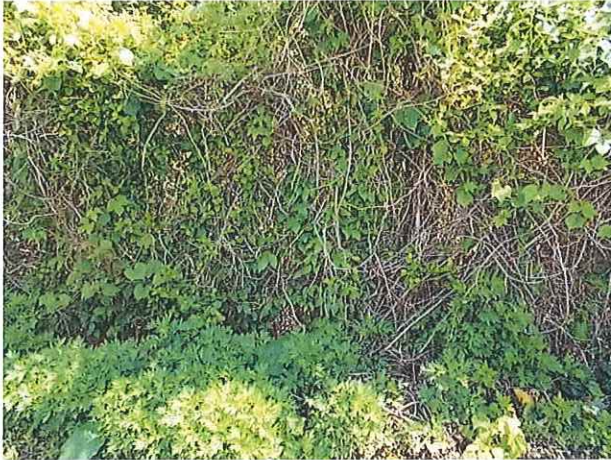
Wells			
Type of Well	# of Wells	Registered	Location
Water (potable)	1	Unknown	Wooded area on the east portion. The well is out of use and Project connected to city service.

Abandoned well

***EMG recommends that documentation confirming proper abandonment of all onsite wells be provided for review. If this information is unavailable or inconclusive, EMG recommends an inspection of the well be performed and the well closed according to all applicable regulations.***

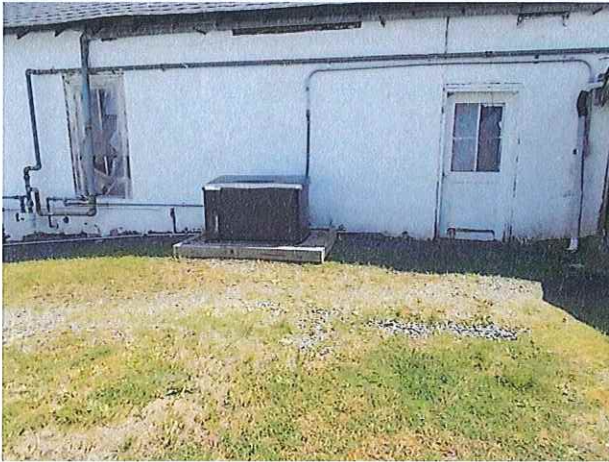
HVAC

Heating and Cooling	
<b>Type of Heating:</b>	Natural gas units
<b>Type of Cooling:</b>	Electric units

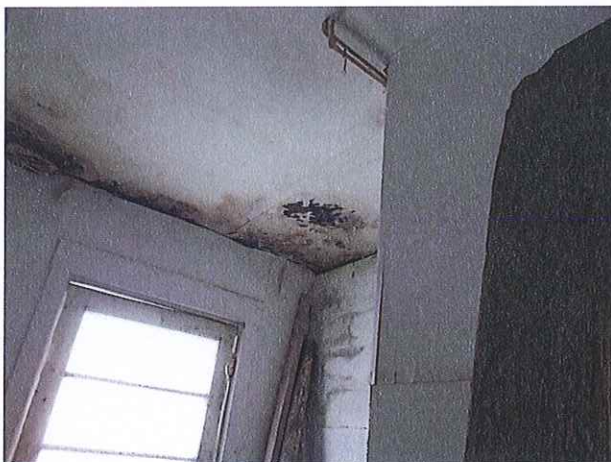
Suspect mold

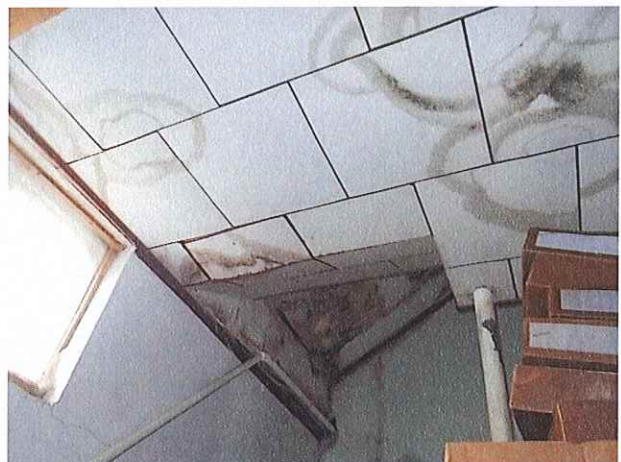
Suspect mold garage 2

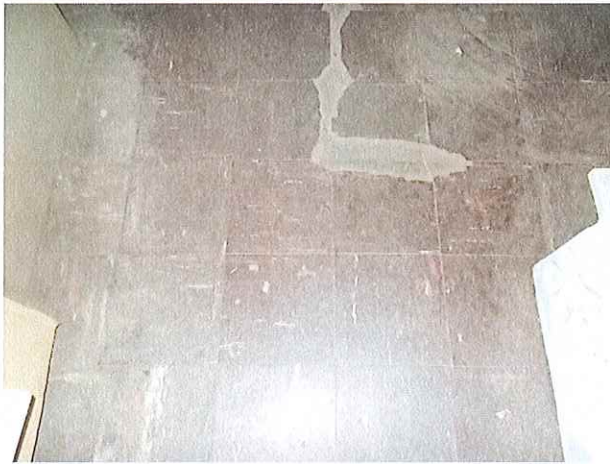
Based on the date of construction (1931), there is a potential that asbestos-containing materials (ACM) exist at the Project. The suspect asbestos containing ceiling tiles were observed in poor condition. The remaining suspect ACM were observed in generally good condition. Based on the scope of work, these materials were not sampled.

9x9 asbestos suspect

Recommendation	Estimated Cost
A file review is recommended to further evaluate the recognized environmental condition.	\$190/hour
A comprehensive demolition ACM Survey of the Project.	To Be Determined
Inspection of the well be performed and removed according to regulation.	To Be Determined
