06. Window and Door Condition Report

The house currently contains 89 doors and windows that fall under the purview of the Commission. We have sorted these into five categories: Basement Windows, Historic Windows, Secondary Windows, Vinyl Windows, and Modern Windows. To assist in understanding and reviewing so many fenestrations, we have color-coded them by type and illustrated their location on the enclosed floor plans and elevations. Also included are photographs of each individual window and door showing its characteristics and condition.

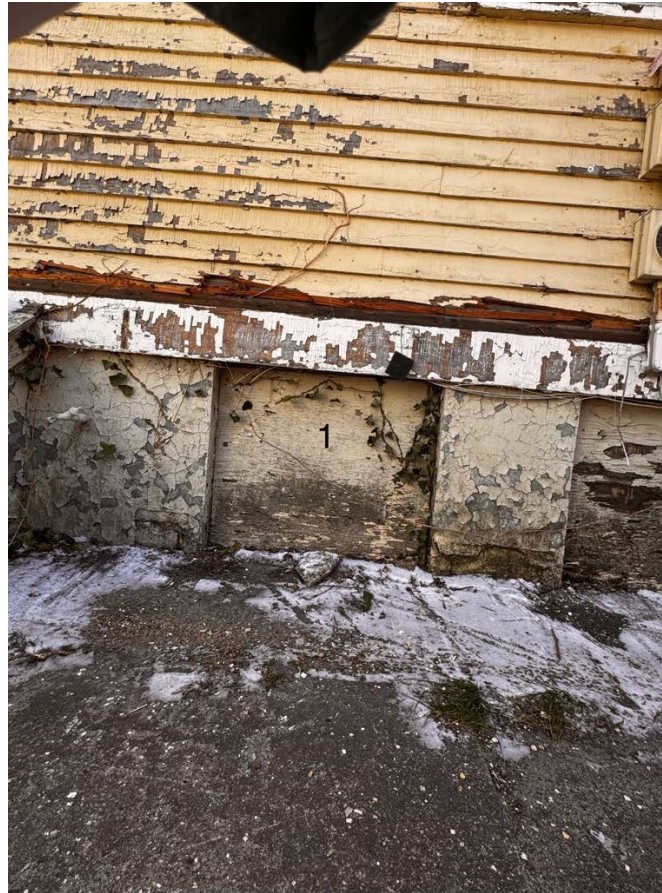
#1 — Basement, west elevation. This basement window is larger than all the other basement windows and may have been modified at an earlier time. A portion of the window sits below grade. We propose modifying the opening to match the dimensions of the other, more typically shaped basement windows that sit above grade.

- ☐ Repair
- ☐ Replicate
- ☒ Replace

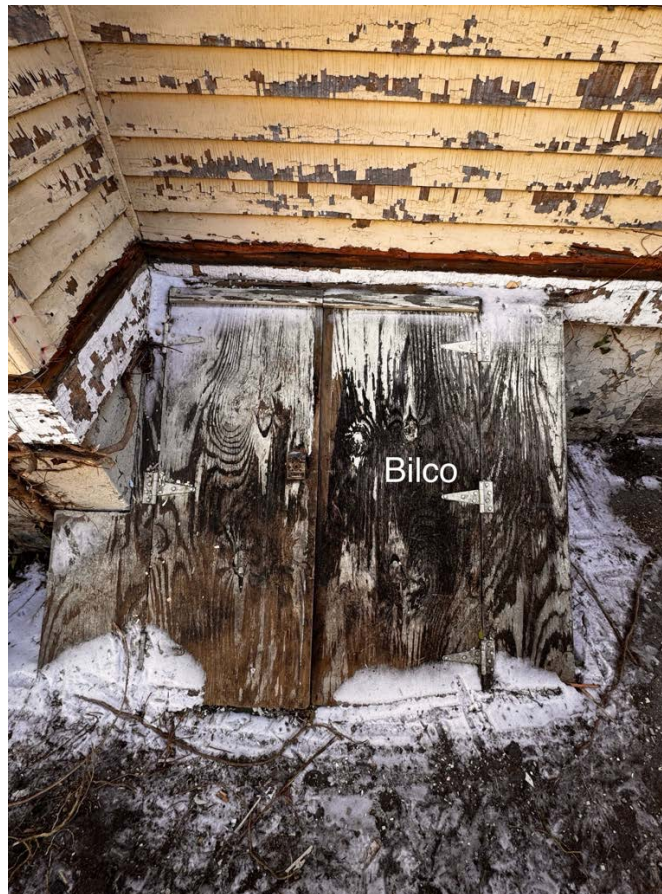
Bilco — Basement, west elevation. Existing concrete steps to exit to grade. There are a pair of interior wooden doors and a pair of exterior wooden doors; all are in poor condition. We propose replacing the entire Bilco enclosure with a new metal unit painted to match the body of the house.

- ☐ Repair
- ☐ Replicate
- ☒ Replace

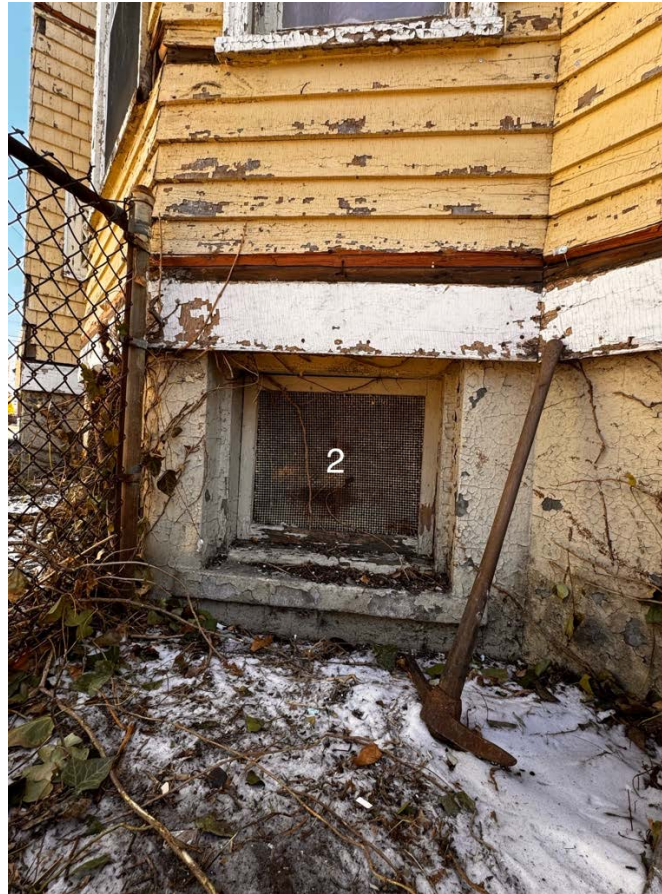
#2 — Basement, west elevation. This window is typical of the single-muntin, two-pane window found throughout the basement. All basement windows are wood and in poor condition. Many of these windows (including this one) have wet rot due to their proximity to grade. The wood is moist and spongy. We proposed replacing all basement windows with a conforming, wood-core window with the same muntin pattern.

- ☐ Repair
- ☐ Replicate
- ☒ Replace

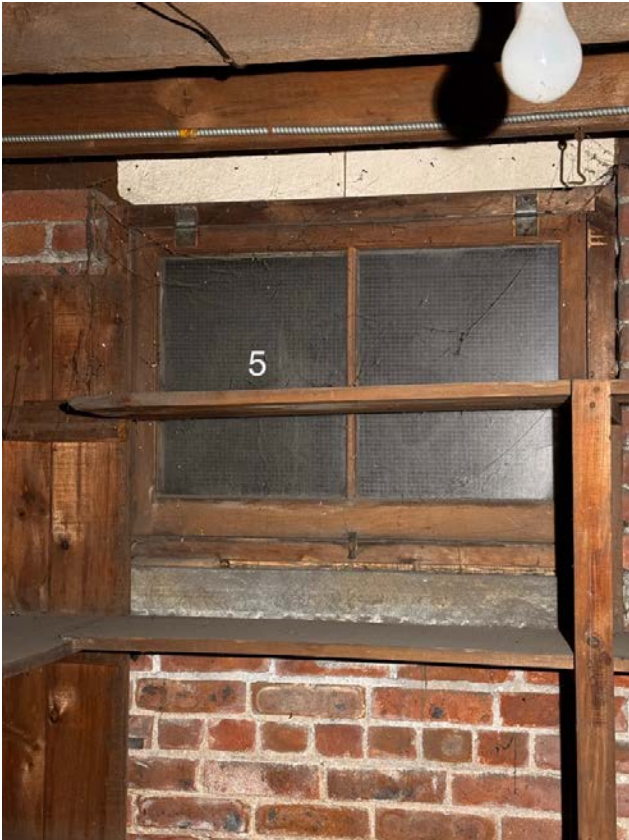
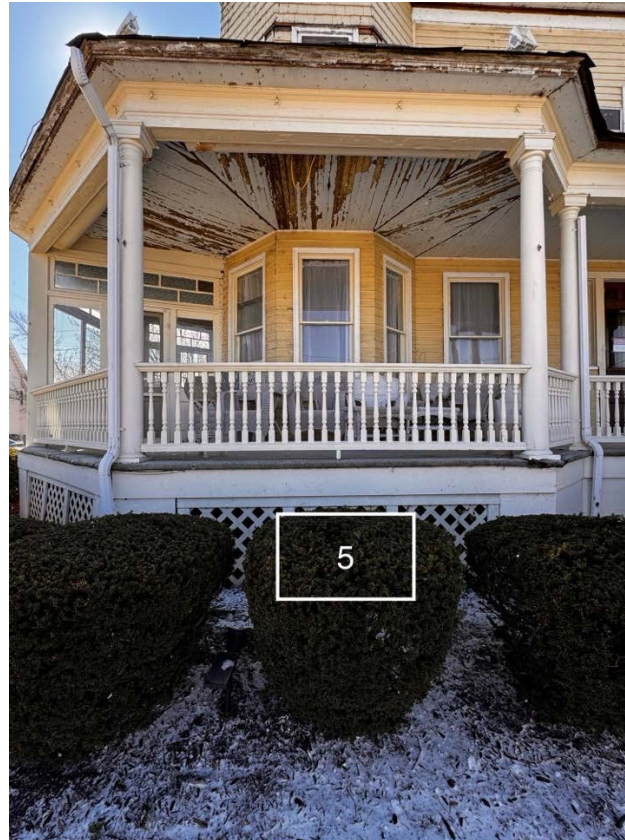
#5 — Basement, north elevation. This window is located beneath the front porch. Because it is sheltered from the elements, it is very good condition. It is not, strictly speaking, visible but we propose retaining it for light and ventilation by replacing it with a conforming, wood-core window to match the others in the basement.

- ☐ Repair
- ☐ Replicate
- ☒ Replace

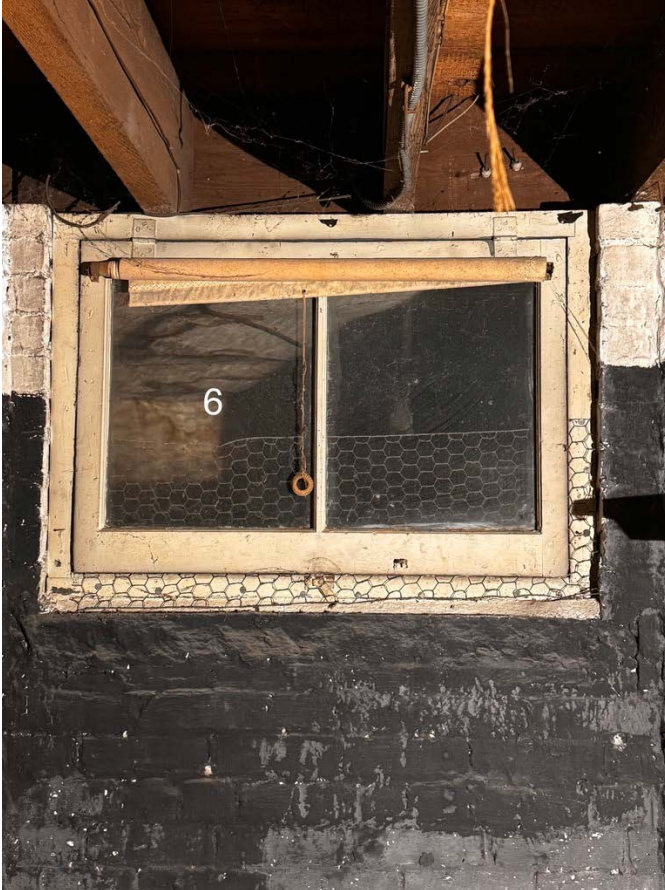
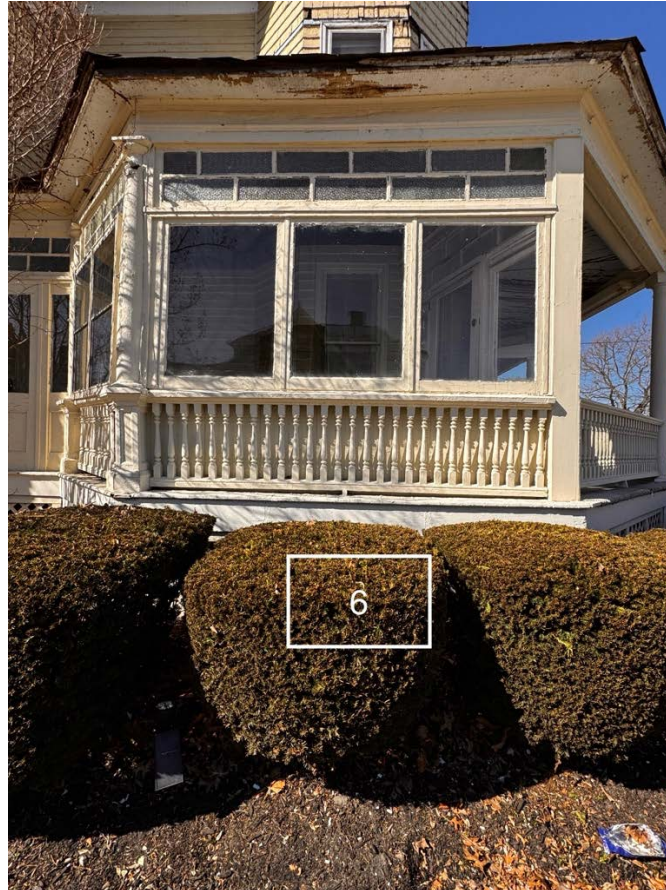
#6 — Basement, east elevation. This window is located beneath the turret porch. Because it is sheltered from the elements, it is very good condition. As above, we proposed replacing this window with a conforming, wood-core window to match the others in the basement.

- ☐ Repair
☐ Replicate
☒ Replace

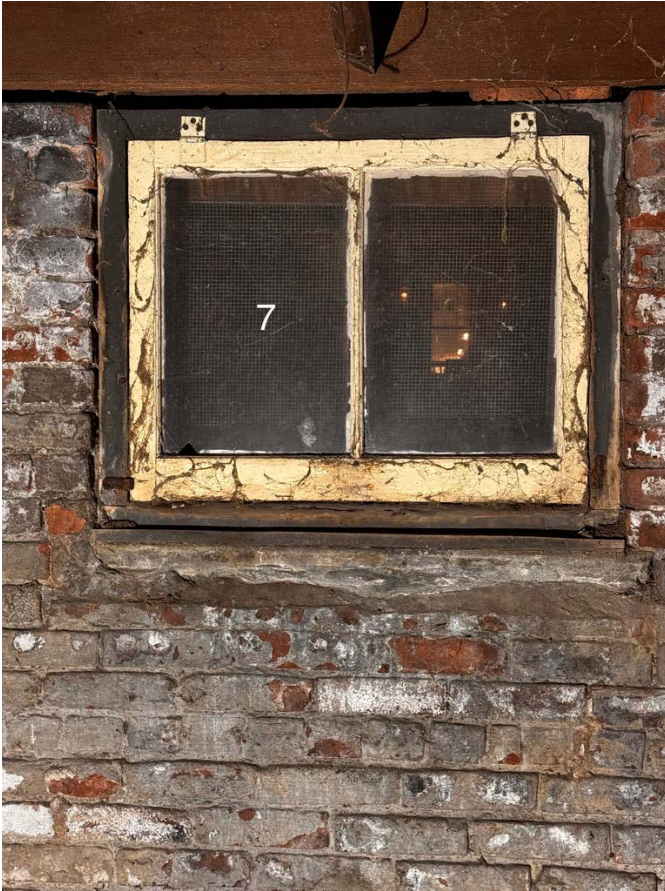
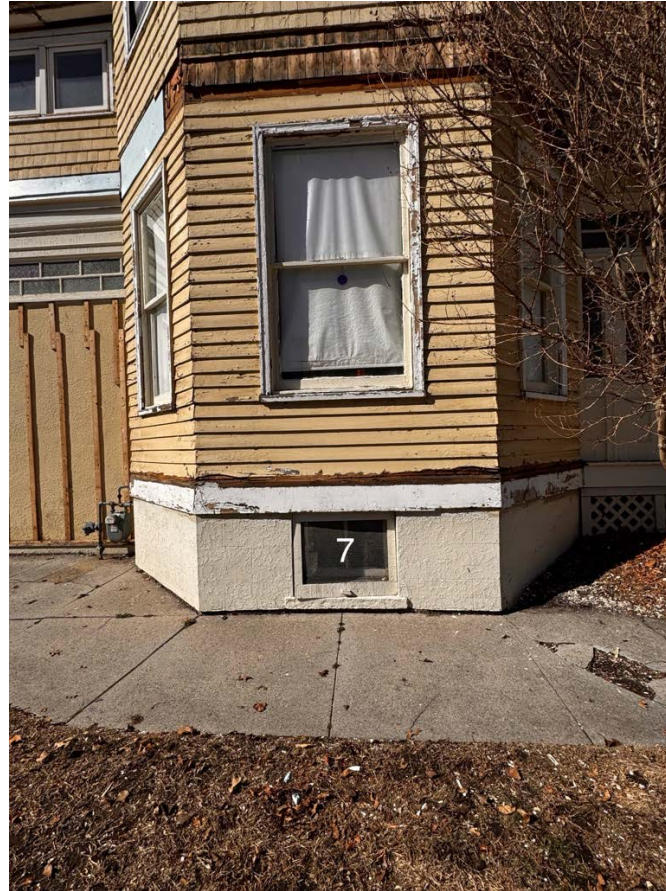
#7 — Basement, east elevation. This window is the only basement window that is visible from the street. The sash and the window frame are both rotted and spongy from water penetration. We propose replacing this window with a conforming, wood-core window to match the others in the basement.

- ☐ Repair
- ☐ Replicate
- ☒ Replace

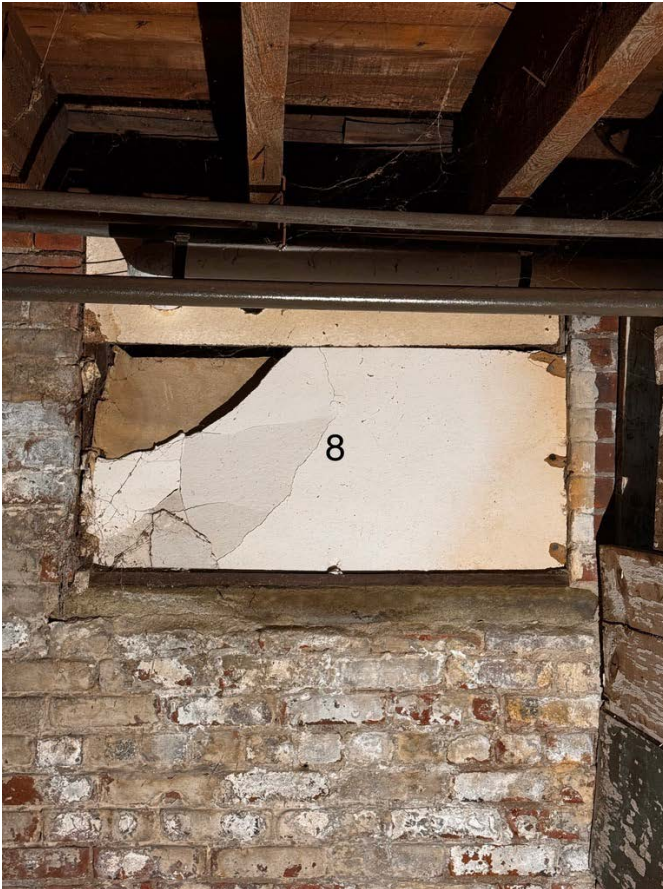
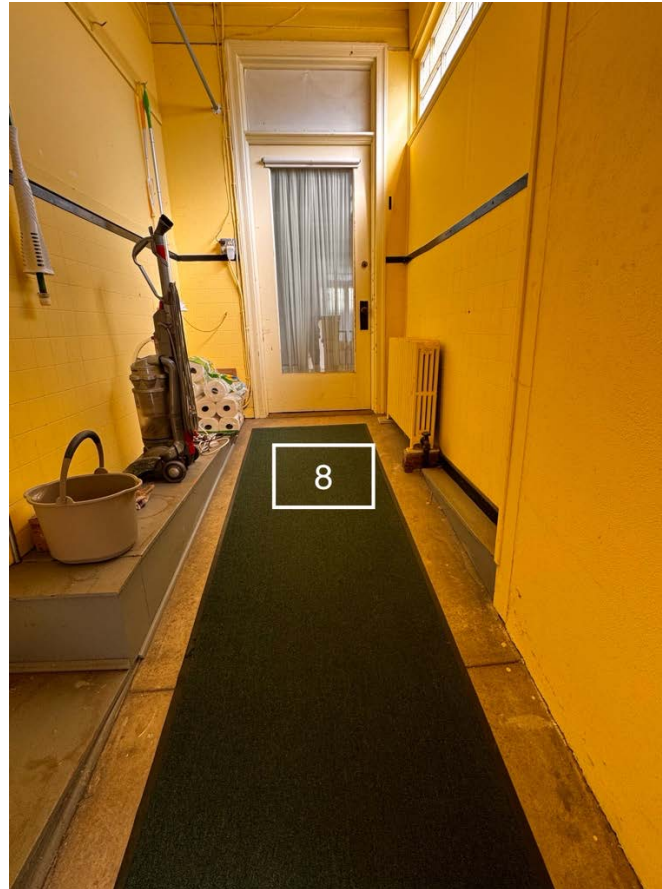
#8 — Basement, south elevation. This window is hidden from view. It used to vent into an area beneath an east-facing side porch (enclosed during an earlier modification. This window (along with window #9) and the existing pitch of roof above this area, are evidence of there once being a porch here (as further shown on the Sanborn maps). This window is now blocked by a concrete ramp leading from the house into the garage. We propose closing this already blocked fenestration.

- ☐ Repair
- ☐ Replicate
- ☒ Replace

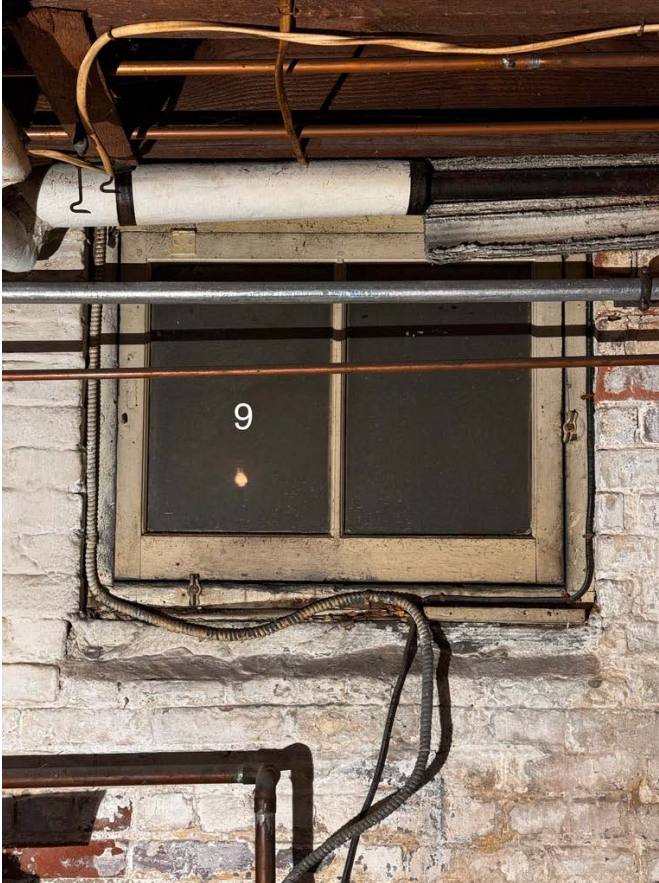
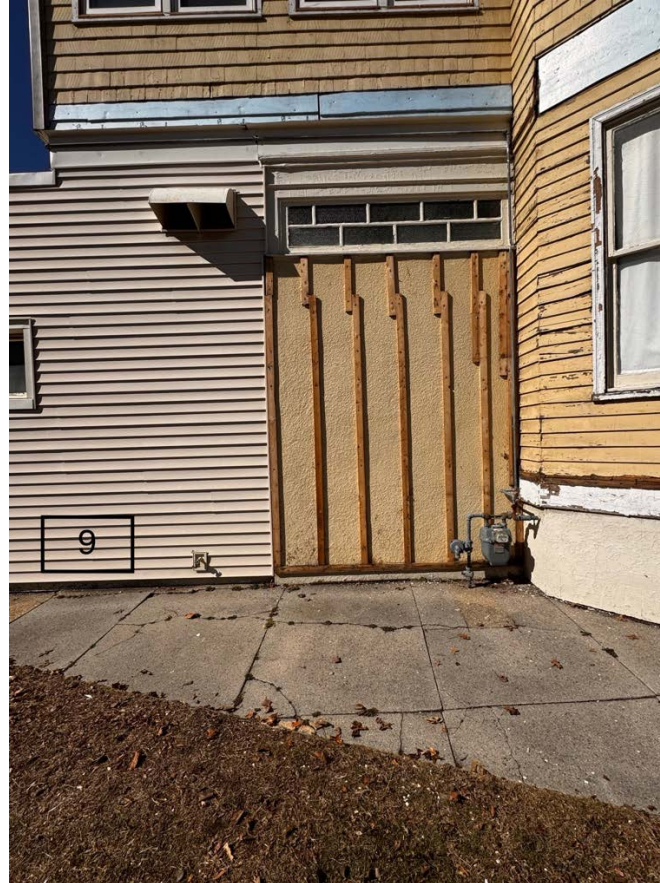
#9 — Basement, east elevation. This window is hidden from view. It used to vent beneath a small east-facing side porch. The window is now blocked by a concrete ramp leading from the house to the garage. We propose closing this opening that is already blocked by poured concrete.

- ☐ Repair
- ☐ Replicate
- ☒ Replace

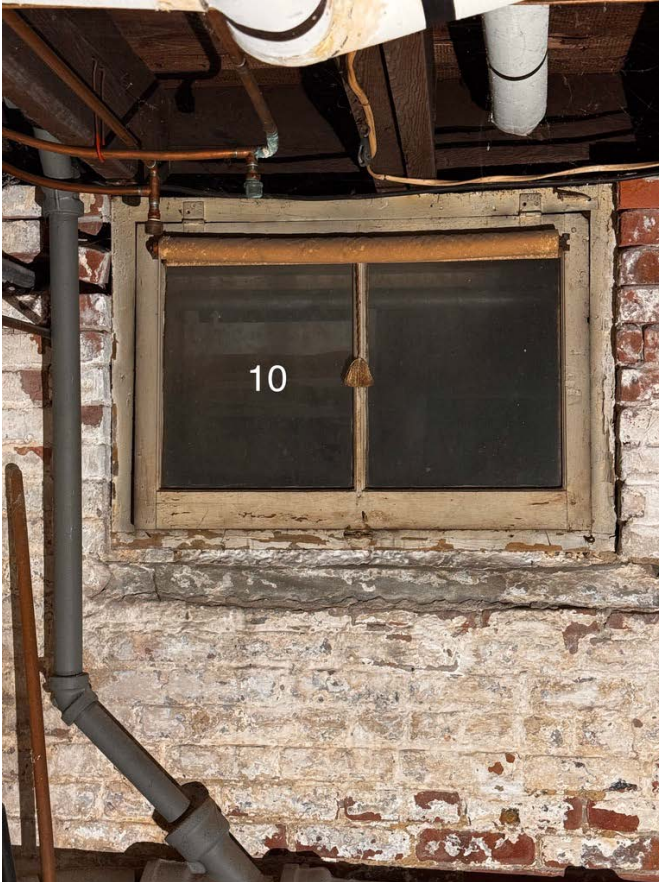
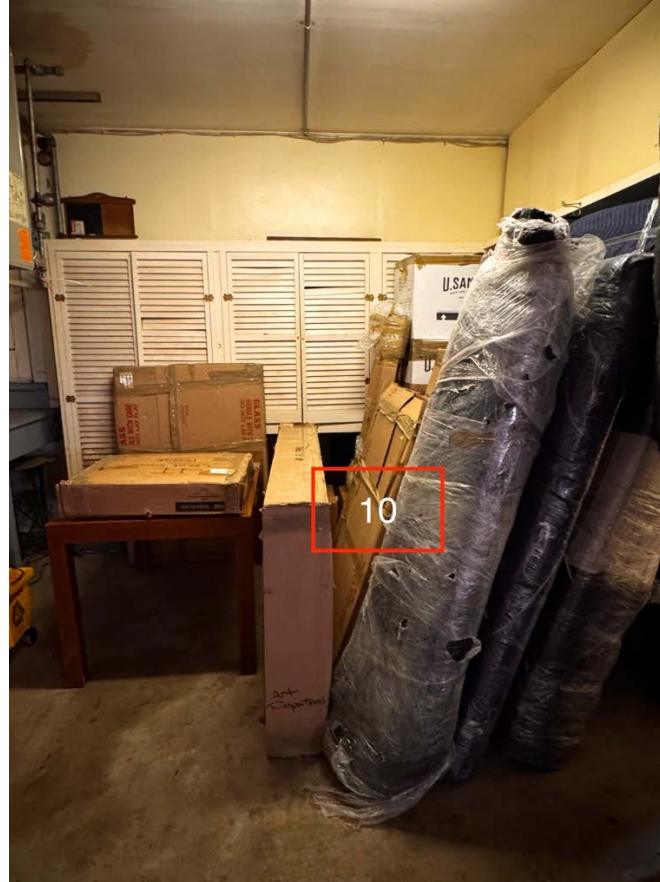
#10 — Basement, south elevation. This window his hidden from view. It used to vent into to the rear of the property but now opens into the garage. We propose closing this opening that no longer opens to the exterior of the building.

- ☐ Repair
- ☐ Replicate
- ☒ Replace

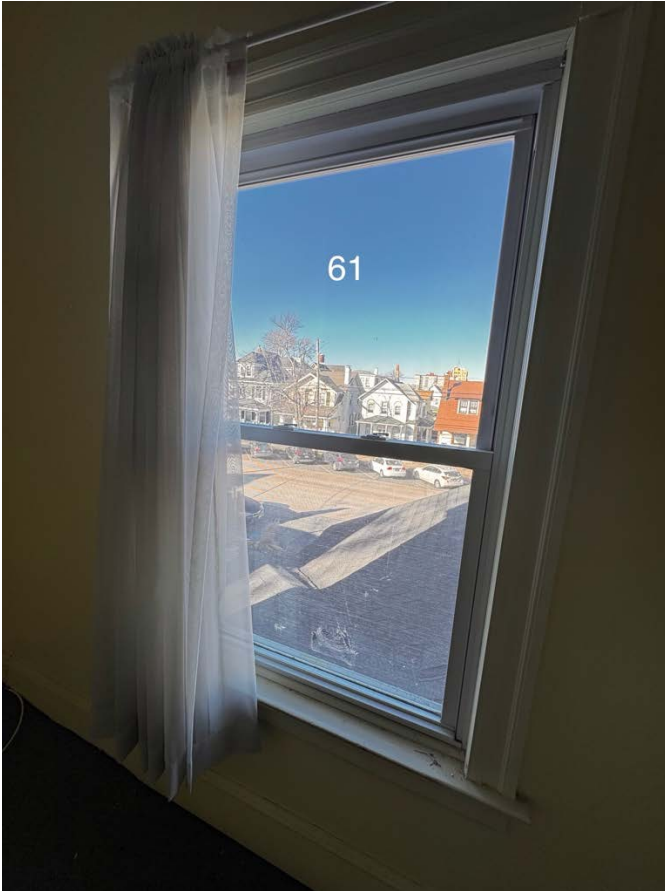
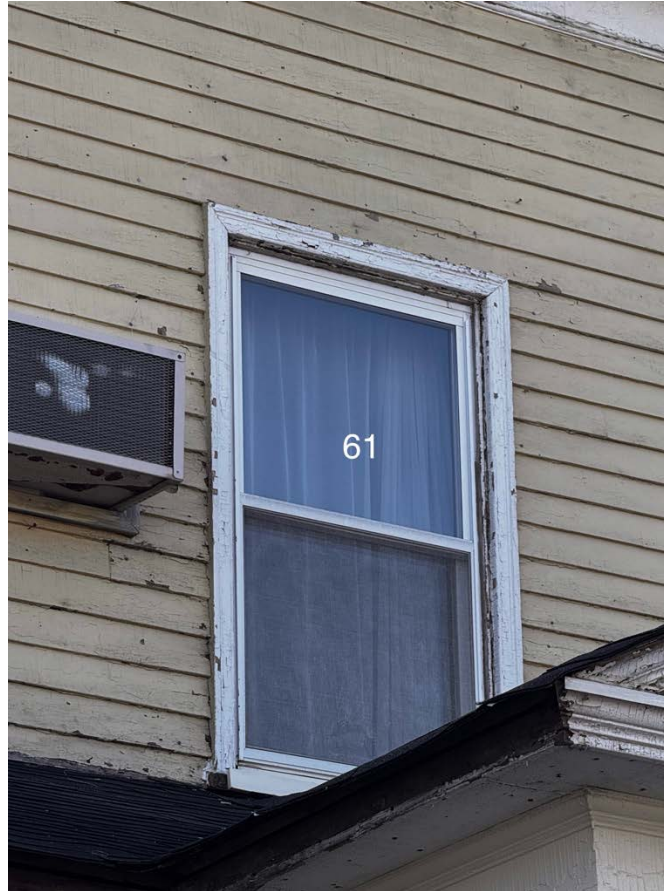
#61 — Level 2, north elevation. This vinyl window is located on Level 2 above the entry pediment.

- ☐ Repair
- ☐ Replicate
- ☒ Replace

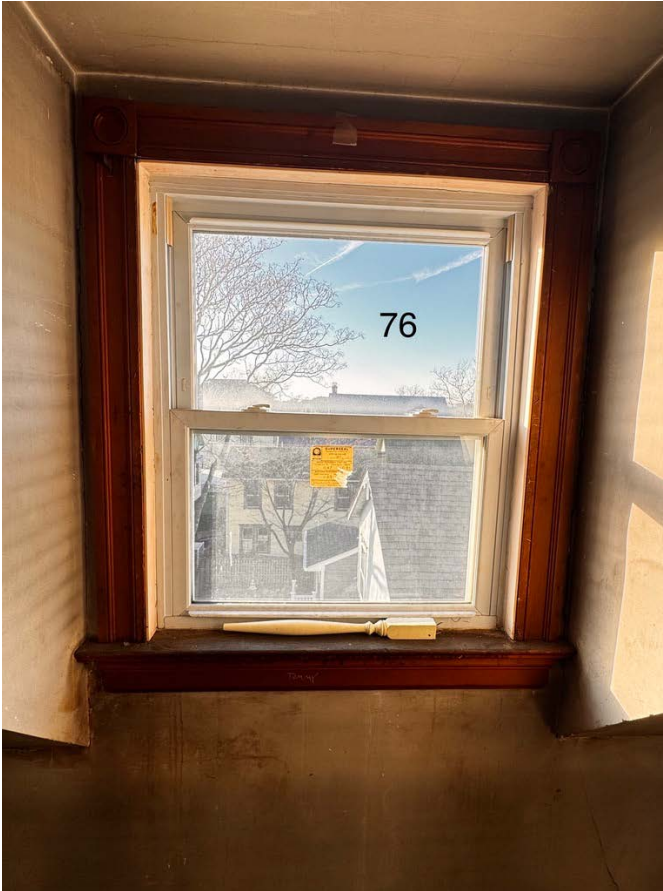
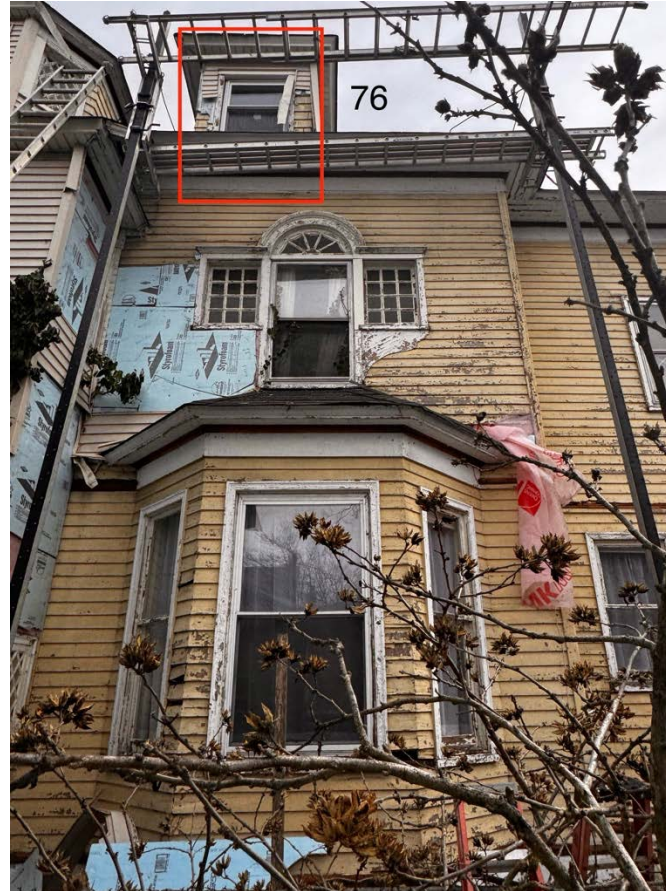
#76 — Level 3, west elevation. This vinyl window is in a west-facing dormer.

- ☐ Repair
- ☐ Replicate
- ☒ Replace

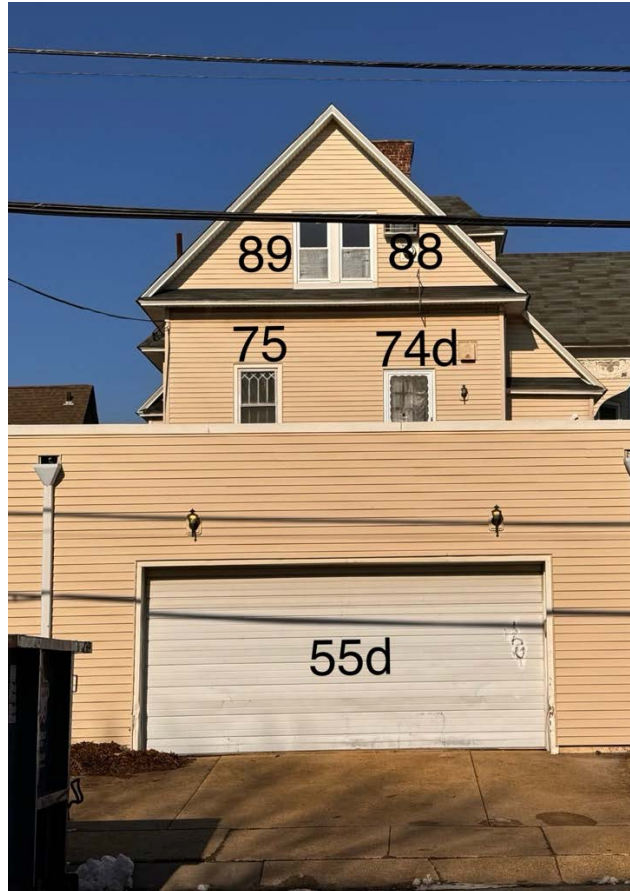
#88 — Level 3, south elevation. This vinyl window is one of a pair in the south facing gable. (This window is not part of the current application but is outlined here for clarity purposes only.)

- ☐ Repair
- ☐ Replicate
- ☒ Replace

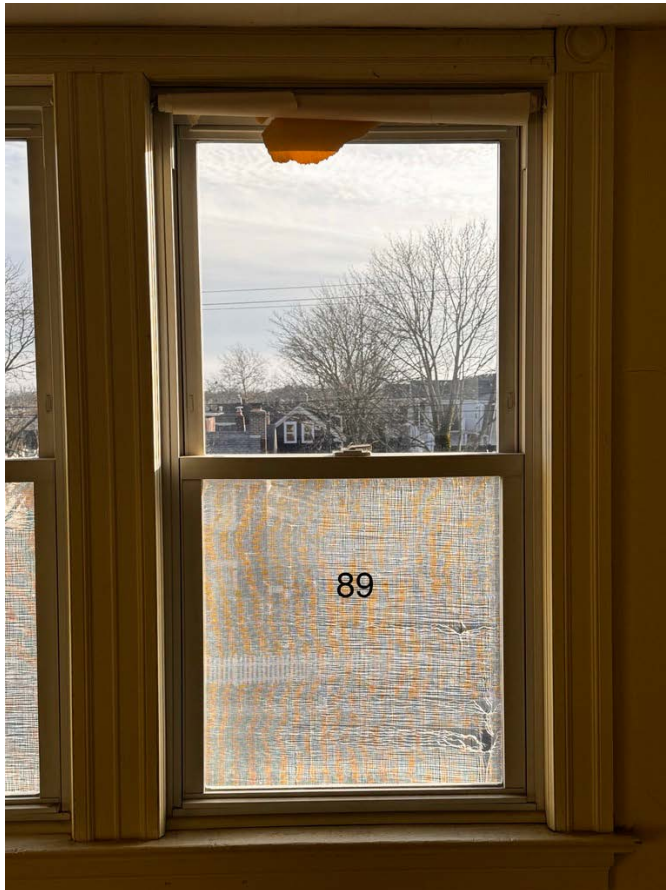
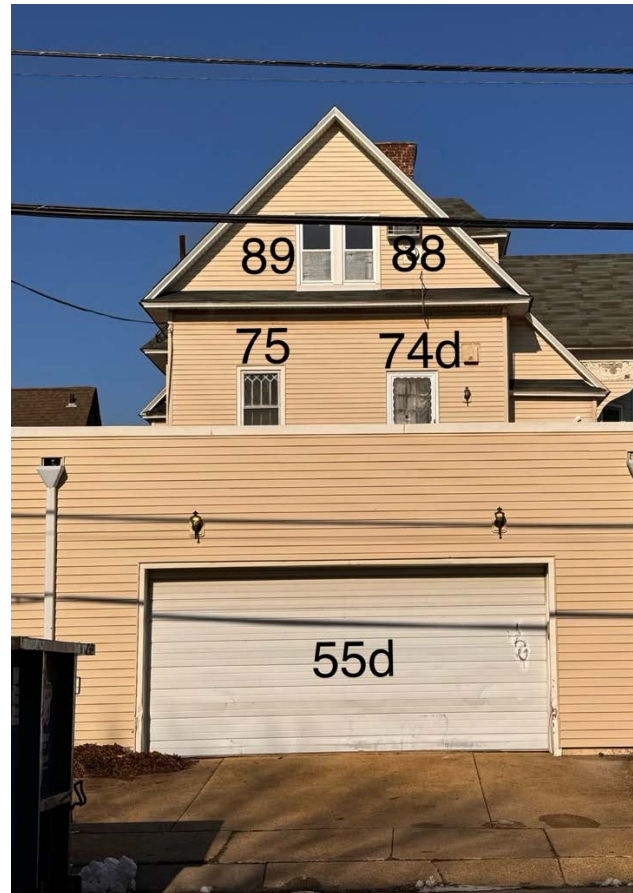
#89 — Level 3, south elevation. This vinyl window is one of a pair in the south facing gable. (This window is not part of the current application but is outlined here for clarity purposes only.)

- ☐ Repair
- ☐ Replicate
- ☒ Replace

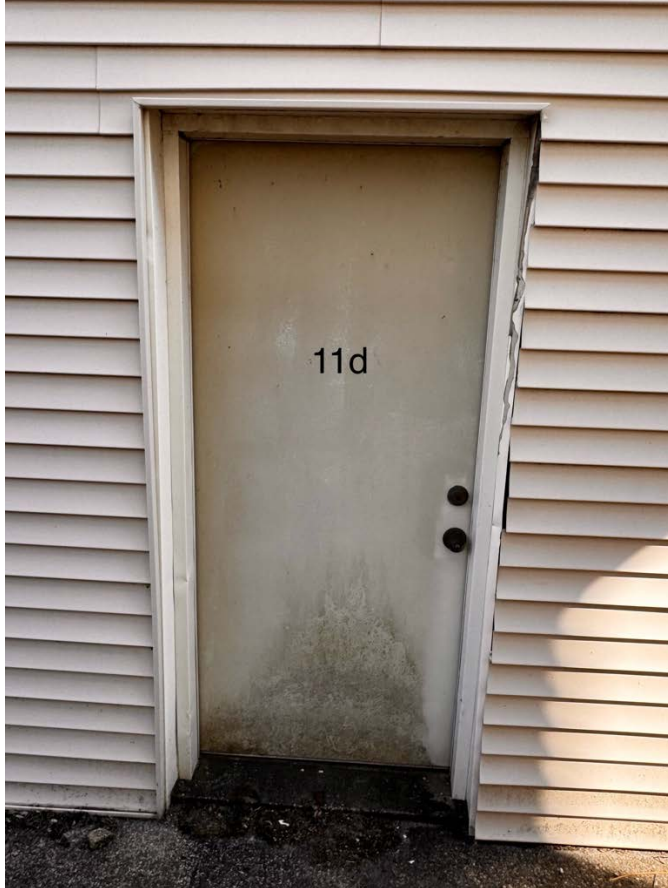
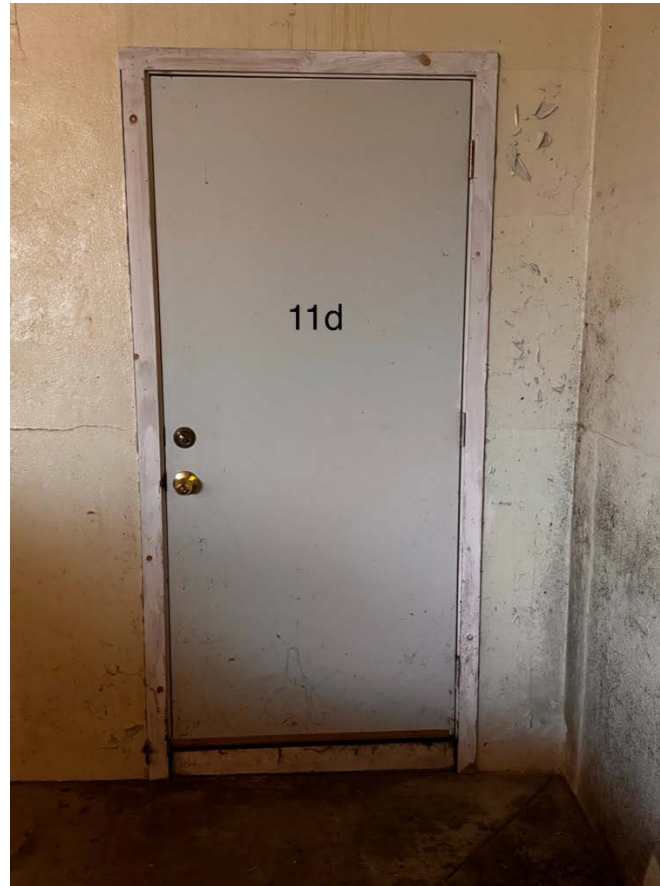
#11d — Level 1, west elevation. This is a metal door at grade on the west elevation of the garage. (This window is not part of the current application but is outlined here for clarity purposes only.)

- ☐ Repair
- ☐ Replicate
- ☒ Replace

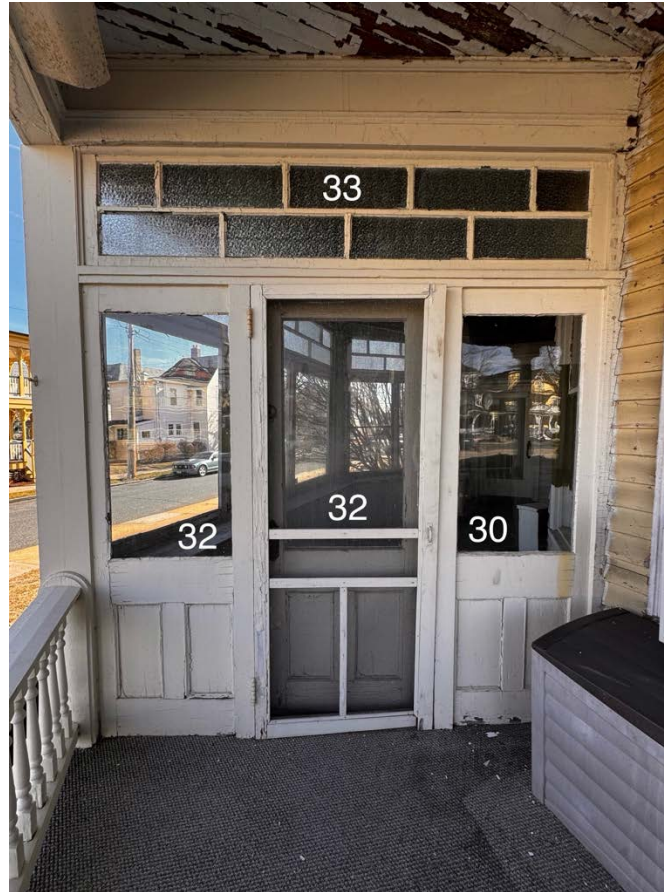
#30d, #31d, #32d, #33 — Level 1, north elevation. These three non-operable ½ light, interior doors were rigged up as a makeshift wall of a non-conforming porch enclosure. They are surmounted by a multi-pane clerestory panel of textured (Florentine) glass. There is no indication any of these elements were part of the original building. These windows to be removed and the historic porch re-opened.

- ☐ Repair
- ☐ Replicate
- ☒ Remove

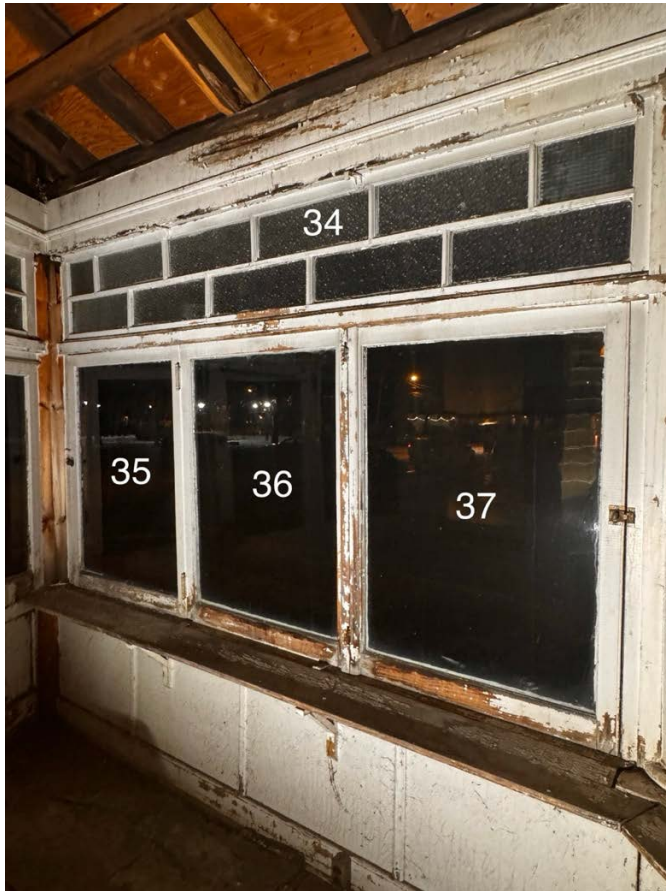
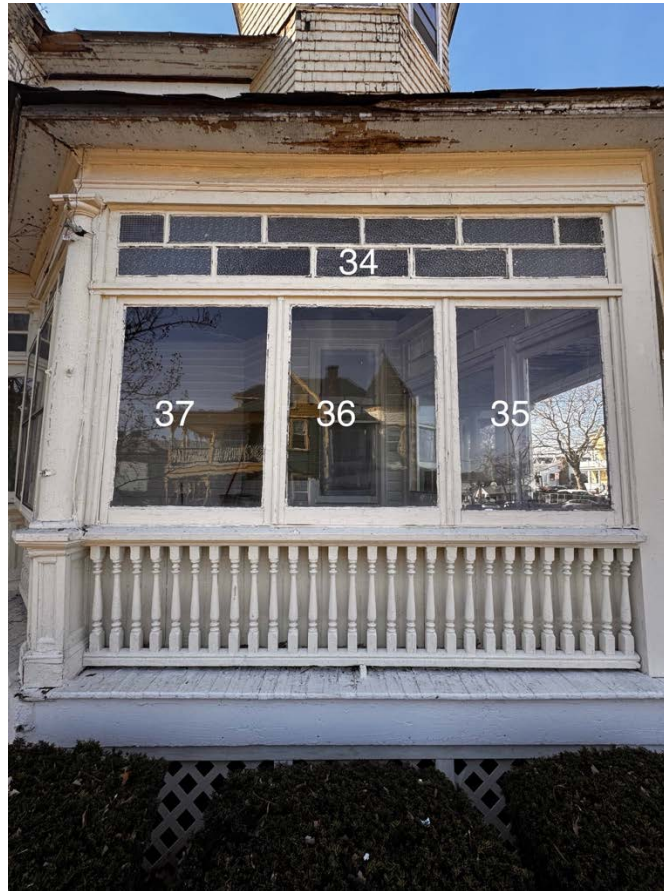
#34, #35, #36, #37 — Level 1, east elevation. These three windows are hinged in such a manner as to have accorded open at one time. They are not original and are inoperable. These windows to be removed completely and the historic porch re-opened.

- ☐ Repair
- ☐ Replicate
- ☒ Remove

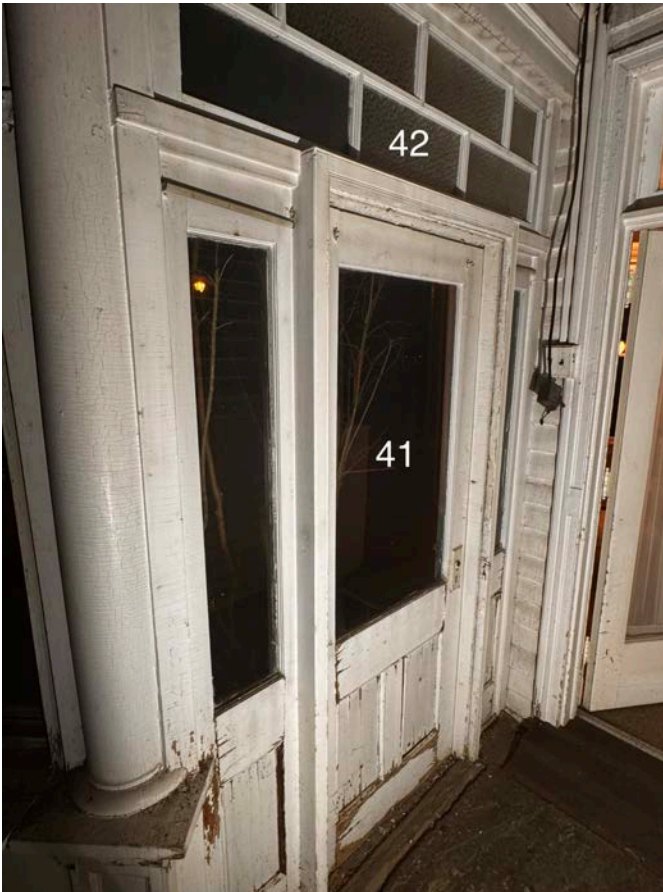
#41d, #42 — Level 1, east elevation. This interior door set with sidelights is not original nor historic. It does not resemble any of the doors or windows found elsewhere in the house. These elements to be removed completely and the historic porch re-opened.

- ☐ Repair
- ☐ Replicate
- ☒ Removed

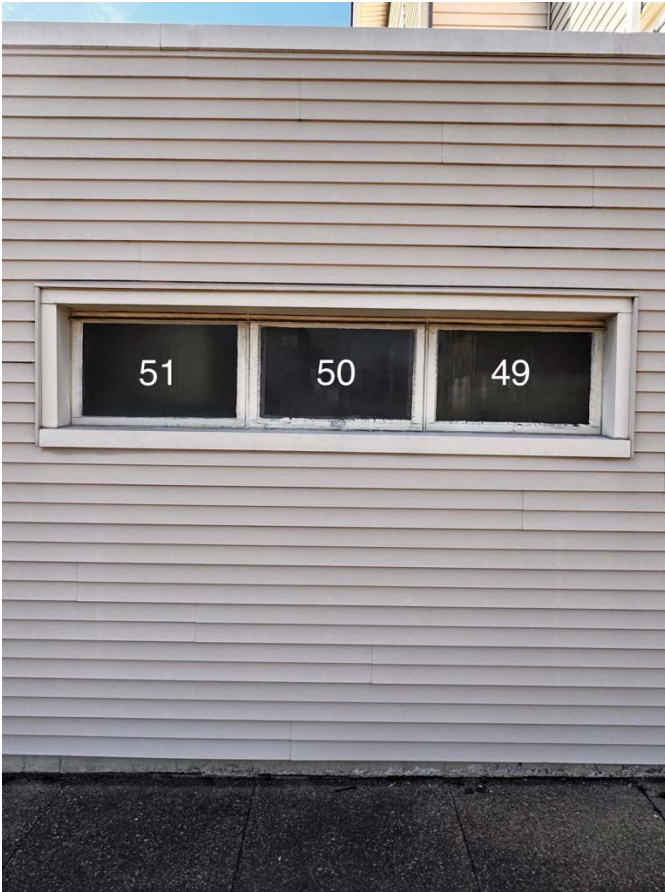
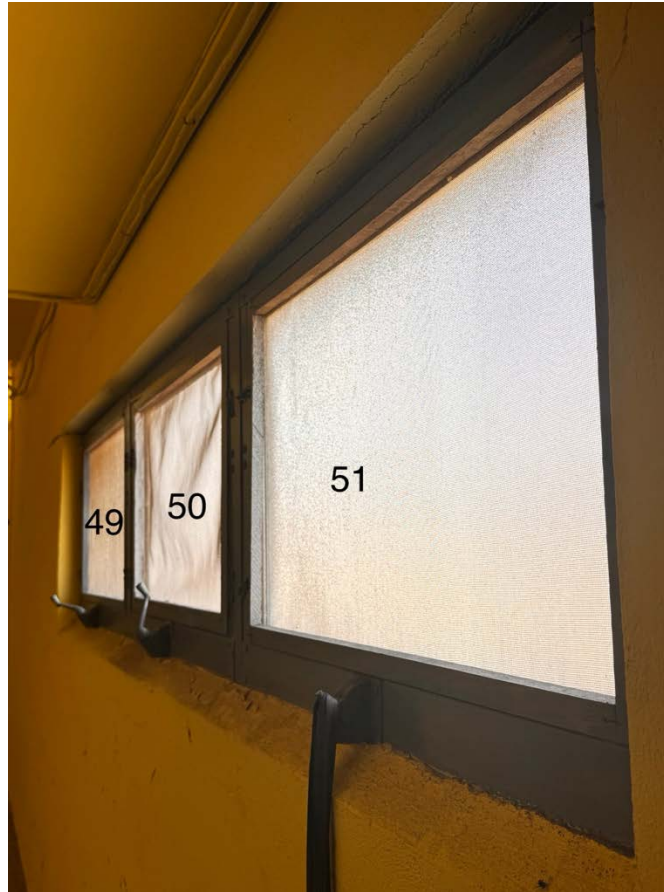
#49, #50, #51 — Level 1, east elevation. This is a set of 3 aluminum awning windows set into the concrete block wall of the garage. New, historically appropriate windows to be installed instead. (This window is not part of the current application but is outlined here for clarity purposes only.)

- ☐ Repair
- ☐ Replicate
- ☒ Replace

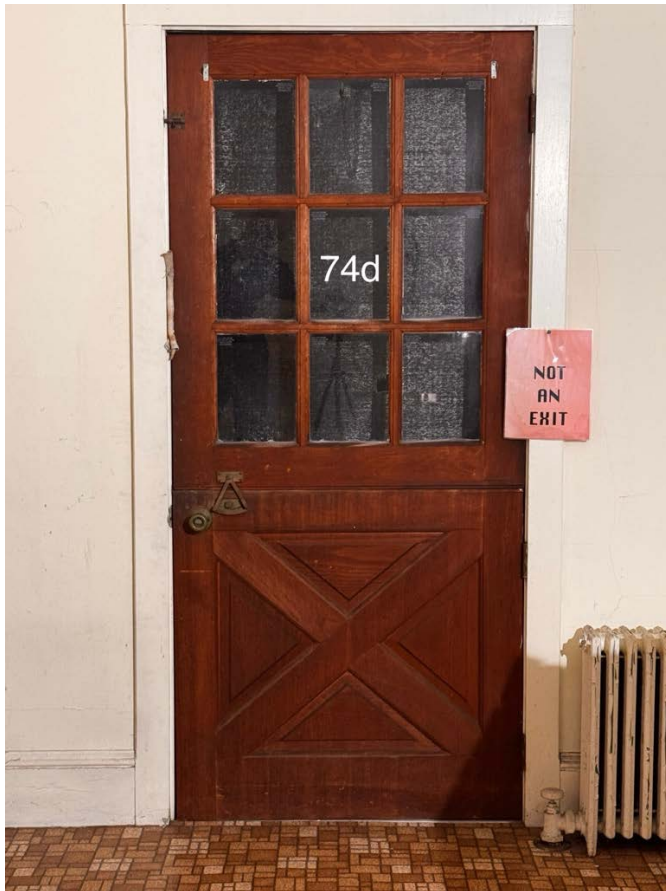
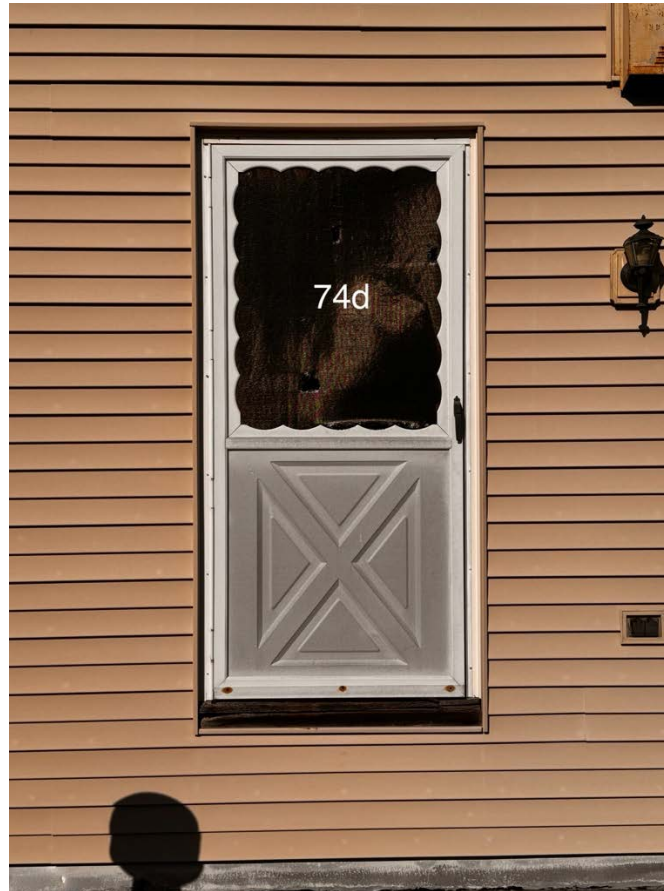
#74d — Level 2, south elevation. This non-conforming Dutch Colonial door is located over the garage and used to lead to a non-conforming roof deck. (This door is not part of the current application but is outlined here for clarity purposes only.)

- ☐ Repair
- ☐ Replicate
- ☒ Remove

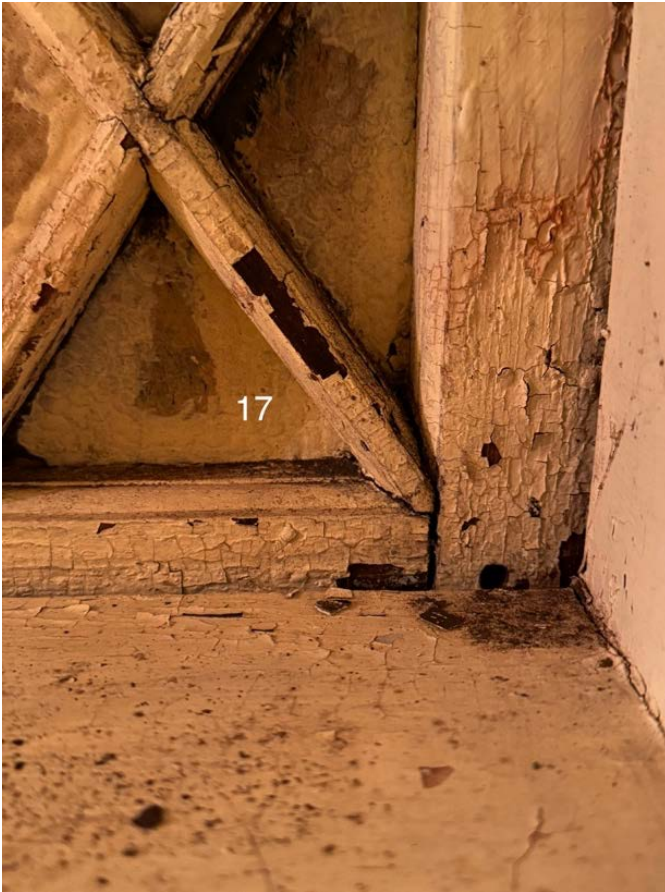
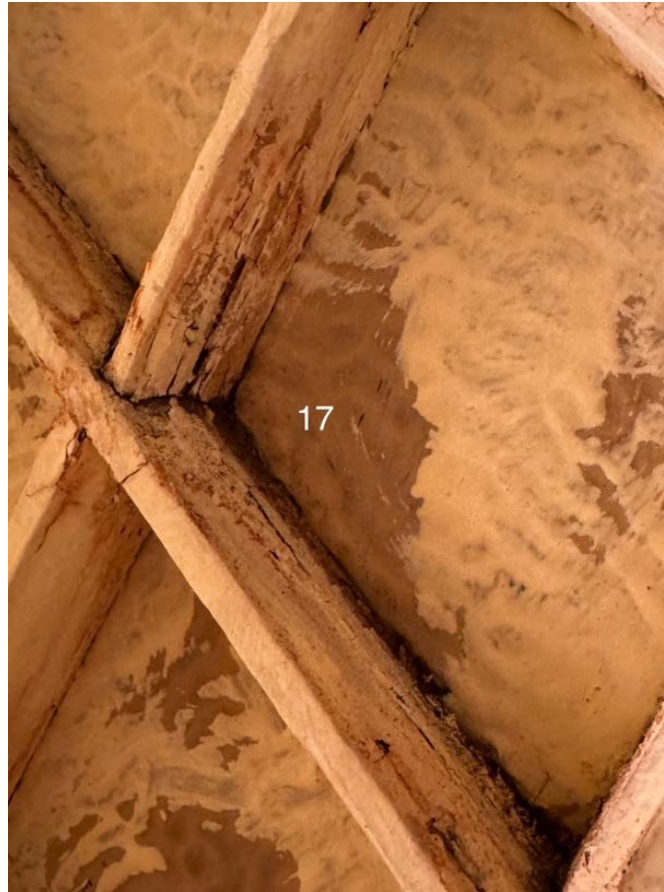
#17 — Level 1, west elevation. This window is located beneath the main stair, in a narrow closet (once a stair leading to the basement). While visible from inside the house, the window had been painted over and buried behind vinyl siding. Removal of the vinyl revealed a window with clear and green, Florentine glass (in a ripple pattern), with diamond muntins. The design and color of this window matches two similar windows on Level 3 (#77 and #70). The presences of these three windows suggests windows #18, #19, and #20 once shared this design. The window is beyond repair but will be replicated by a custom builder using the existing glass.

Detail images show the rot, deterioration of joints, splitting of muntins, evidence of water penetration, and mold.

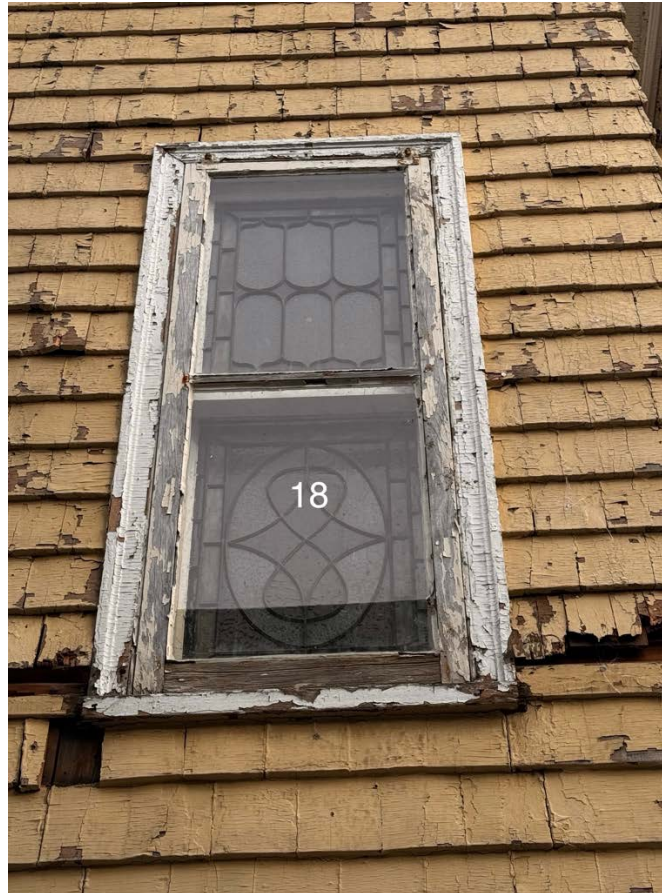
#18 — Level 1, west elevation. We proposed returning these to diamond muntin windows that replicate the patterning, texture and color of windows #17, #77, and #79.

- ☐ Repair
- ☐ Replicate
- ☒ Replace
