06. Window and Door Condition Report

The house currently contains 89 doors and windows that fall under the purview of the Commission. We have sorted these into five categories: Basement Windows, Historic Windows, Secondary Windows, Vinyl Windows, and Modern Windows. To assist in understanding and reviewing so many fenestrations, we have color-coded them by type and illustrated their location on the enclosed floor plans and elevations. Also included are photographs of each individual window and door showing its characteristics and condition.

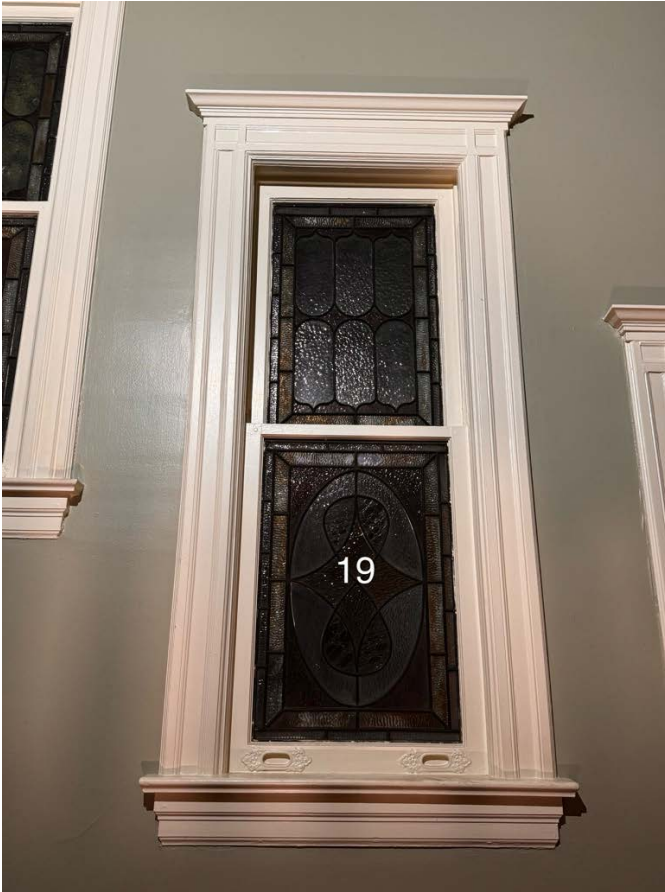
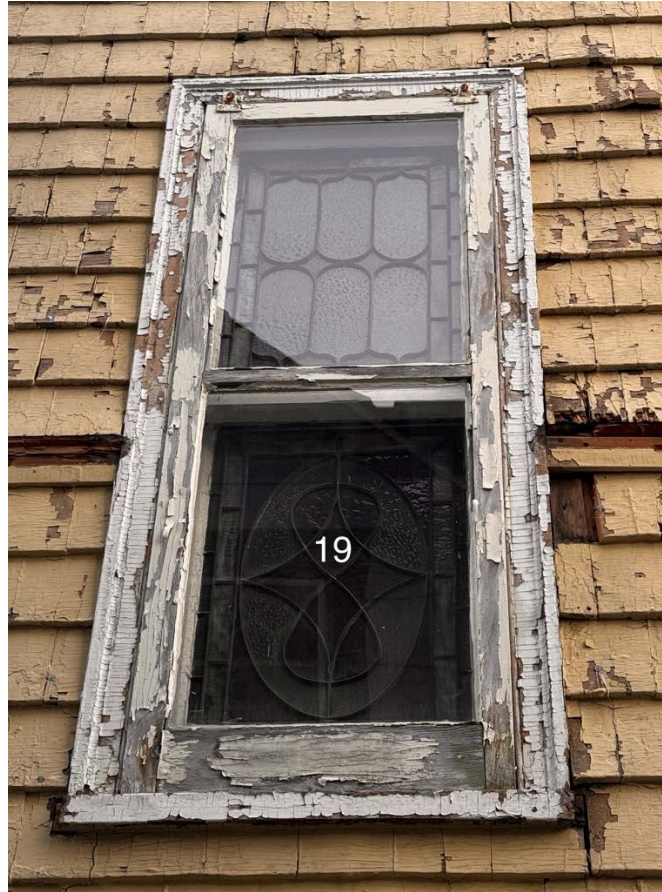
#19 — Level 1, west elevation. We proposed returning these to diamond muntin windows that replicate the patterning, texture and color of windows #17, #77, and #79.

- ☐ Repair
- ☐ Replicate
- ☒ Replace

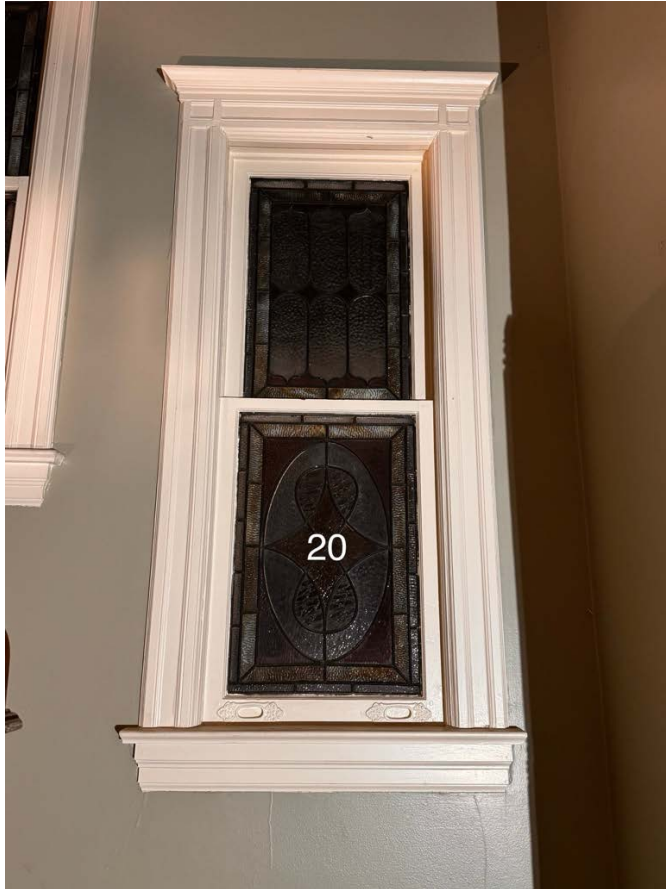
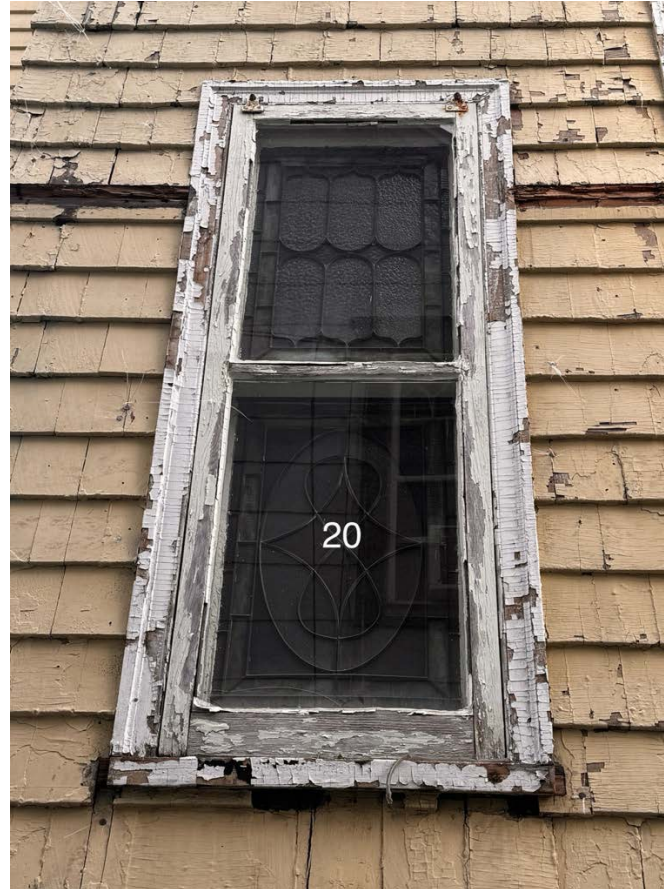
#20 — Level 1, west elevation. We proposed returning these to diamond muntin windows that replicate the patterning, texture and color of windows #17, #77, and #79.

- ☐ Repair
- ☐ Replicate
- ☒ Replace

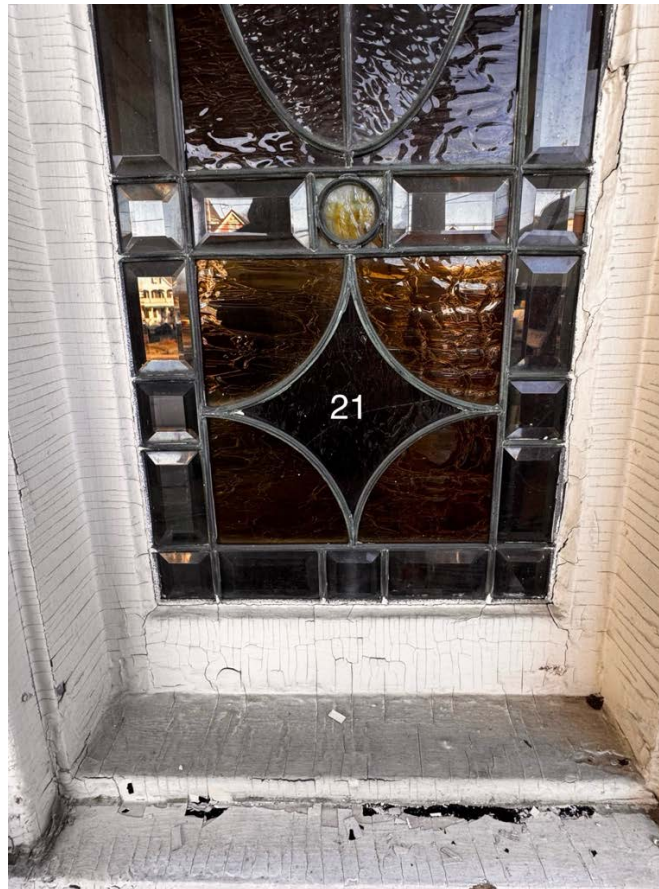
#21 — Level 1, north elevation. The how the sidelight at the right of the entry doors does not abut, and is not enclosed in the entry trims, as is typical with sidelights. Also, note how the upper right corner of the window crowds the area where the porch roof returns to the body of the house.

It is impossible to know why this one sidelight is offset. We proposed nudging the window left so that it flanks the door set (and falls within the door-frame trim) in a more historically appropriate manner.

- ☒ Repair
☐ Replicate
☐ Replace

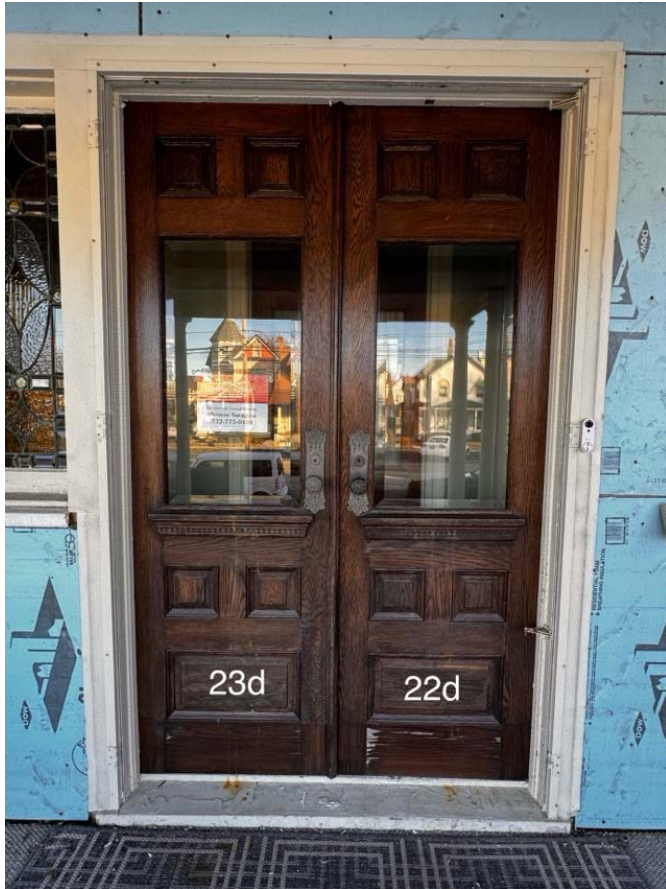
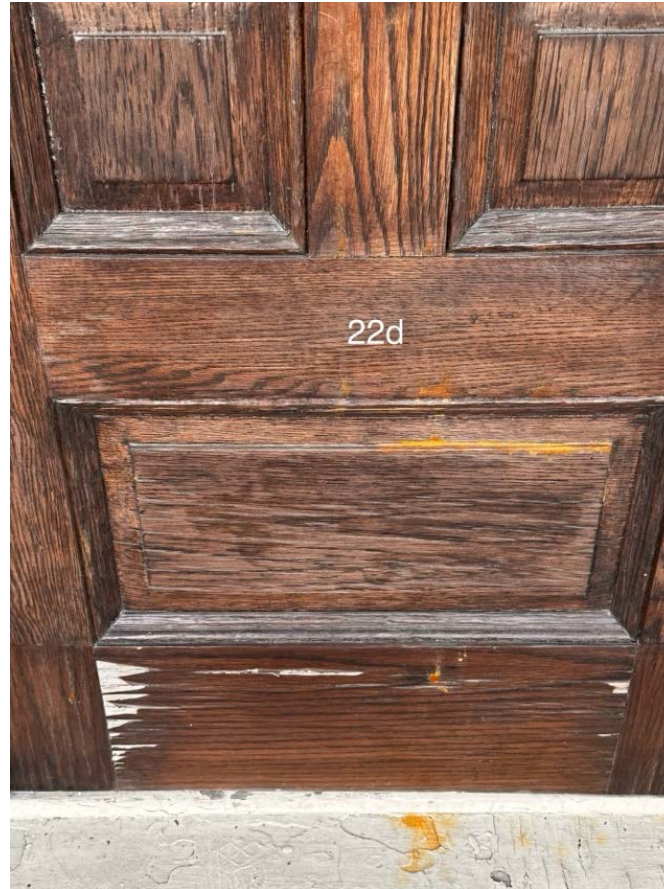
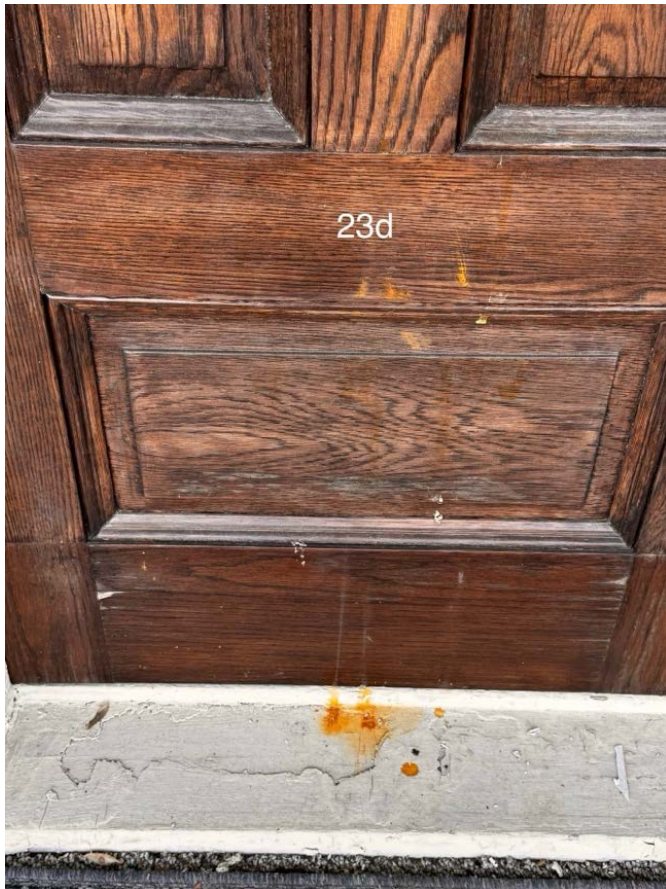
#22d, #23d — Level 1, north elevation. Minor deterioration will be repaired and the restored doors retained.

- ☒ Repair
- ☐ Replicate
- ☐ Replace

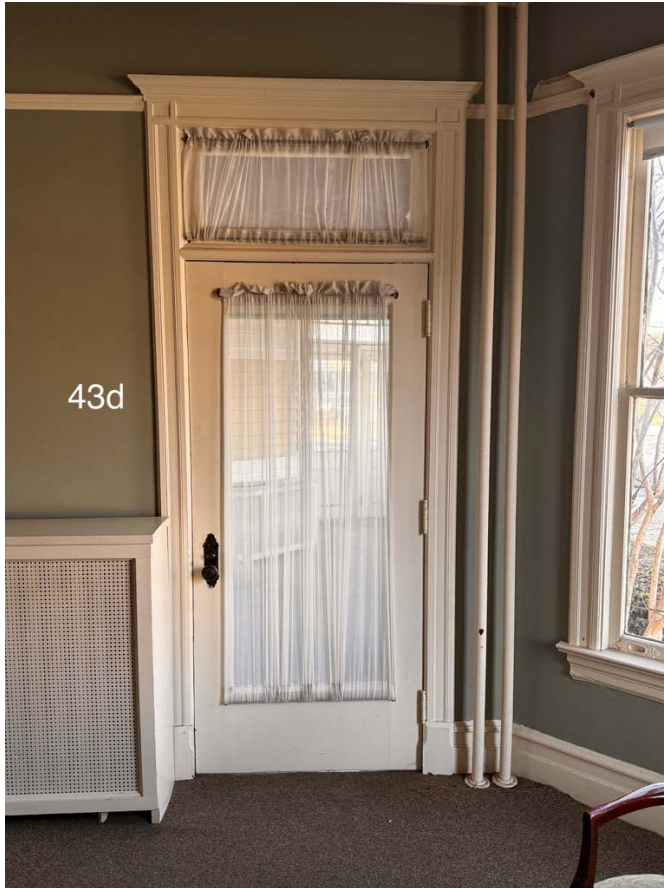
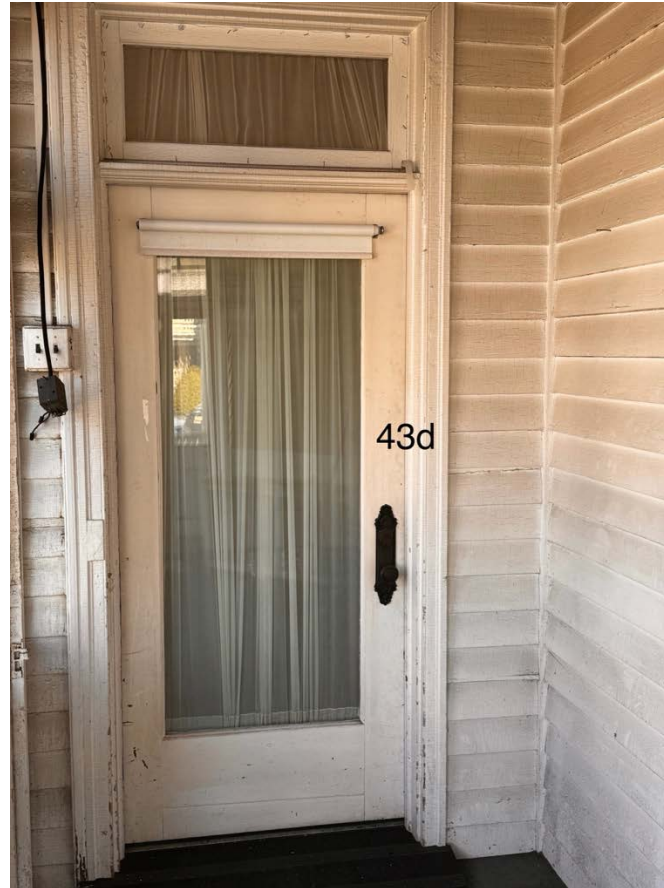
#43d — Level 1, east elevation. This door currently opens into the enclosed portion of the front porch. Once the porch is re-opened to its historic configuration, this door and transom will become a highly visible exterior elements. They will be retained and restored.

- ☒ Repair
☐ Replicate
☐ Replace

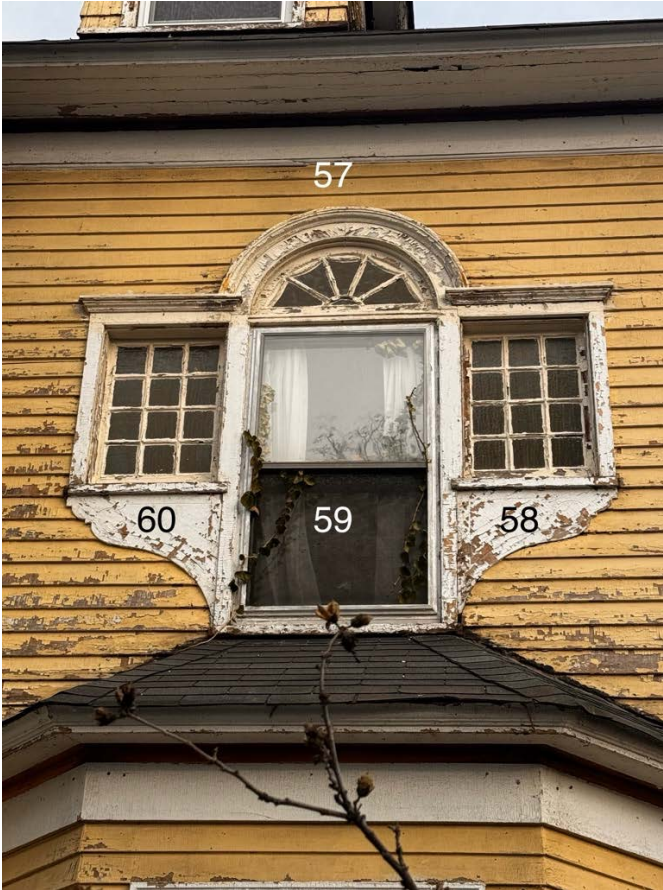
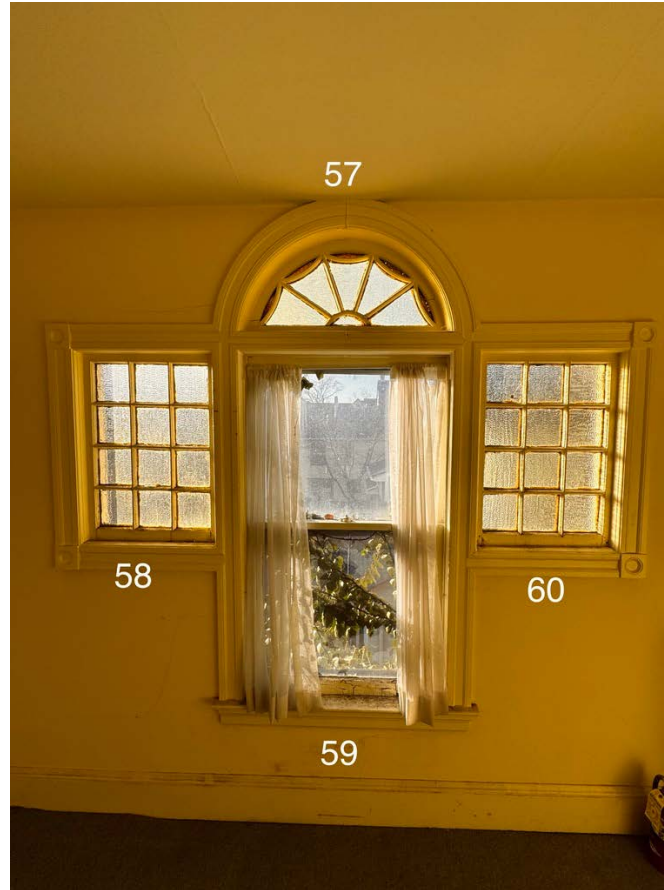
#57, #58, #59, #60 — These sashes are beyond reasonable repair in my opinion.”

#57, #58, #59, #60 — Level 2, west elevation. These four windows form a group.

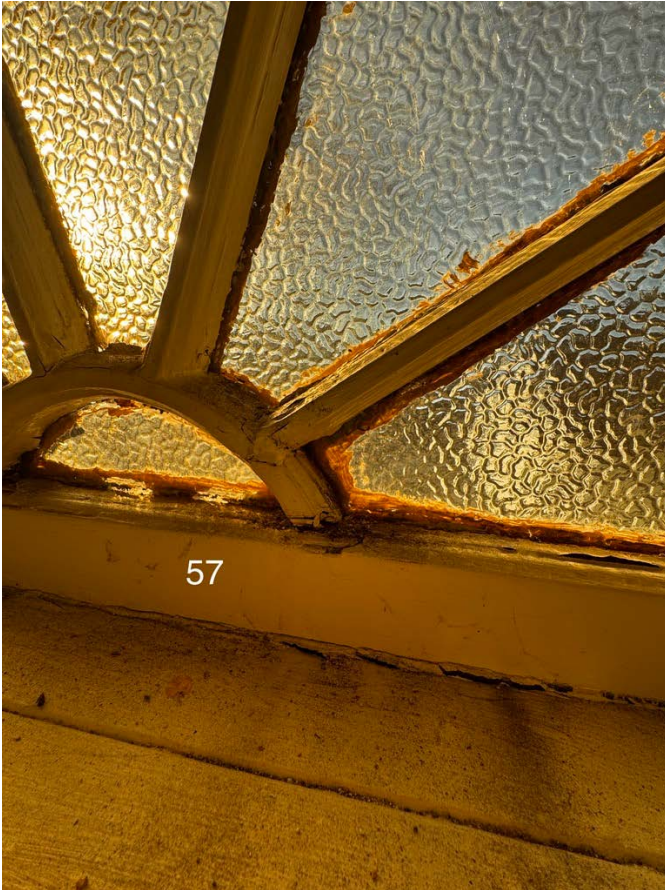
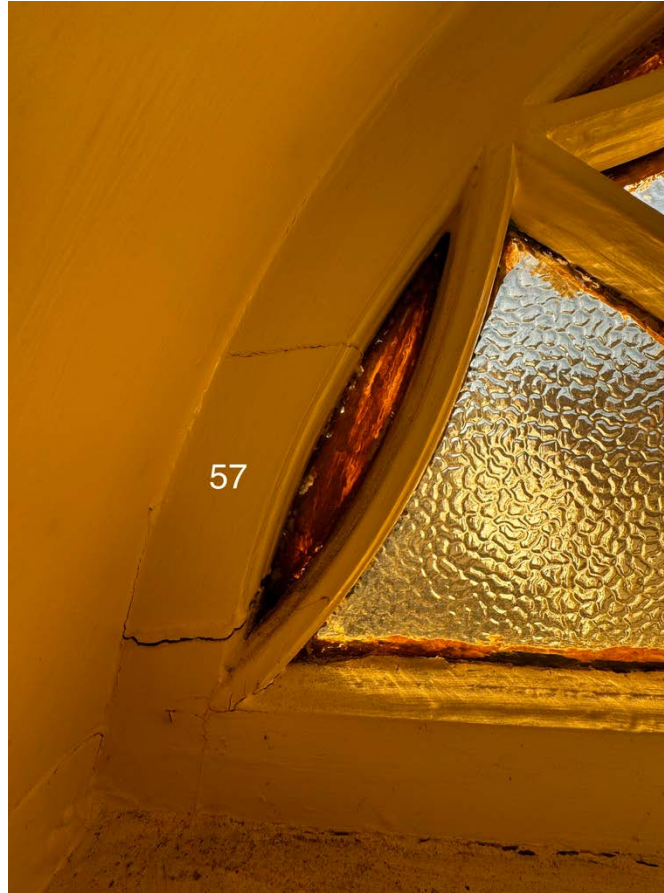
#57 – Level 2, west elevation. This is the only fan window in the building. Mr. Eastin’s report states, “The mulls have deteriorated to the point that only the pressure of the window being in place is keeping them together.” The window to be replicated by a custom building using existing glass.

- ☐ Repair
- ☒ Replicate
- ☐ Replace

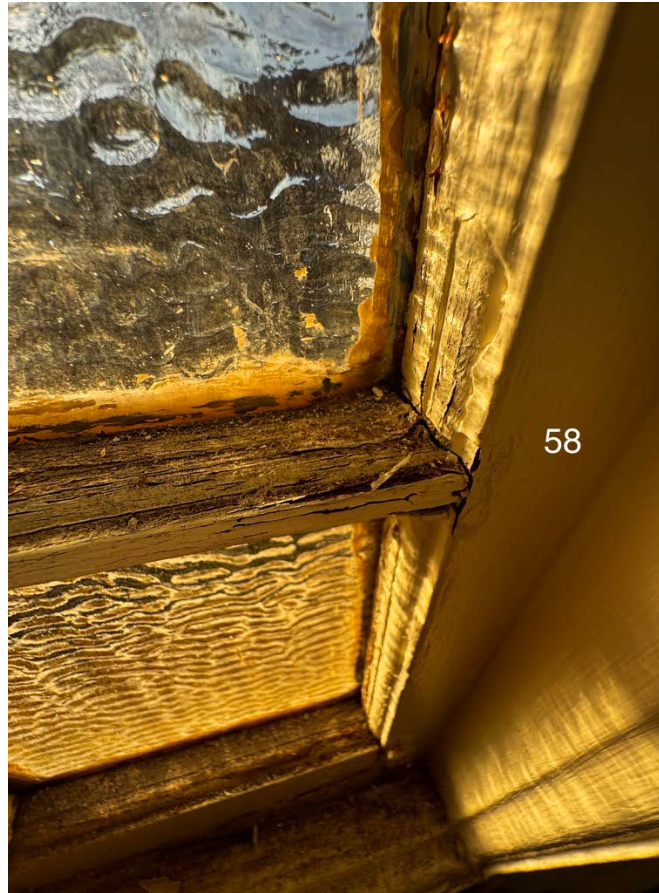
#58 — Level 2, west elevation. This appears to be a stationary window, though it may be a hopper windows (as is be found in #84 and #86). The window will have to be removed before its operability can be determined. The wood of the window is not restorable. Window to be replaced with a conforming window of the same dimensions and muntin configuration.

- ☐ Repair
- ☐ Replicate
- ☒ Replace

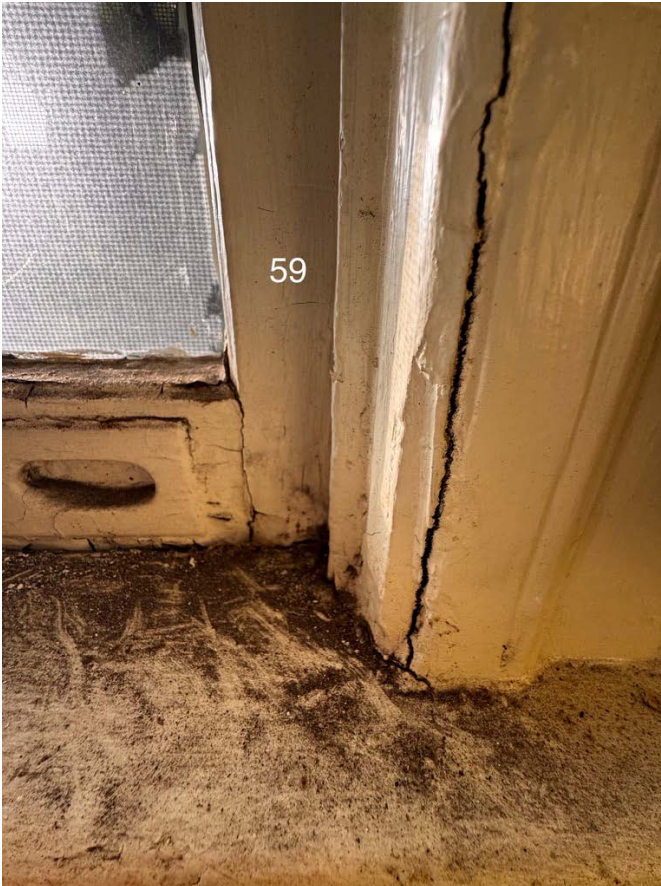
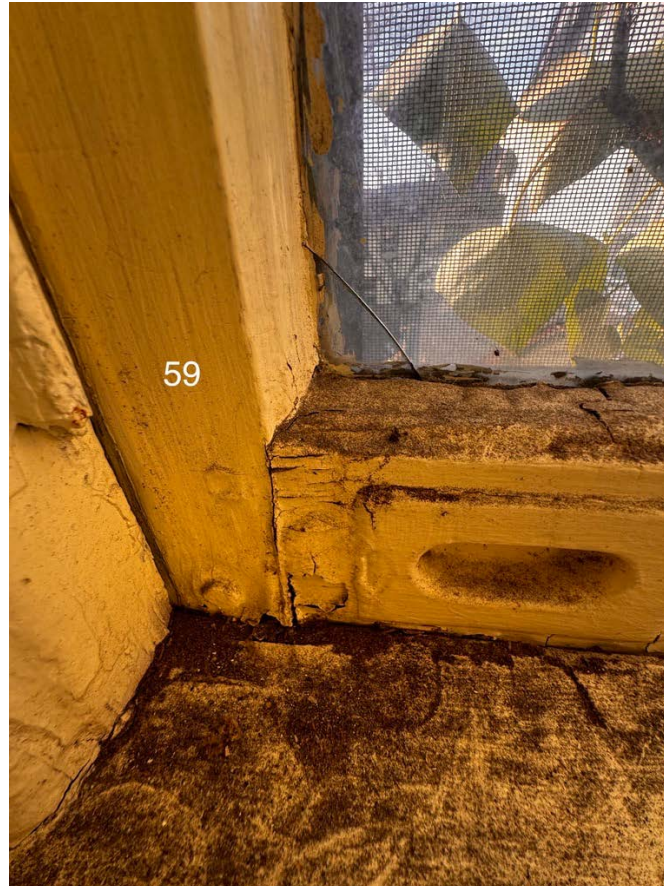
#59 — Level 2, west elevation. This double-hung window is the only operable window in this group. The interior wood condition is poor with the assembly pegs missing in areas (and replaced with caulk). Window to be replaced with conforming Andersen “A” Series.

- ☐ Repair
- ☐ Replicate
- ☒ Replace

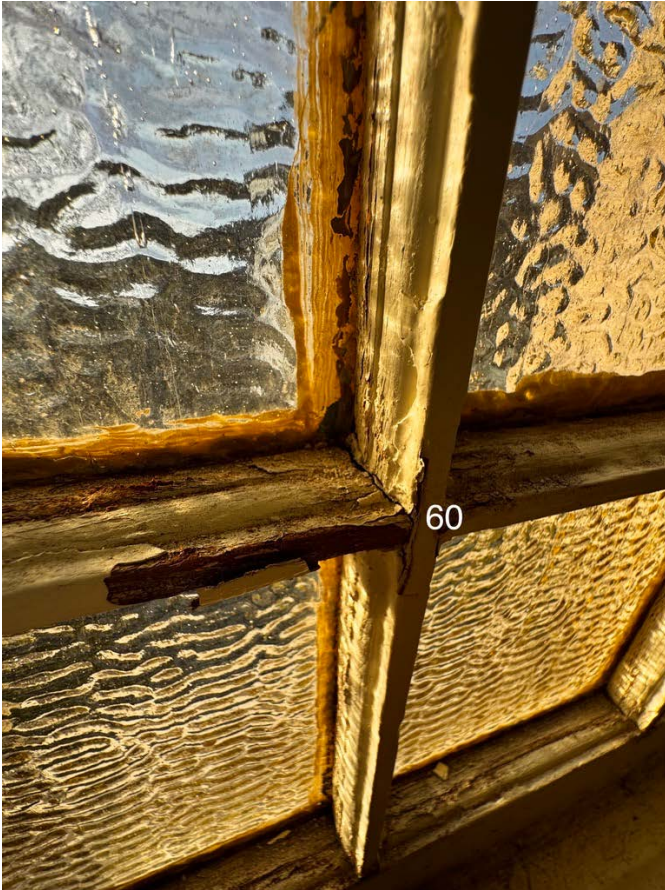
#60 — Level 2, west elevation. This window is the pair to window #58. Pegs holding the sashes together have dried and shrunk to the point where they have come unmoored or fallen out completely. Exterior conditions are very poor. Window to be replaced with a conforming window of the same dimensions and muntin configuration.

#60 — Level 2, west elevation. Detail of muntins showing them deteriorated to the point they’ve become soft and fibrous.

- ☐ Repair
- ☐ Replicate
- ☒ Replace

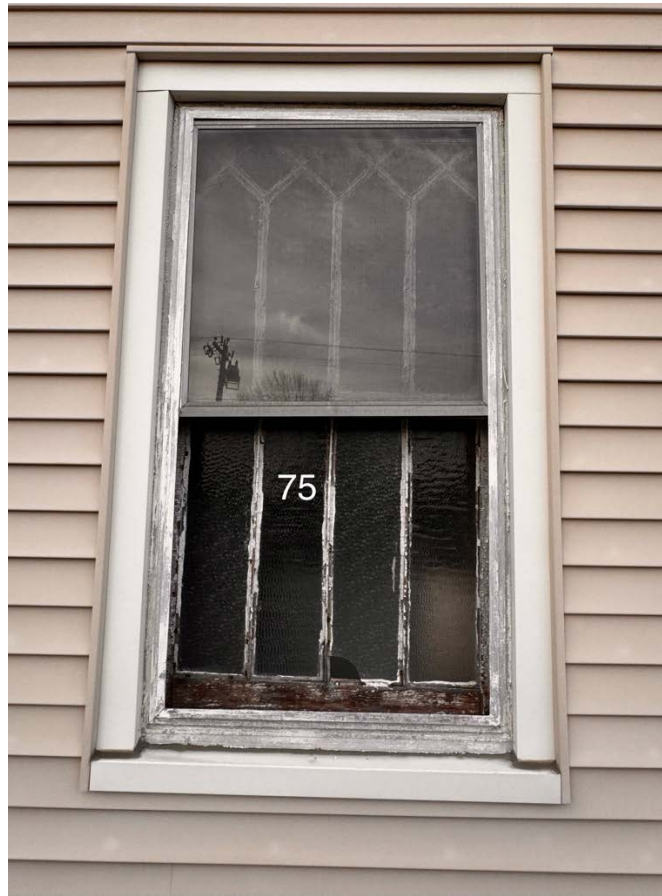
#75 — “The sashes are beyond reasonable repair in my opinion.”

#75 — Level 2, south elevation. This appears to be the type of window that was used throughout the house prior to later renovations. While one of the oldest windows, it is also the most severely damaged. Mr. Eastin’s report states, “Muntins are worn down or rotted down to near nothing leaving no area to be glazed.” Exterior conditions (the window is accessible from the garage roof) are very poor and are representative of exterior conditions on all original windows. Window to be replaced with a conforming Andersen “A” Series window with diamond and bars upper sash.

- ☐ Repair
- ☐ Replicate
- ☒ Replace

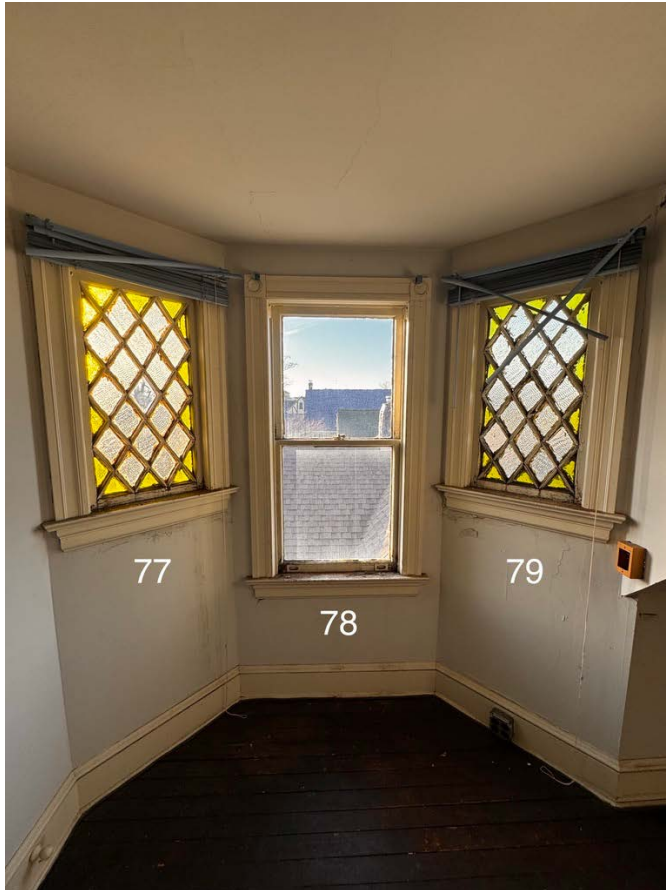
#77, #78, #79 — Level 3, west elevation. These three windows form a group. They are located above the staircase projection at the west. Two of the windows (#77, #79) share the same muntin pattern, glass type (ripple) and coloration as window #17, located to levels below.

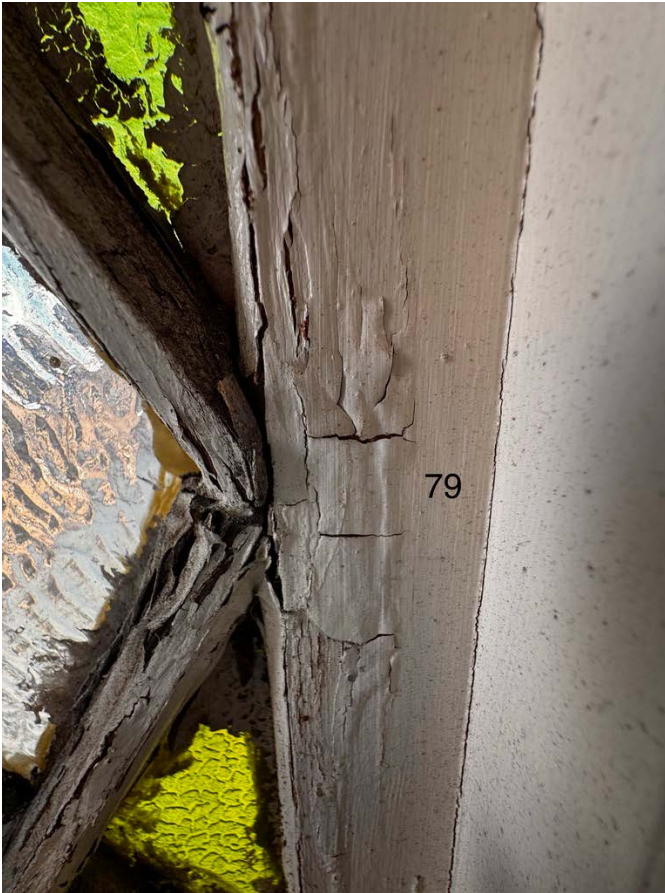
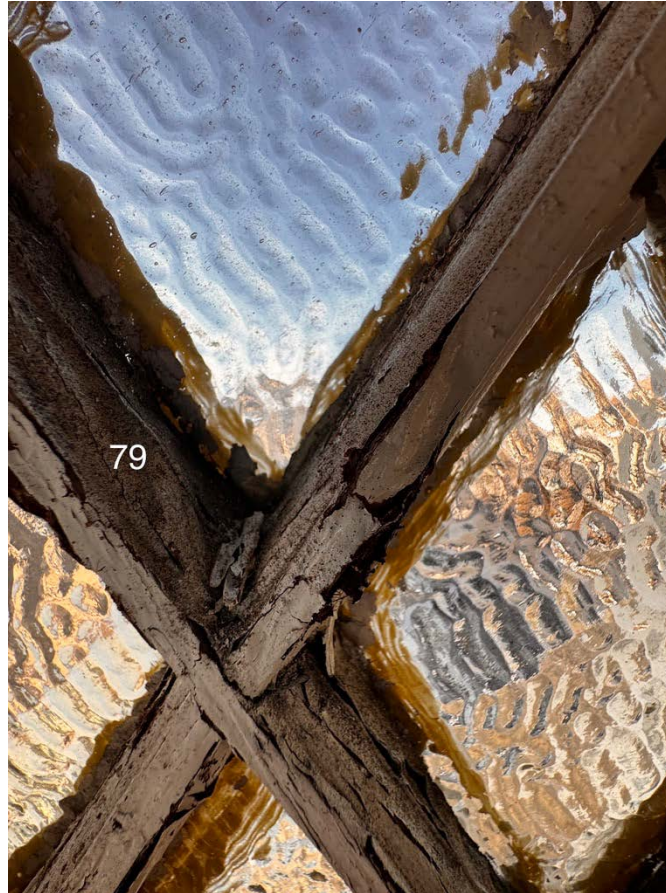
#79 —Level 3, west elevation. This is the pair of window #77.

#79 —Level 3, west elevation. This is the pair of window #77. Window to be replicated by custom builder reusing existing glass.

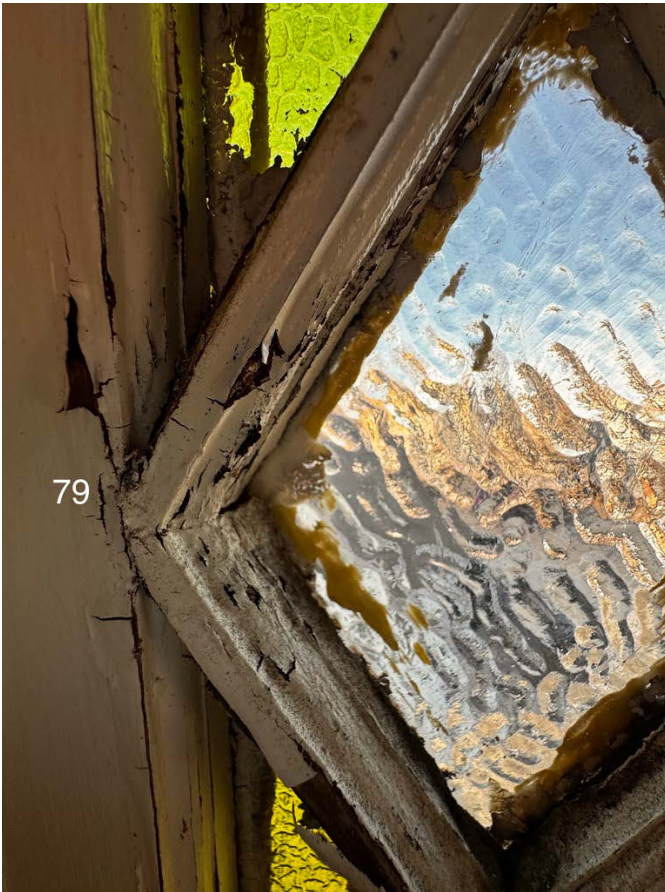
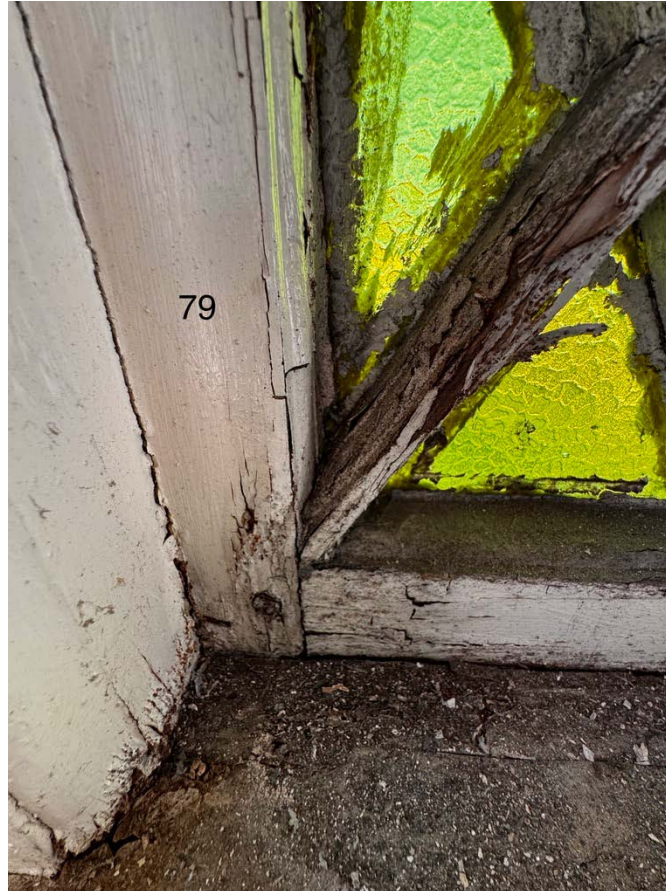
#79 —Level 3, west elevation. This is the pair of window #77.

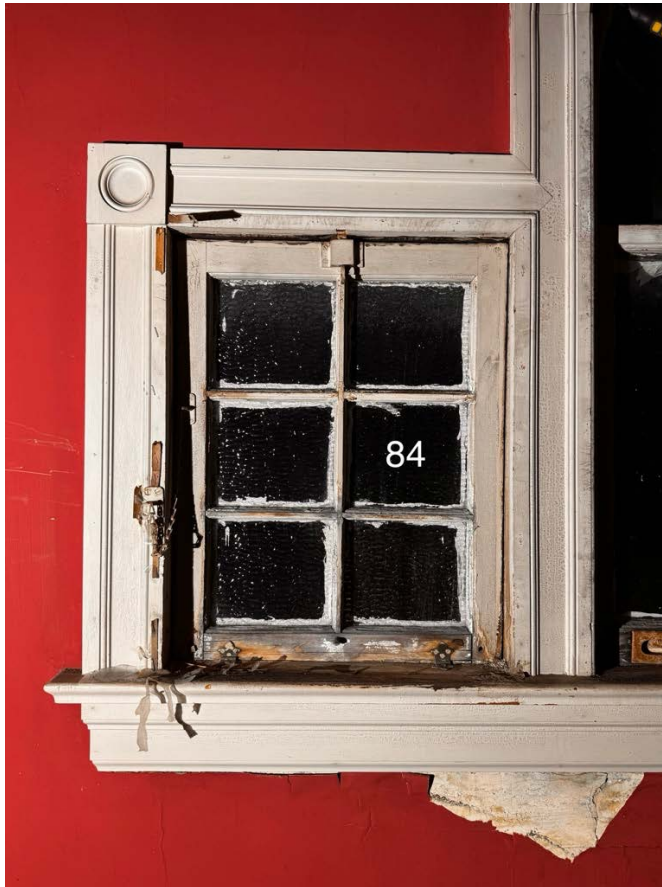
#84, #85, #86 — Level 3, east elevation. These three windows form a group: a Palladian window flanked by two, six-pane hopper windows (i.e., bottom-hinged). The rounded window has wide molding with ornamental “keystone” ornament (common to certain Queen Anne and Italianate styles) Similarly hefty molding surrounds the two hopper windows. The trims on this window group mirror those of a similar group on Level 2 on the west elevation (see: #57, #58, #59, and #60). Mr. Eastin’s report states, “These sashes are beyond reasonable repair in my opinion.”

#84 — Level 3, east elevation. Replace with an Andersen “A” Series hopper window with the same muntin pattern.

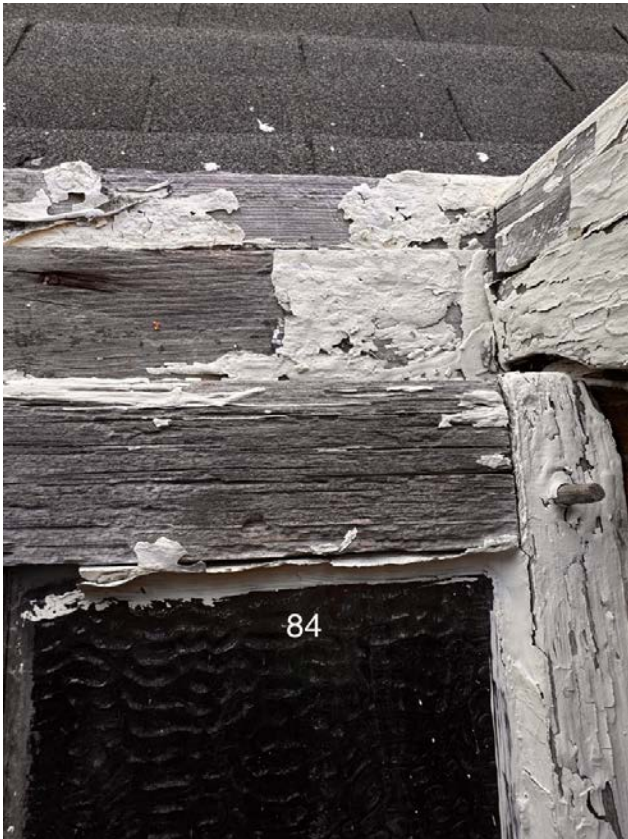
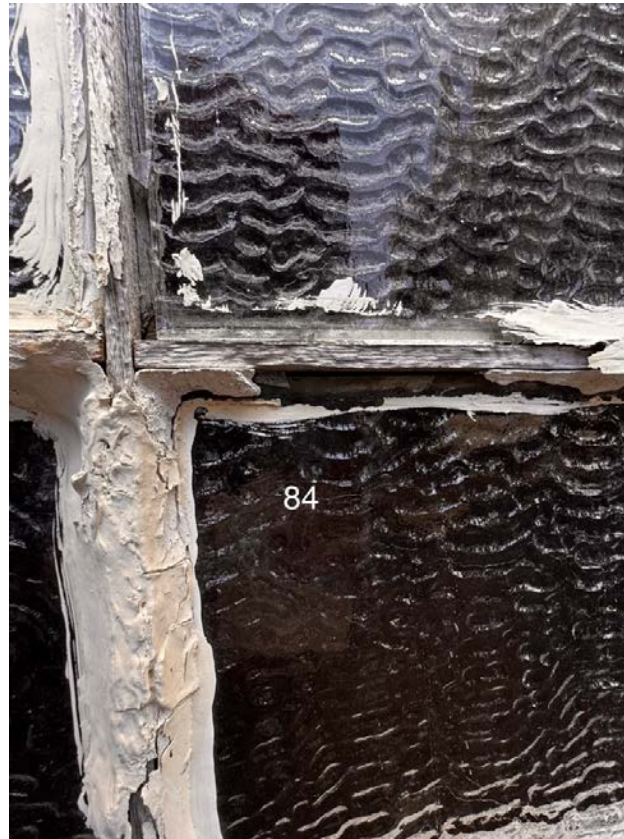
#84 — Level 3, east elevation. Exterior images show the extent of the dry rot in both the sashes and the frame. The wood is powdery with a lightweight “Styrofoam” texture.

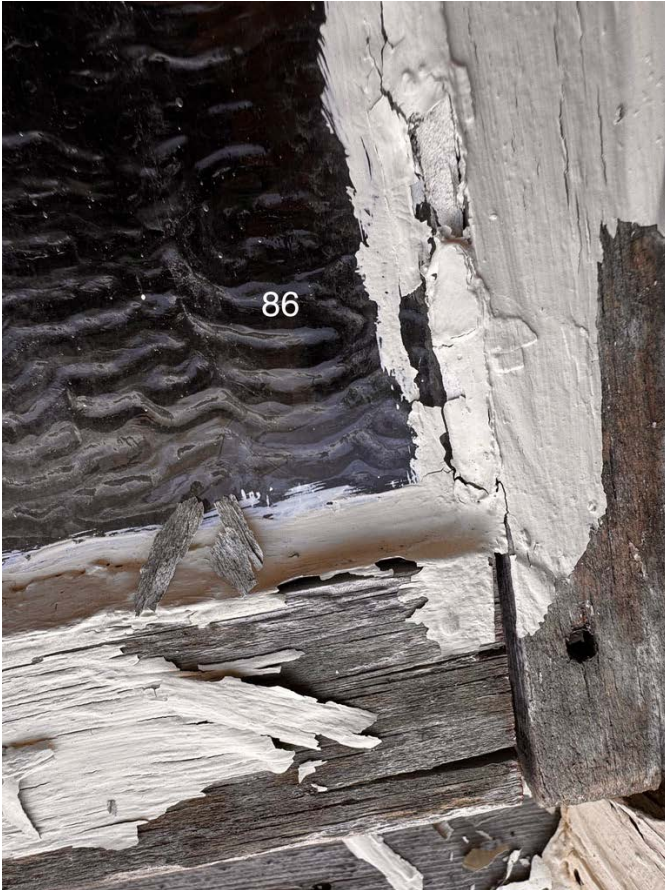
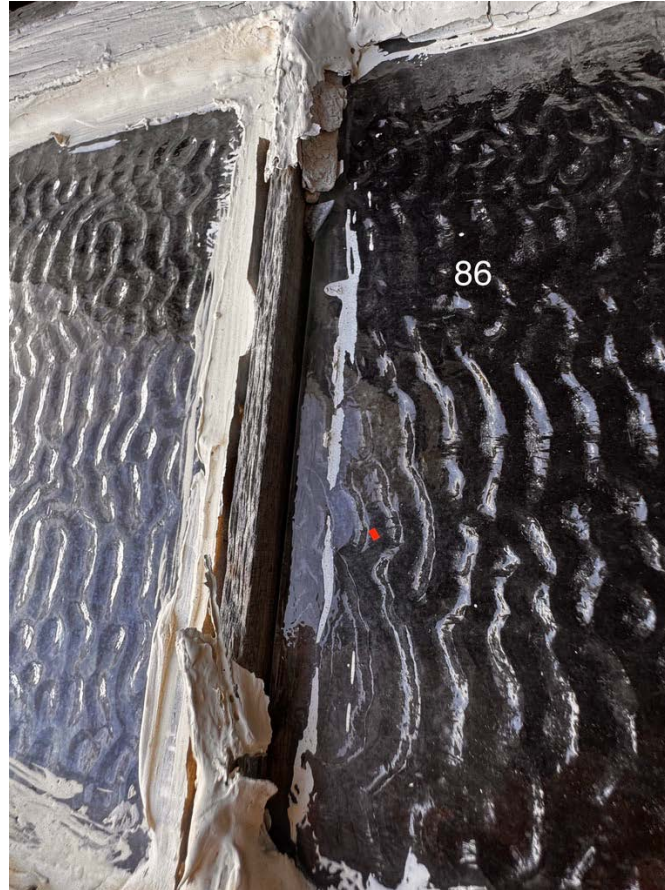
#86 — Level 3, east elevation. The exterior of this window is equally deteriorated, with missing pegs connecting sash components, cracking, and dry rot.

#86 — Level 3, east elevation. Replace with an Andersen “A” Series hopper window with the same muntin pattern.

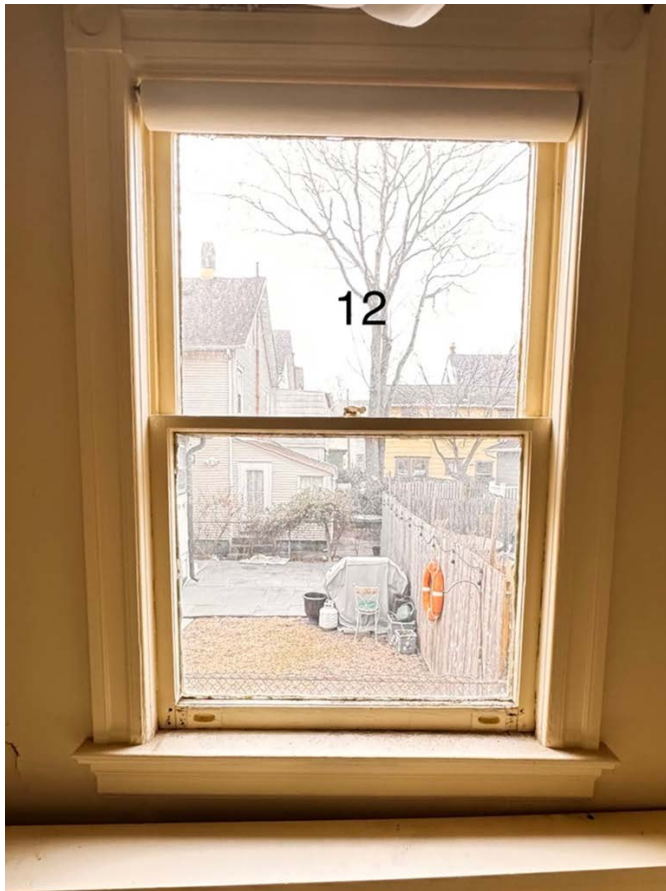
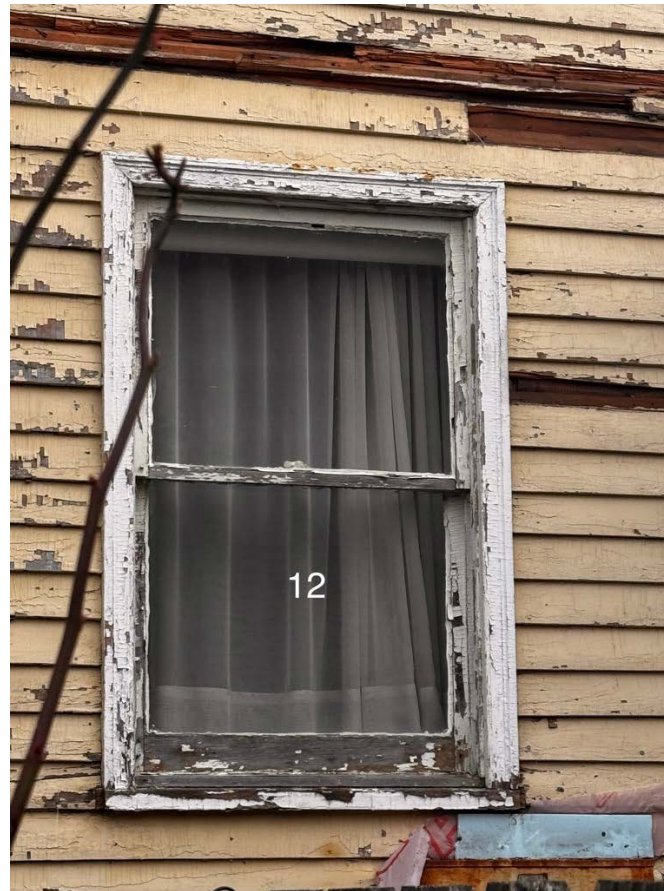
#12 — Level 1, west elevation. This window is located where an earlier open, 1 story porch used to be. The original porch was enclosed, and a 2-story addition was added likely around 1894 when other major changes occurred. This window does not match the window shape found elsewhere on the house; the sill appears to have been raised, and the window narrowed.

#12 — Level 1, west elevation. Cycles of moisture and heat have dried the windows and caused the pegs of the joints to wiggle free and deteriorate completely. These sashes are being held together by the window frames that surround them, as you can see in this photo showing missing pegs at the corner joint,

Since all Secondary windows are not original to the house, and all but four (severely deteriorated windows) date from the 1950s, we propose replacing all Secondary windows with new, Andersen “A” Series windows in a variety of muntin patters including gothic diamond-and-bar upper sash windows, Georgian upper sash windows, and 1/1 windows.

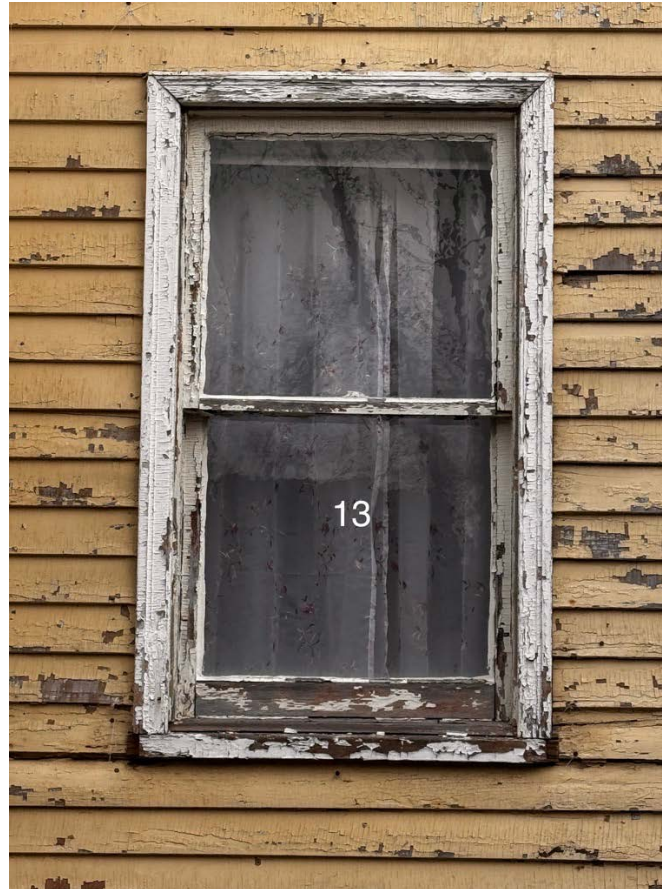
#13 — Level 1, west elevation. This window is on at the west elevation in what was once an open porch but was later enclosed. It does not match the historic window dimensions found elsewhere in the house and the sill height appears to have been raised (though there is no interior counter to rationalize such a shortening of the windows).

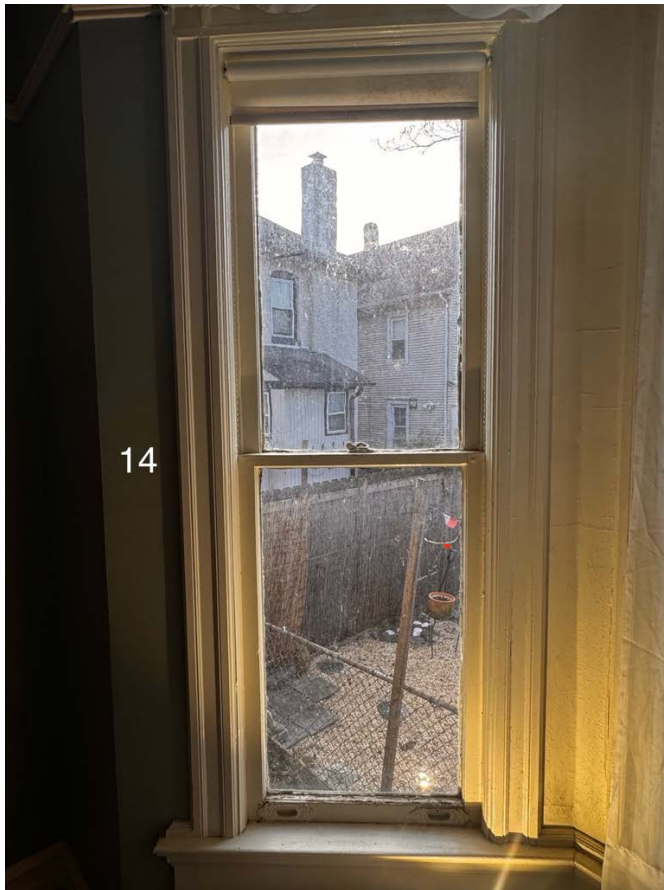
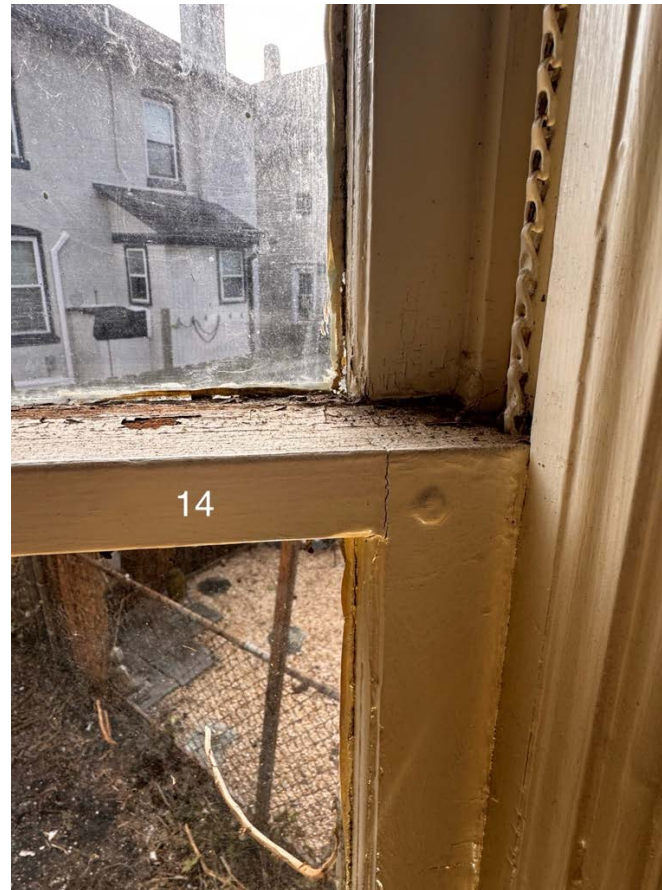
#14 — Level 1, west elevation. This window at the west elevation in the Level 1 bay. From the inside the condition appears moderate to good. However...
