06. Window and Door Condition Report

The house currently contains 89 doors and windows that fall under the purview of the Commission. We have sorted these into five categories: Basement Windows, Historic Windows, Secondary Windows, Vinyl Windows, and Modern Windows. To assist in understanding and reviewing so many fenestrations, we have color-coded them by type and illustrated their location on the enclosed floor plans and elevations. Also included are photographs of each individual window and door showing its characteristics and condition.

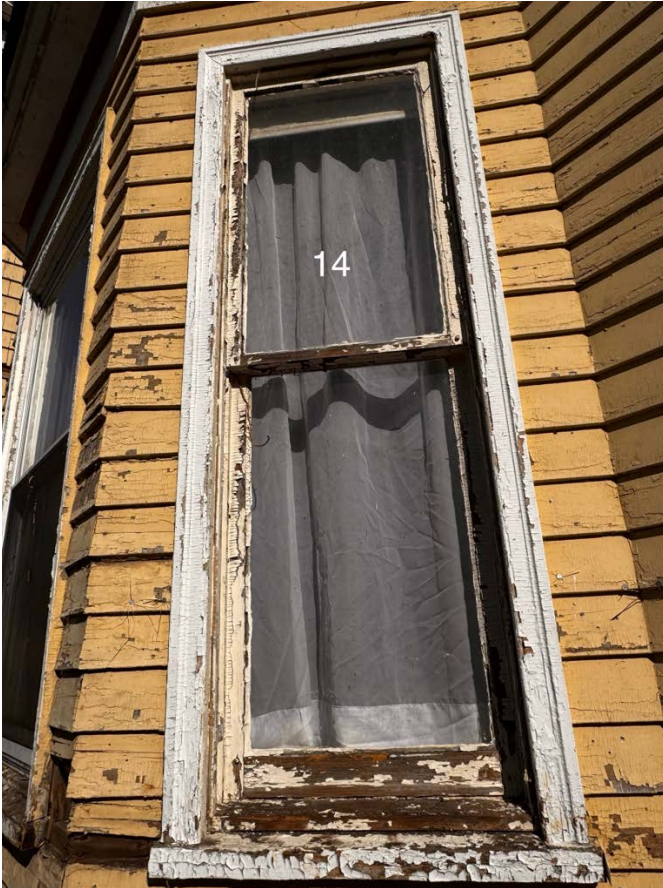
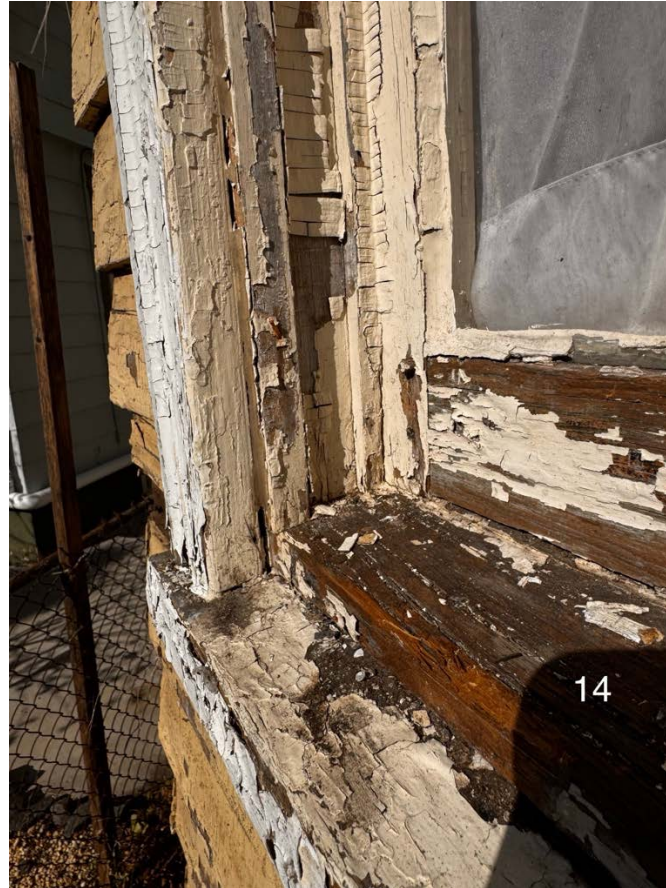
#14 — Level 1, west elevation. ...conditions outside show the extent of the rot and deterioration.

Since all Secondary windows are not original to the house, and all but four (severely deteriorated windows) date from the 1950s, we propose replacing all Secondary windows with new, Andersen “A” Series windows in a variety of muntin patters including gothic diamond-and-bar upper sash windows, Georgian upper sash windows, and 1/1 windows.

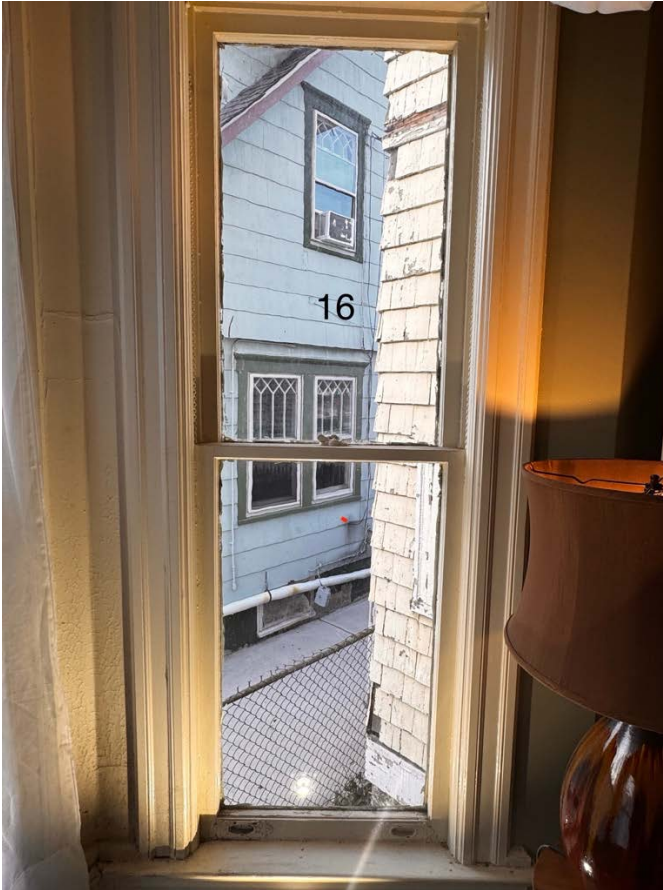
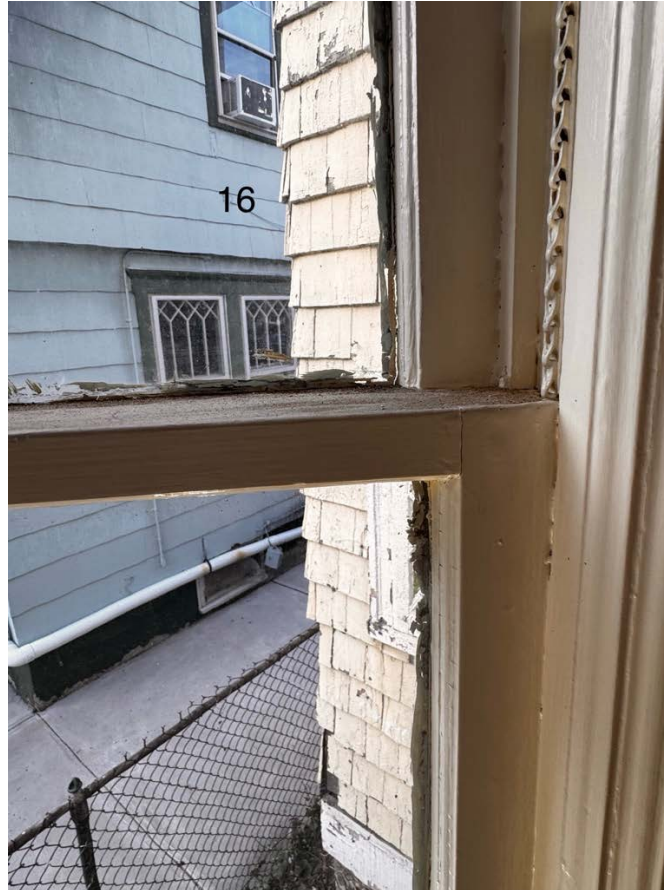
#16 — Level 1, west elevation. This is the pair to window #14 and is in similar condition.

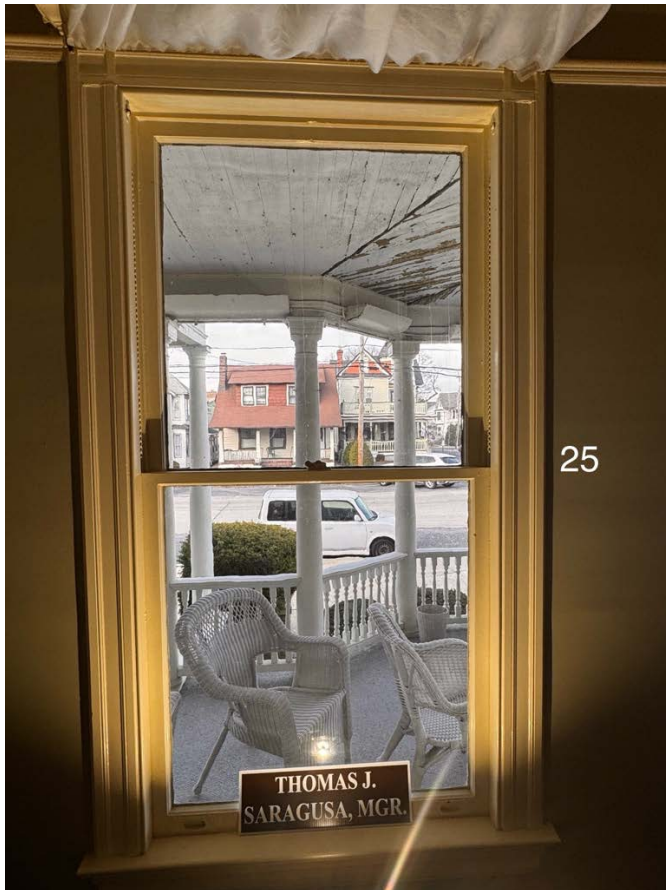
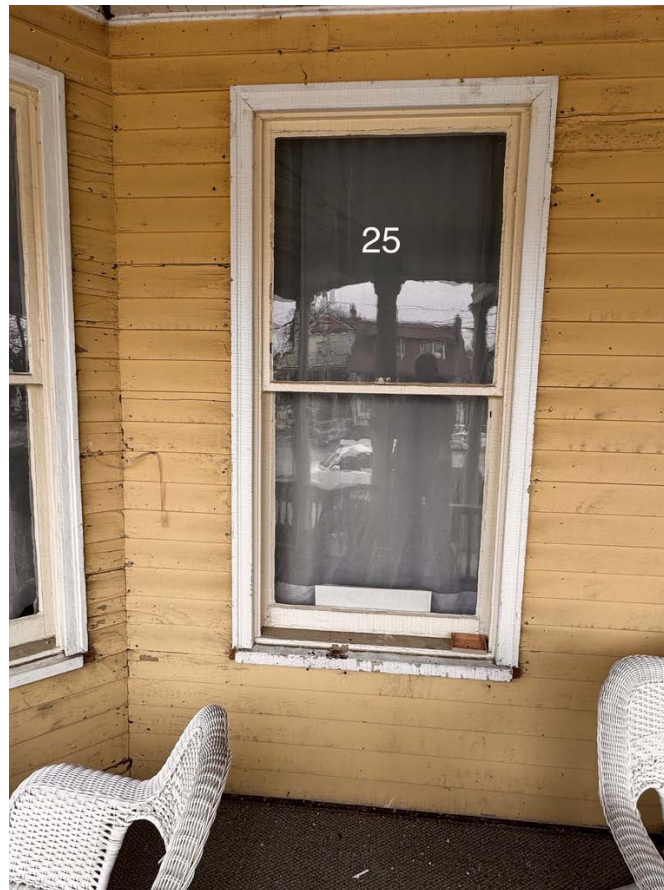
#25 — Level 1, north elevation. These Level 1 windows (#25-#29) have sashes in moderate to good condition but sit inside non-historic, frames with metal rails. These windows date from a later renovation and are not original.

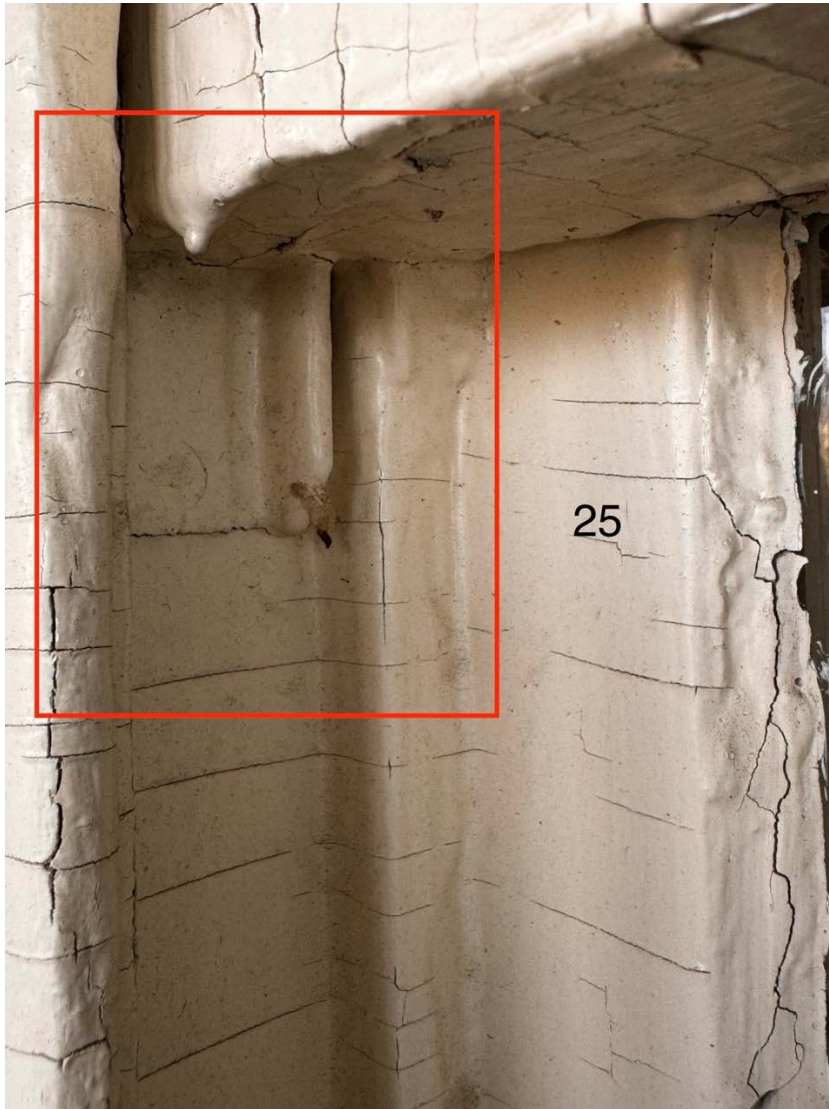
#25 — Level 1, north elevation. Metal guide rails are present in all the Level 1 and Level 2 1/1 double-hung windows.

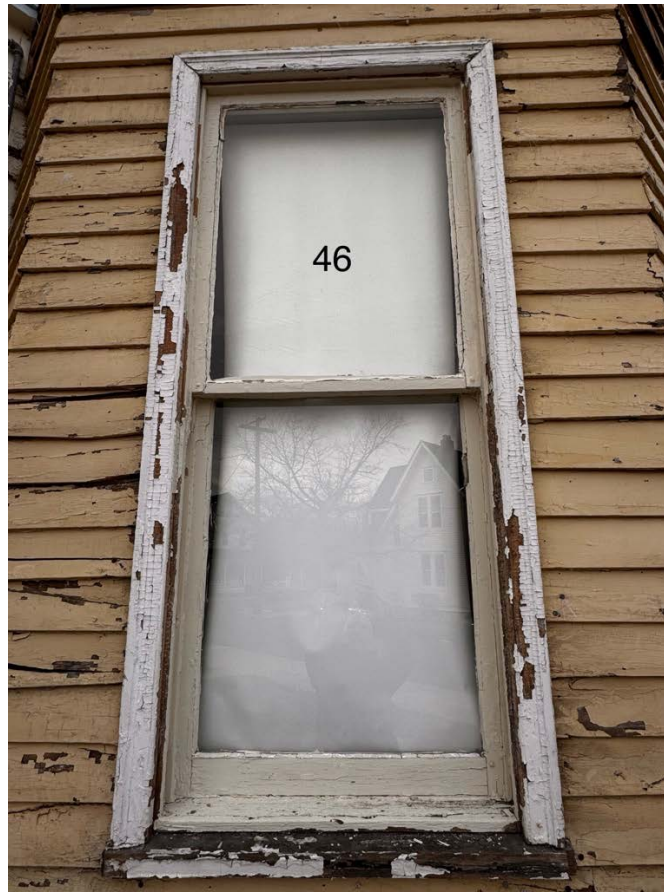
#46 — Level 1, east elevation. Even 1/1 window that are not original have suffered from decades of exposure to weather. The lack of proper storm windows has allowed water to pool in the frames, deteriorate the wood, and penetrate interior walls.

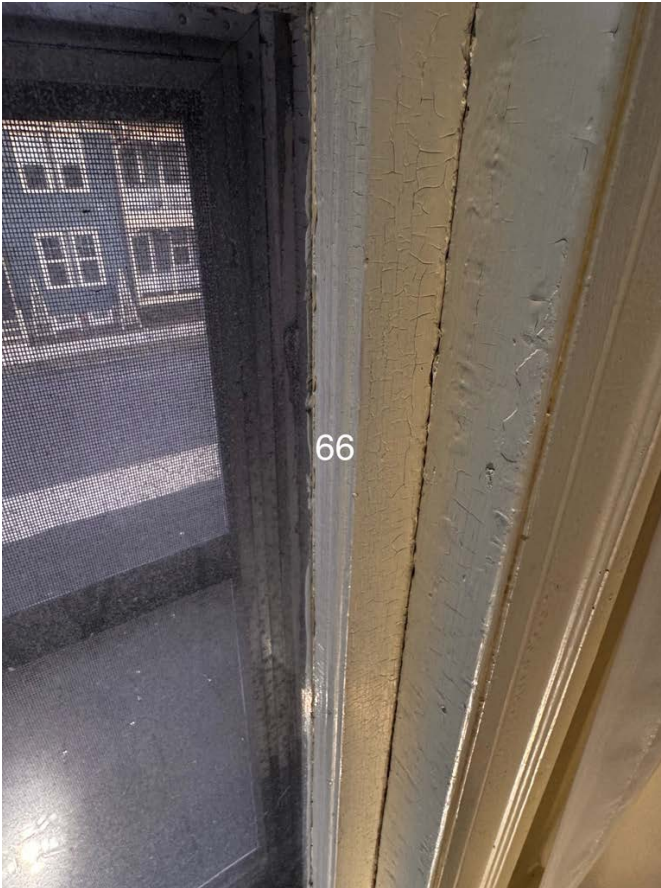
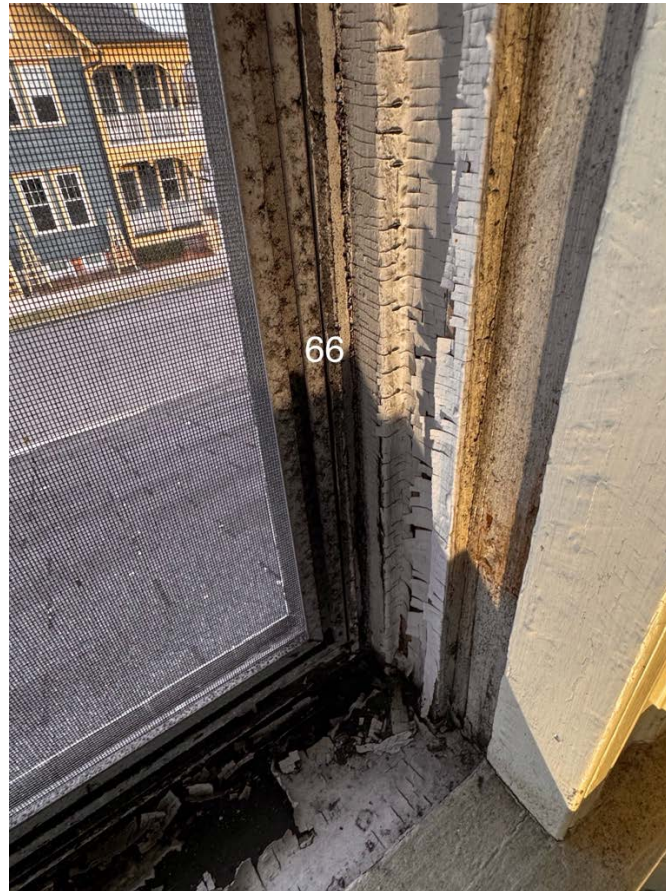
#66 — Level 2, east elevation. A representative example of the sash being in repairable condition but the pan of the window frame being rotted out and the lower glides split with rot (or missing completely).

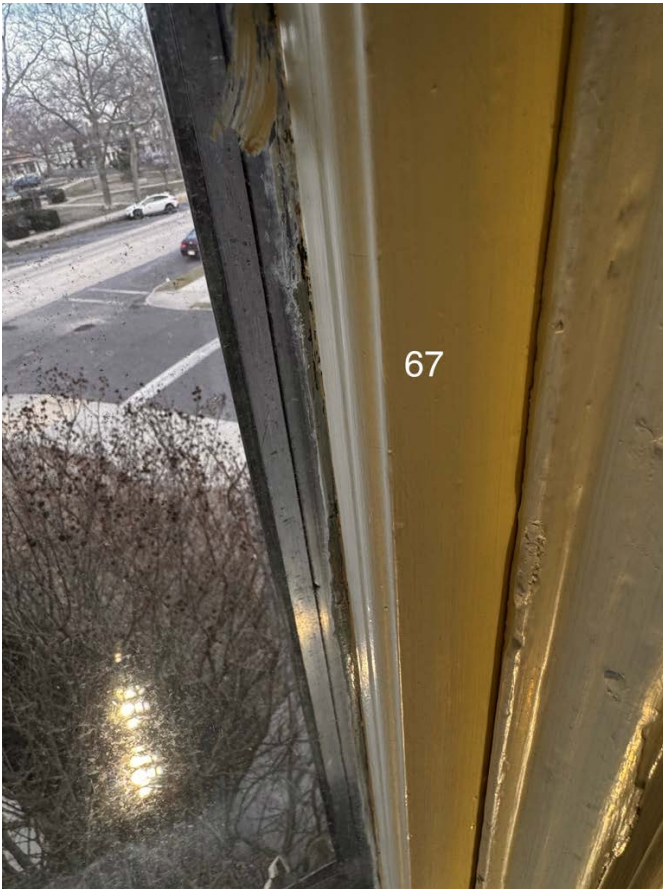
#67 — Level 2, east elevation. Another example of a newer, rebuilt sash. The condition of certain sashes, suggest they are 50-70 years old rather than 135 years old.

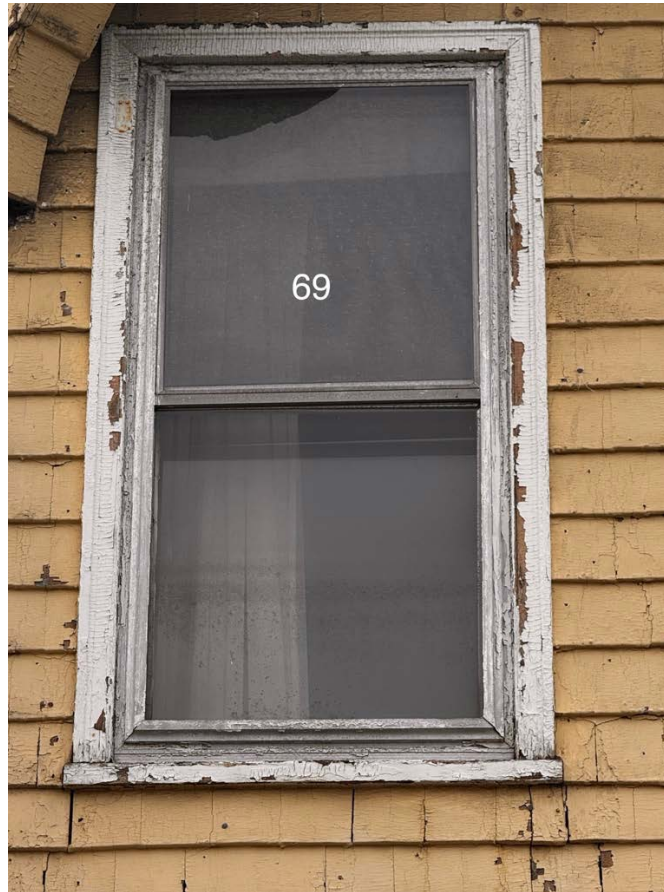
#69 — Level 2, east elevation. Another representative example of interior sashes that look restorable.

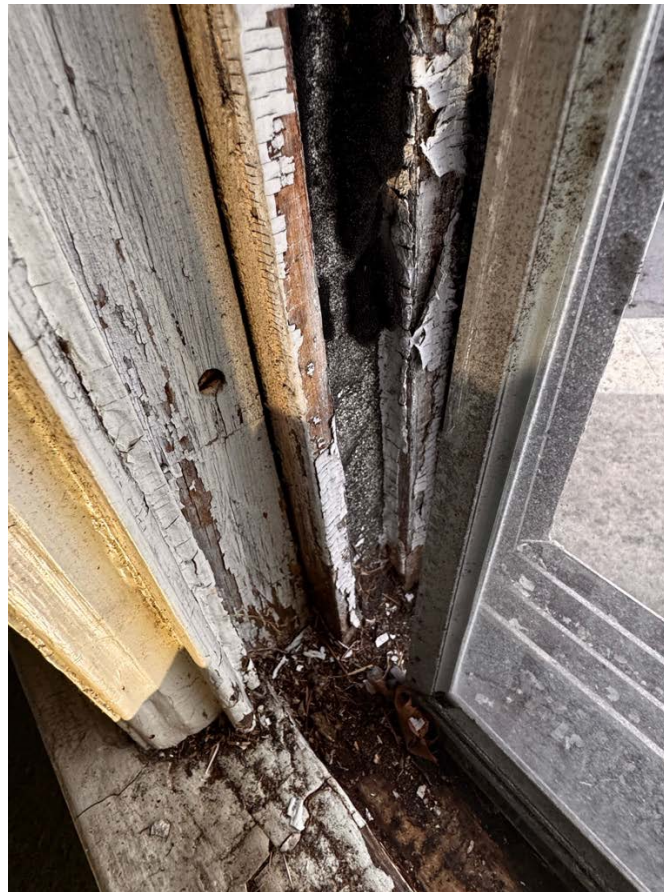
#69 — Level 2, east elevation. However, lifting the sash reveals window frames destroyed by rot and weather.

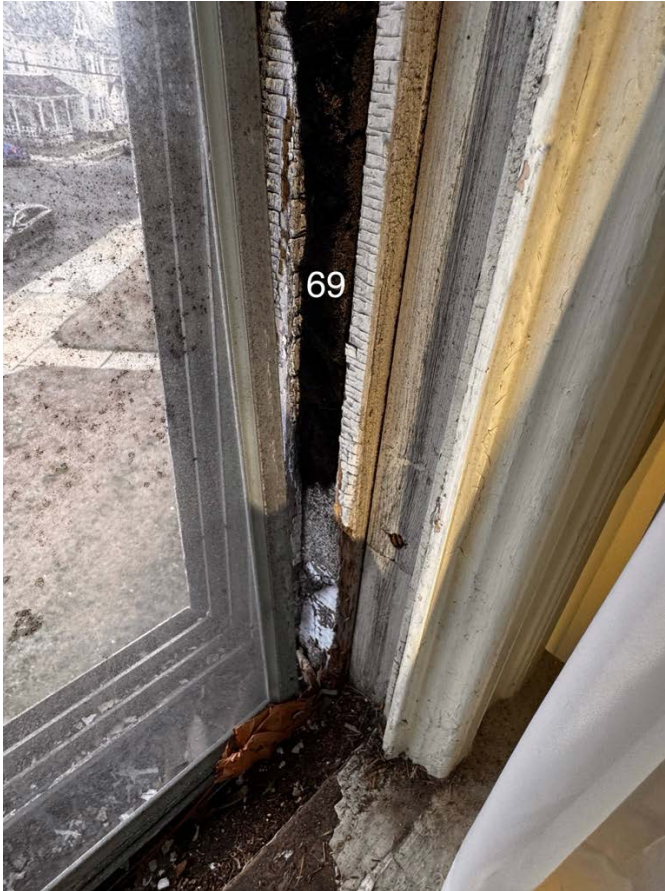
#69 — Level 2, east elevation. However, lifting the sash reveals window frames destroyed by rot and weather and open to the interior of the wall.

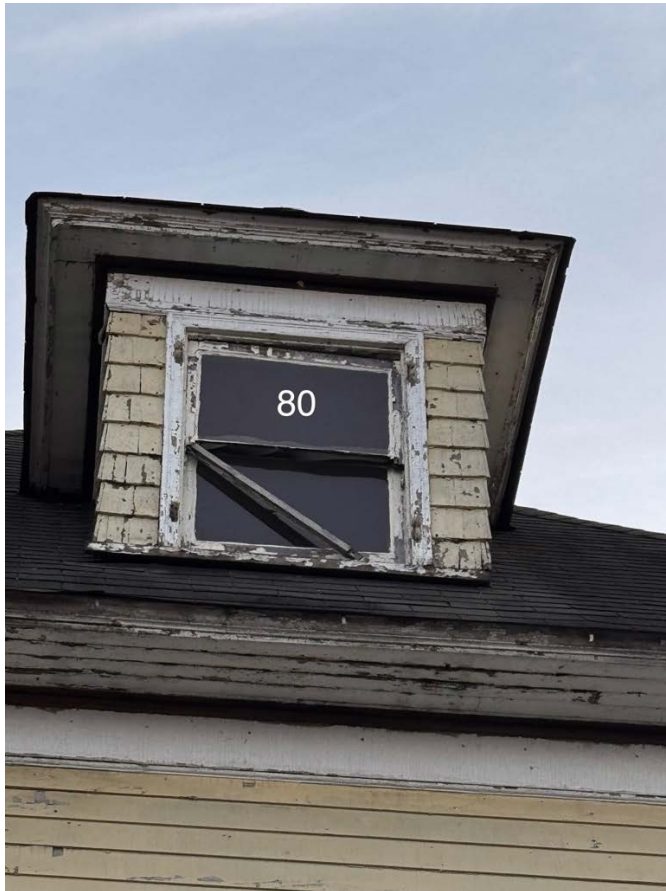
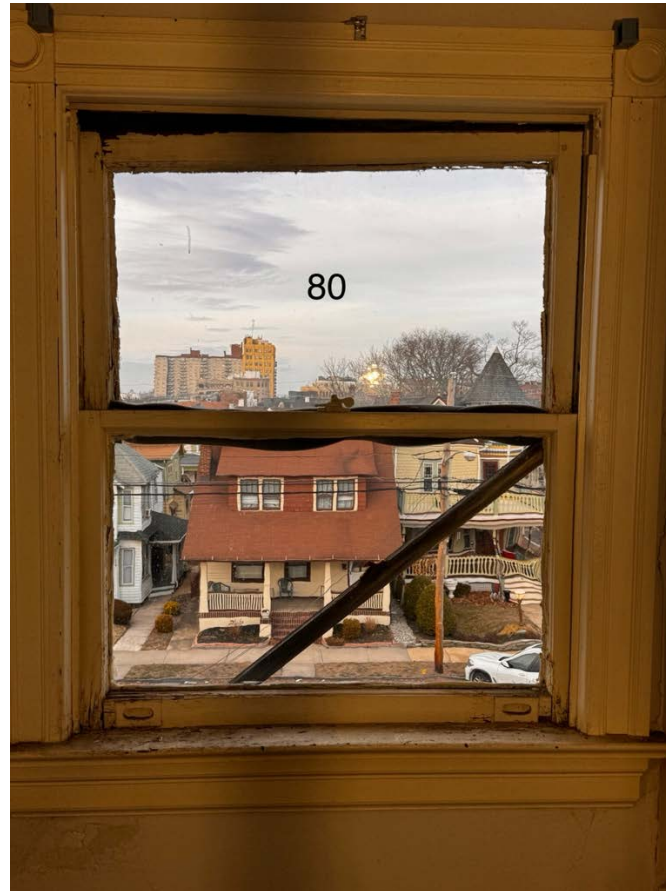
However, further investigations revealed ONLY four of the existing 1/1 windows likely date from the 1894 renovation. They are the Level 3 dormer window (#80) and the Level 3 turret windows (#81, #82, and #83,) Unfortunately, these four windows are some of the most deteriorated in the entire house; decades beyond any hope of repair or restoration.

#80 — Level 3, north elevation. This Level 3 dormer window appears to be one of the original 1/1 fenestrations installed in 1894. The deterioration is extreme in both the sash and the window frame.

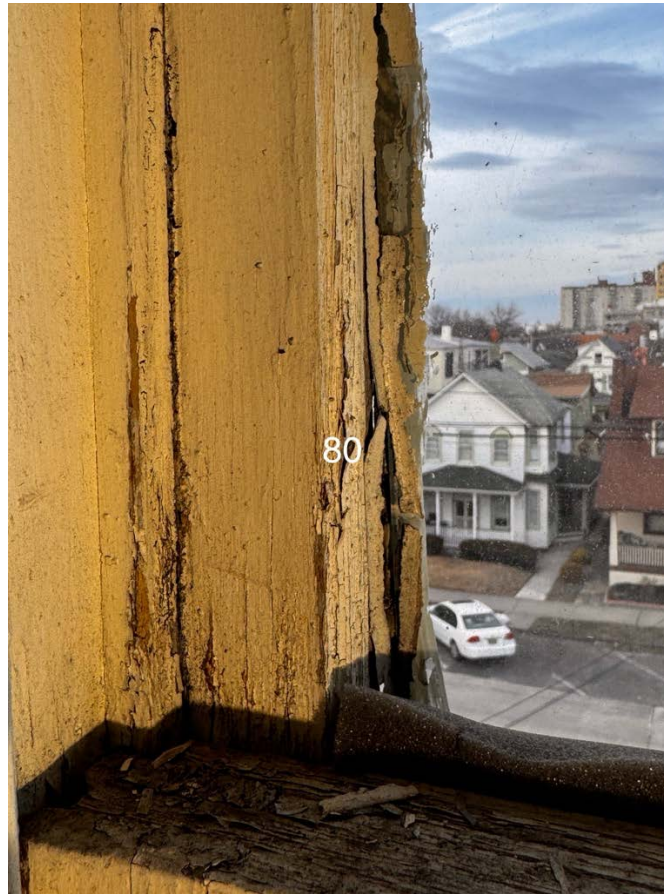
#80 — Level 3, north elevation. This Level 3 dormer window appears to be one of the original one-over-one fenestrations installed in 1894. The deterioration is extreme in both the sash and the window frame. Note: Windows #80, #81, #82, and #83 all date to the 1894 renovation and are beyond repair.

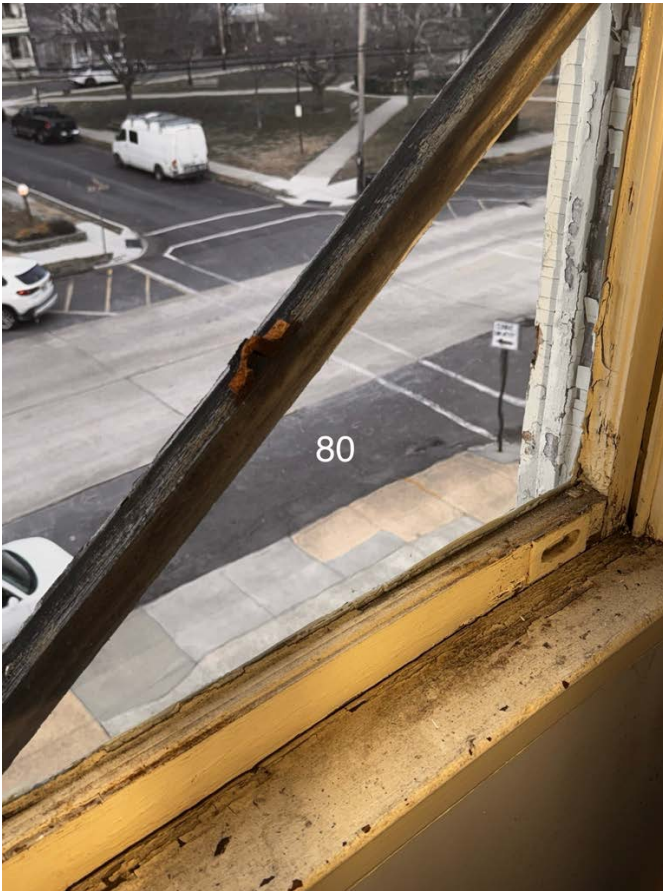
#80 — Level 3, north elevation. This Level 3 dormer window appears to be one of the original one-over-one fenestrations installed in 1894. The deterioration is extreme in both the sash and the window frame.

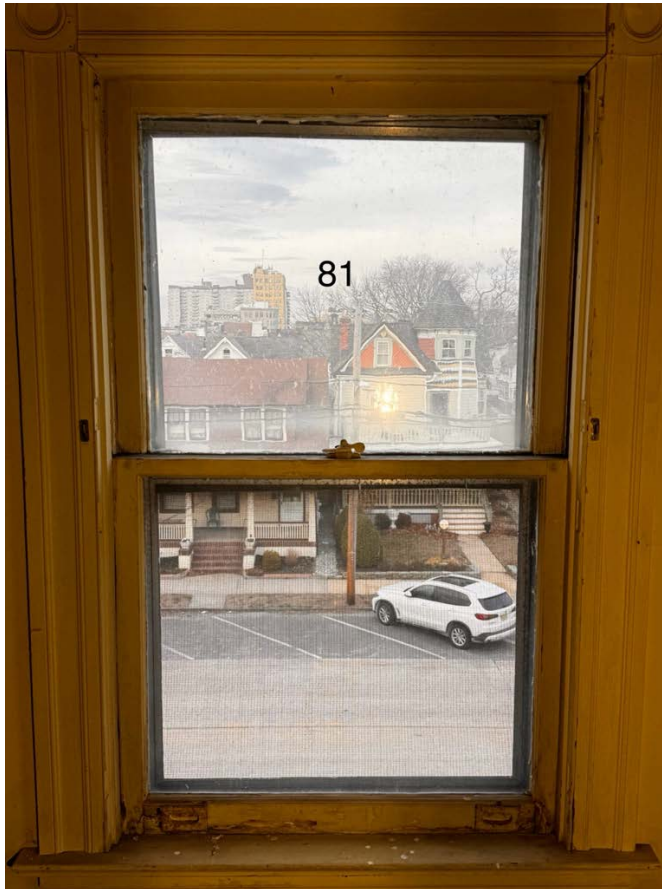
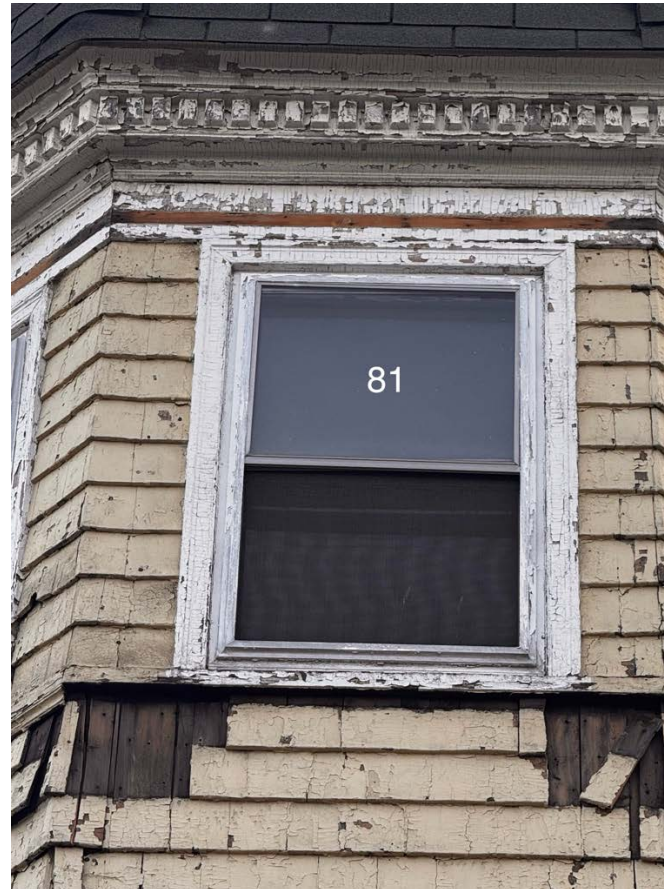
#81 — Level 3, north elevation. Another of the original one-over-one windows, this one in the turret, shows deterioration in both the sashes and the window frame.

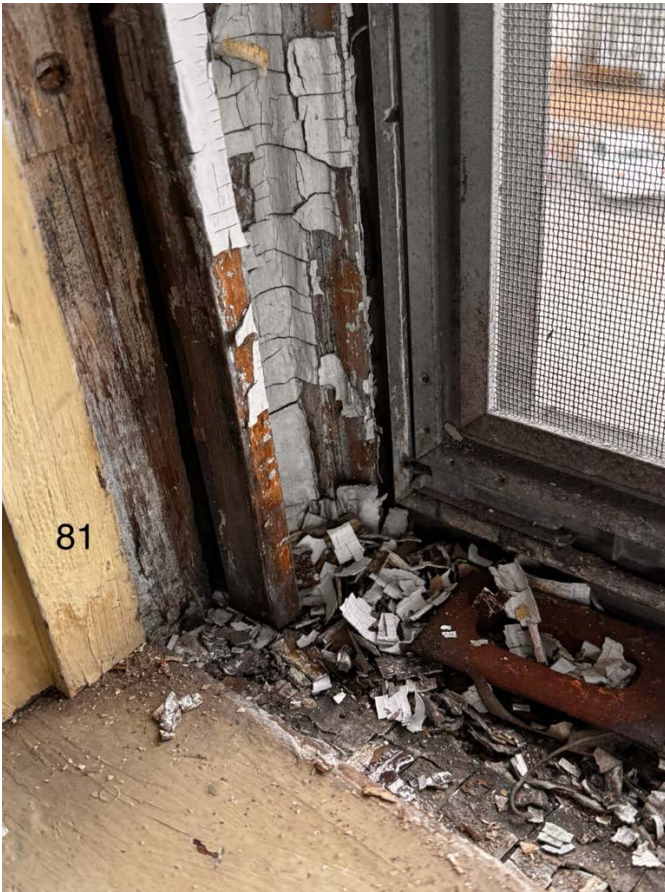
#81 — Level 3, north elevation. Another of the original one-over-one windows, this one in the turret, shows deterioration in both the sashes and the window frame.

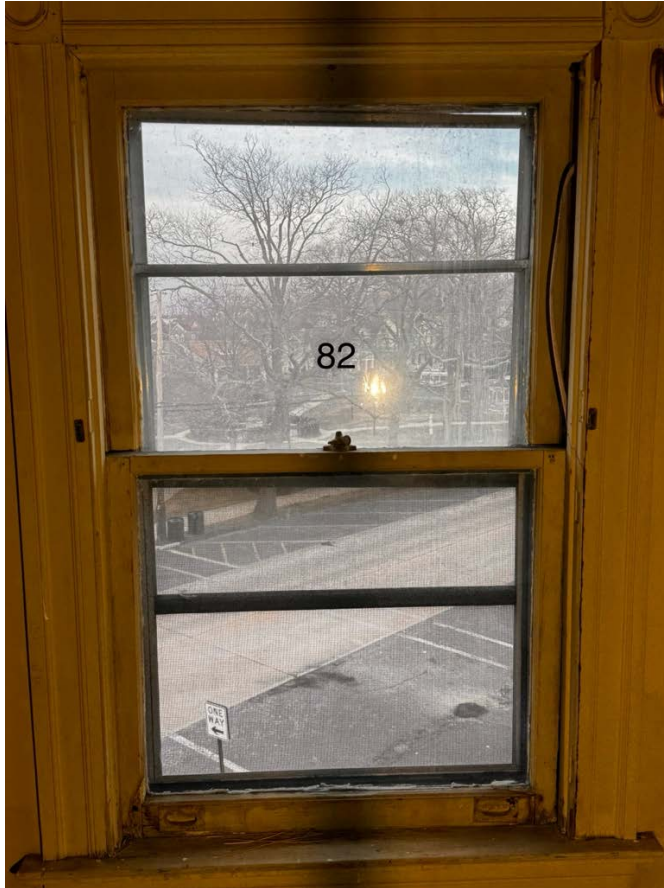
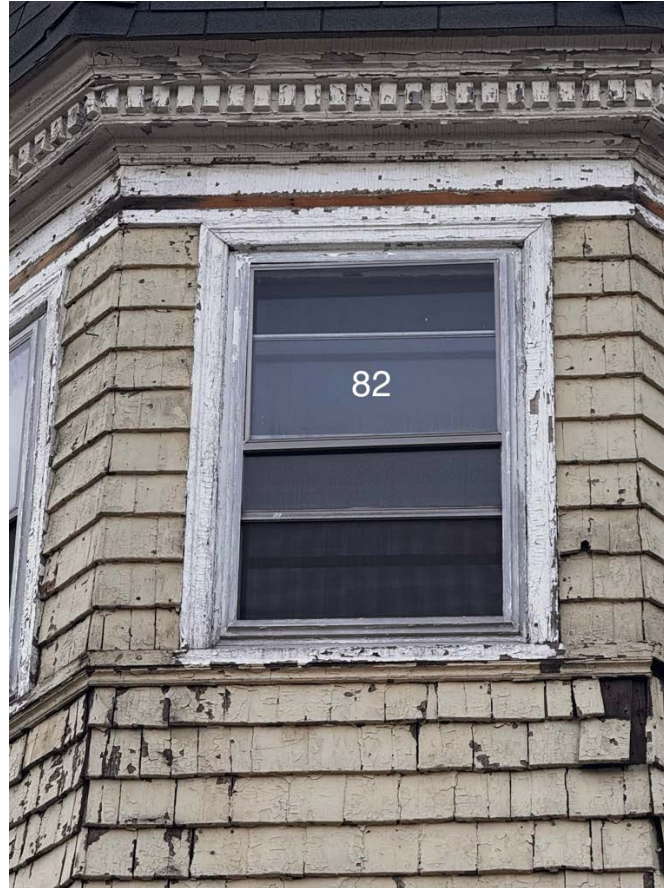
#82 — Level 3, north elevation. Note: the deterioration of the exterior trim (i.e., crown and dentil) at the tower roof.

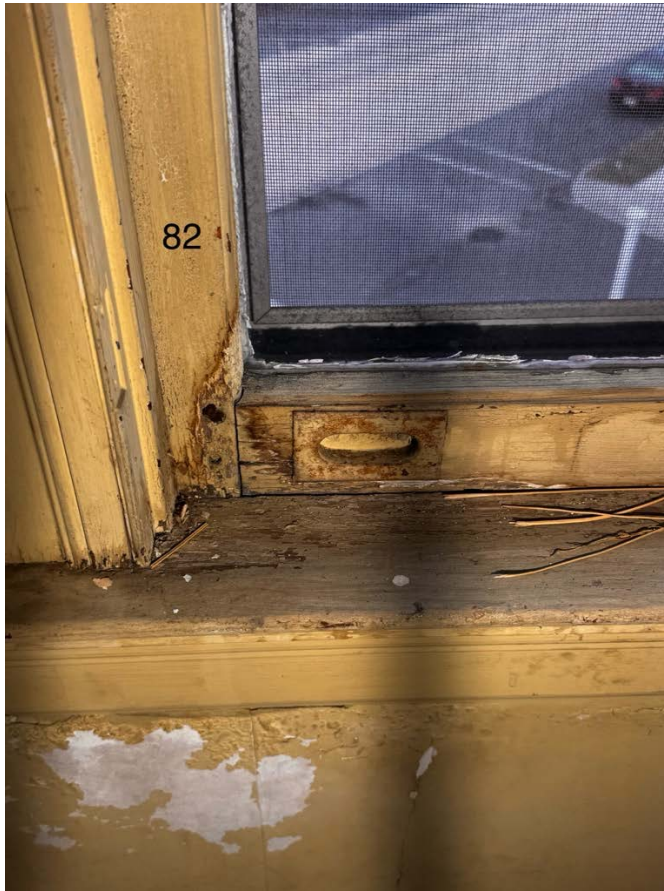
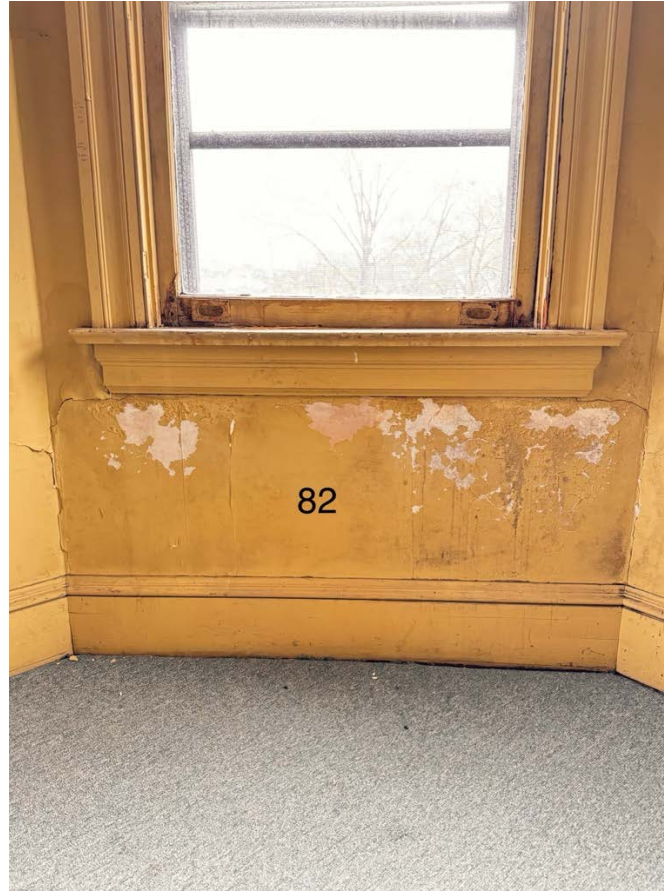
#82 — Level 3, north elevation. Details of the type of water penetration throughout the house at locations where 1/1 window frames are deteriorated. The damage does not stop at the sash but show in the nearby wall, as well.
