# SHORE POINT ARCHITECTURE, PA

## DEMOLITION APPLICATION TEXT

Date: May 5, 2023  
SPA Job Number: 2023-11 (Martin Residence)  
Property Address: 76 Mt. Tabor Way (Block 149, Lot 2)

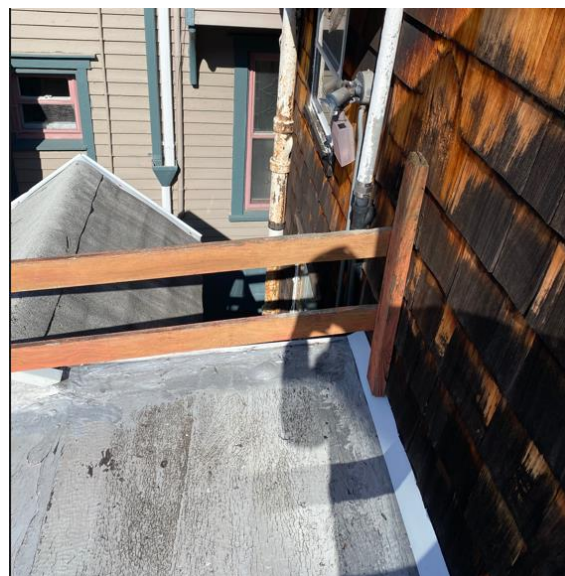
The Sanborn maps suggest the rear of the house was constructed sometime between 1905 and 1930, however it has been expanded and modified numerous times, and now includes a large, inappropriate, cantilevered, uncovered second floor roof deck. Within the rear area proposed for demolition, there are four windows and a door, as outlined below:
