HPC Site Inspection — 07 June 2023
140 Broadway, Window Inspection
Deborah Ospechuk, & Jeffery Rudell

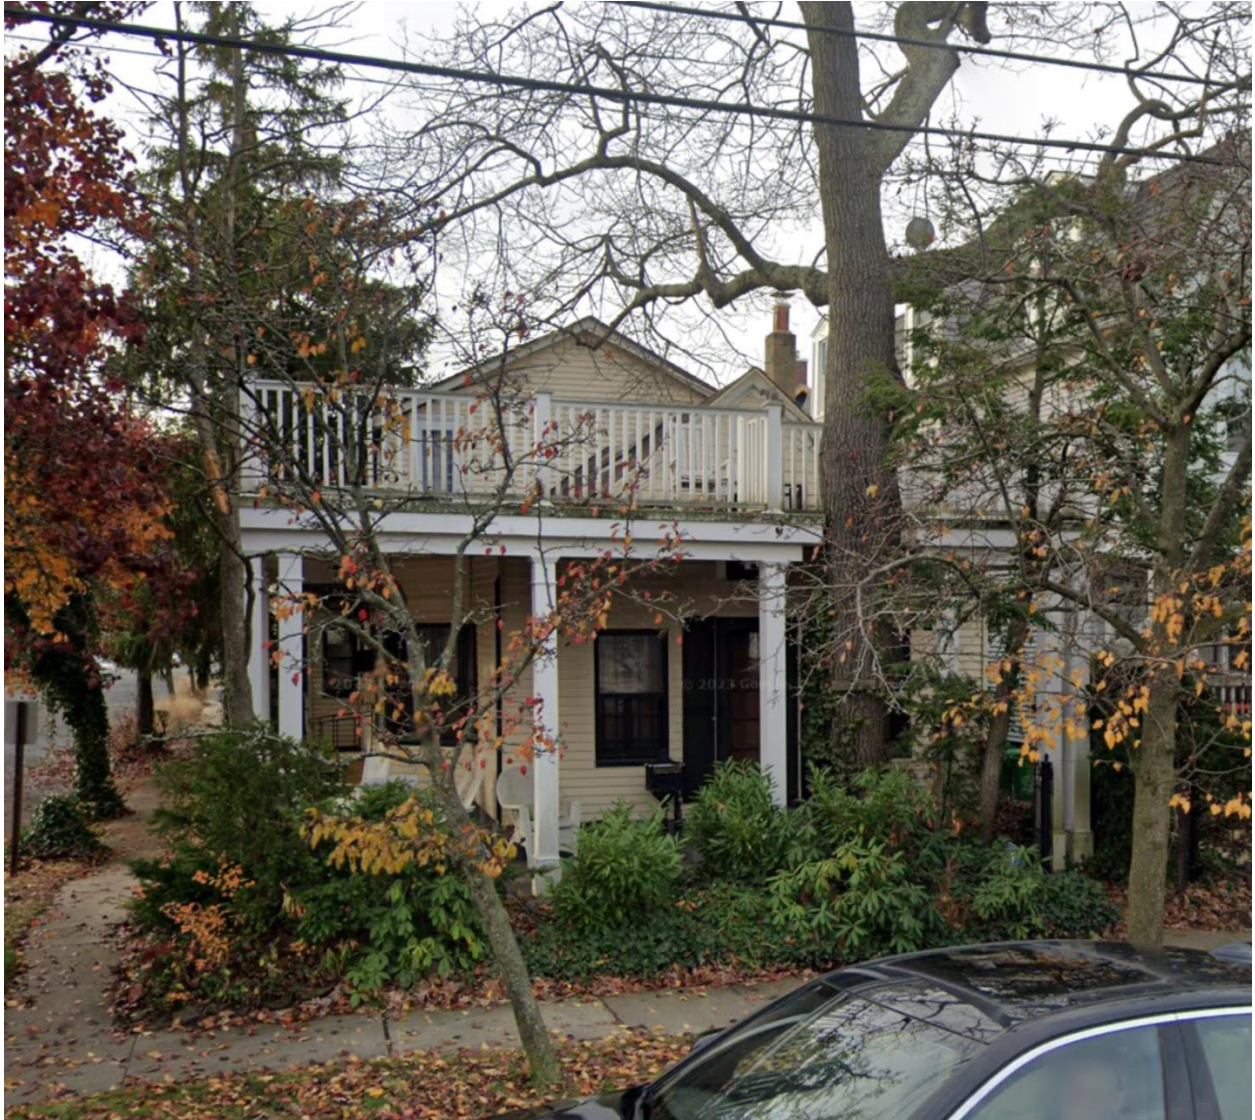
We met the contractor, Chris (848-223-8953) at 140 Broadway and he showed us around the property. The applicant is proposing to replace five (5) windows on the ground floor in the back of the house and seven (7) windows on the second floor, also toward the back of the house.

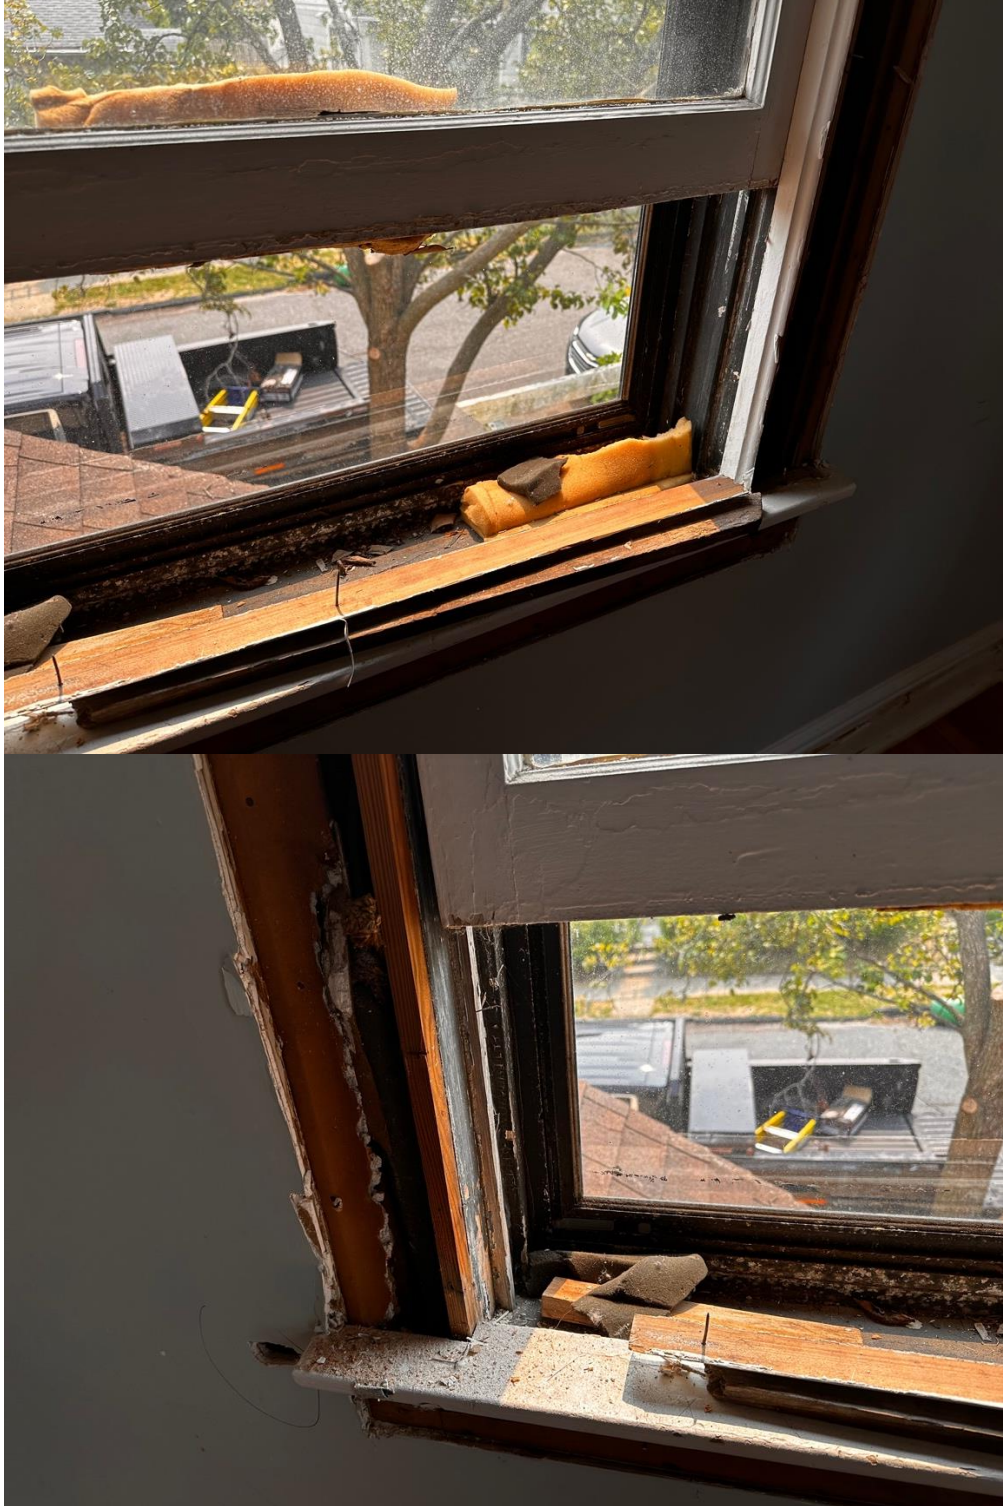
Windows are in need of stripping and sanding and conditioning but did not appear rotted or beyond restoration.

Findings: All twelve windows appeared to be in fair to good condition and are candidates for restoration. Some windows were painted shut and could not be closely inspected, but based on the condition of the material we saw, we recommend all existing windows be retained.
