76 Mount Tabor Condition Report: Siding, Doors, and Windows

20 December 2023

Jenny Shaffer and Kurt Cavano

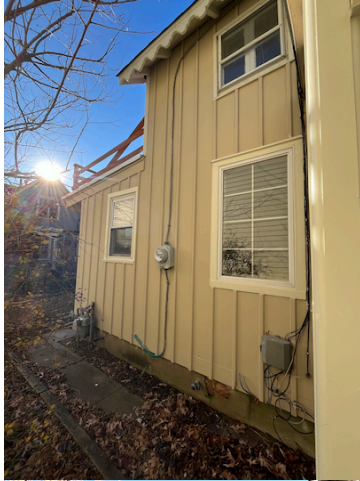
← east elevation to rear
east elevation towards north ↓

- The wood siding dates ca. 2009 and is in good condition; deterioration is visible in places.
- This siding was applied directly over historic board and batten that is in very poor condition; this historic siding peeks out below the newer siding on the rear/south elevation of the building.

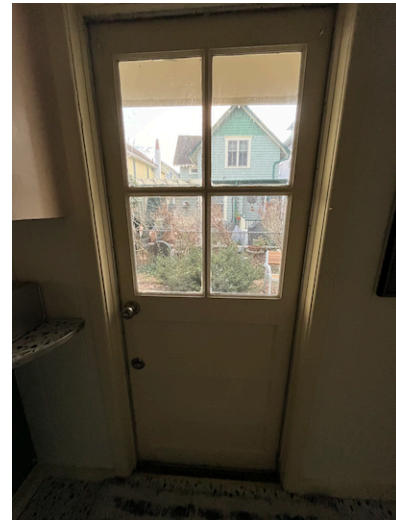
Doors: The front and back doors are wood, in good condition, of different configurations, and relatively modern in date.
