# **92 Cookman Avenue Window Assessment Report**

92 Cookman Avenue, Ocean Grove, New Jersey  
Block #262, Lot #5

**The Architect's Studio**

October 16, 2023

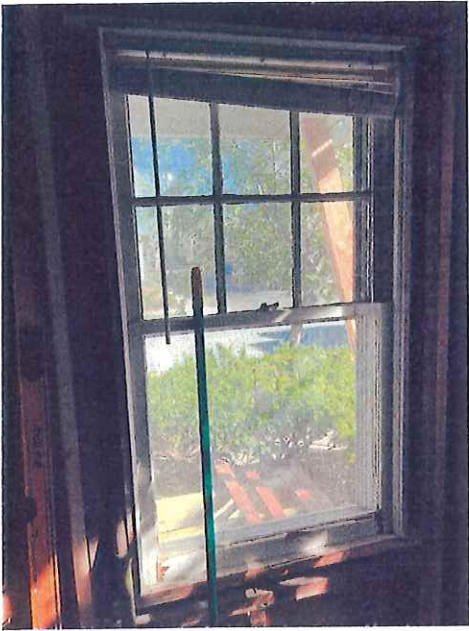
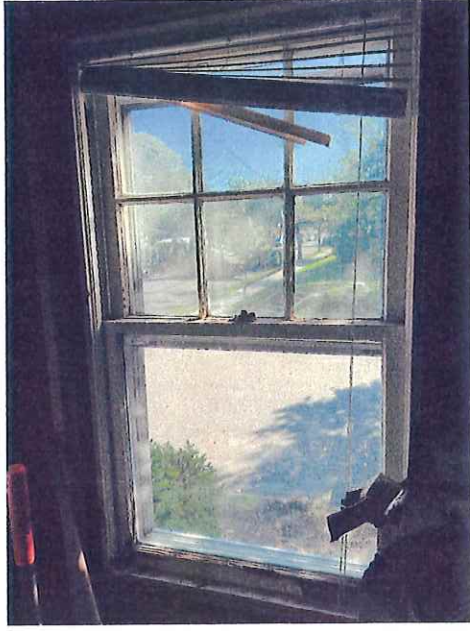
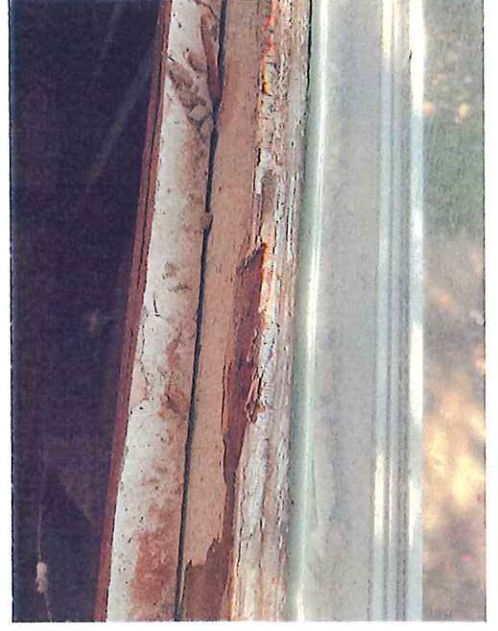
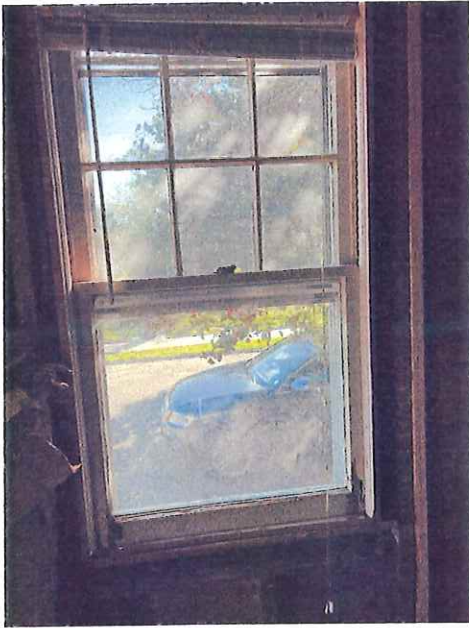
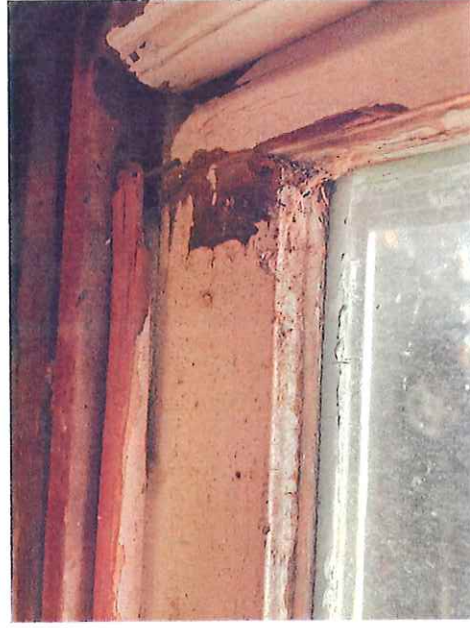
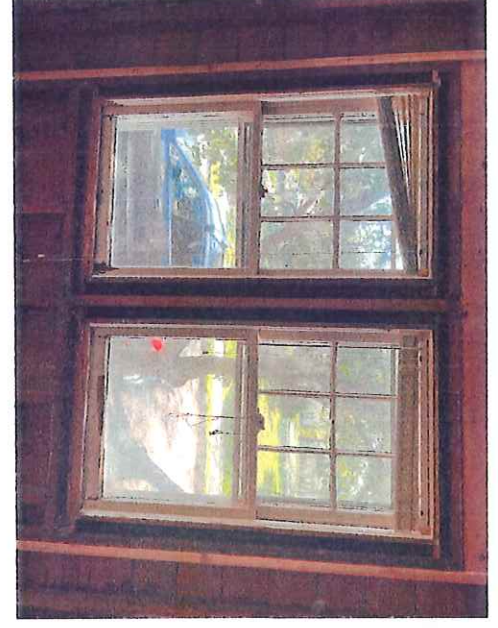
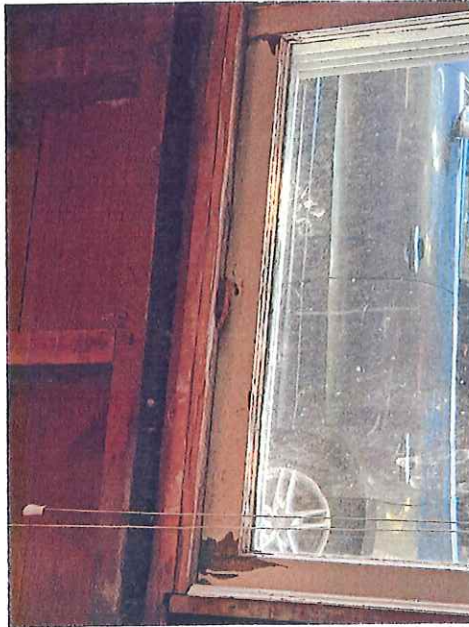
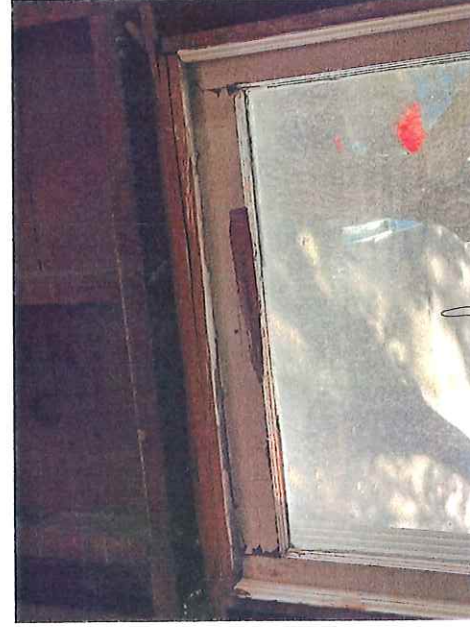
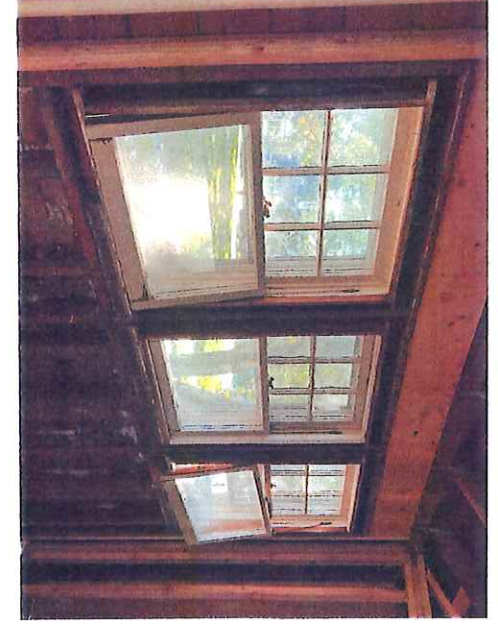
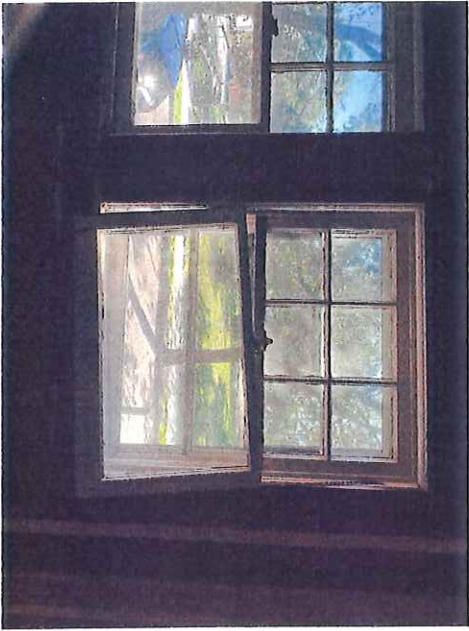
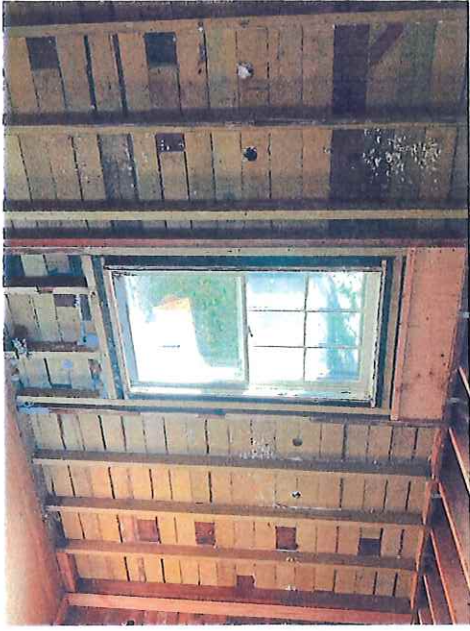
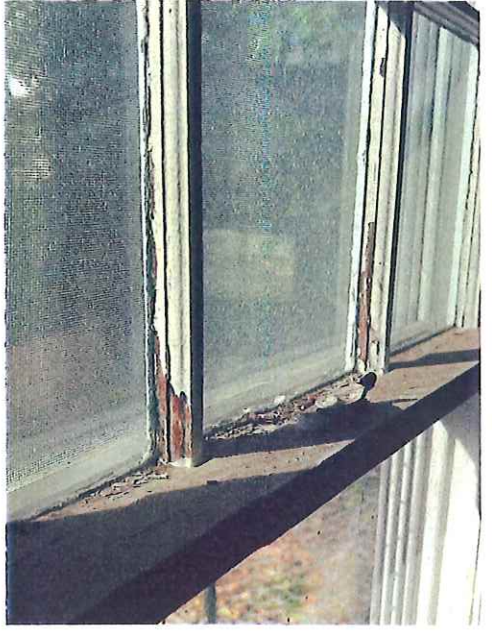
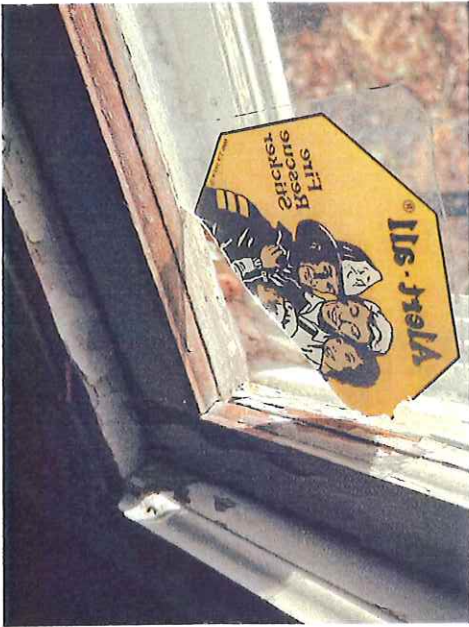
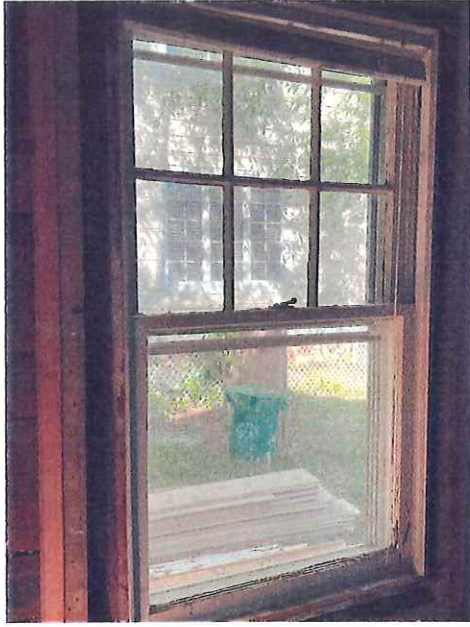
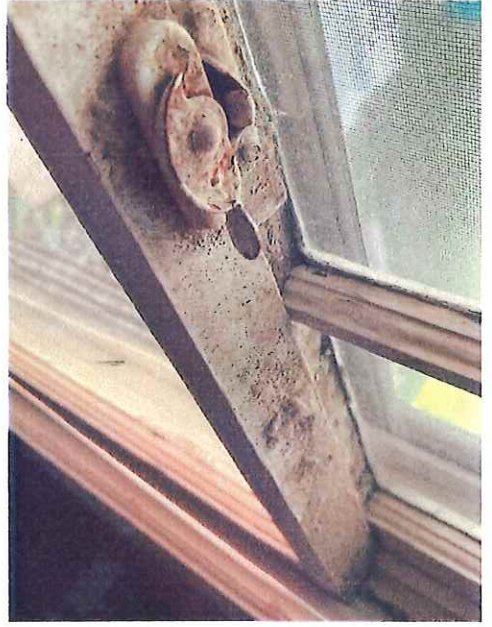
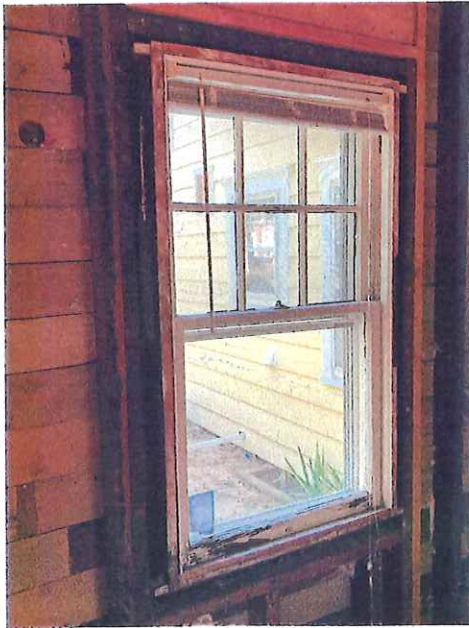
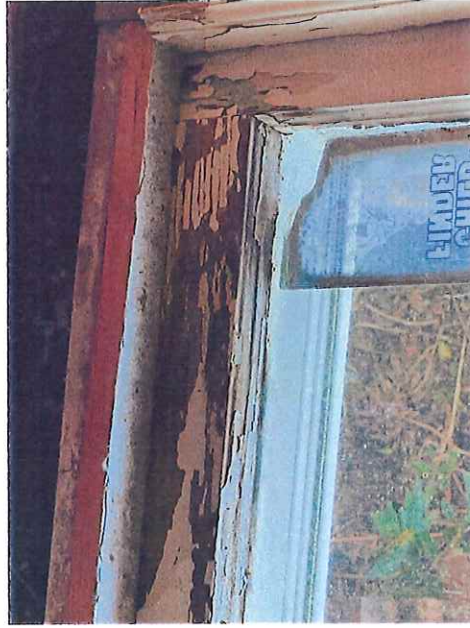
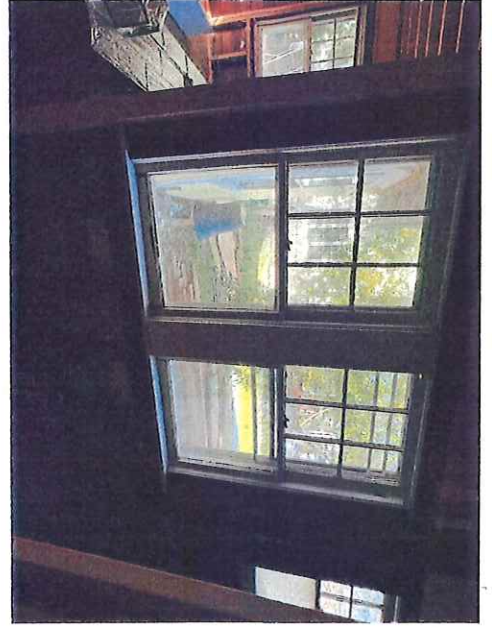
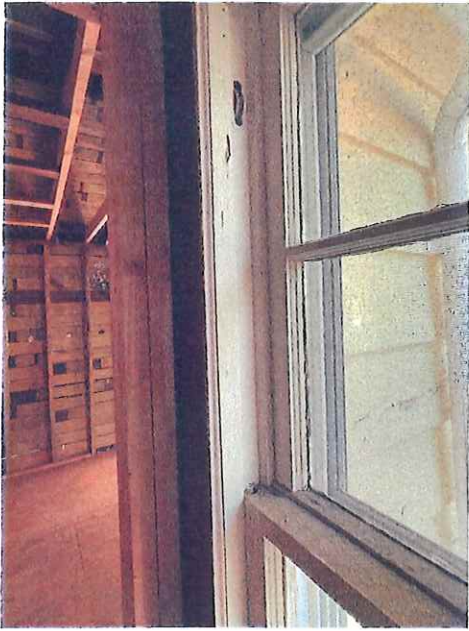
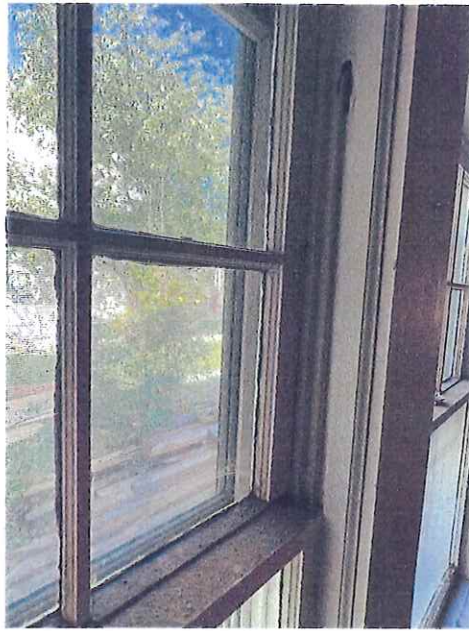
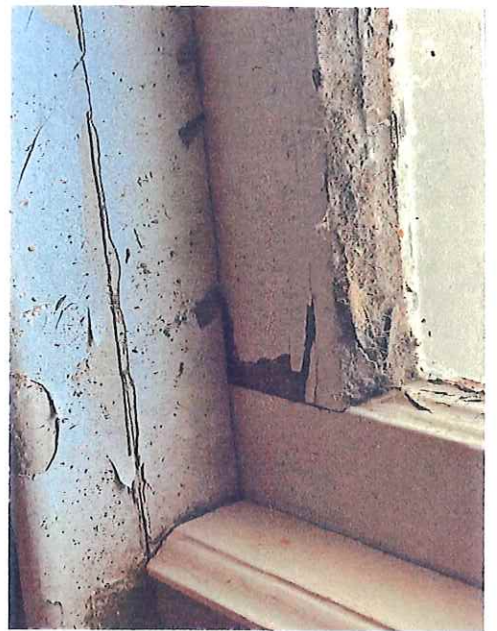
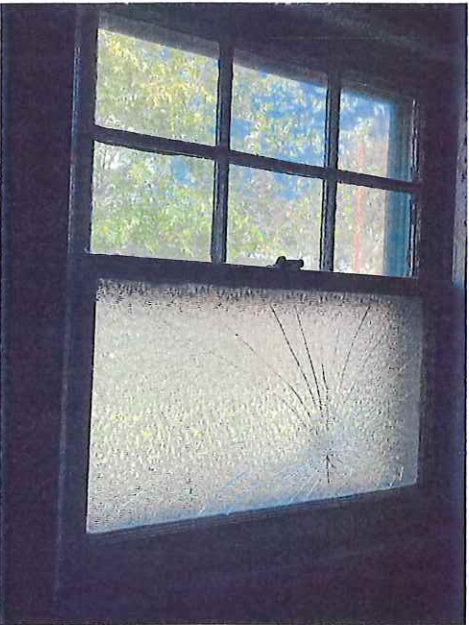
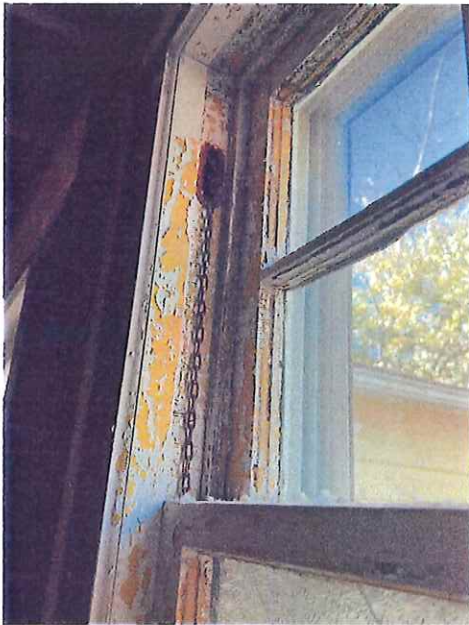
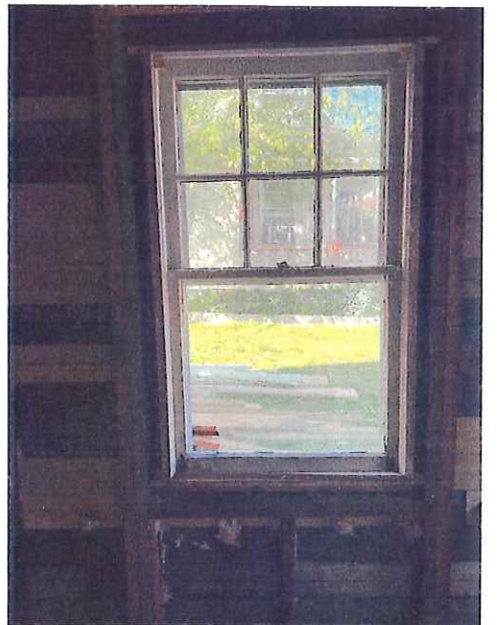
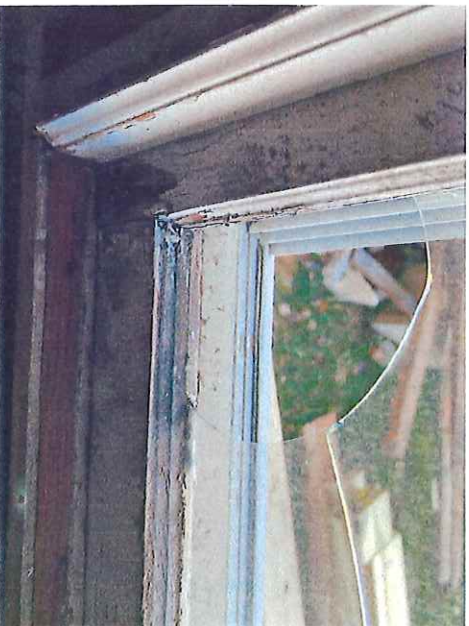
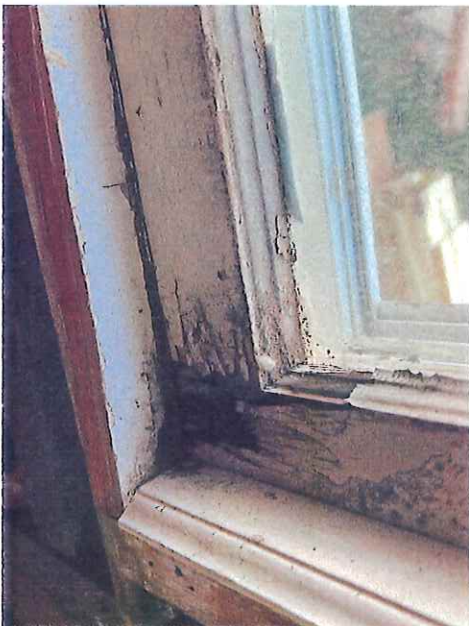
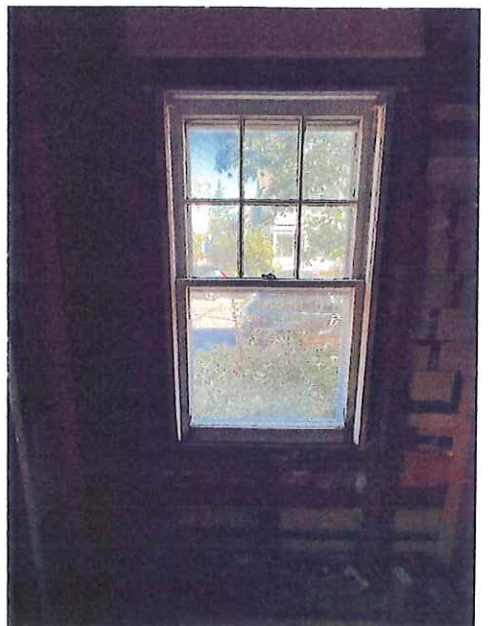
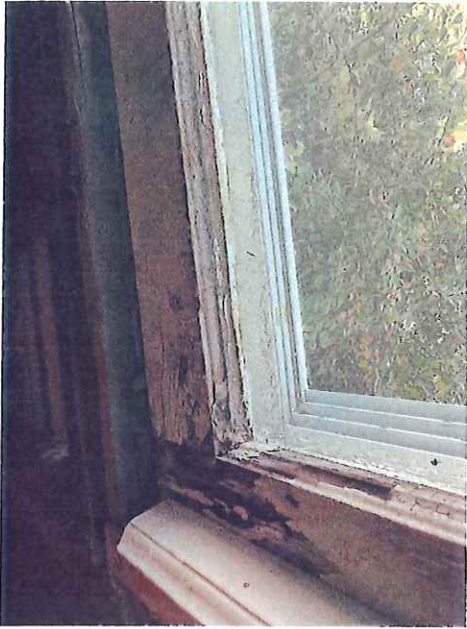
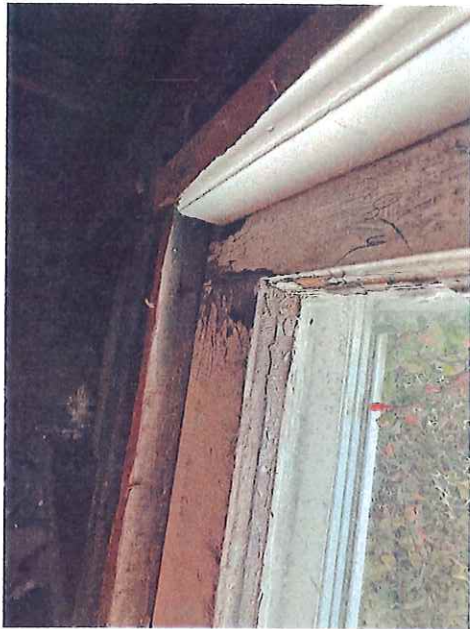
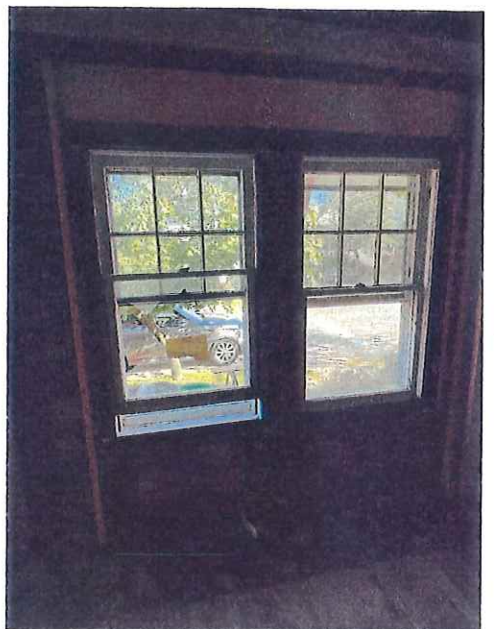
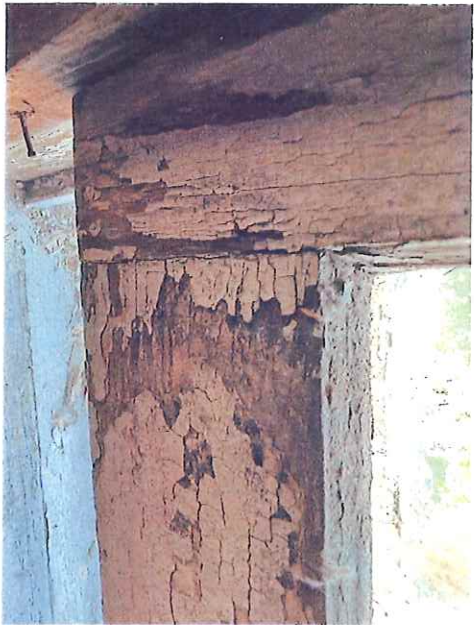
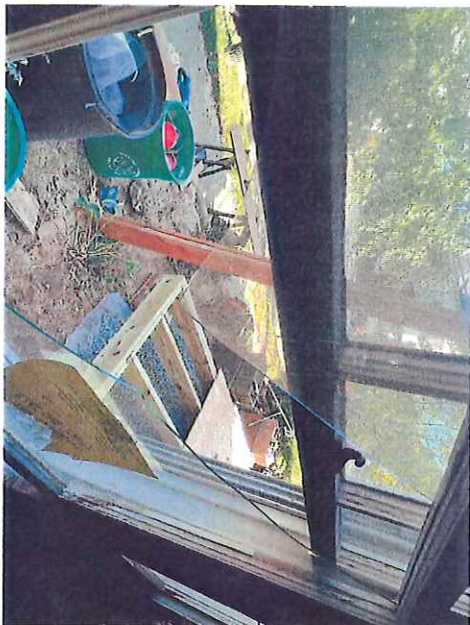
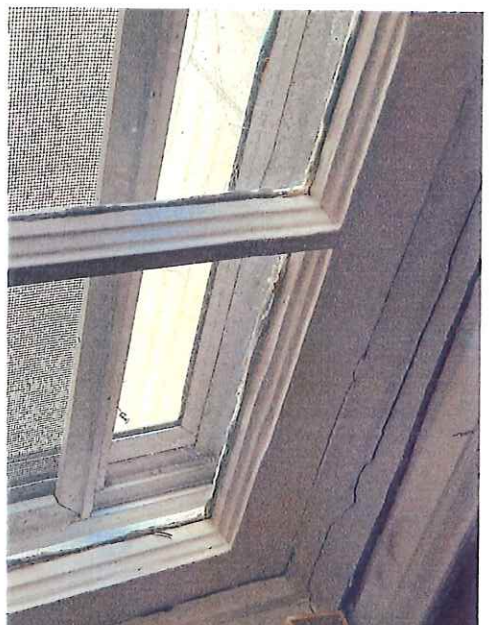
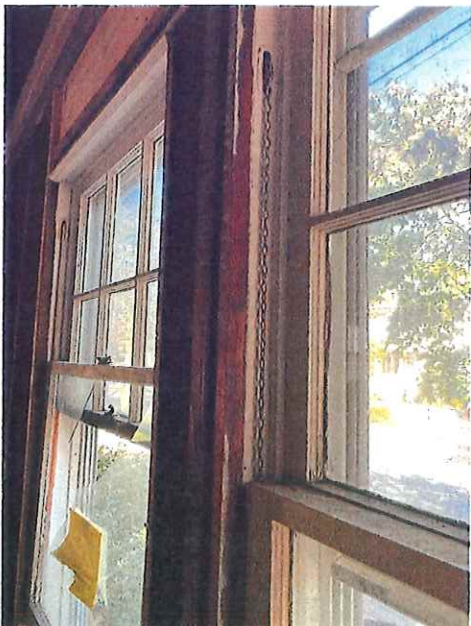
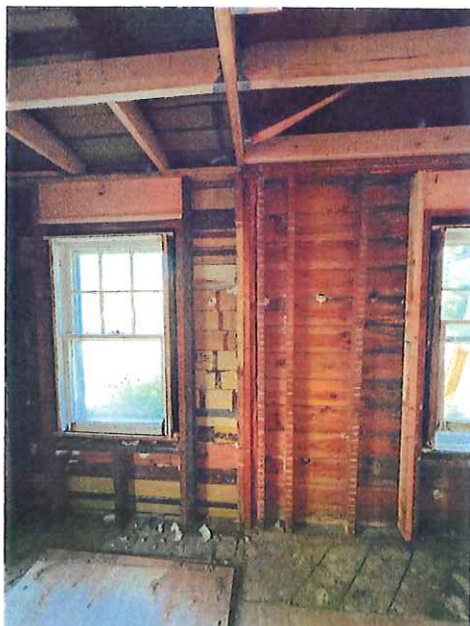
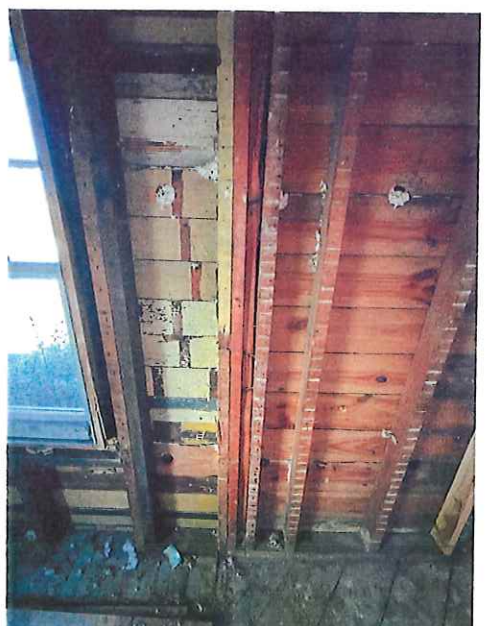
**WINDOWS SASH AND FRAME HAVE BEEN PERMEATED WITH MOLD, FOUND TO BE SEVERELY COMPROMISED FROM WATER DAMAGE AND GENERALLY INOPERABLE WITH MISSING, RUSTED AND BROKEN HARDWARE**
