## D\_Response\_to\_Tech\_Notes

HPC Tech Review 4/22/2025I

118 Main Ave

### Introduction

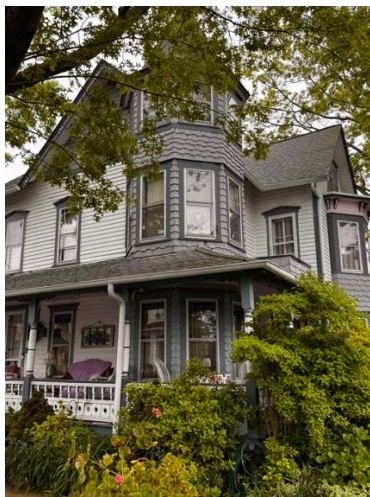
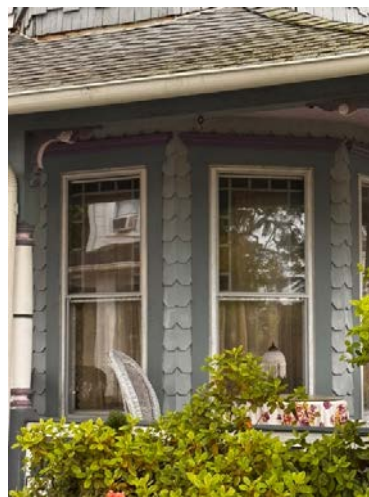
115 Mount Hermon Way, with singles at the Level 1 tower. (Also on Fireman’s Park).

To help Commissioners in their deliberations, we have included belcoe related Queen Anne properties that include shingles/shakes on their Level 1 towers.

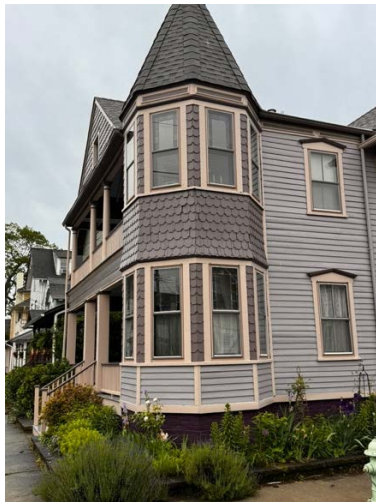
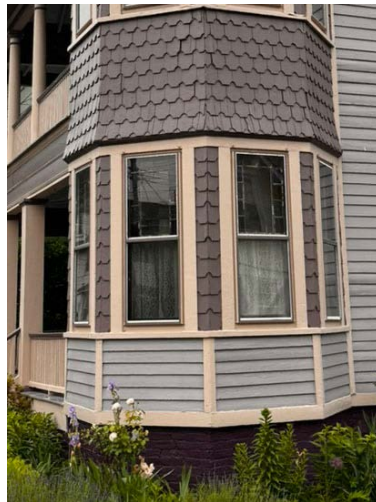
90 Mount Tabor Way, with shingles at Level 1 (where shakes are found between the windows).

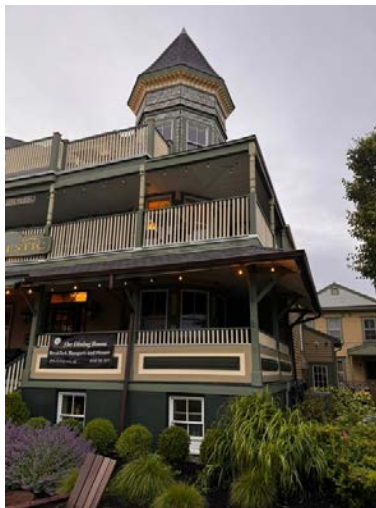
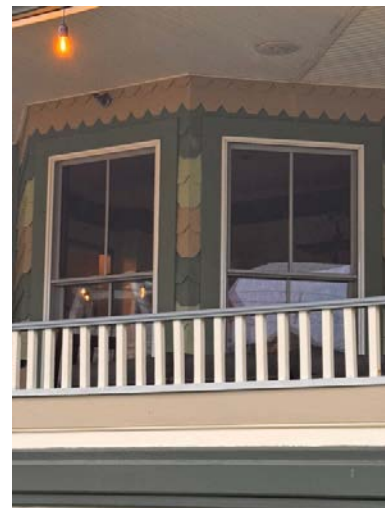
19 Main Avenue (the Majestic) with shingles on the Level 1 tower.

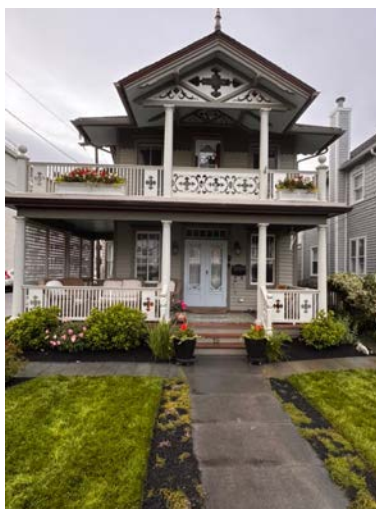
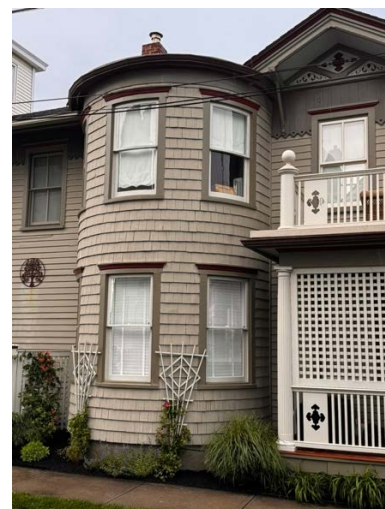
15 Heck Avenue, with shingles from top to bottom of tower.

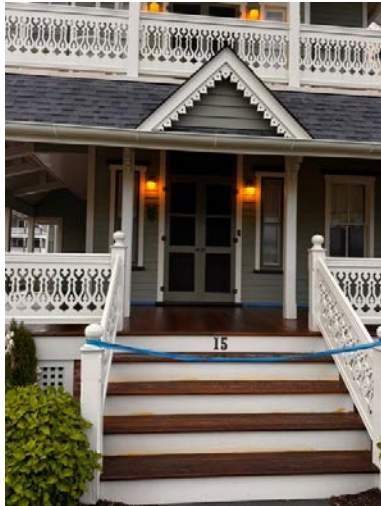
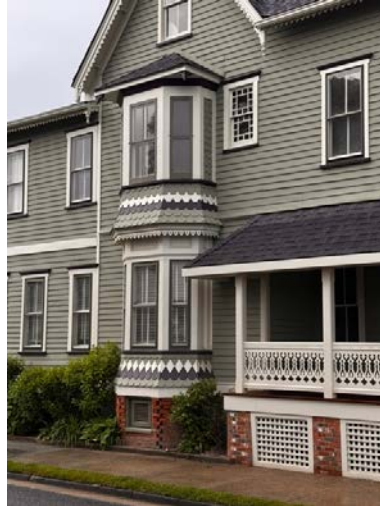
15 Ocean Pathway, another elaborate Queen Anne with shingles extending to Level 1.

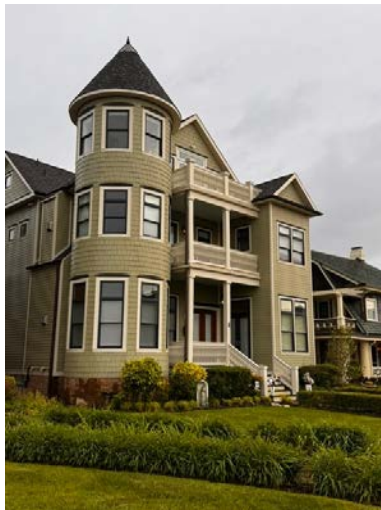
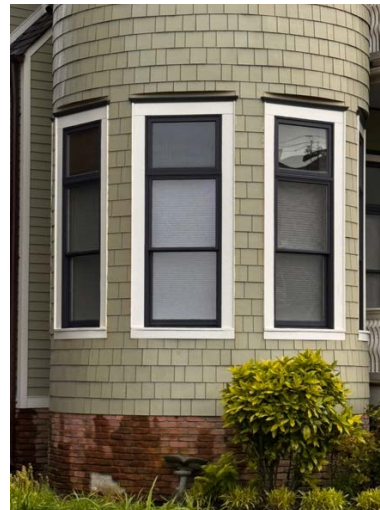
4 Main Avenue, a modern example of Queen Anne with shingles at all levels of the tower.

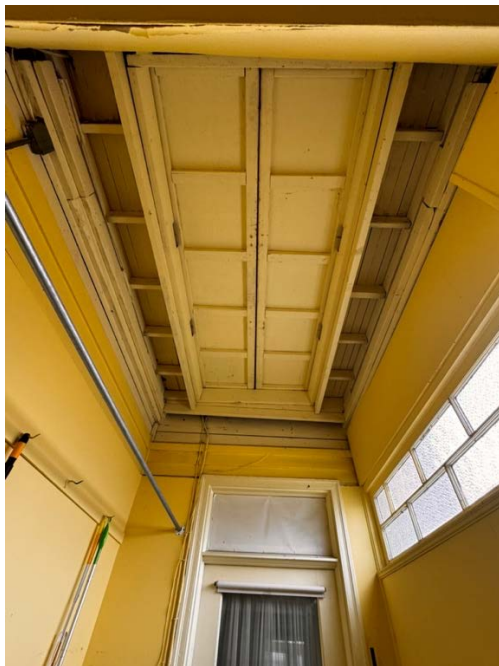
Looking up at the existing 2<sup>nd</sup> floor side porch floor. Note the pitch of the support boards running left to right. Also visible are the underlying floorboards of the original porch.

**Existing:** There are no existing side porches, though the Sanborn maps and physical evidence in the house indicate there was once both a 1st and 2nd floor porch at the east elevation just south of the central bay. Both areas were enclosed and conditioned during an earlier modification of the building.

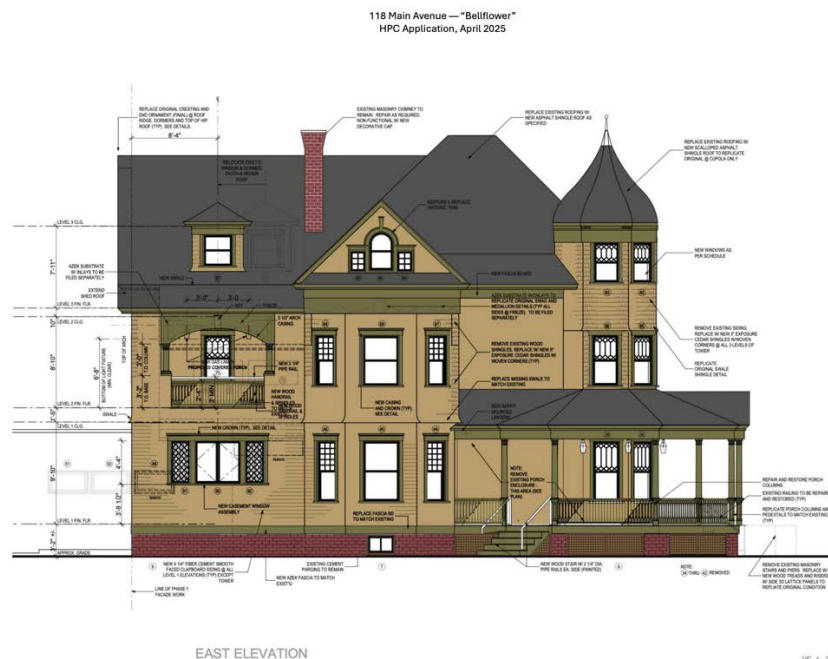
An illustration of the proposed palette with brick veneer showing at the foundation. Note: brick veneer is not proposed in this application but may be proposed in a subsequent application.

Note: a color illustration (east elevation) of the proposed palette (included in the application) shows how such a brick veneer might appear, but brick veneer is not proposed at this time.

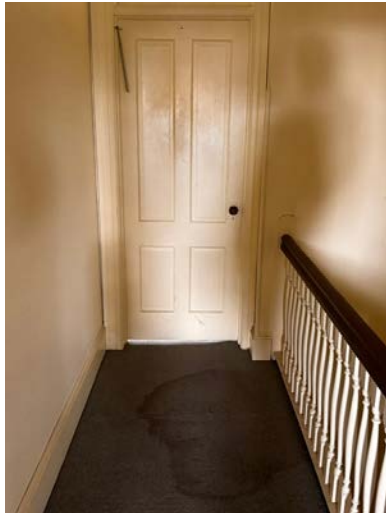
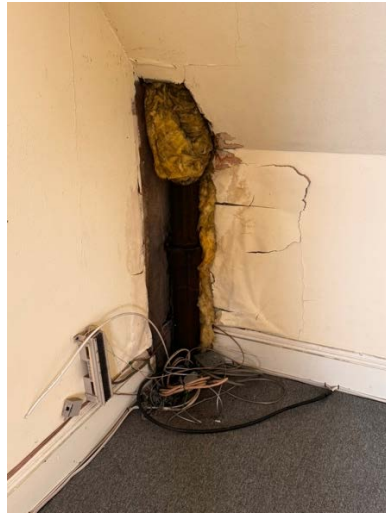
Door to attic area at rear of house and exposed pipes and wires.

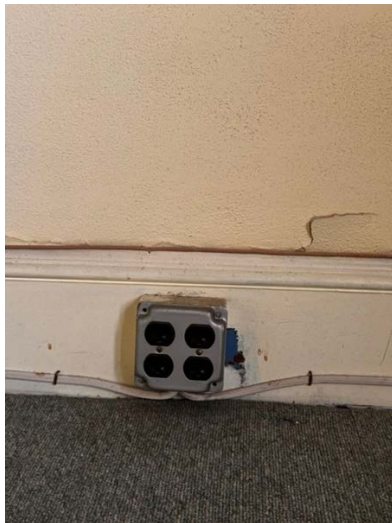
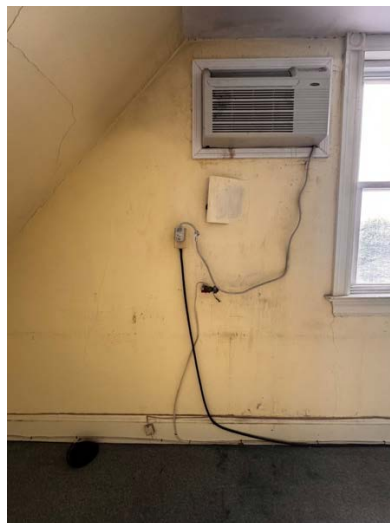
Electrical in this room is limited to junction boxes mounted to baseboards with un-enclosed electrical wires running between them. The room is unheated. (A non-conforming A/C unit was installed by cutting a non-conforming hole in the south wall sometime in the 1980s).
