03. Description of Existing Structure

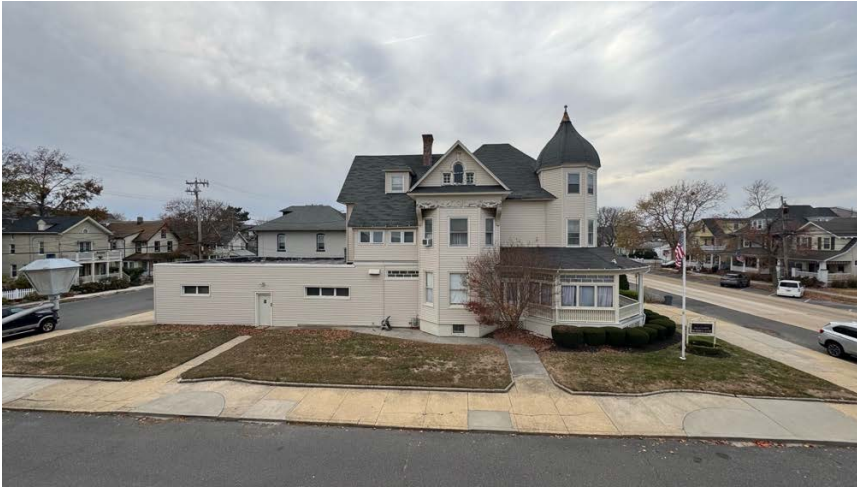
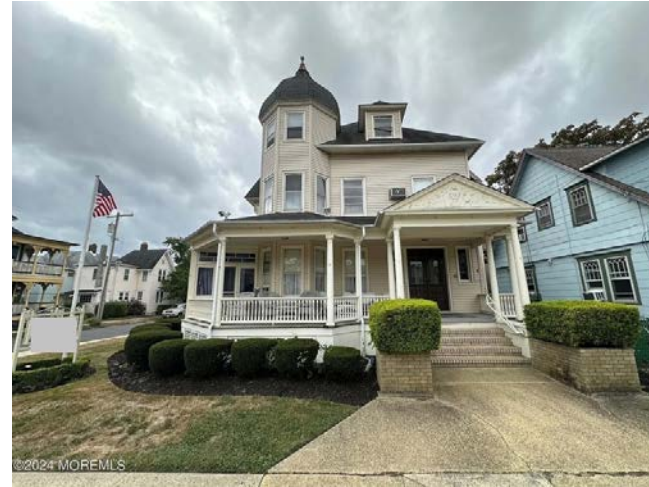
The property was once covered in beige vinyl siding. All such siding has been removed from the east, west, and north elevations. The south elevation is not included in this application and will be part of a later application, along with the garage.
