STORMWATER MANAGEMENT MEASURES

MAINTENANCE PLAN & FIELD MANUALS

**GALILEEE EGLISE ADVENTISTE INCORPORATED
PROPOSED CHURCH**

**3313 NJ RTE 33,
NEPTUNE, NJ 07753**

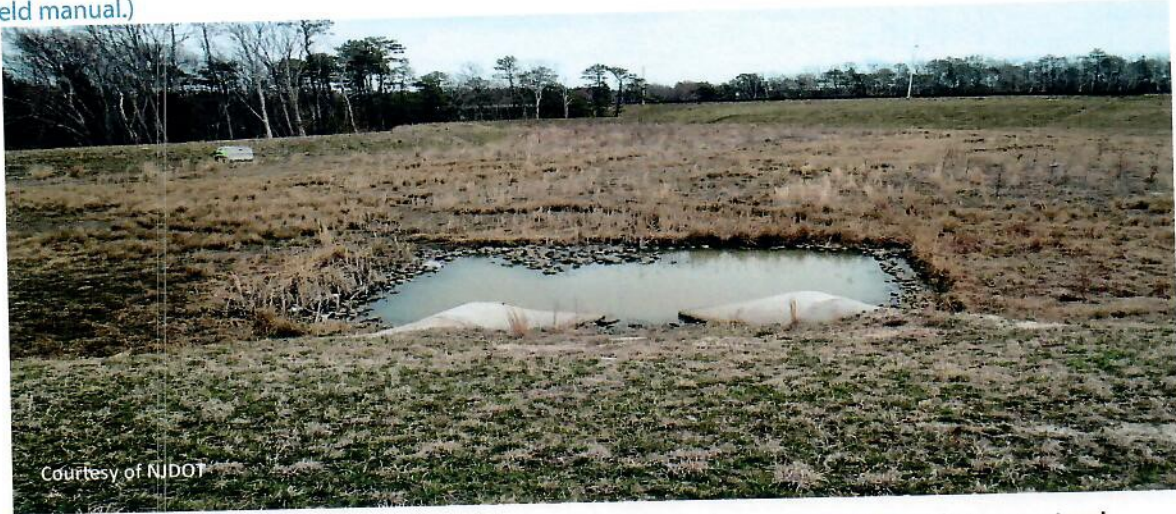
Issue:

The inlet is not properly drained, assuming it has not rained within 72 hours.

Preventative Action:

Routine inspections and removal of sediment from the forebay.

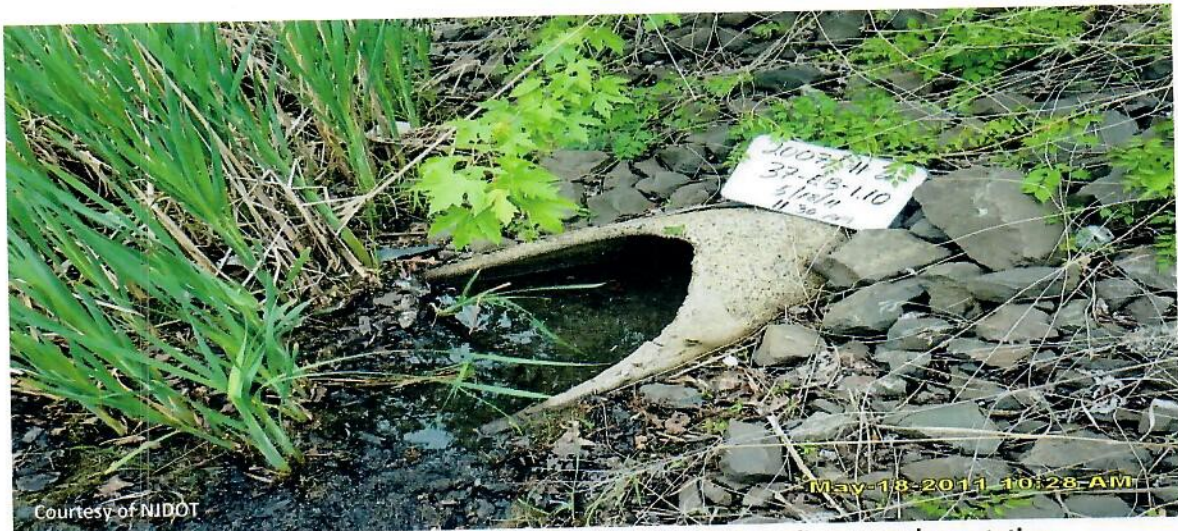
Issue:

The Inflow pipe is clogged by sediment and vegetation.

Preventative Action:

Routine inspection and removal of sediment and unwanted vegetation.

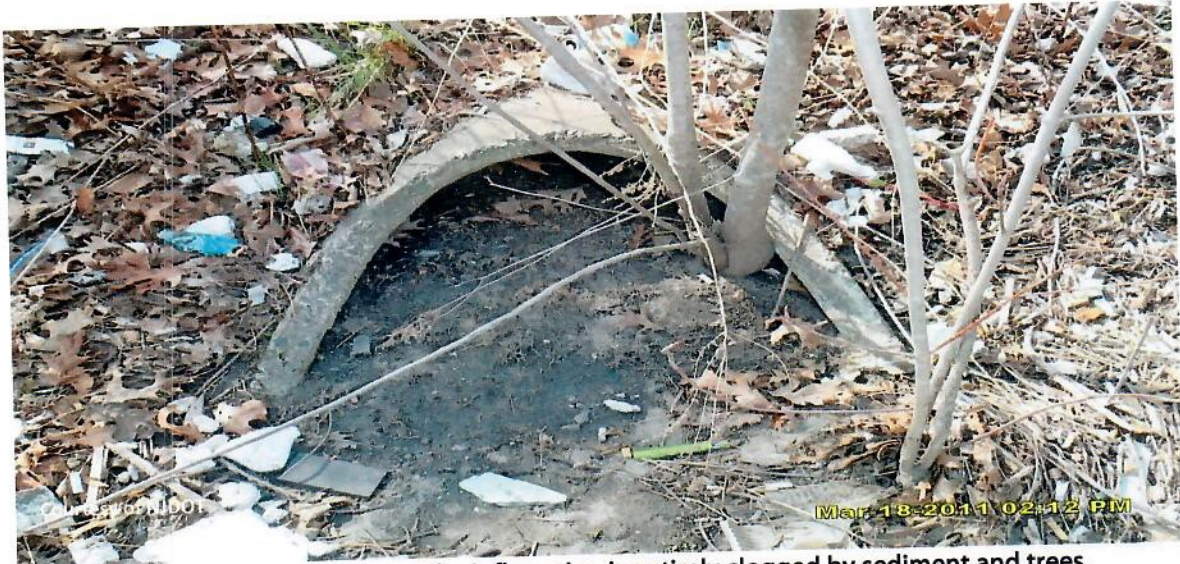
Issue:

The Inflow pipe is entirely clogged by sediment and trees.

Preventative Action:

Routine inspection & removal of sediment and unwanted vegetation.

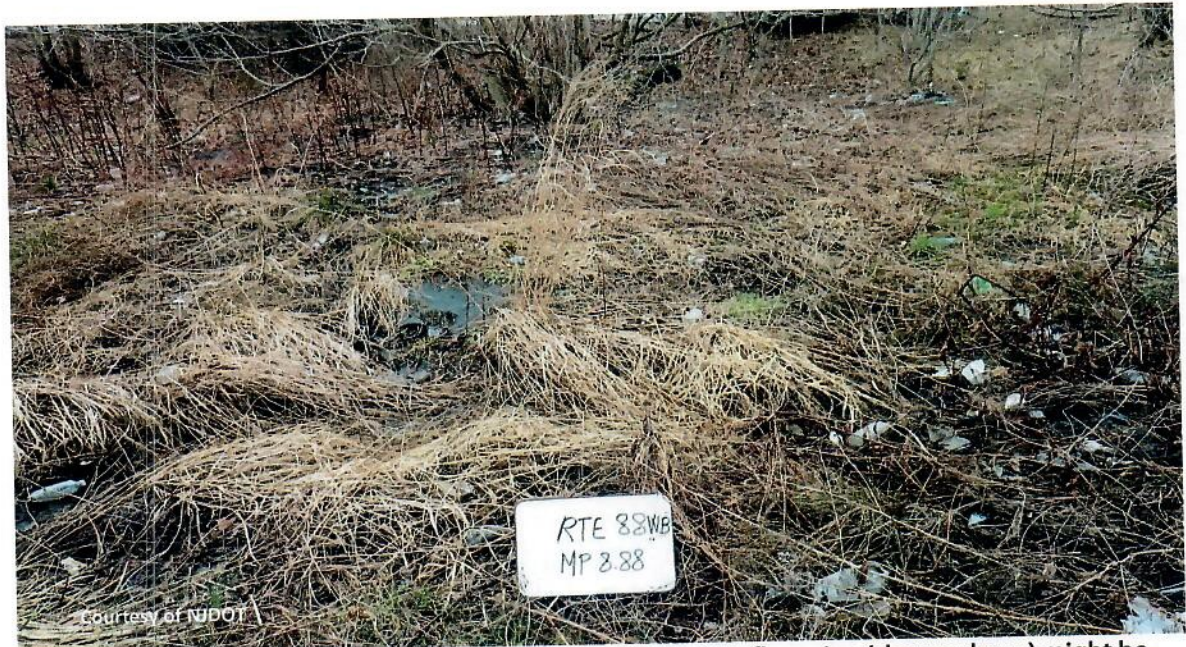
Issue:

The excessive sediment in inflow pipe (shown above) might be caused by a blockage of flow to the basin due to excessive vegetation and overgrown trees.

Preventative Action:

Routine inspection and removal of sediment and unwanted vegetation.

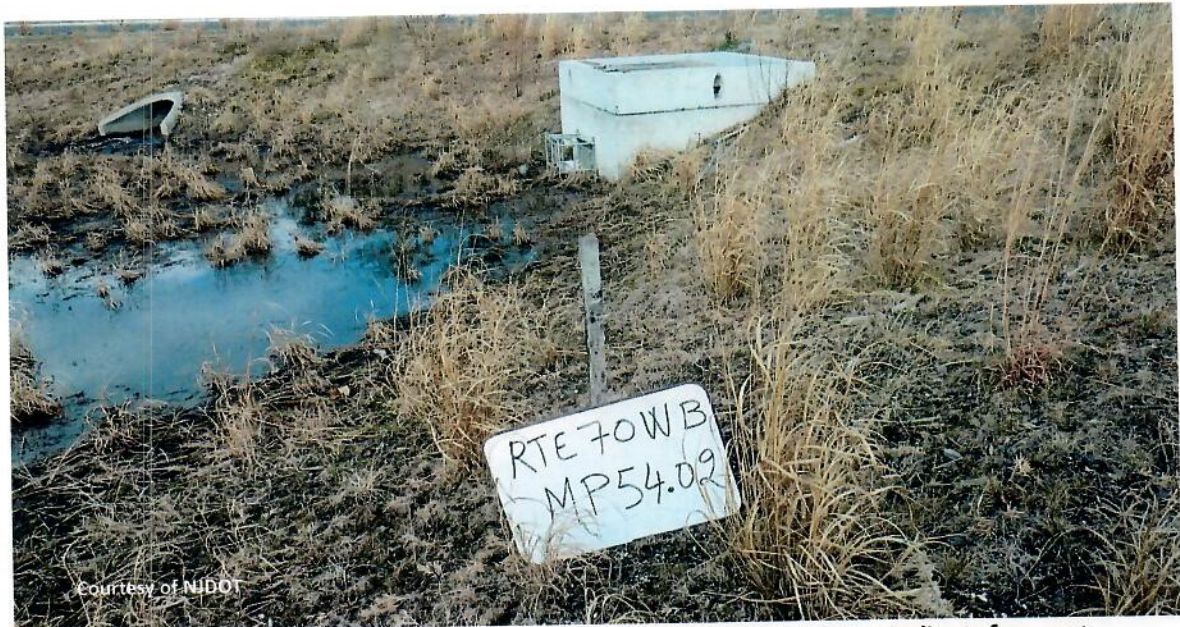
Issue: The vegetation loss and the blackish soil may indicate frequent inundation.

Corrective Action: Check the permeability rate of the soil and the water table elevation. Replace the soil if necessary.

Preventative Action: Routine inspection and tilling/aeration, if necessary.

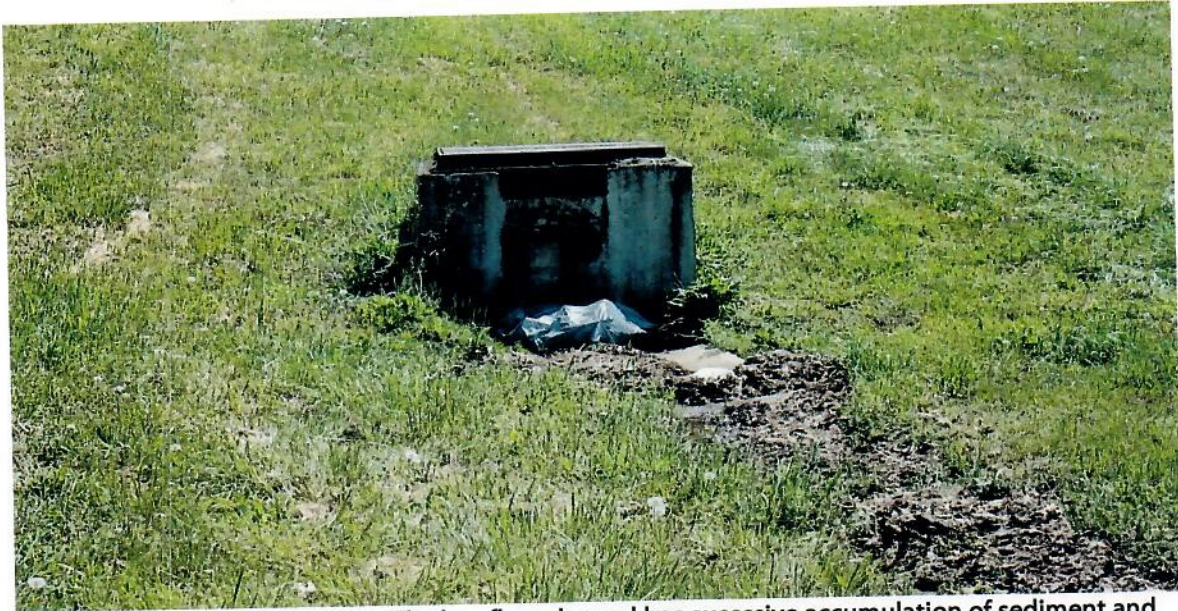
Issue:

The low flow channel has excessive accumulation of sediment and debris. The outflow orifice is clogged by a trash bag and debris. Note that there is no trash rack installed.

Preventative Action:

Routine inspection and cleaning.

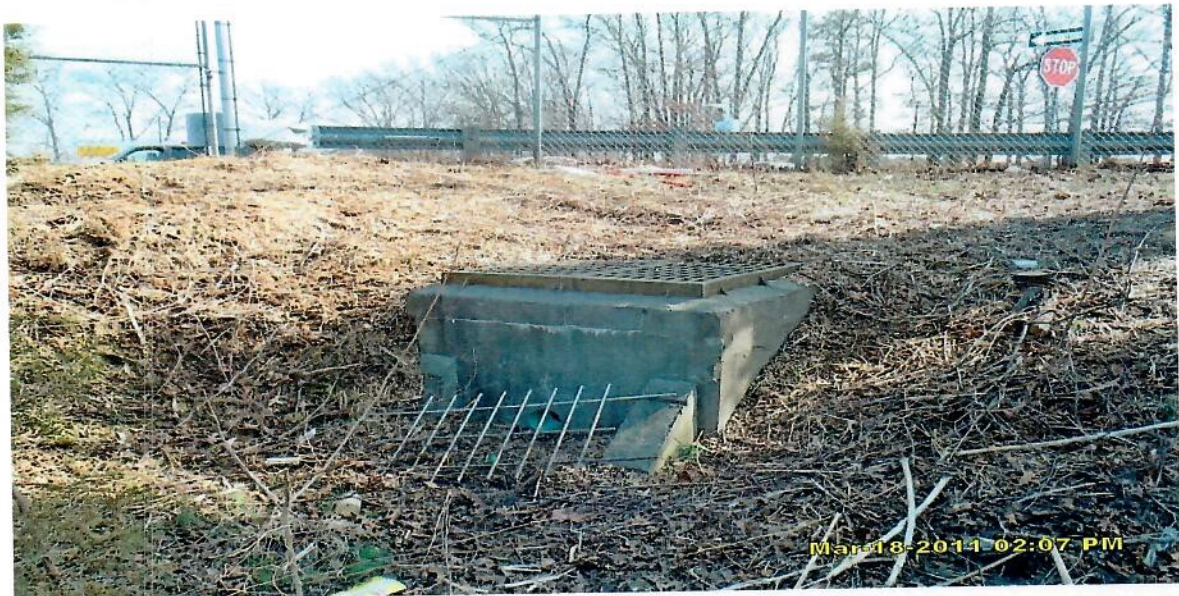
Issue:

Trash rack is damaged.

Preventative Action:

Routine inspection, especially after large storm events. Tighten any loose bolts and repair structural flaws.

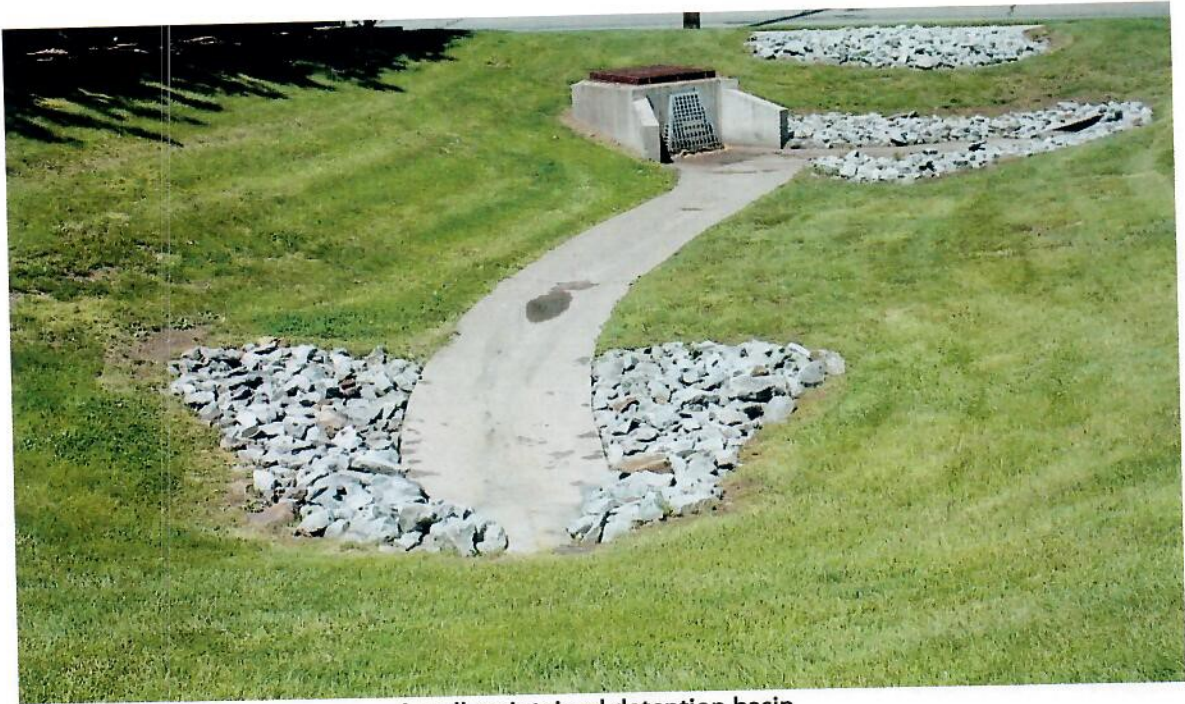
A well maintained detention basin
