## EXISTING WINDOW , SIDING & STRUCTURAL OBSERVATIONS -90 CLARK AVE.

Gannon Building & Remodeling has worked on hundreds of homes and other structures in and around Ocean Grove since 1985 . We have rebuilt countless Victorian era windows and doors over the last 35 years. We also have extensive experience in overall renovation of historic structures including but not limited to salvaging, repairing, weaving in of existing wooden clapboard siding. Mr. Heil , owner of 90 Clark Ave, at the request of the Neptune Township HPC, instructed us to prepare this report based on several site visits in 2019 and 2020. The architect, Brian Berzinskis, has numbered the windows, delineated areas of original siding on the attached elevations and provided photographs of same. We will refer to those items in this report.

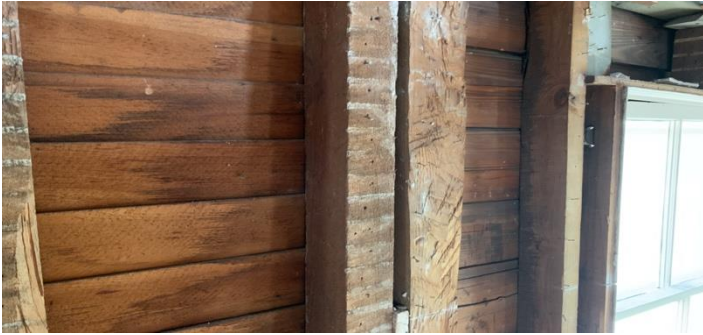
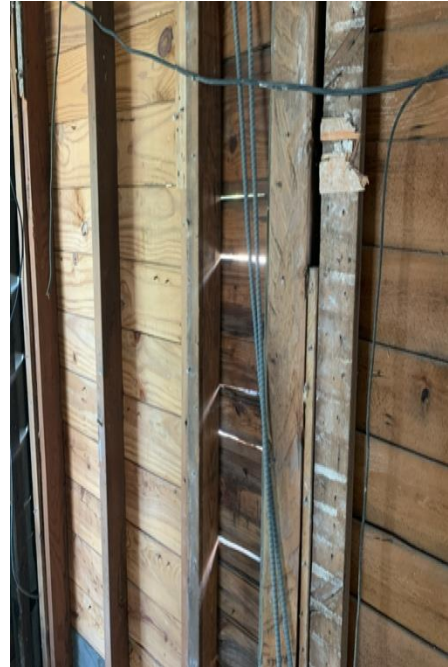
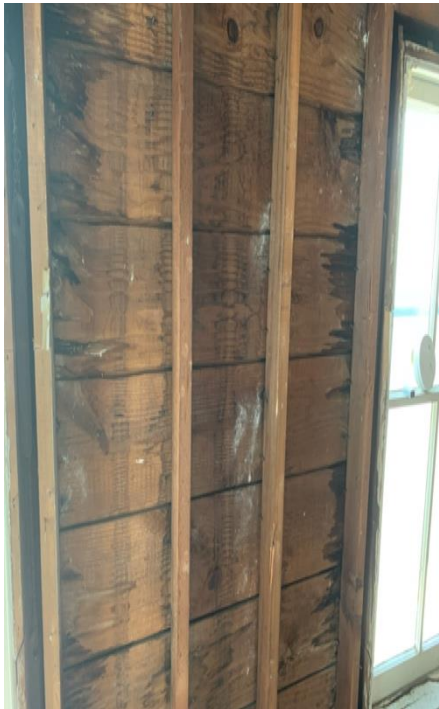
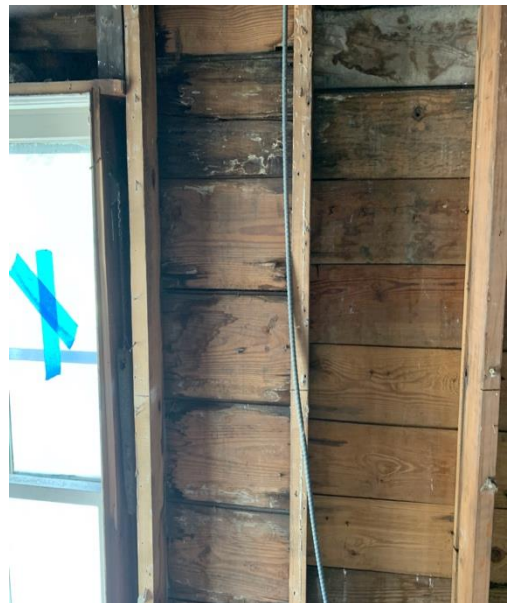
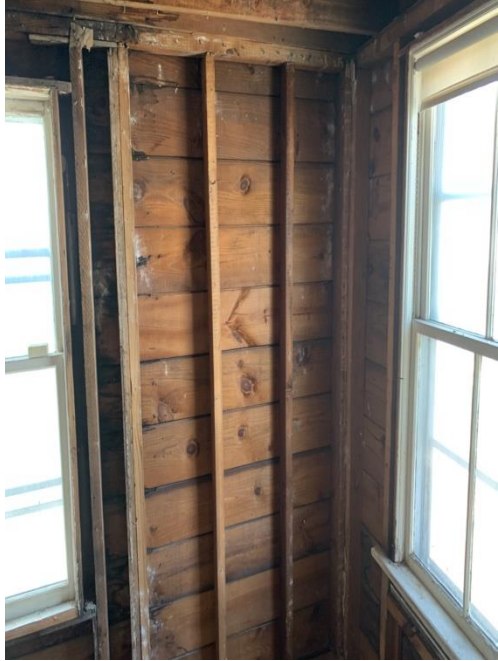
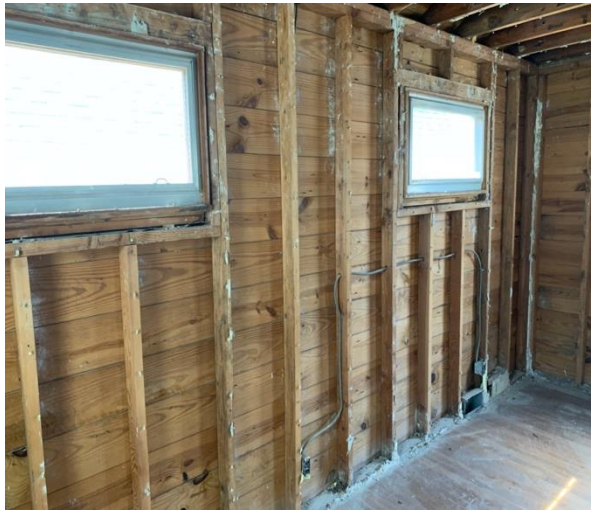
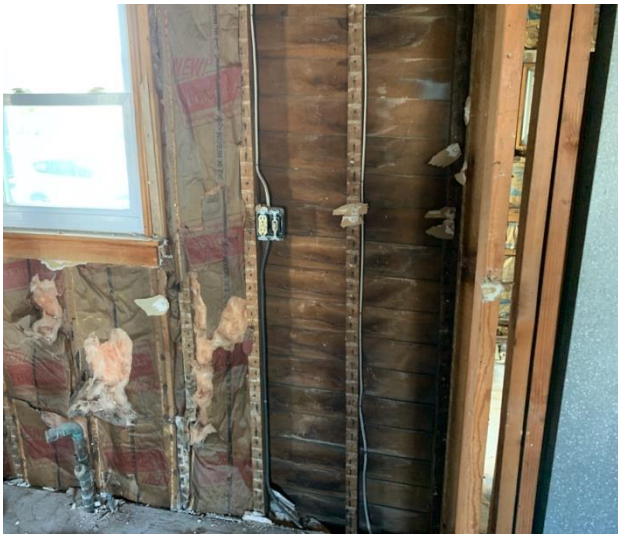
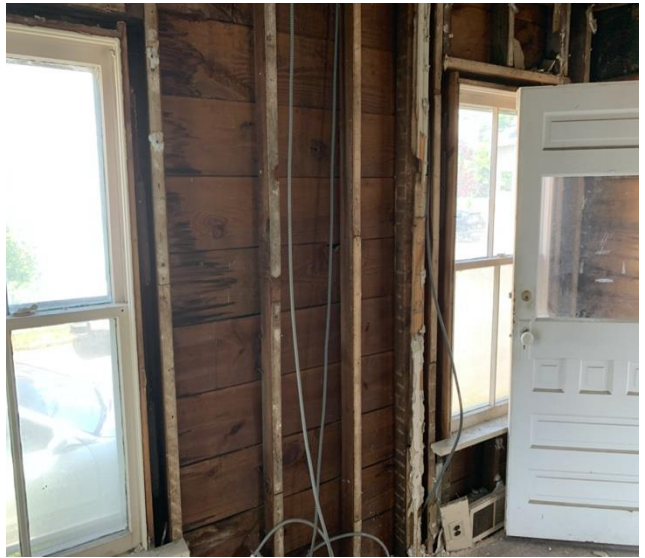
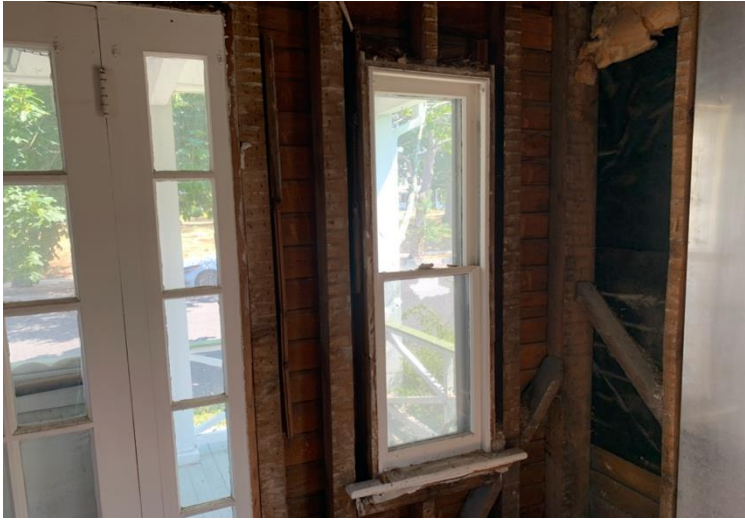
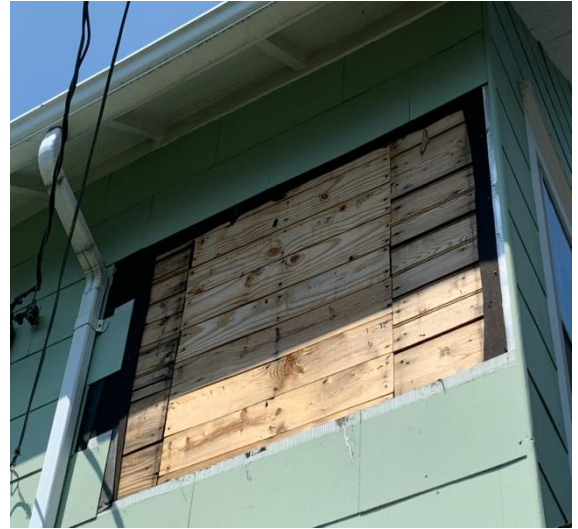
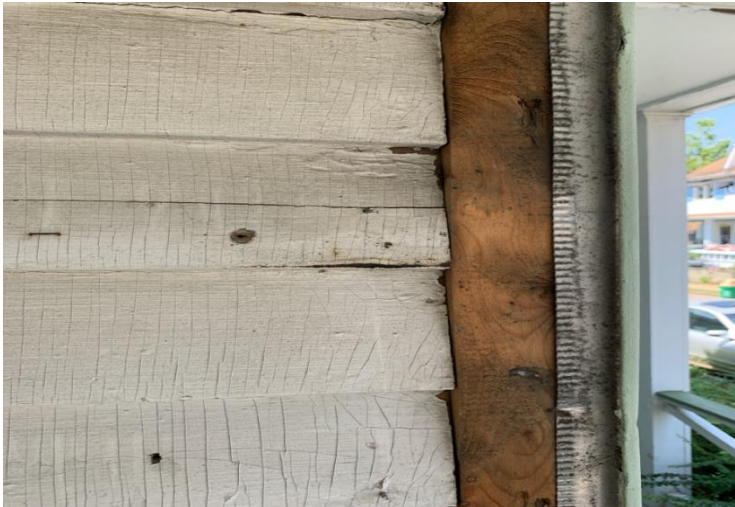
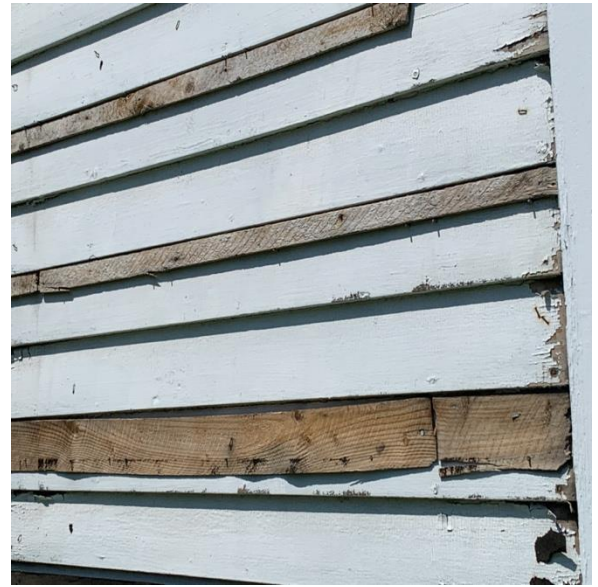
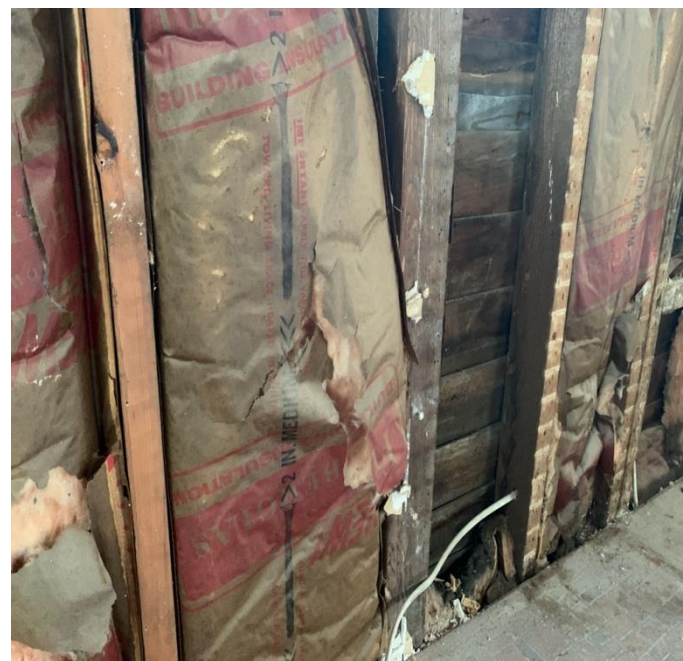
## Siding reveal

**Siding Overview:** Clapboard siding was found under some sections of the exterior layer of asbestos siding. Other areas of the house were sided with horizontal 1 by 6 and 1 by 8 pine . Some of it was tongue and groove, some was flat stock. The amount of original siding remaining on the building is fractional and denoted on the Elevations attached marked as area #1. The majority of the remaining original clapboard siding has been compromised by the removal of corner boards, rim trim boards as well as a multitude of cut out areas , furring strip damage , nail damage and years of neglect.(See photos attached) In addition, the original house was built as a balloon frame structure with the clapboard siding nailed directly to the structural vertical studs.(See Photos attached). In order to properly obtain structural code compliance, the existing clapboard should be removed and exterior plywood sheathing attached to the existing (some sistered/all firestopped ) vertical framing. Then the finished siding should be applied.

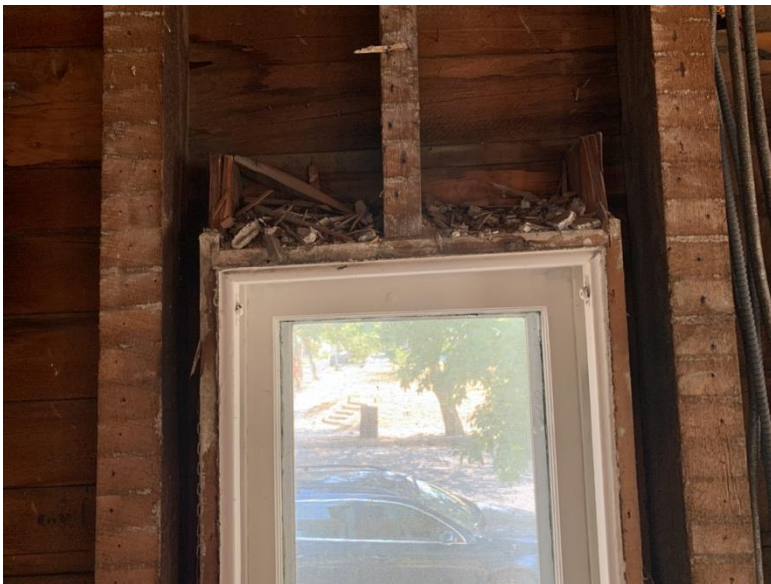
## Window 103

ORIGINAL – Same as window 101 and severely out of square

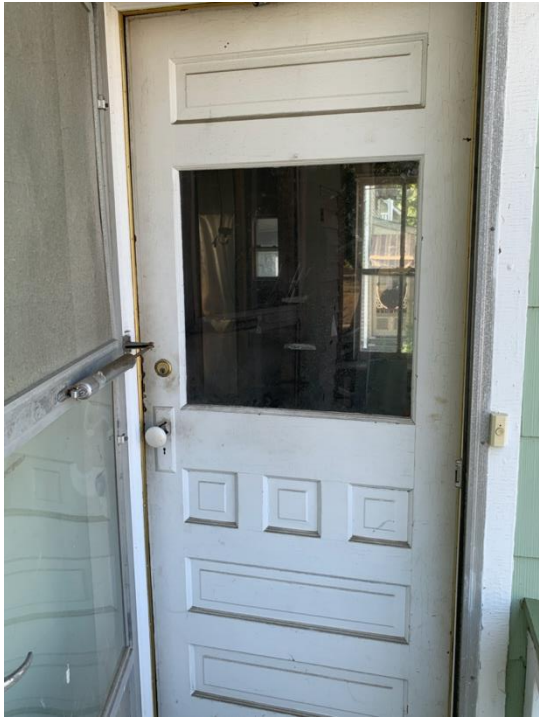
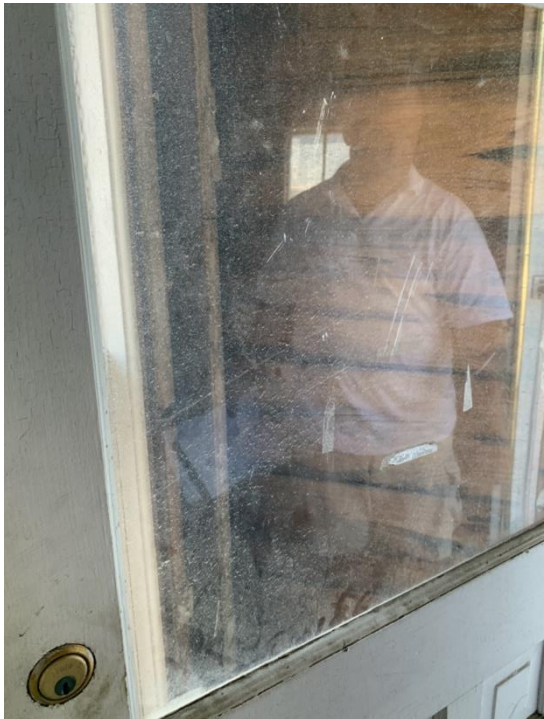
## Side Door 105

Side Door – 1 $\frac{3}{8}$ " thick . Not an exterior door – Plexiglass window in opening

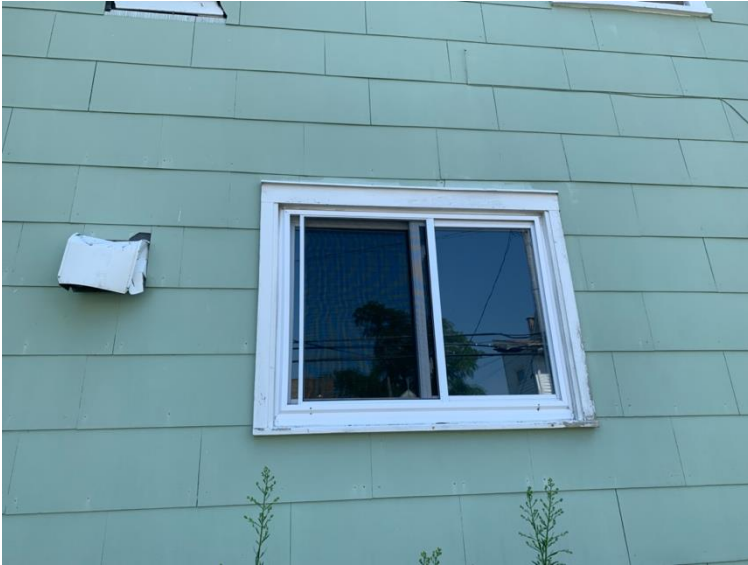
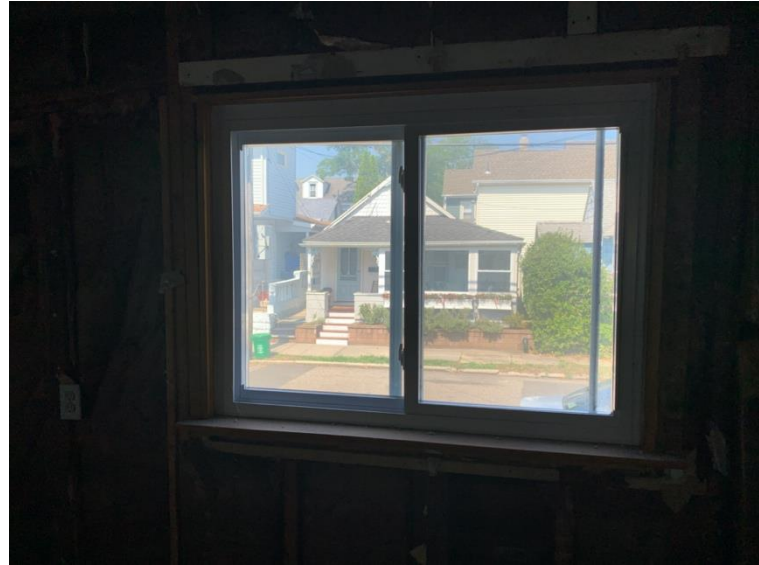
## Window 109

Vinyl Slider

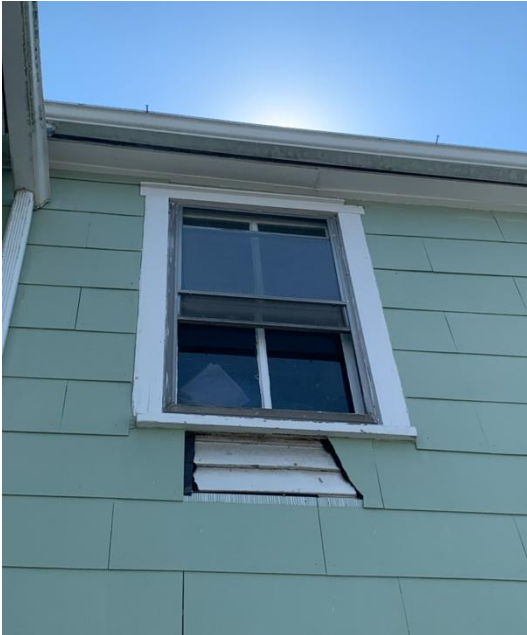
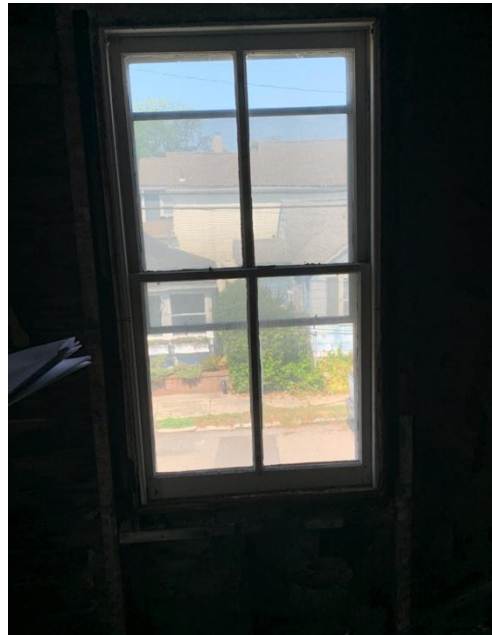
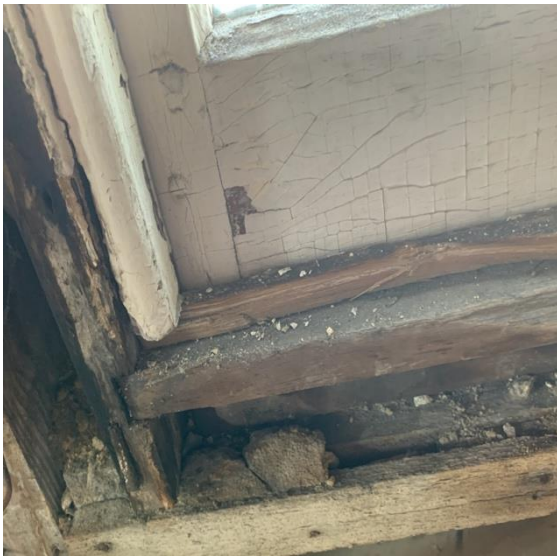
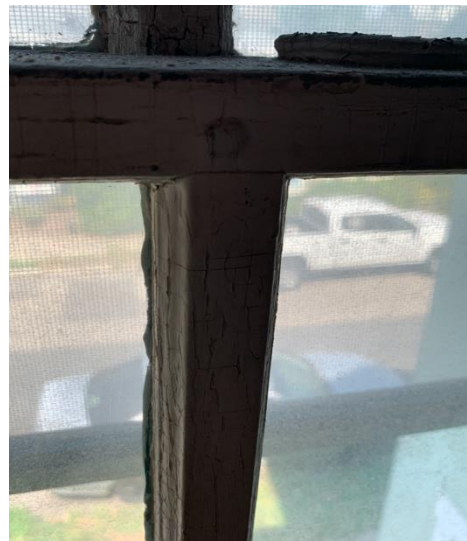
## Window 207

Rear Addition – Non original different mullion thickness and frame structure different than original dovetail mortice  
– Newer window – needs full rebuild

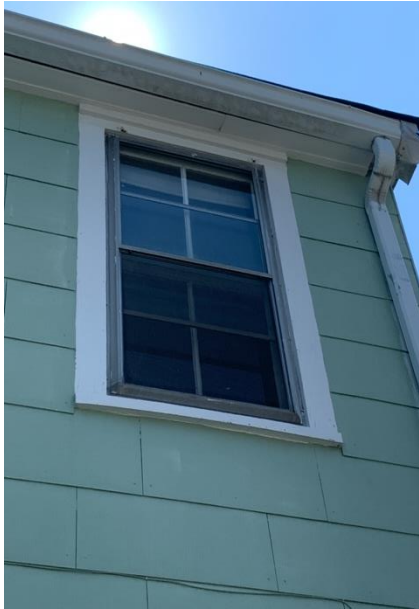
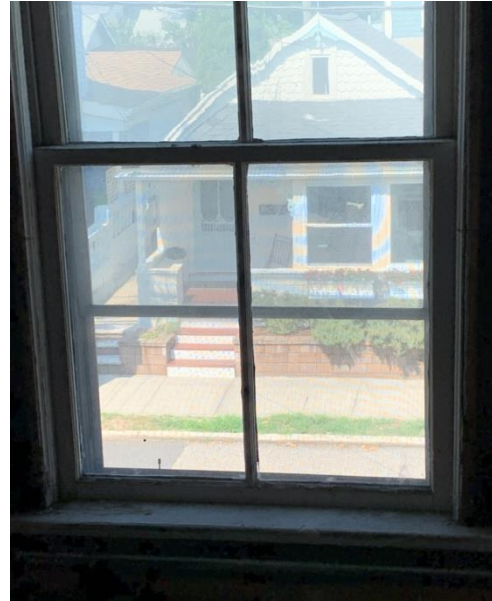
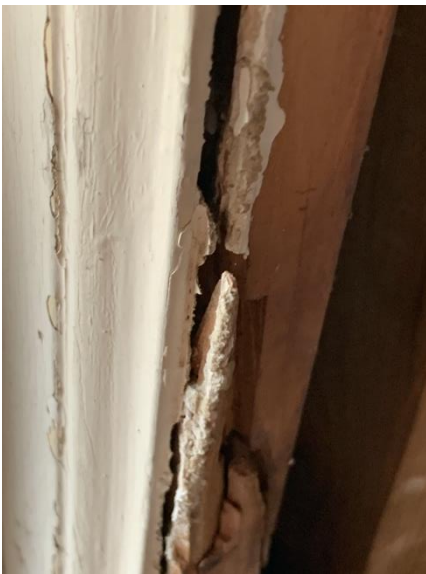
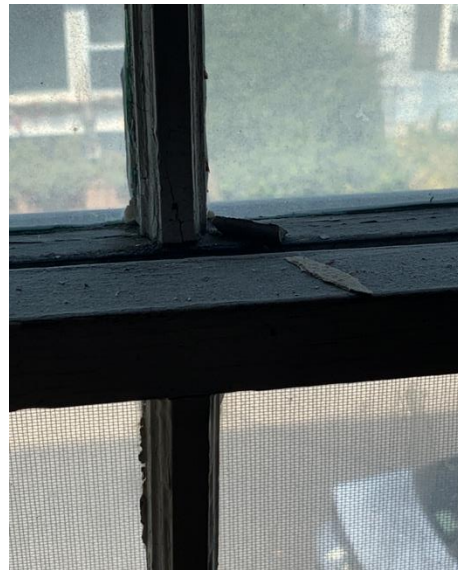
## Window 208

Non original different mullion thickness and frame structure different than original dovetail mortice – Newer window – needs full rebuild

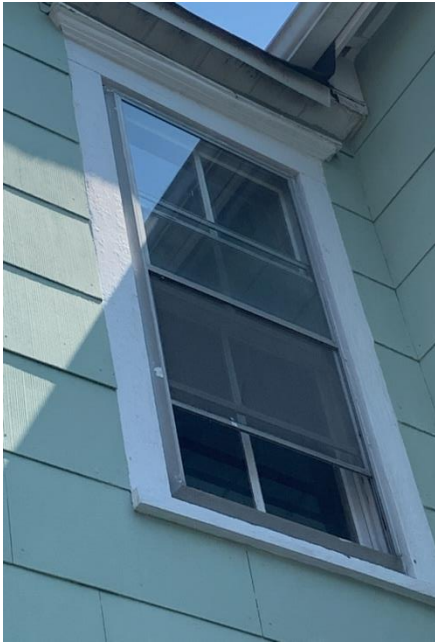
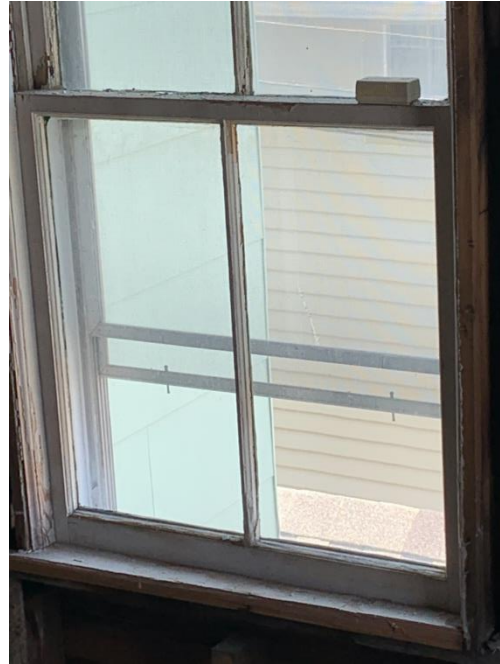
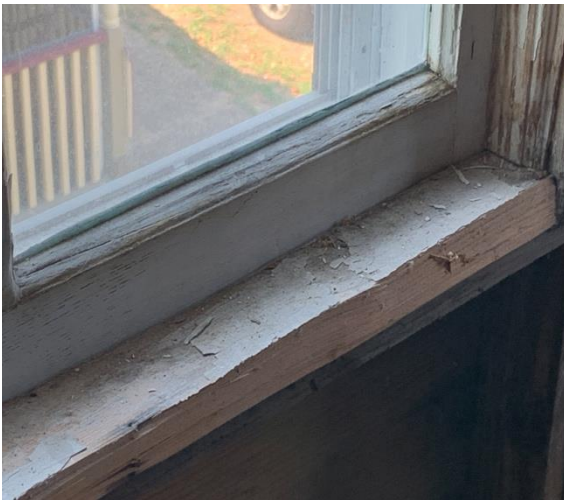
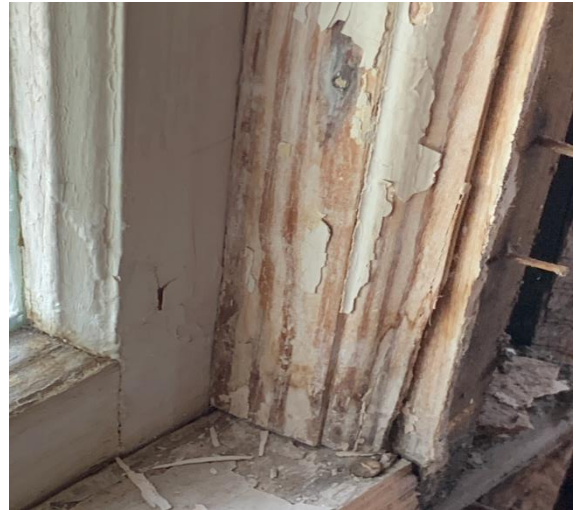
## Window 209

Non original different mullion thickness and frame structure different than original dovetail mortice – Newer window – needs full rebuild

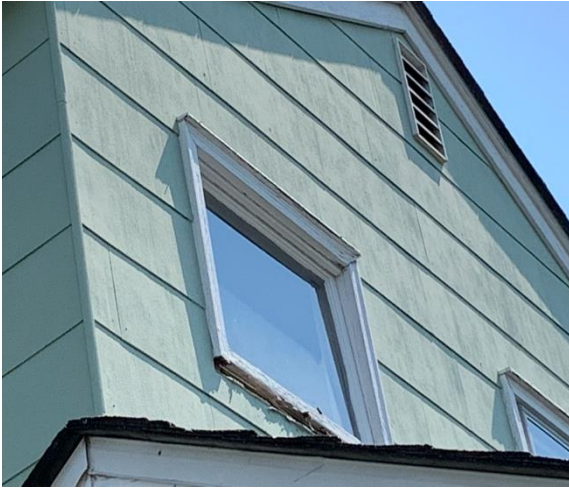
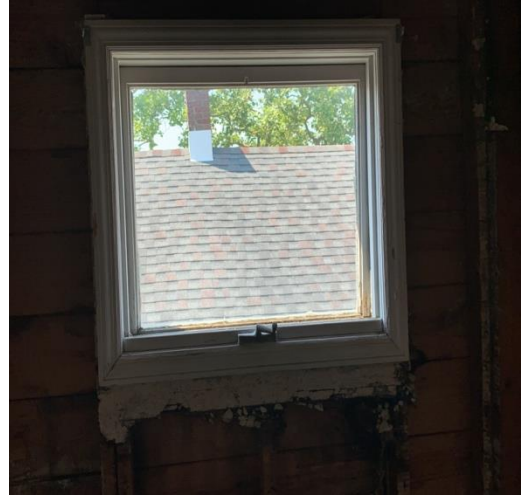
## Window 210

Casement Awning window – totally rotted wood

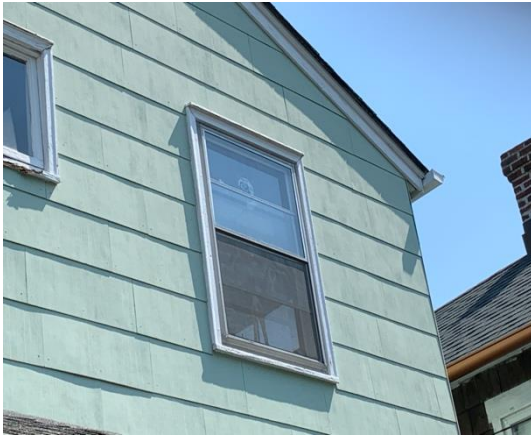
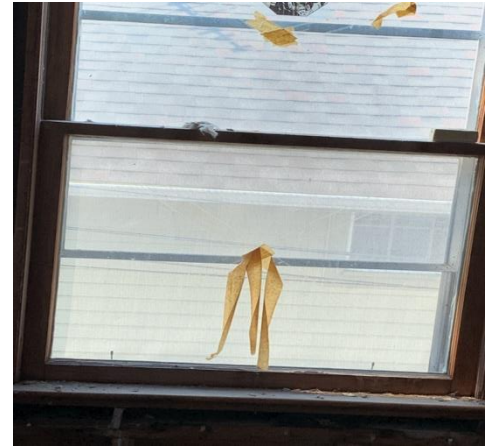
# Window 211

1980's ? Wood double hung – does not operate

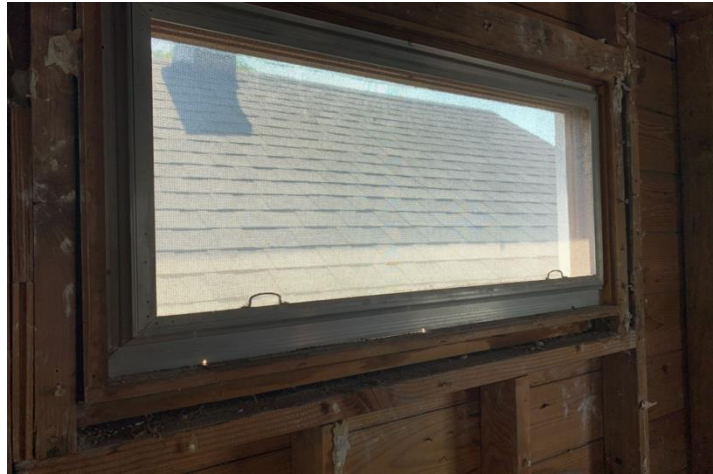
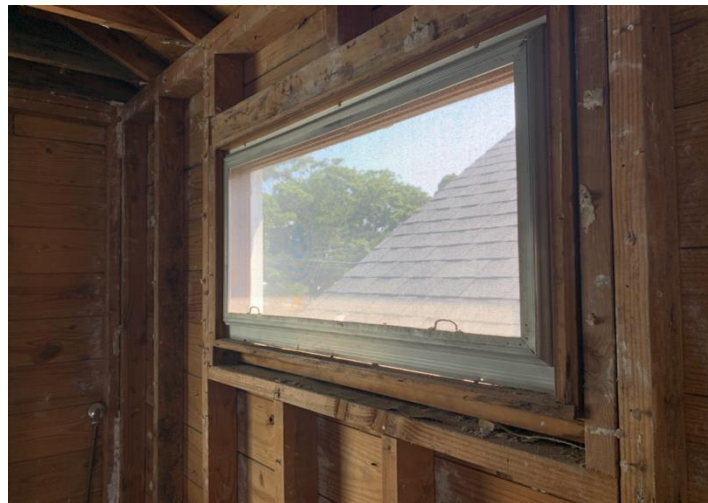
## Window 212/213

1980's ??? Wood Awning Windows

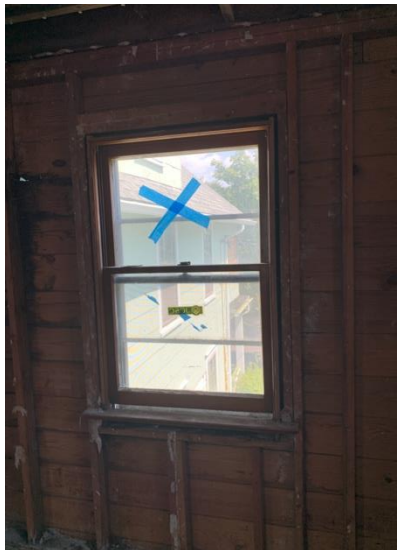
# Window 214

1980's Wood Double Hung

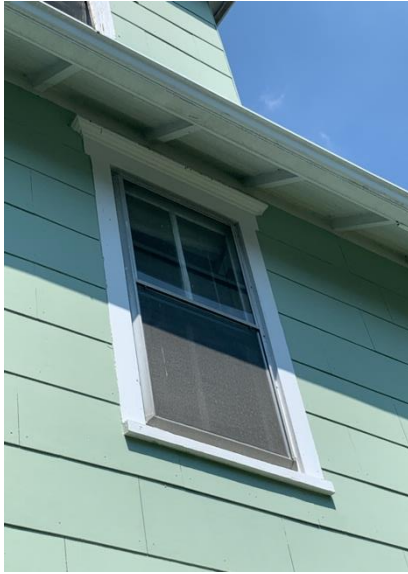
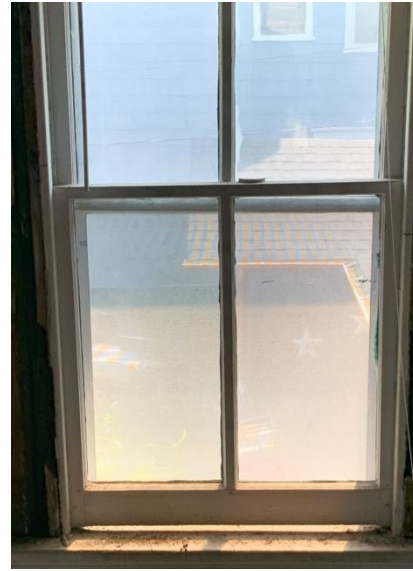
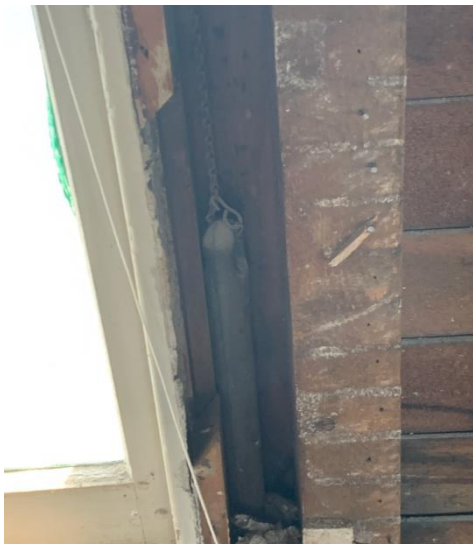
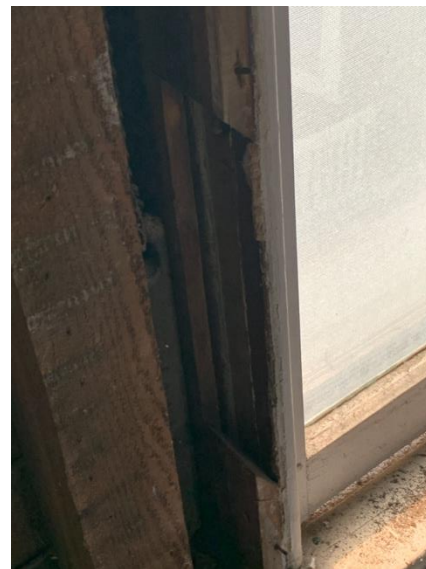
## **Window 215**

West Side Front \_ Original – Same as 101 Frame in total disrepair

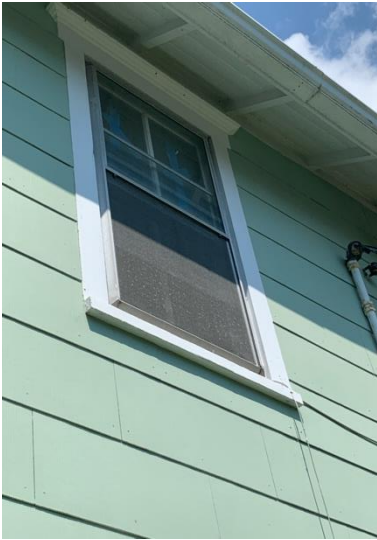
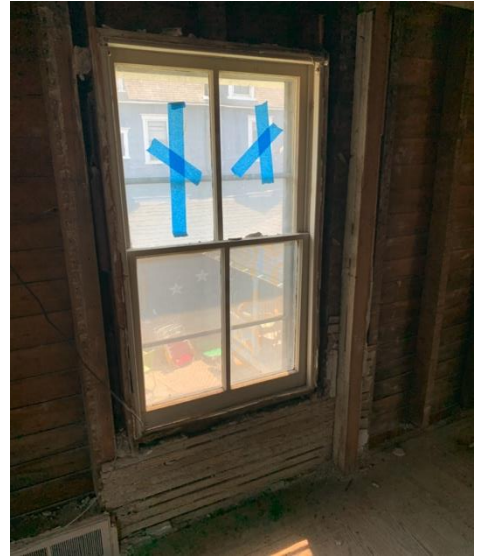
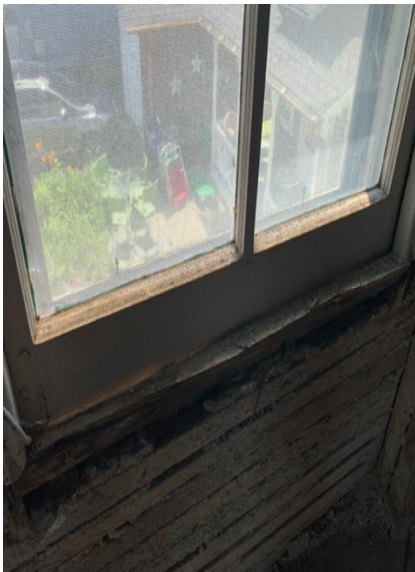
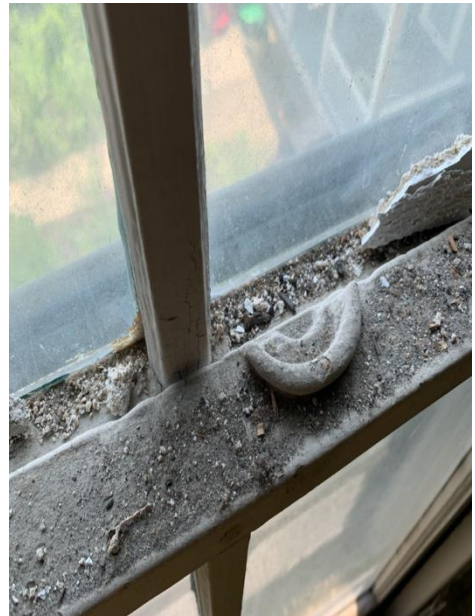
## Window 216

Original – Same as 101 frame in bad shape
